KENTUCKY HISTORIC RESOURCES  
Individual Inventory Form

NOV 2 1985  
Resource # BT-22  
Butler County

1. Name of Resource: Ice House on Muddy Creek

Historic Property Name Ice house on Little Muddy Cr. Site # BL-22  
Multiple Resource/Thematic Nomination Title Early Stone Buildings

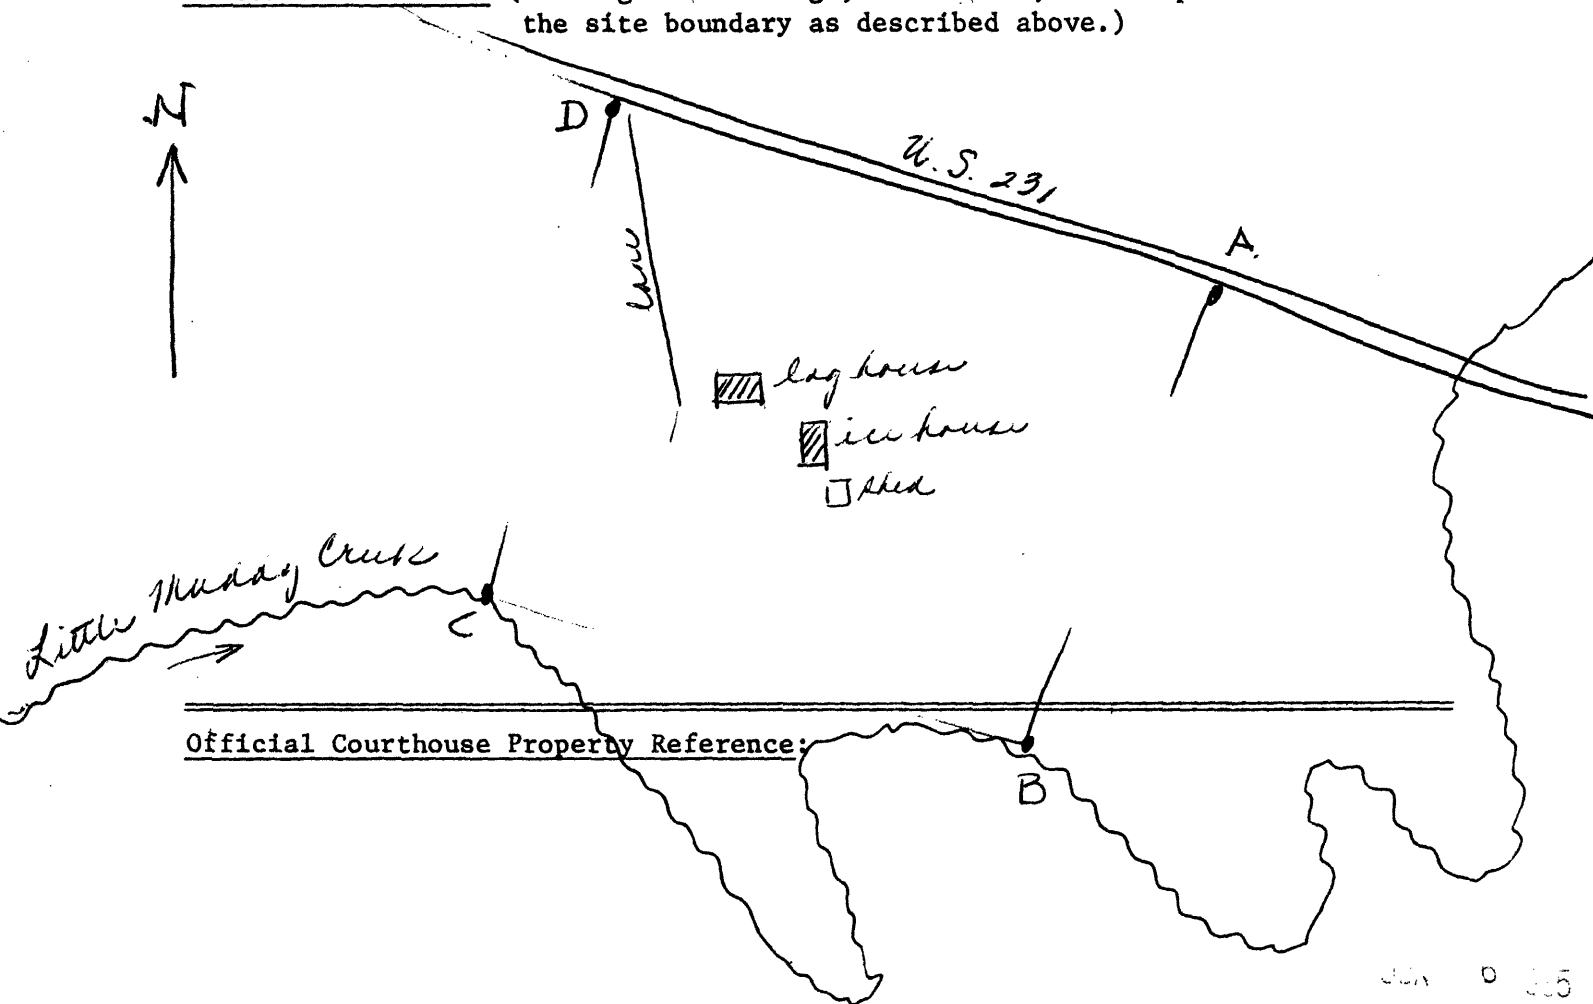
Sketch of Site Plan (Showing outbuildings, structures, landscape features and the site boundary as described above.)

Site enclosed by A.B.C.D as shown. B and C are on the creek. D-A is with the road. Boundary includes log house and ice house and surrounding field. No other early buildings remain.

2 contrib buildings  
1 non contrib bldg.

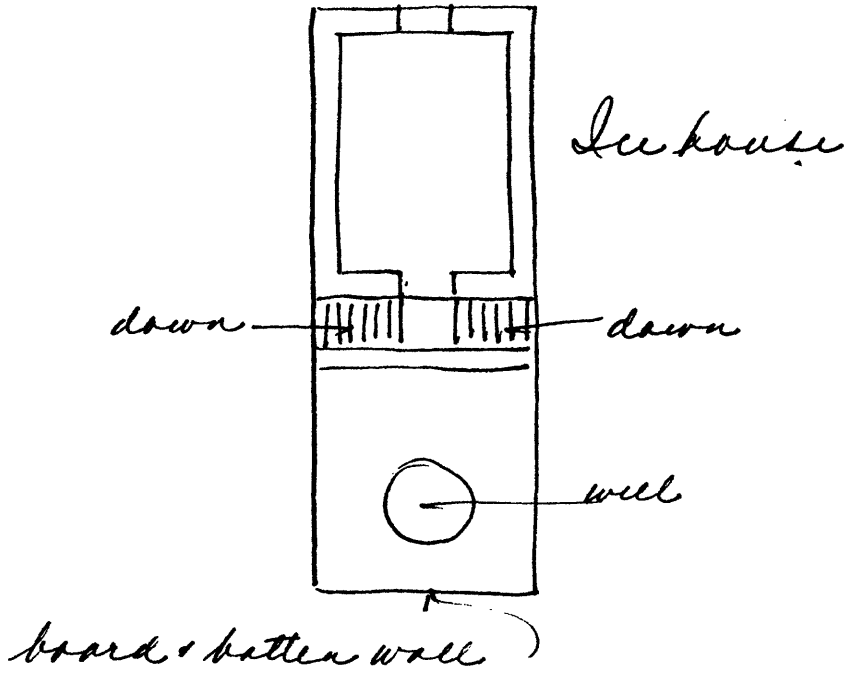
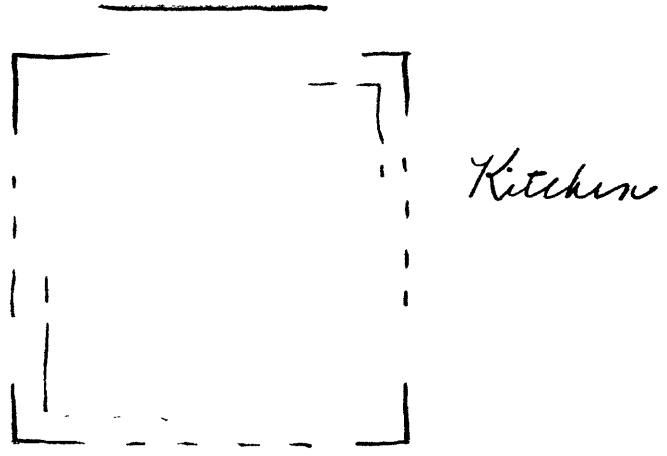
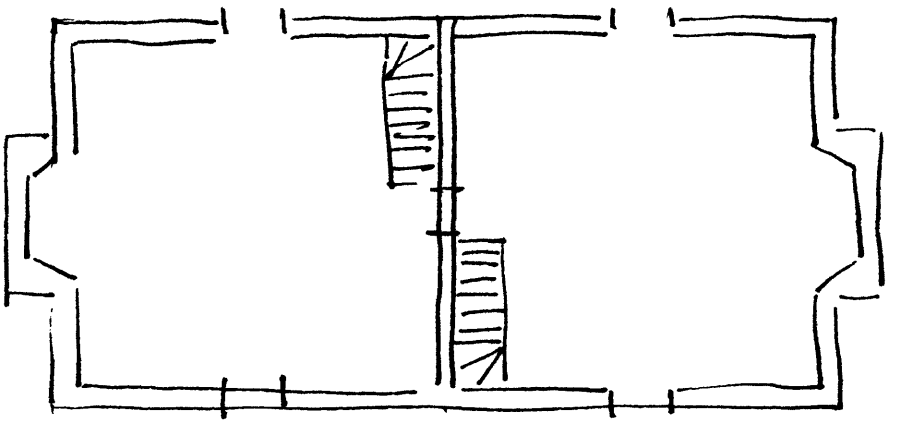
Log house

Single-cell, two-story, dry-laid ashlar ice house, 9 x 12 feet. Gable roof (now gone) extended on east gable end to cover stairways and well (see plan). Steps descend from north and south sides, outside and against east wall of ice house, to landing outside entrance to lower room (ice pit). Twelve inch tall joists between floors were filled with sawdust to insulate ceiling of ice room, which is floor of upper room, used for food storage. Masonry is carefully squared, tooled, and laid in courses of alternating height. Lower portion of building has rough faced masonry. Stone is Tradewater Formation of Middle Pennsylvania limestone; is golden tan color, sandy textured. Small openings on sides of each floor have mitered frames and vertical diamond bars. Well house had open sides and board and batten wall on east end (roof and wall now gone).

Ice house located behind two-story, double-cell, log house having exterior stone chimneys in each gable end. Enclosed corner stairs in each room along center wall. Has two Greek Revival mantels (later ?), beaded board walls around stairs. (Original) plan has one door into each room on east front and west rear with windows above each door on second floor. One small attic window in each gable end beside chimney.

House sheathed in weatherboard and windows cut into front wall beside door. Portico and rear kitchen added.
