MEDFORD ELKS' BUILDING

Medford Elks Building
202 N. Central Avenue
Medford, Jackson County, Oreg.

1 of 14 - Historic view of
newly completed project, 1915.

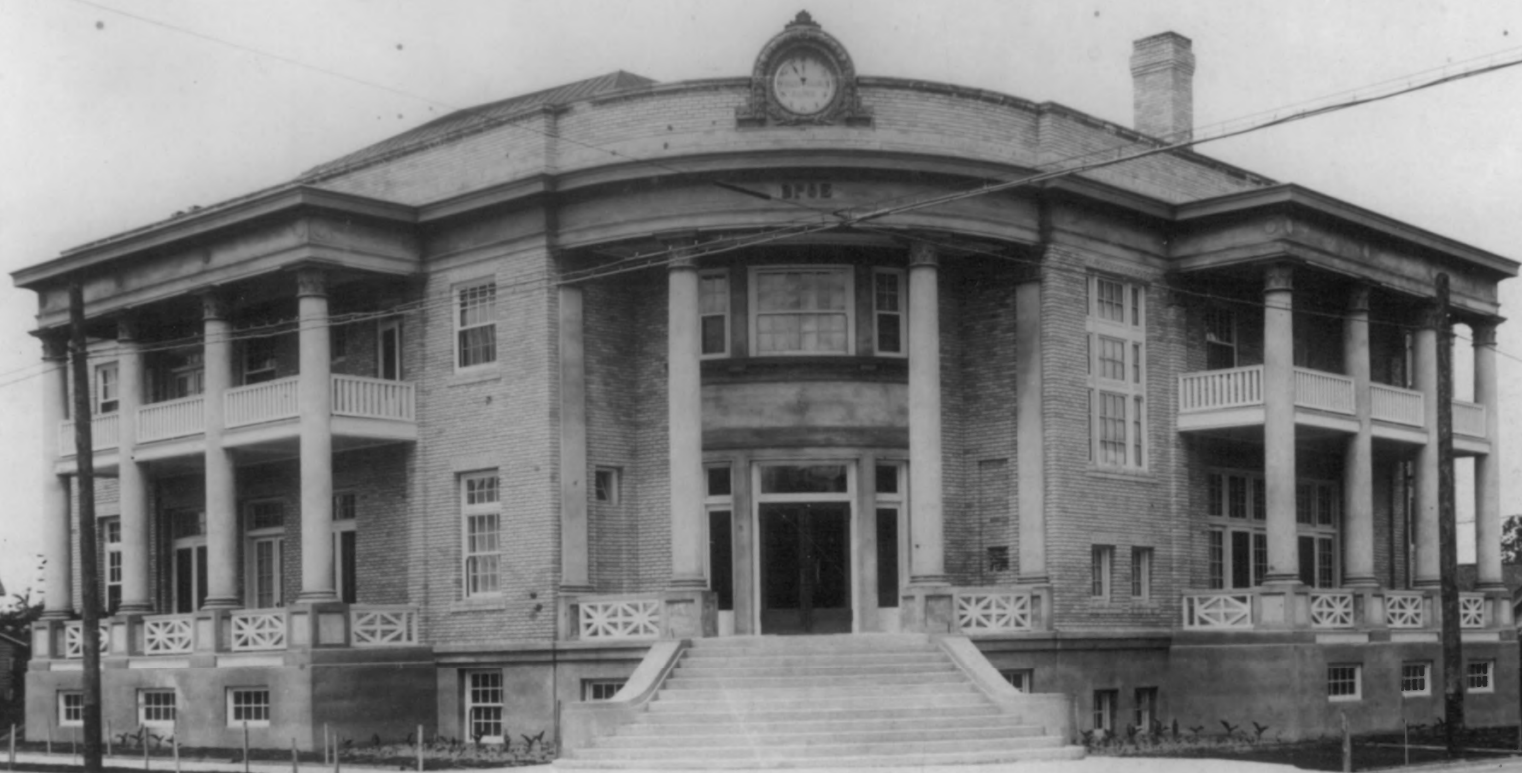
West and south elevations from
intersection of Central Avenue
and 5th Street.

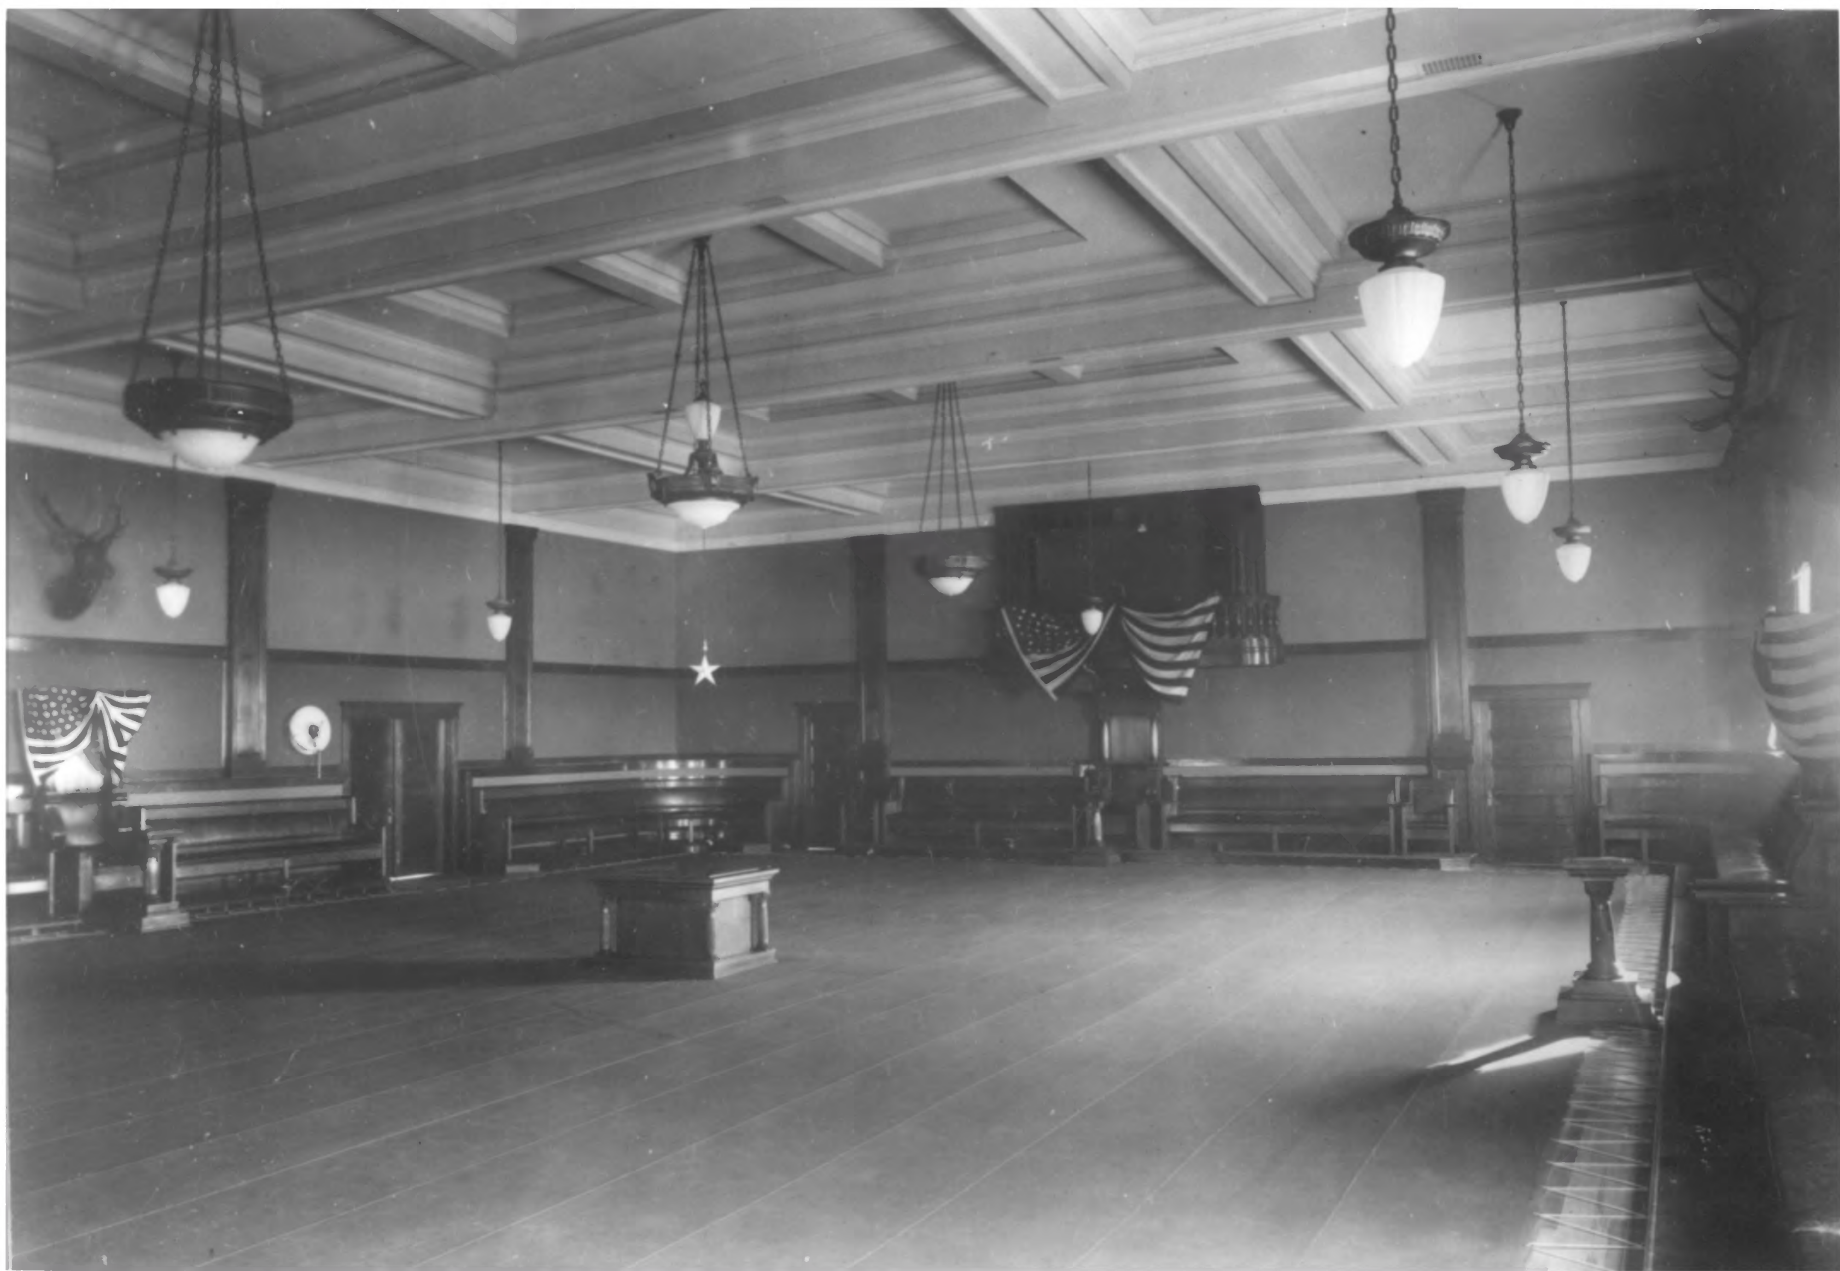
2 of 14 - Interior view,
Lodge Room, 1915, showing
beamed ceiling, classical
pilasters, and perimeter
benches.

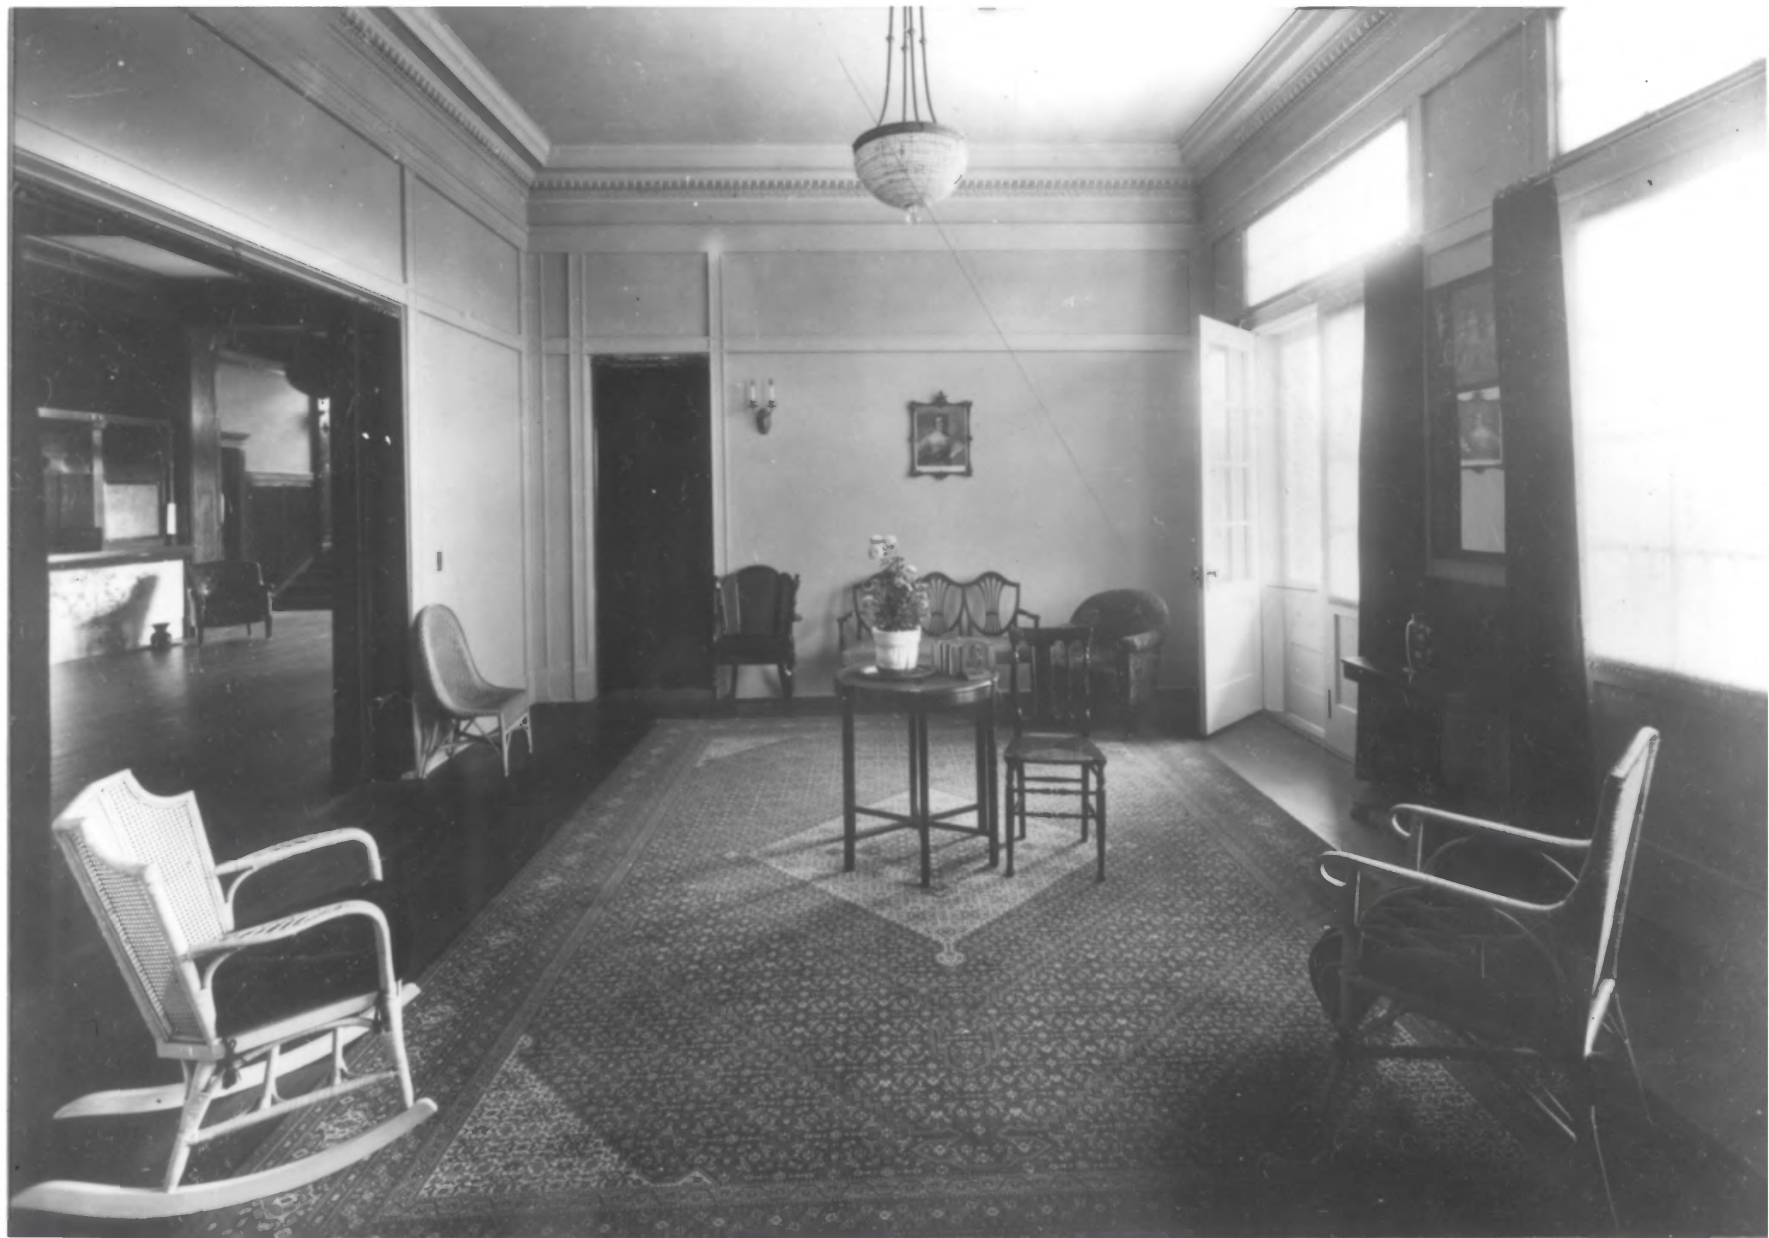
3 of 14 - Interior view,
Ladies' Parlor, 1915, showing
classical cornice molding.

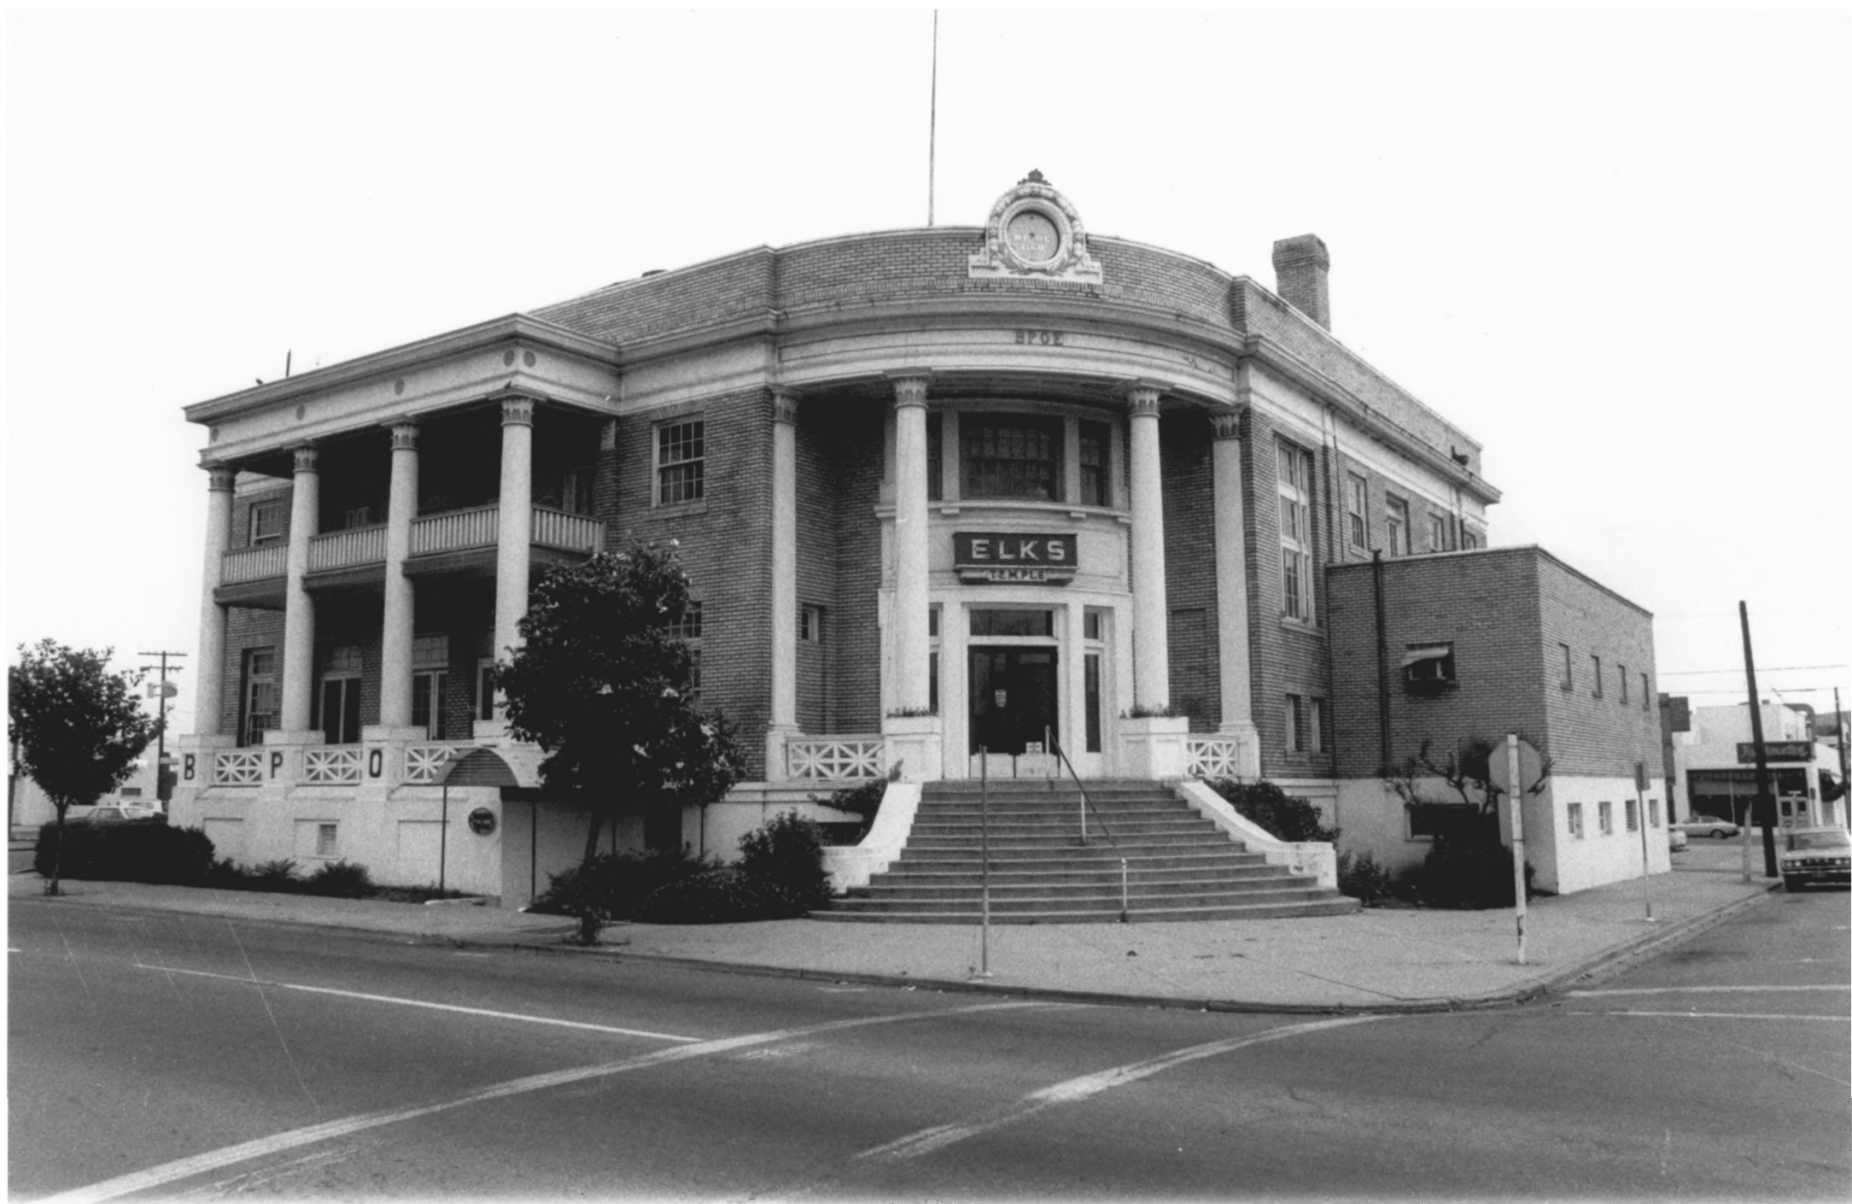
6 of 14 - West and south eleva-
tions from intersection of

Central Avenue and 5th Street,
showing loss of 2-story portico
on south face and replacement
by addition in compatible mater-
ials.

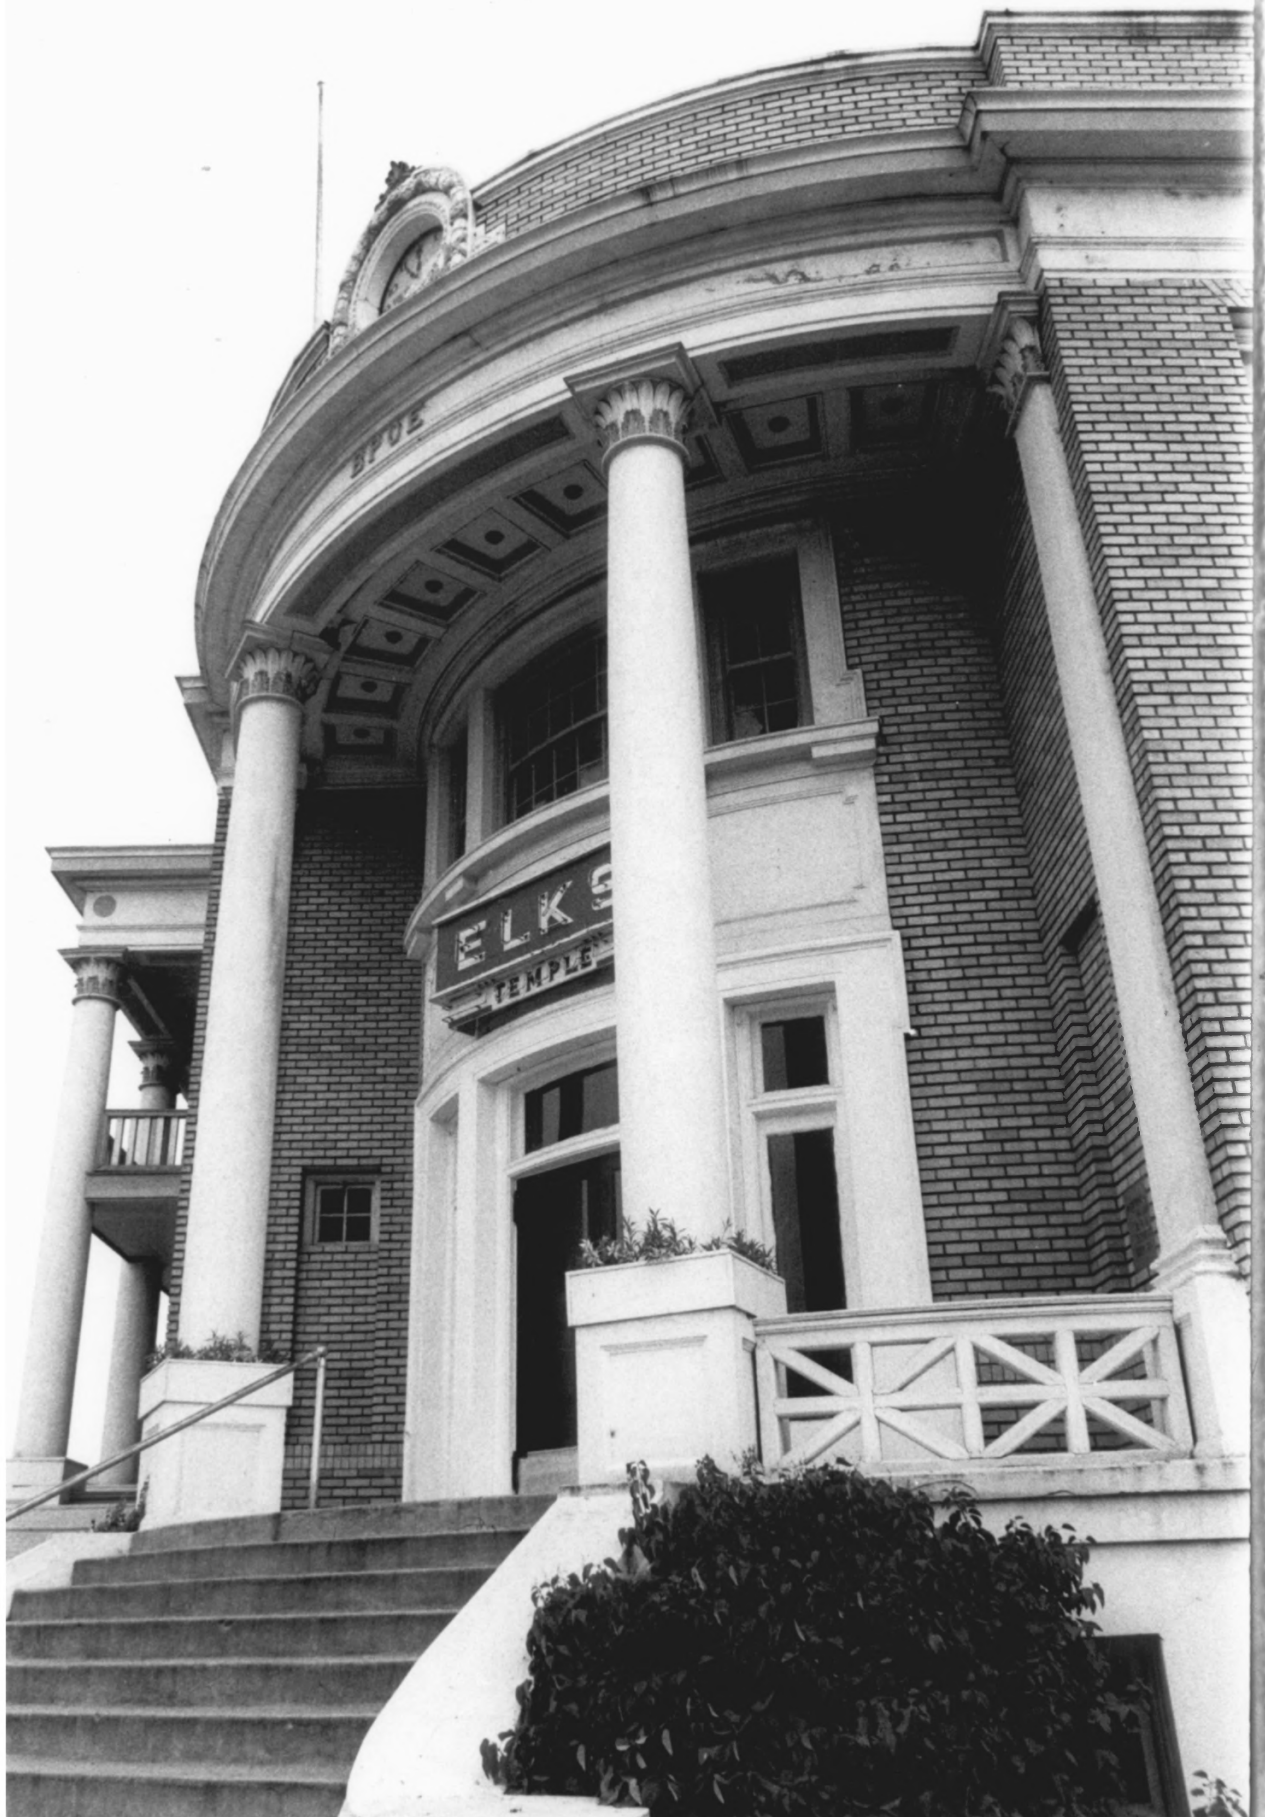
7 of 14 - Detail view of bowed
2-story portico at SW corner,

showing coffered ceiling.

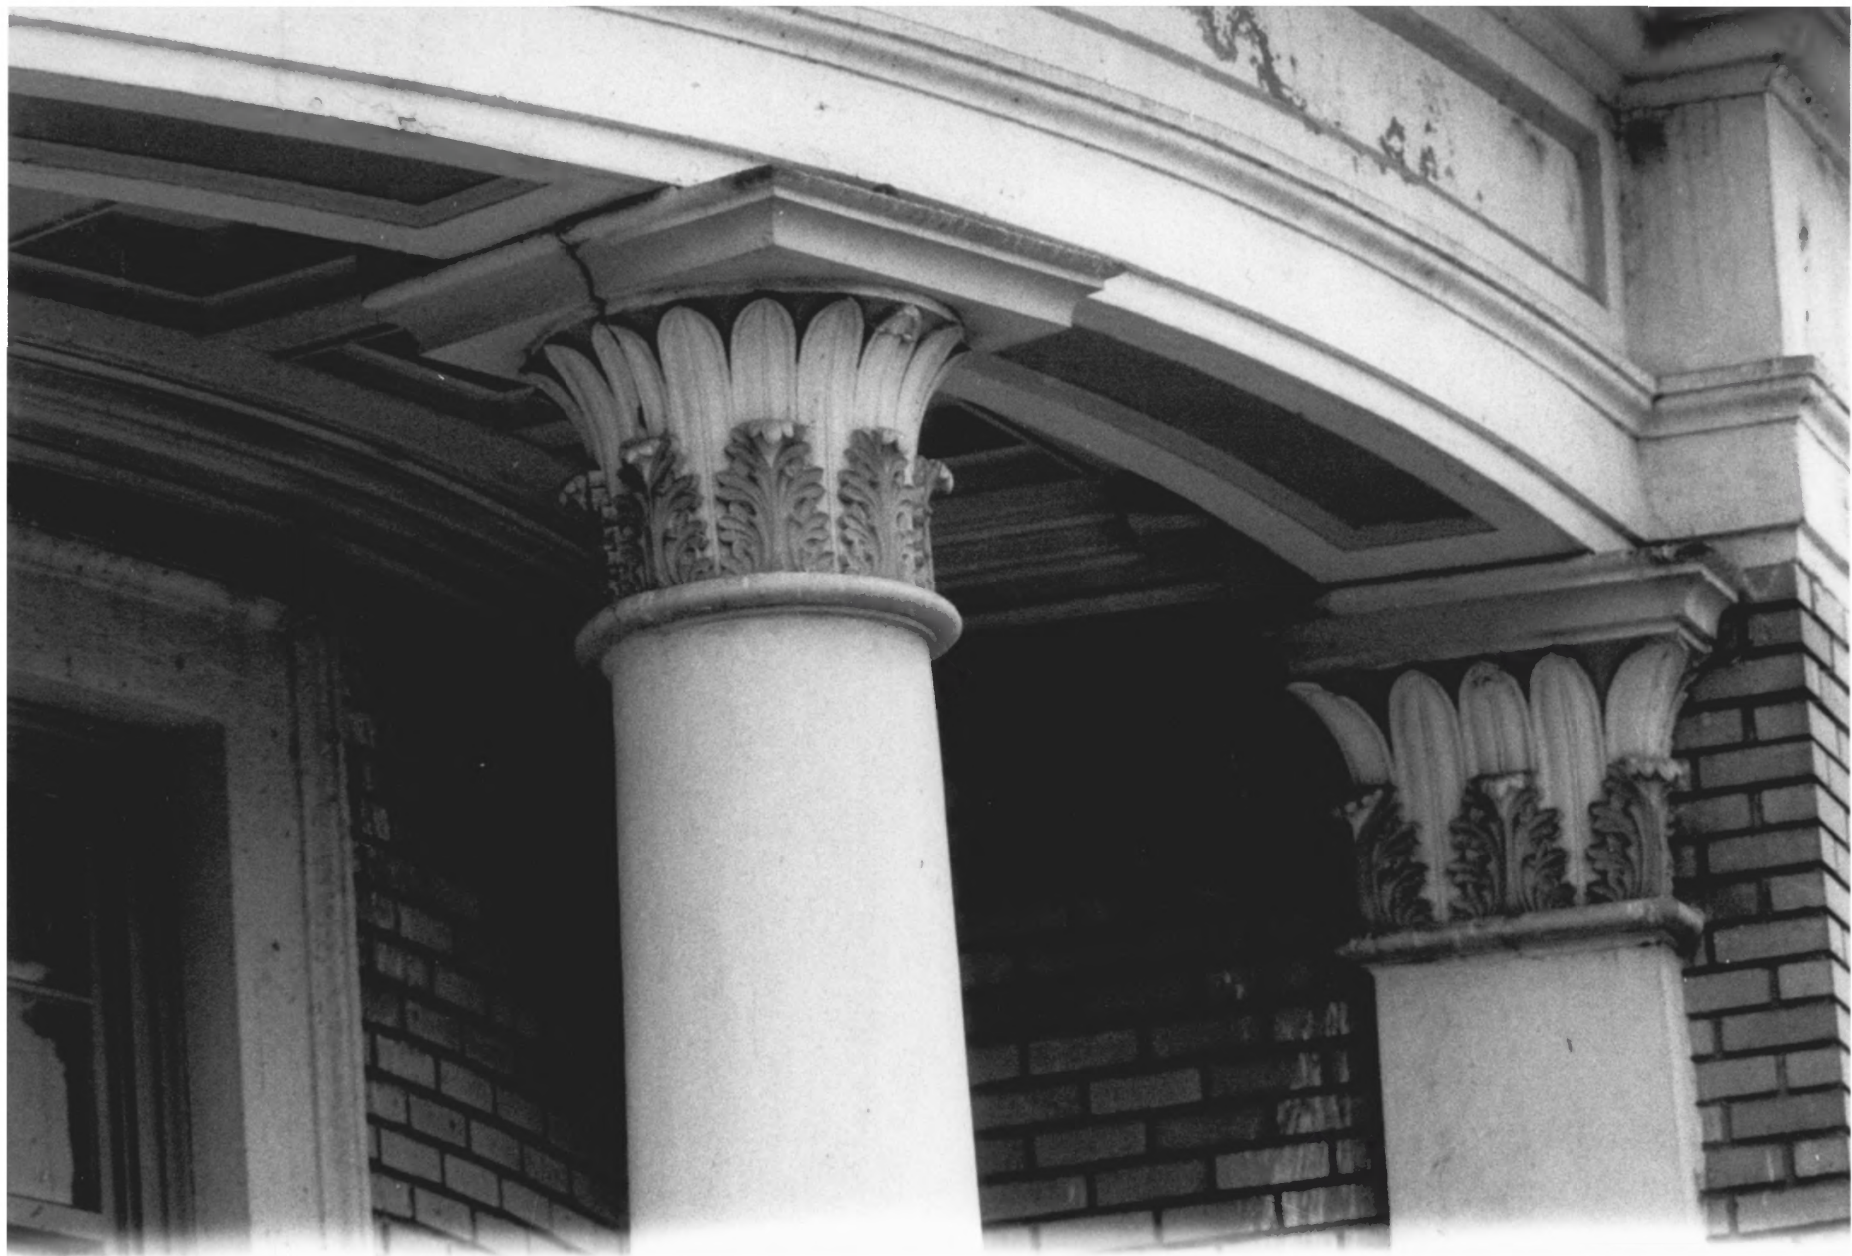
9 of 14 - Detail view of pal-
mate capitals with acanthus
leaves, portico, SW corner.

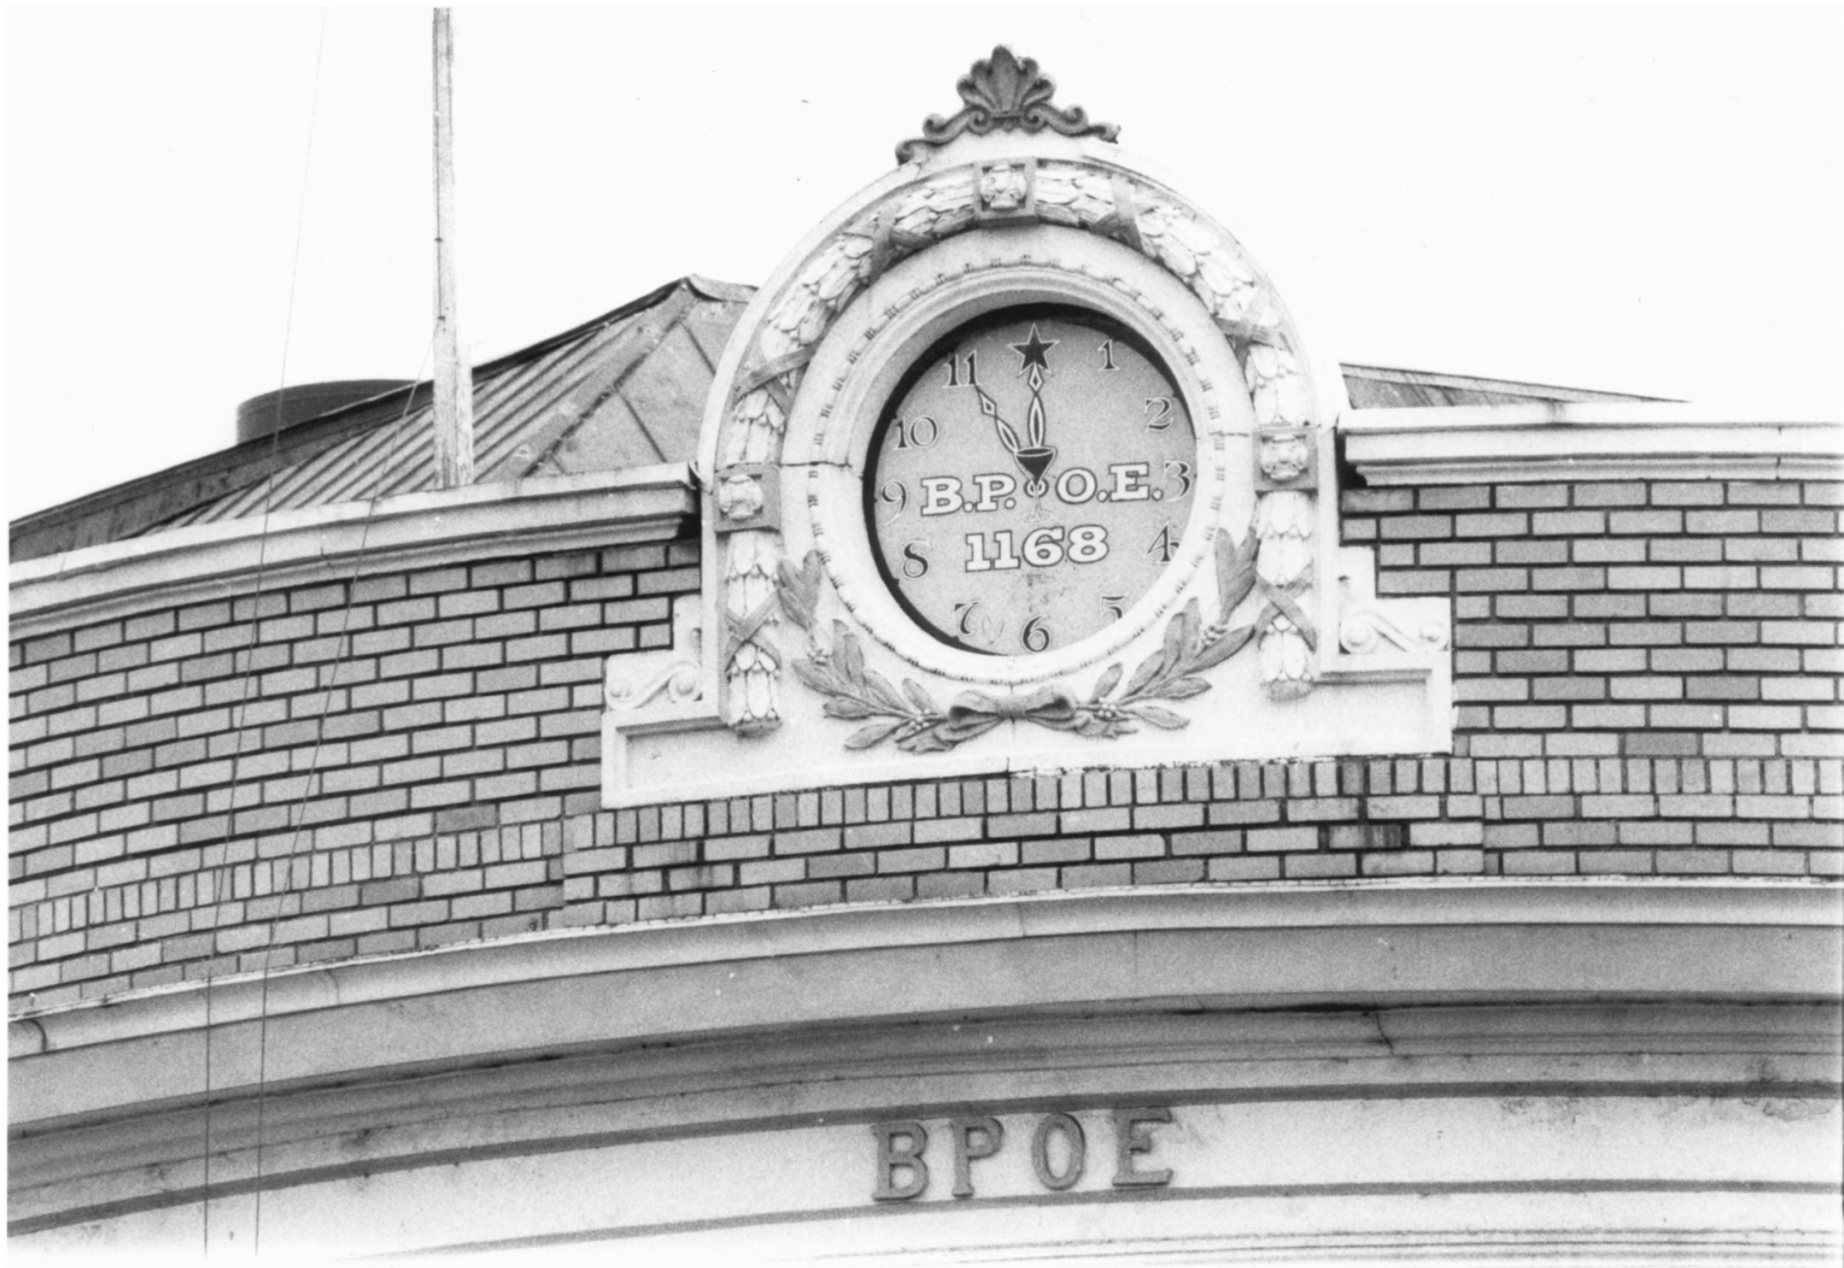
10 of 14 - Detail view of
wreath-framed clock surmount-
ing bowed entrance bay, SW
corner.

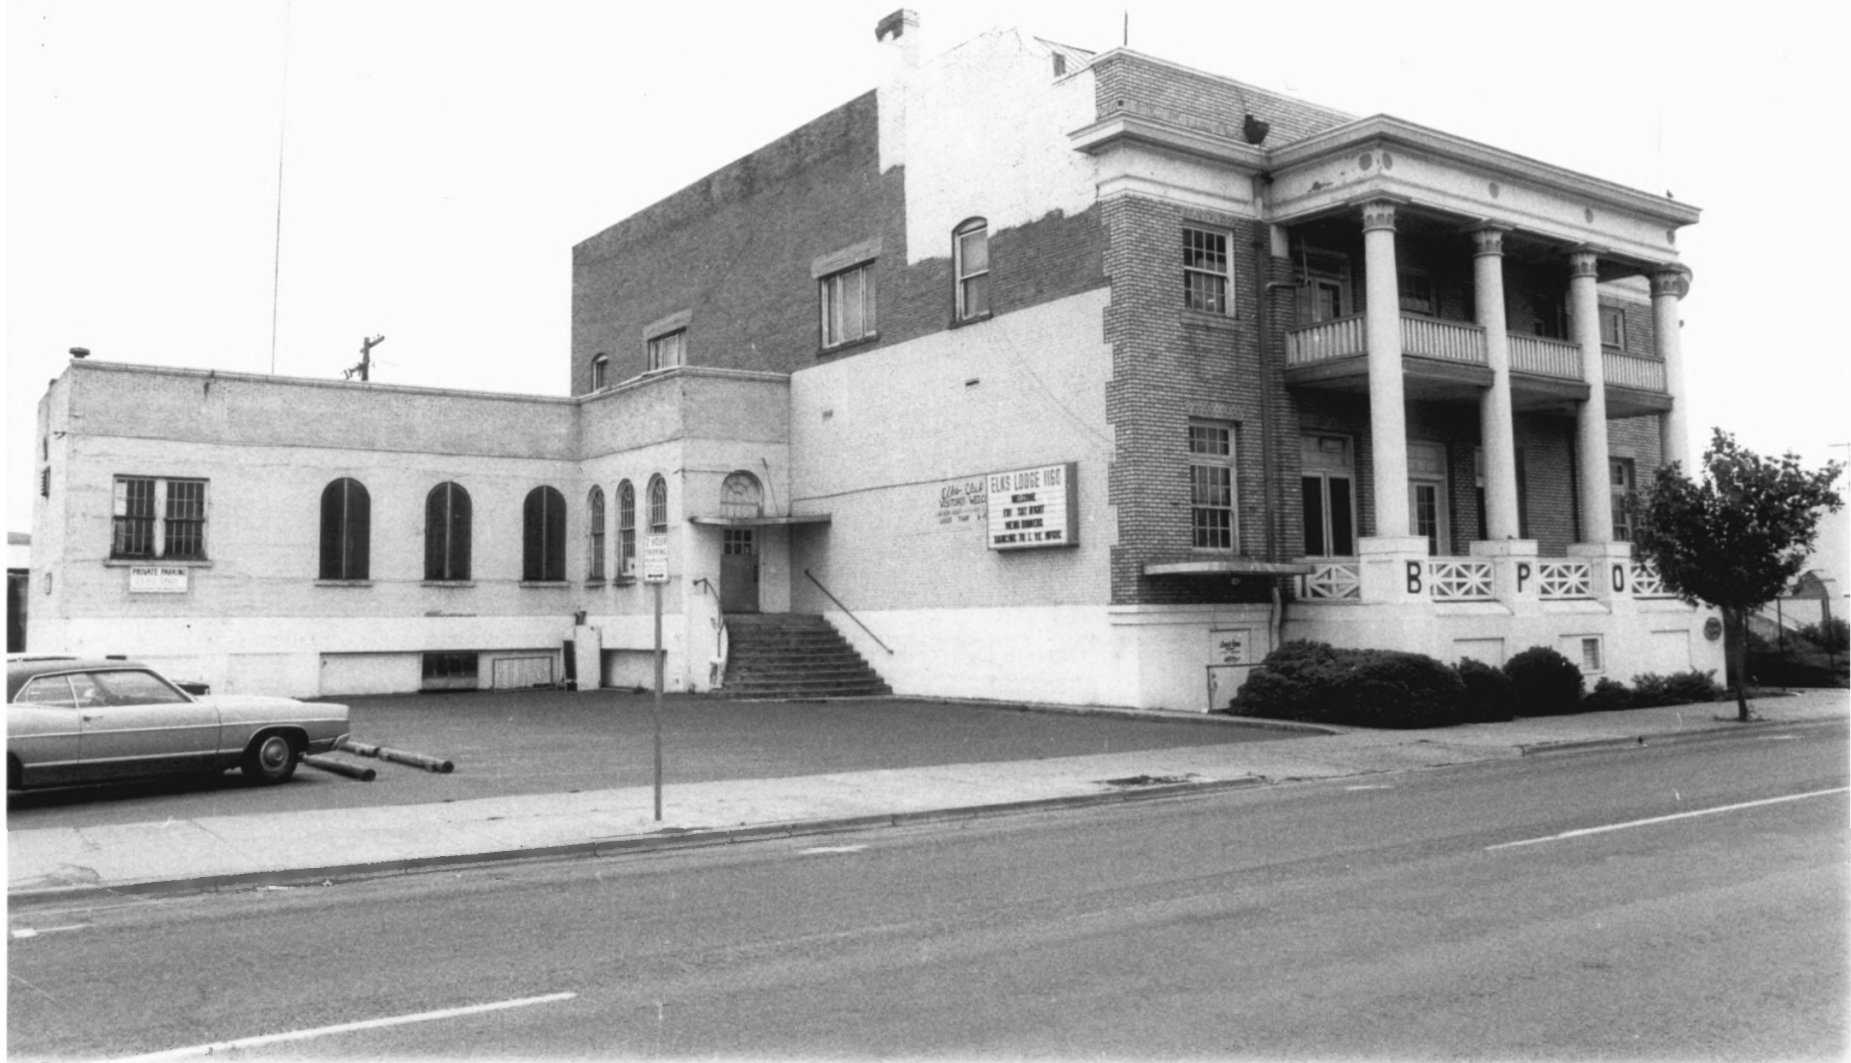
11 of 14 - North and west
elevations

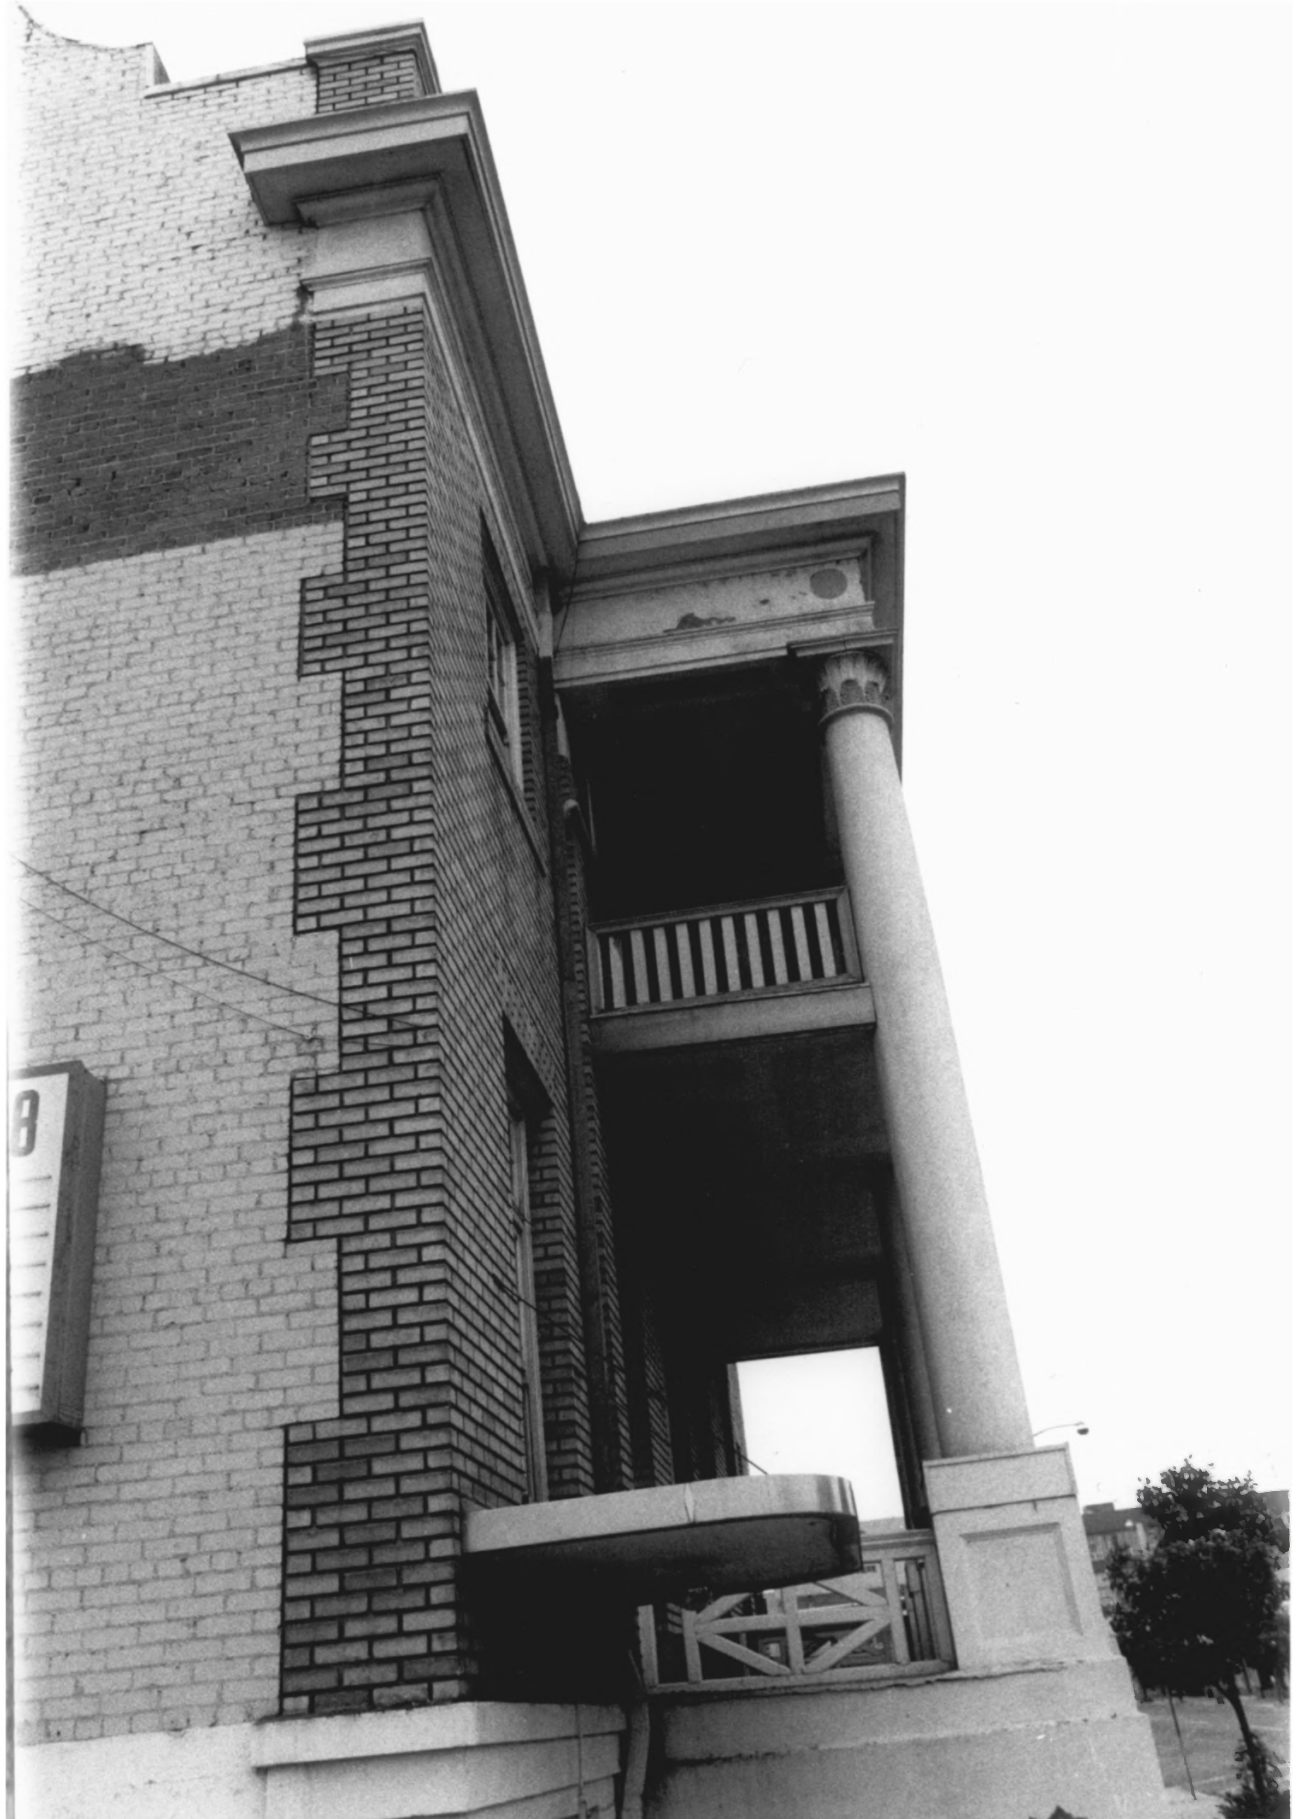
12 of 14 - Detail view of
face brick of west facade

wrapping around NW corner in
pattern of staggered quoins.

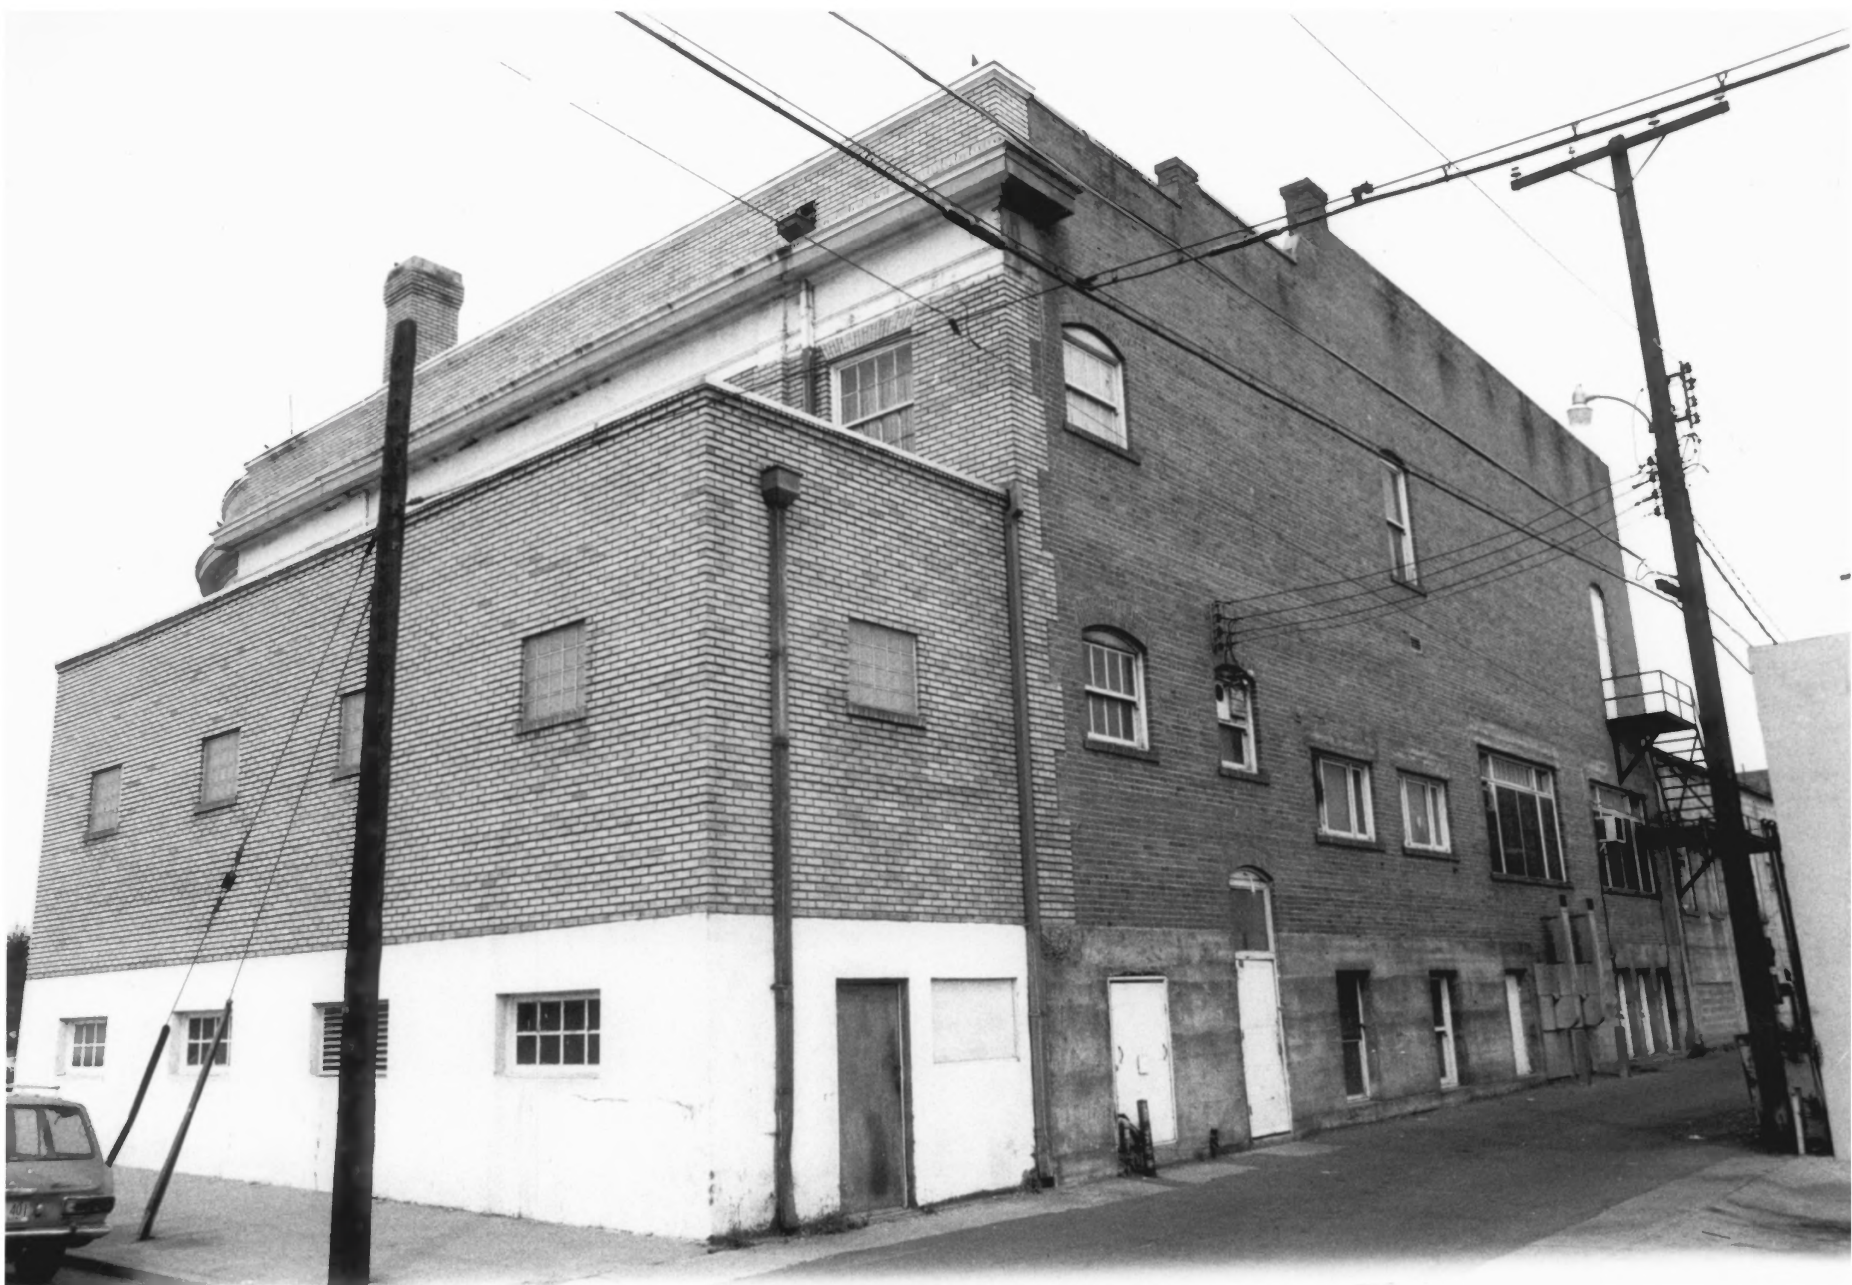
Medford Elks Building
202 N. Central Avenue
Medford, Jackson Co, Oregon
13 of 14 - South and east
elevations.
