MEDFORD ELKS' BUILDING

Medford Elks Building
202 N. Central Avenue
Medford, Jackson County, Oreg.

1 of 14 - Historic view of
newly completed project, 1915.

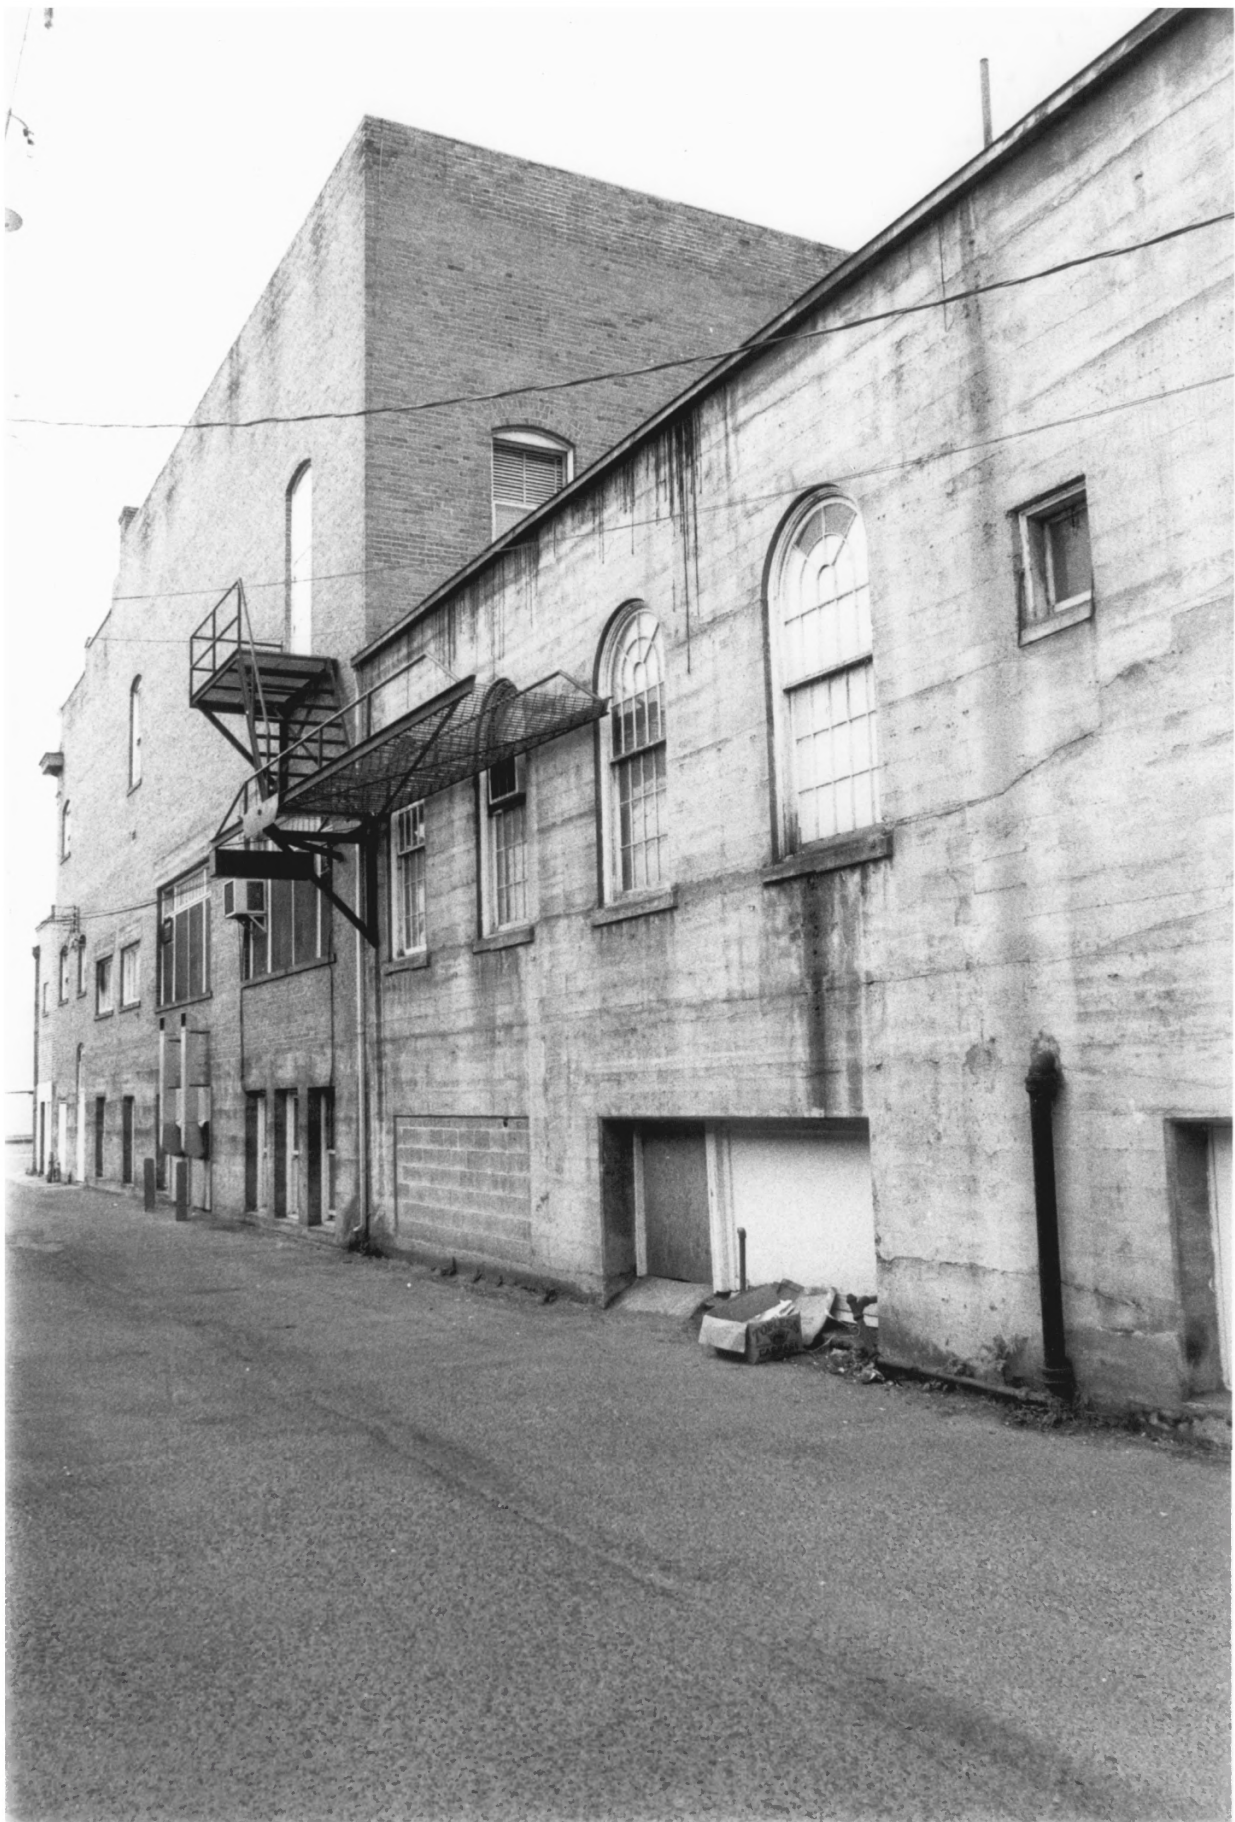
Medford Elks Building
202 N. Central Avenue
Medford, Jackson Co, Oregon
14 of 14 - East elevation of
main block and single-story
north annex.
