# KENTUCKY HISTORIC RESOURCES Individual Inventory Form

Continuation Sheet SH 244 George S. Johnston house

SITE PLAN & BOUNDARY MAP SH 244 JOHNSTON HOUSE (NOT TO SCALE)

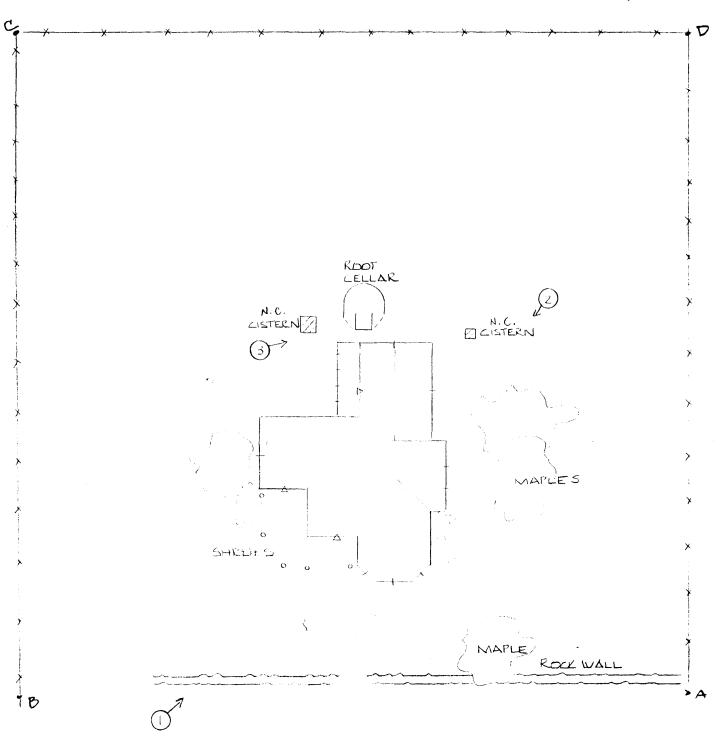
THE PROPERTY BOUNDARIES ARE JUSTIFIED AS THE THMEDIATE, DOMESTIC YARD AREA, DEFINED BY A BOARD AND WOVEN WIRE FENCE MARKING THE EAST, SOUTH AND MEST EDGES OF THE PROPERTY, WITH THE NORTH-EAST LINE DEFINED BY THE SOUTH EDGE OF KY.714, HEMPRIDGE ROAD. THE BOUNDARY ENCOMPASSES ABOUT ONE ACRE OF THE 25 ACRE FARM. A SMALL STOCK BARN, SOUTH OF THE HOUSE AND THE REMAINING ACREAGE IS NOT INCLUDED WITHIN THE MOMINATED AREA RECAUSE THE PROPERTY IS MO LONGER USED FOR INTENSIVE ABRICUL-TURAL PURPOSES: INCLUDED ARE THE HOUSE, ROOT CELLAR, TWO CISTERNS, AND A LOW STONE WALL IN THE FRONT YARD.

The boundary begins at point A, at the north corner of the intersection of the Hemp Ridge Road and a board and wire fence (approximately 60' west of the west side of the house); proceed southeast along the south edge of the Hemp Ridge Road 200' to point B, 20' east of the driveway where there is a fenceline; follow the fenceline southeast 200' to point C on the rear, south fenceline; then follow that fenceline northwest 200' to point D on the north fenceline; then proceed northeast 200' to the point of origin.

A root cellar with brick vestibule entry and cistern are located directly behind the house and are included within the property boundaries. Another cistern or well is also located within the rear yard area. And, a low, stone wall raising the level of the front yard from the road is also included within the boundaries of the site. (see site plan)

The property boundaries contain two contributing buildings, one contributing structure and two non-contributing structures.

house	С
root cellar	C
rock wall	С
cistern	NC
cichero	NC
