Structure/Site Information Form

Street Address: UT 30, Fountain Green, UT UTM: 12/445120/4386060 Sanpete County Name of Structure: Τ. R. S. Barentsen, Andrew, House Plat A, Block 12, Lot 3 Present Owner: Euray Allred Acreage: Less than one Fountain Green, UT **Owner Address:** Tax #: Year Built (Tax Record): Effective Age: Legal Description Kind of Building:

Building Type/Style: Pair House Type II/Vernacular

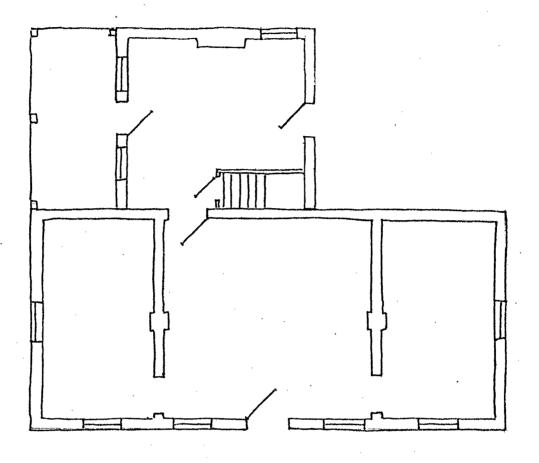
The Andrew M. Barentsen House is a 1-1/2 story, brick structure which was built in 1874. The front section of the house has a three-room plan which falls into Type II of the pair-house classification. There is a one-story brick rear "T" extension which appears to be an original part of the house. The paired internal chimneys on the ridge exhibit decorative corbelling, a motif which is continued on the raking eaves. Smooth stone pedimented window heads are found on the facade openings. There is a stone over the front door which reveals the building date, "1874."

The Barentsen house has been vacant for a number of years and its present condition reflects this neglect. The house was last used in the 1970s for hay storage.

The Barentsen house's deteriorated condition remains a problematic aspect of this nomination. The house is vacant and is not being maintained at the present, nor is it clear what the owner's intentions are regarding its future plans. The dwelling, at this time (November 1982) retains enough of its historic fabric to warrant inclusion in the Scandinavian Pair-house thematic group nomination. The photograph, while taken in spring of 1981, is an accurate representation of the house's present condition.
