**NATIONAL REGISTER OF HISTORIC PLACES
INVENTORY -- NOMINATION FORM**

****** HISTORIC MARSHALL HALL
AND/OR COMMON Marshall Hall

Marshall Hall
Charles County
Maryland

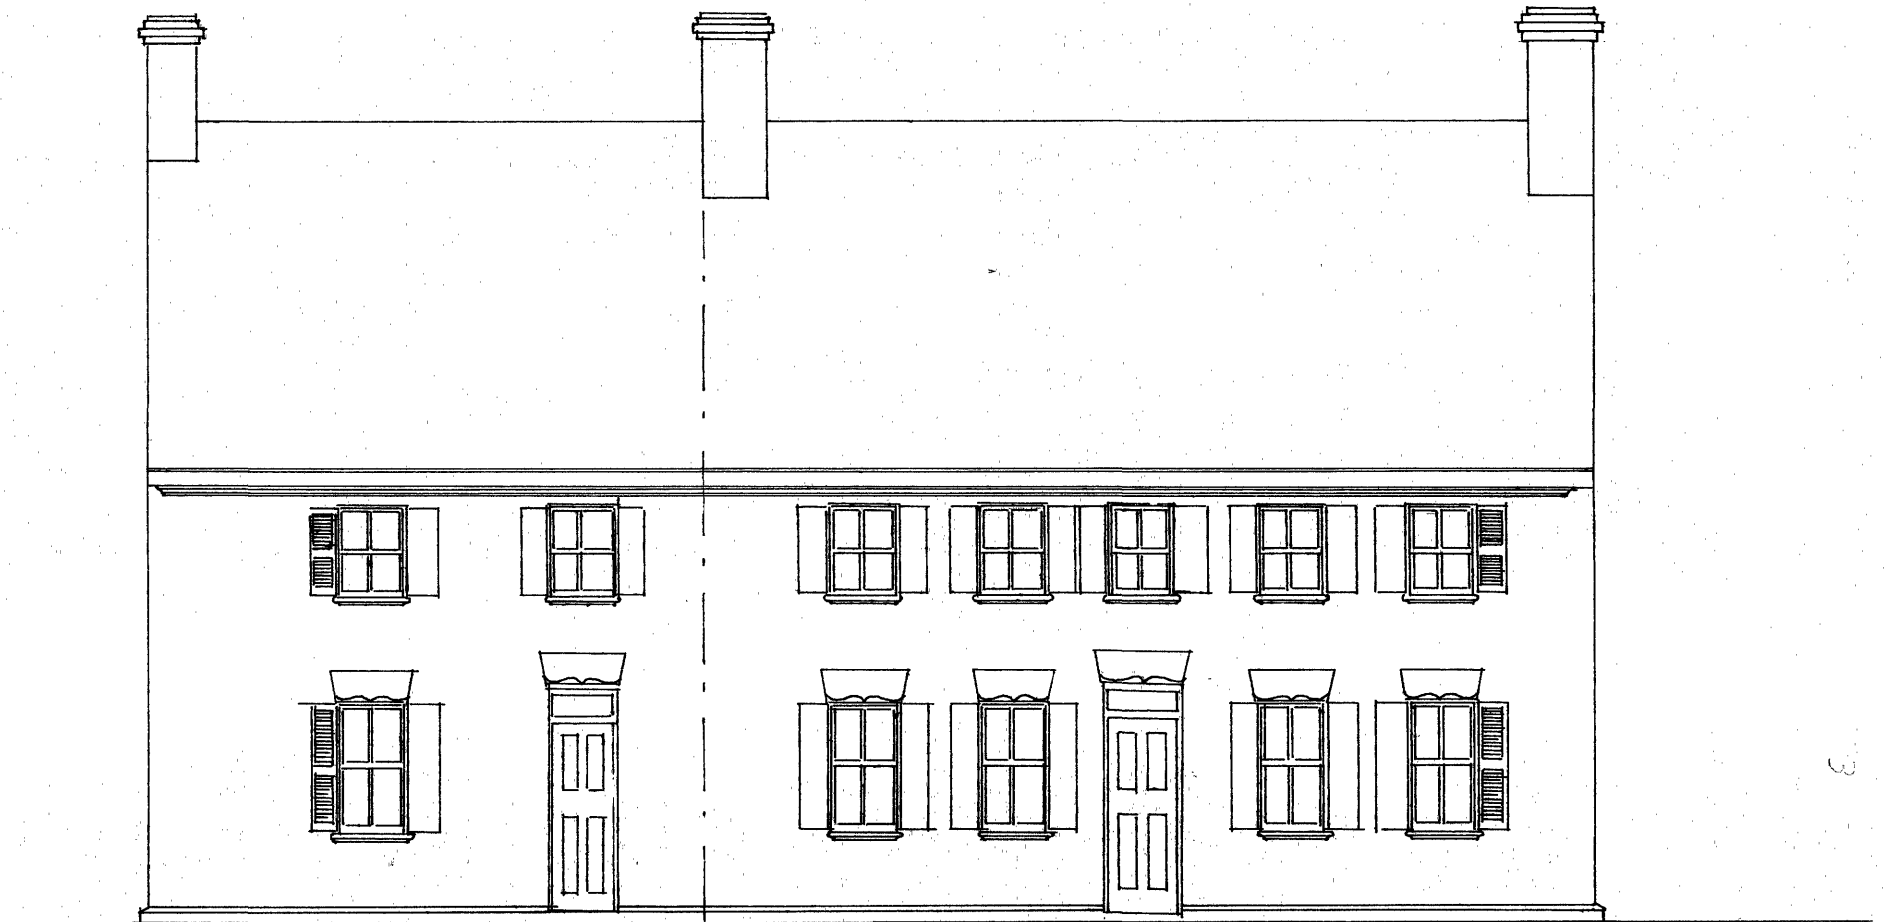
north elevation (drawing)

• Marshall Hall "Mansion"
North Elevation, Front
scale: $\frac{3}{8}$ in. = 1 ft.

The river front (north facade) of the 60 X 30 foot house is seven bays in length (see Figure 1). The first five bays from the west end constitute the original house of circa 1725; the two easternmost bays date from an extension of the house made in about 1760. On the first floor the original five bays consist of a center door flanked by two windows on each side. These windows and the door have splayed brick arches of rubbed and gauged brick, the bases of which are molded in a double-ogee pattern creating a highly decorative effect.² The five similarly spaced windows above have flat unornamented heads that are flush with the base of the roof cornice. All the windows have sash of two-over-two panes that are of Victorian vintage, although the windows themselves occupy the original locations. The doorway frames a modern door and transom and is now slightly narrower than it was originally.

The two first and second floor bays of the addition (a window and a door on the first floor and two windows above) also occupy the original locations and have two-over-two Victorian sash. The doorway frames a modern door and transom; the original width, however, is retained. An interesting feature on this elevation of the addition is the manner in which the bases of the window and door heads of the first floor were crudely chiseled out in an attempt to repeat the decorated flat arches of the four windows and door of the original house.

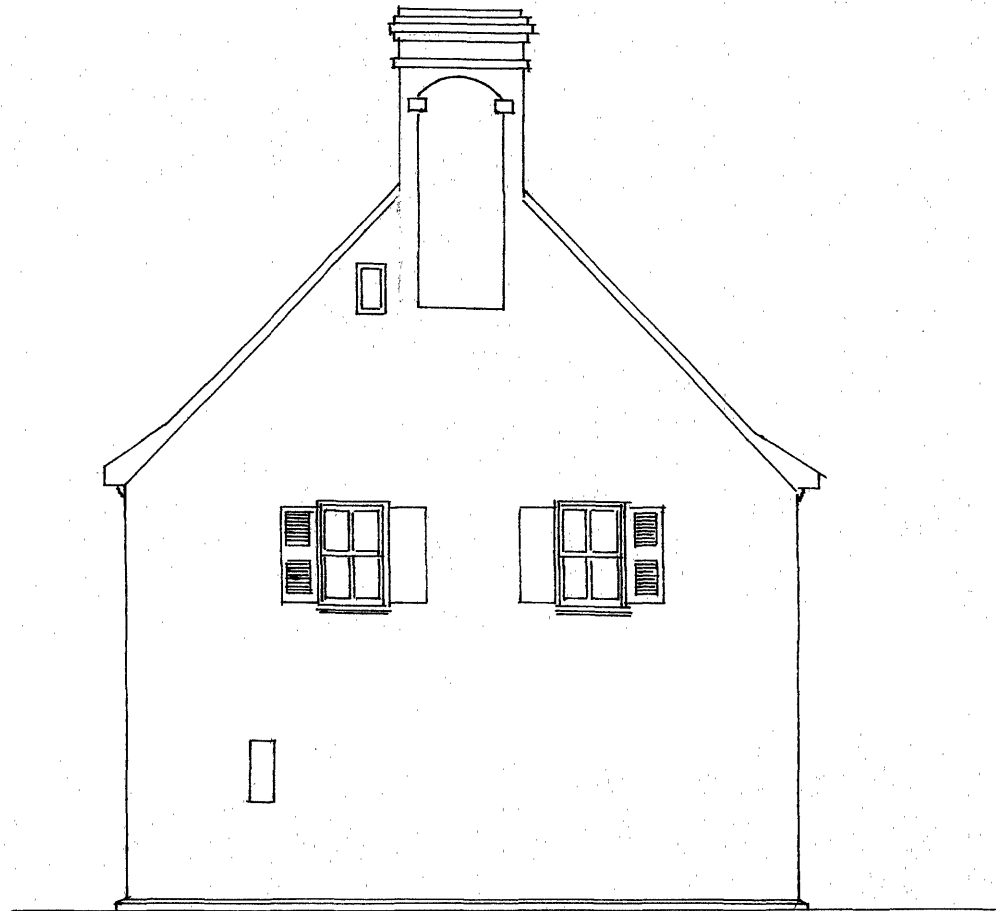
west end elevation (drawing)

Marshall Hall "Mansion"
West End Elevation
scale: $\frac{1}{8}$ in. = 1 ft.

Before renovation of the house in 1966, the west end displayed a large flush chimney decorated on its outside face by an arched blind panel extending up from about the middle of the gable to just below the corbeled chimney cap (see Figure 2).³ In 1966 the chimney stack was rebuilt above the gable peak and, though the panel was rebuilt, the arch was not. When first built, the west end was broken only by a very narrow closet window near the north end of the first floor and an even smaller louvered vent near the top of the gable. Of these two openings, only the attic vent remains, the closet window having been bricked up at an unknown date. At the present time, there are two second floor windows that replaced doors introduced when a veranda was added to the house in the late nineteenth century. The east end of the house is now devoid of any openings as the two windows originally near the north end of the first floor were later bricked up.

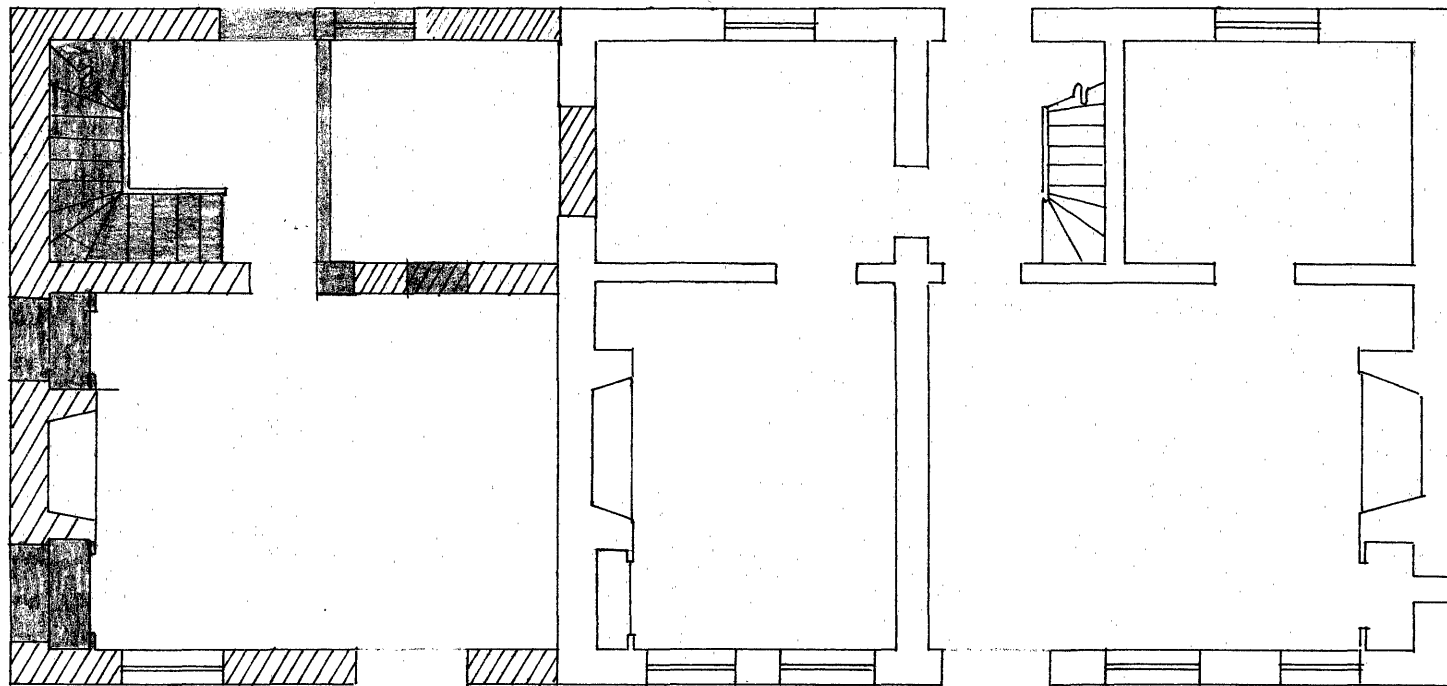
ground floor plan (drawing)

↖ Marshall Hall "Mansion"
GROUND LEVEL FLOOR PLAN ↗

Ca. 1727

Ca. 1750

Ca. 1800

In 1966 the interior of Marshall Hall was renovated for conversion to offices. The basic plan was retained (see Figure 3), as

The ground floor room configuration of the older, circa 1725 house consisted of four rooms with a short, centered, rear stair hall, a plan characteristic of Charles County architecture throughout the eighteenth century.⁴ The front entrance door opened into the largest (northwest) of the four rooms, which had walls completely covered with fielded panels, as well as heavily molded baseboards, chairrails and ceiling cornices, paneled window and door reveals, and a plastered ceiling. On the west wall was an expansive fireplace with rounded back, framed by a wide bolection molding. This fireplace was made smaller in size in the late nineteenth century and a new, Victorian-style mantel installed within the area framed by the earlier bolection molding. Flanking the fireplace on the north side is a shallow closet with paneled door and shelved interior. The closet was once lighted by a small window in its west wall which has since been bricked up and plastered over.

The initial plan of the addition included a large, full width front room that from all available evidence served as a kitchen (see Figure 3). The rear section of the first floor was a recessed porch, open to the outside by a wide arched doorway. The only early features known are that the north kitchen room had plastered walls, exposed beaded ceiling joists, a large fireplace on its east wall flanked by a window on each side, a door and window in its north wall, and a door and window on the south side. The kitchen floor might have been wood, as it is today, but it was probably paved with brick, as was the porch floor. In about 1800 the kitchen was remodeled to serve as an additional living area by plastering over the ceiling and installing new baseboards, chair-rails and a ceiling cornice. The fireplace was made smaller and a Federal-style mantel provided. The two windows flanking the fireplace were bricked up and two cupboards, each with two sets of paneled double doors, were installed in these areas. The porch was divided into two rooms and the former arched doorway filled in and a single door and window installed in its place. It is believed that the existing stair on the east wall of the southeast rear room was provided at this time, probably replacing a stair in the former kitchen room.
