National Register of Historic Places Registration Form

Historic name: Watkins School

Street & number: 26 Watkins Avenue

City or town: Rutland State: Vermont County: Rutland

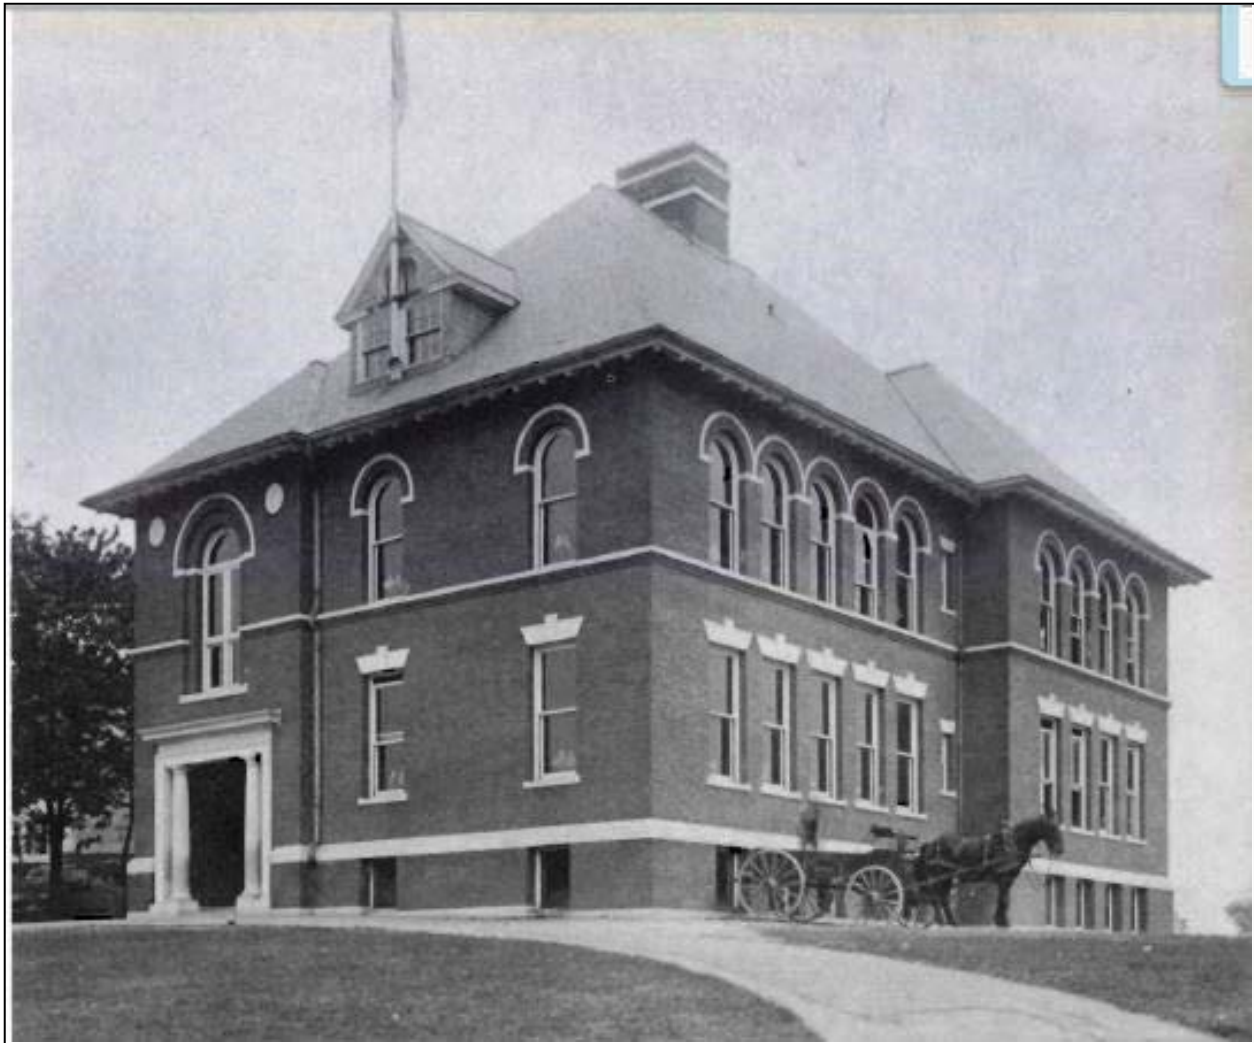
c. 1900 photograph printed in *Rutland in Retrospect*, page 99. View looking northeast (courtesy Rutland Historical Society)

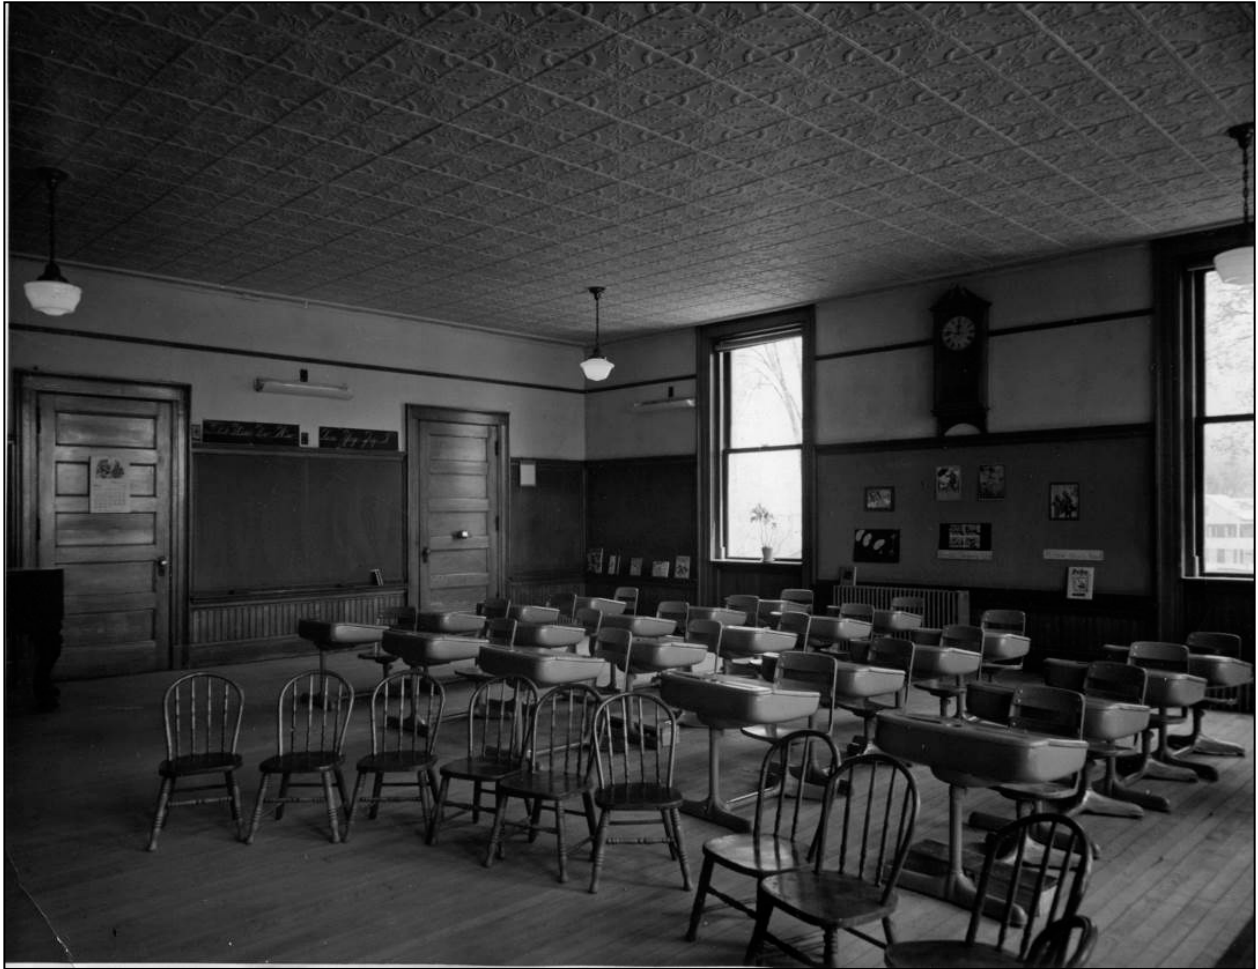
1952 view of east classroom on first floor looking northwest. Photo taken as a “before” shot for a publication on modern lighting in Rutland Schools. (Courtesy Rutland Historical Society)

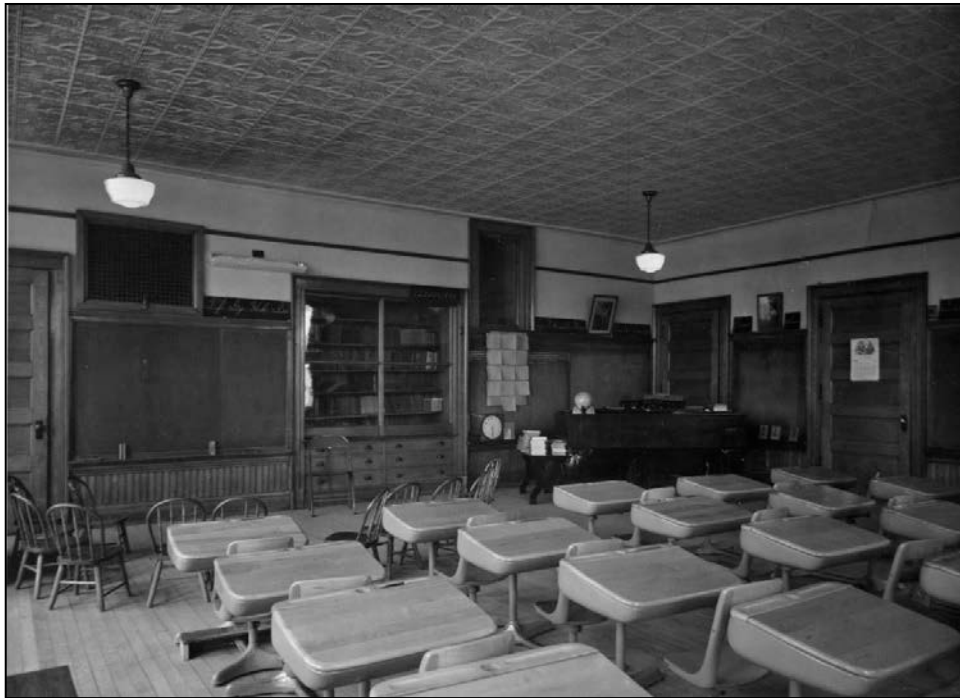
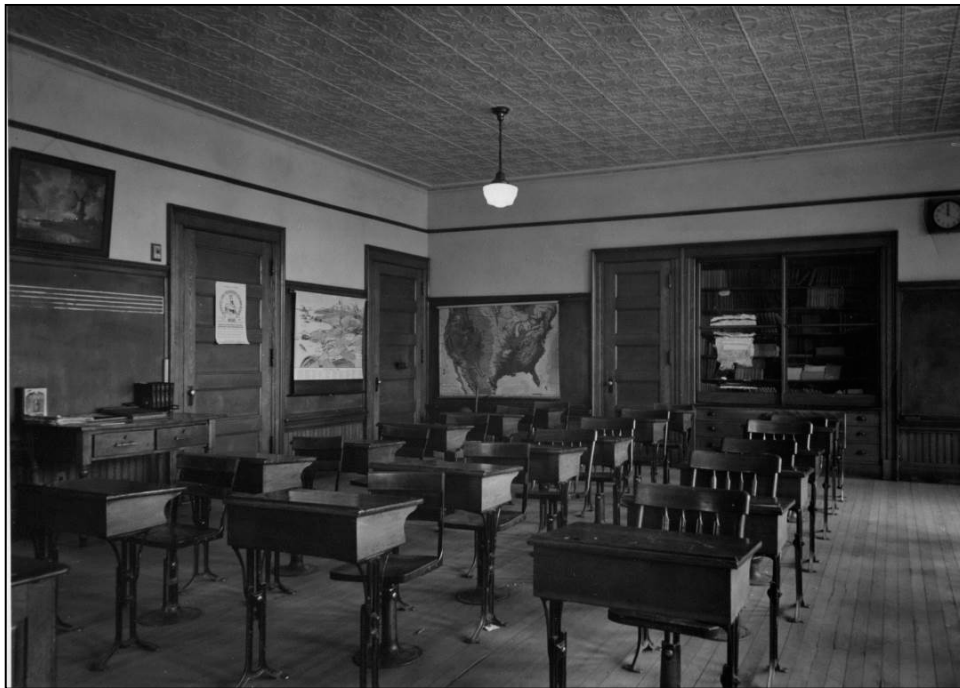
Top and Bottom: 1952 views of east classroom on first floor looking northeast (top) and west classroom on first floor looking northeast (bottom). Photos taken as a “before” shot for a publication on modern lighting in Rutland Schools . (courtesy Rutland Historical Society)

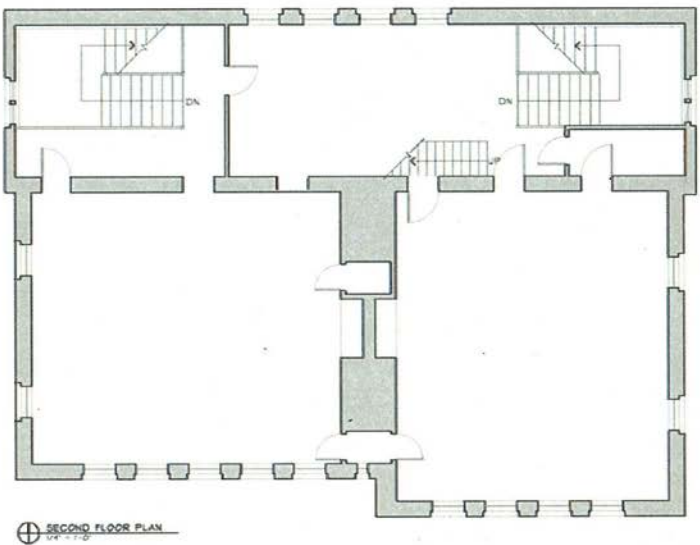
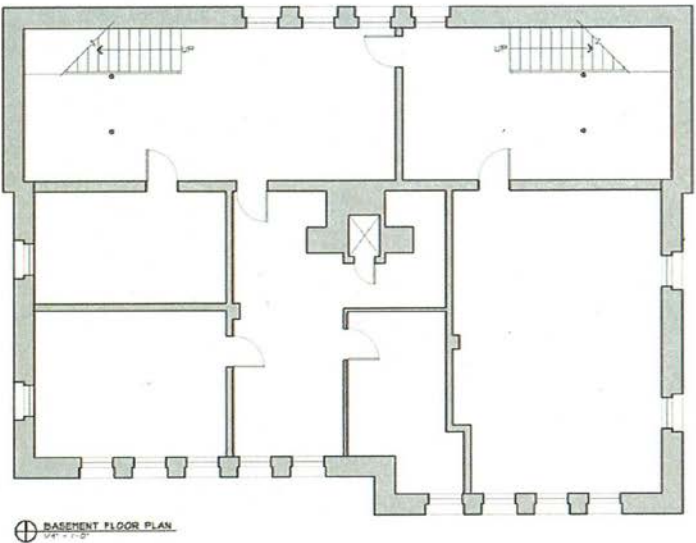
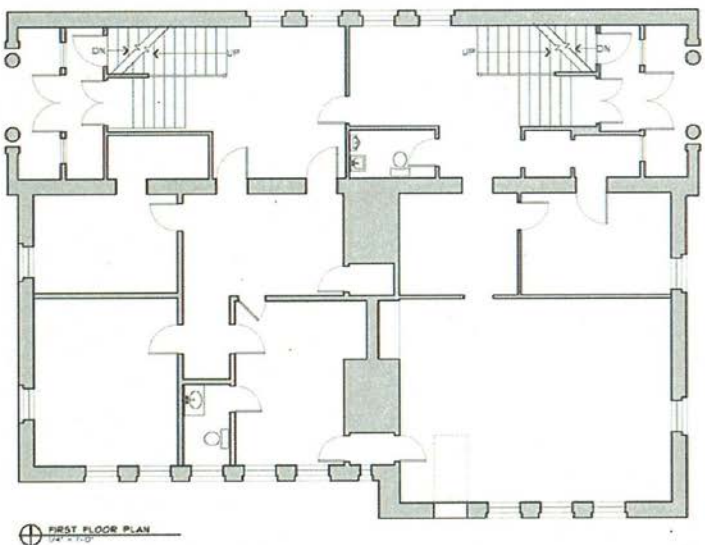
Section number _____ Floor Plans _____

Watkins School, 26 Watkins Avenue, Rutland, Rutland County, Vermont
Floor Plans, Not to scale (Courtesy Arnold & Scangas Architects)

The four room school's original floor plan was comprised simply of a large hall extending between monumental front and rear staircases along the entire north side of the school and off of this to the south were two large classrooms on each floor. The classrooms were the same, nearly square size but turned 90 degrees in orientation from each other so that one projects south beyond the other in the pavilion. In the west classrooms the long side has the windows with a bank of five while in the east classrooms, the short wall has the windows with a bank of four. In both the east and west classrooms the other exterior wall has two windows. Between the east and west classrooms was a 5' section containing masonry chimneys and ventilation shafts as well as closets and built-in storage. Slate blackboards and banks of windows characterized the classroom walls. At present some modern partitions have been added that divide the main hall on both floors as well as create smaller rooms and offices in the first floor classrooms and adds a restroom in the first floor hall. The first floor office spaces have dropped ceilings and many of the blackboards have been removed along with their trim work. In addition, there is an added modern wooden staircase to the attic in the second floor hall. The interior has rich trim work and details including heavy moldings, elaborate wainscoting, picture railing, and blackboard trim and chalk rails. In addition there are original, built in drawers topped by a recessed glass fronted cupboard in three classrooms as well as a heavily trimmed ventilation grate built into the wall trim in one of the second floor classrooms. Originally there were also internal borrow lights between classrooms and closets, some of which remain under modern finishes. There are original tin ceilings exposed in full height two rooms that were formerly part of a single first floor classroom. In addition, original tin ceilings are extant above the dropped ceilings in most of the first floor spaces. The second floor ceilings are plaster as are the original walls of both floors above the wainscoting.

The first floor is a half level above ground floor level of the east and west entrances. Each entry has a vestibule from which stairs lead down to the basement and up to the first floor. The first floor level entry lobby is currently divided in half by a modern partition into front and rear halls. The north elevation's banks of four windows on each floor light this long hallway. There are presently two windows on either side of the modern partition on the first floor. At the second

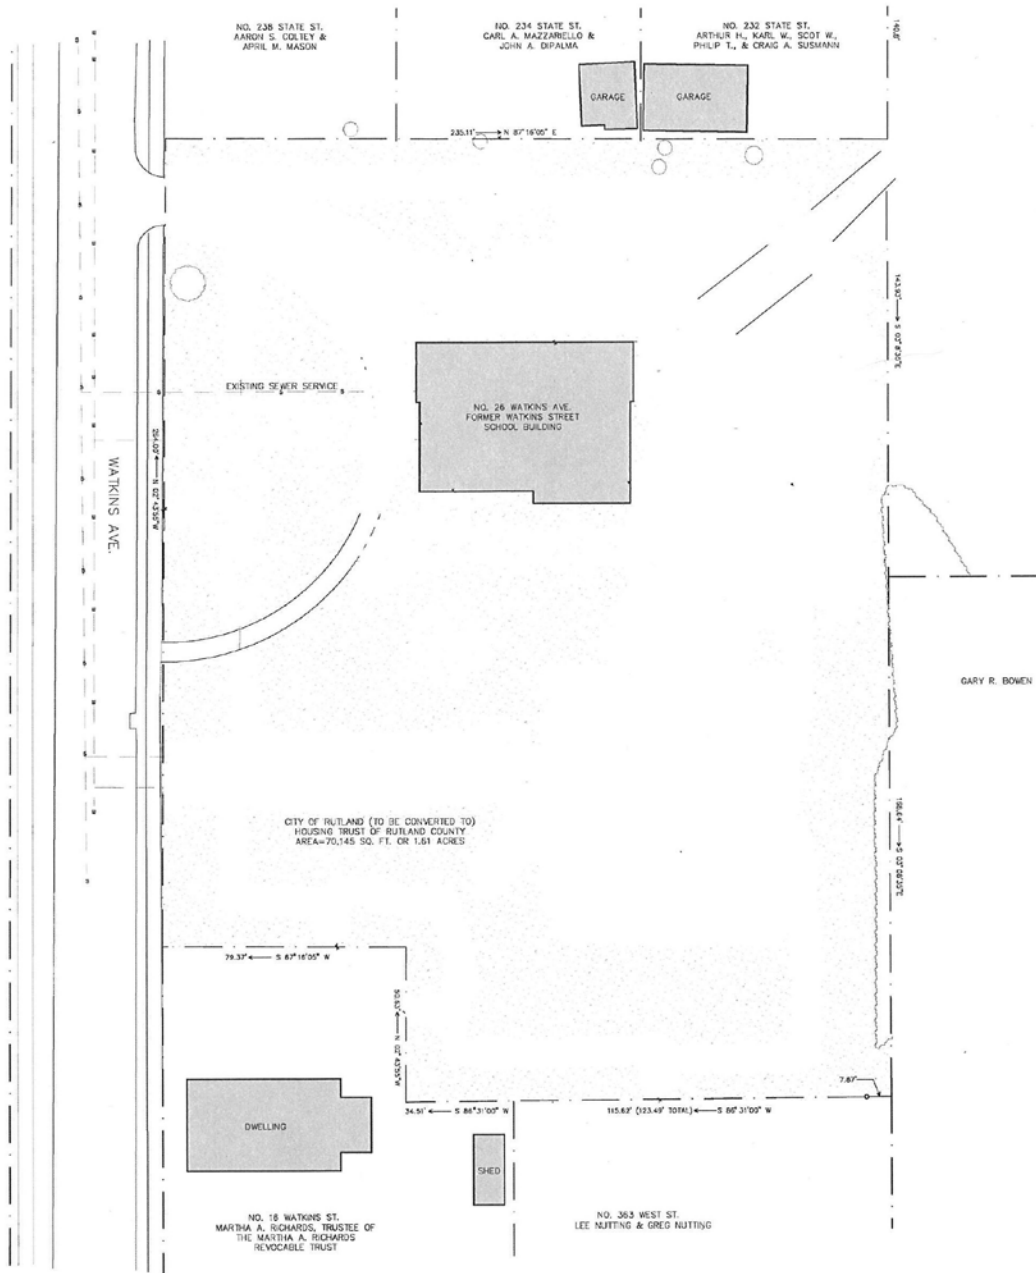
Section number Site Plan Page 1

Watkins School, 26 Watkins Avenue, Rutland, Rutland County, Vermont
(courtesy Arnold & scangas Architects)
