National Register of Historic Places  
Registration Form

historic name BENNETT-SHATTUCK HOUSE

street & number 653 MARTINS POND ROAD N/A not for publication

city or town GROTON \_\_\_\_\_ vicinity \_\_\_\_\_

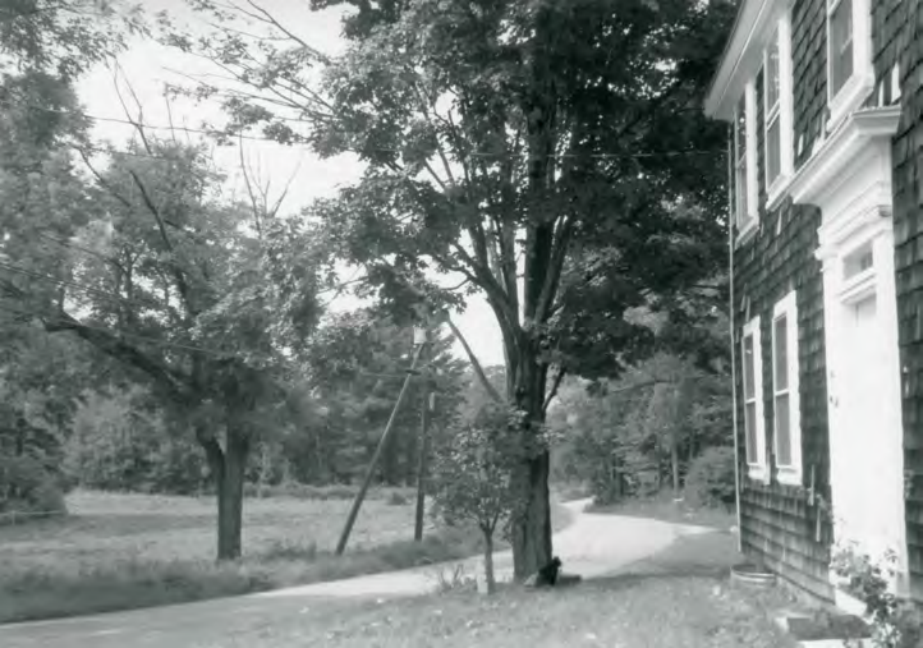
Bennett Shattuck House  
Middlesex Co., Groton Mass  
Photo: S. Johnson 9/03  
Maps on file w/owner  
south Elevation, west view  
photo 1

The ca. 1800 Federal-style Bennett-Shattuck House (**photo #1**) is located in Groton, Massachusetts on Martins Pond Road, a lightly traveled winding lane in the northeast part of the town. The 2½-story side-gabled, double-pile house has a post and beam frame, asphalt shingle roof, wood shingle exterior walls, and a foundation of split granite with fieldstone. A three-bay, two-story 15' x 30' parallel gabled addition or ell was added ca. 1900 to the east elevation of the main block and is set back 15' from the plane of the facade. The principal decorative elements are the symmetrical fenestration in the facade and the center entry surround with its pilasters, transom and full entablature. The landscape surrounding the house is agricultural fields and forest. Baddacook Pond is 800' south of the house. Floyd Hill (also called Baralock Hill), a drumlin with an elevation of 360 feet, rises in the rear or north.

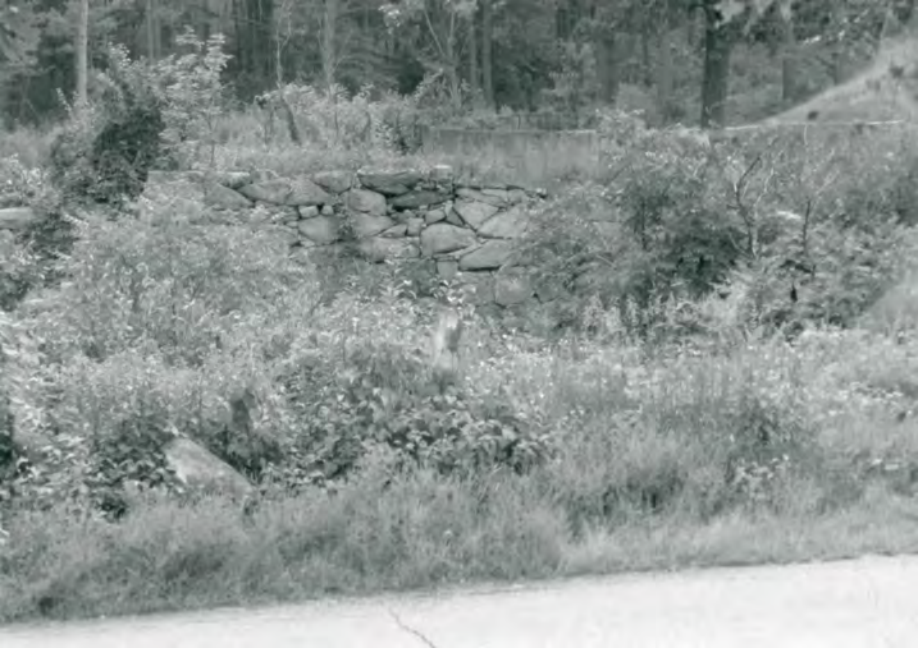
Bennett Shattuck House  
Middlesex Co, Groton Mass  
photo: S. Johnson 9/03  
negs on file w/owner  
south view, Barn foundation, south  
side Martins pond Rd  
photo 2

The stone barn foundation across Martins Pond Road (**photo #2**), once part of the Bennett-Shattuck farm, will also be retained. This is owned by the town of Groton and occupies a separate parcel. The foundation consists of large hand split boulders with smaller chinking stones between. The northwest corner has collapsed into the interior but the remaining walls survive intact. It measures approximately 30' x 40' and retains a wall of eight feet at its highest point. Granite piers that formerly supported the building remain but are no longer in a standing position. A former trashpit containing metal, glass and rubber trash exists on an embankment behind or south of the former driveway to the barn. A circular silo foundation and driveway lined in fieldstone also exist.

The house was part of a farm established on the site by the early 18<sup>th</sup> century. The dry-laid split granite foundation of a barn exists across the road. The barn burned in 1930. Evidence of other buildings and the foundation of a silo also exist in this area. The parcel south of the road comprises approximately 30 acres and was historically associated with the house parcel. This was subdivided and bought by the town for use as conservation land in 1999. The house is in fair condition and retains integrity of location, design, setting, workmanship, feeling, and association. Original clapboards were covered in the early 20<sup>th</sup> century with wood shingles.

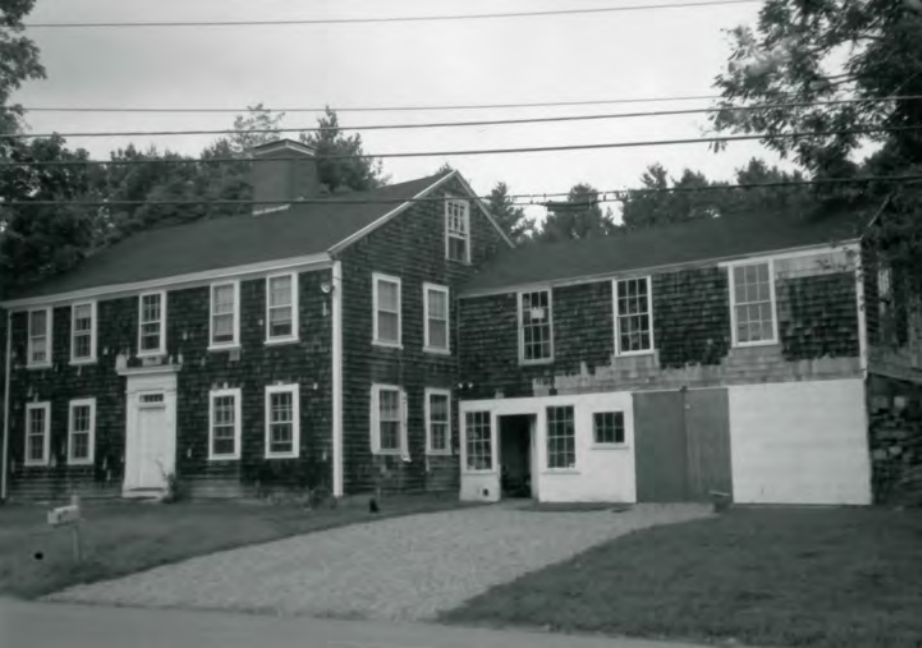
Bennett Shuck House  
Middlesex Co. Boston, Mass  
photo: S. Johnson 9/03  
negs on file w/owner  
north view, south elevation  
~~#1~~ photo 3

The Bennett-Shattuck House is a rectangular, five by three-bay, side-gabled, 2½-story form distinguished by the Federal style symmetrical fenestration and by the classical center entry surround (**photo #3**). The plan of the main block is approximately 40' wide by 30' deep. The ell at the east side is a three-bay, side-gabled form of two stories measuring 30' wide by 15' deep (**photo #6**). The ell is set back 15' from the plane of the facade of the Federal style block. The ground slopes up behind and to the east of the building, resulting in a slope immediately behind the main block of the house. The first story of the ell is built into the bank. Secondary masses consist of the four by four foot, shed roofed outhouse attached to the northwest corner and the stout center brick chimney measuring 45"x54" x45".

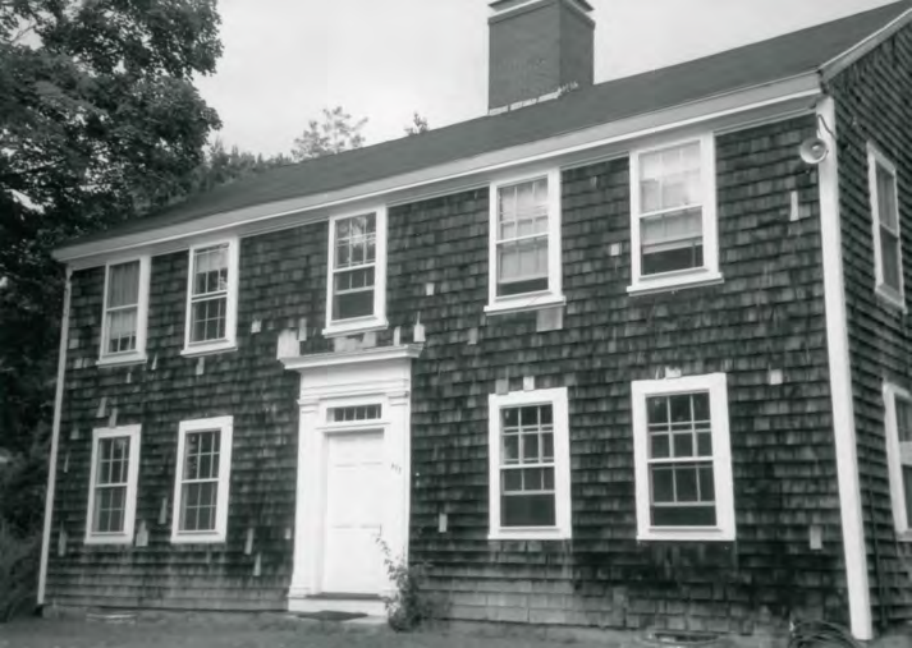
Bennett Shuffuck House  
Middlesex Co. Groton Mass  
photo: S. Johnson 9/03  
negs on file w/owner  
north view, south elevation  
photo 4

Openings are symmetrical on the main block of the house. Fenestration in the facade consists of five windows with 6/6 double-hung sash which light the second story, and four which light the first (**photo #4**). The principal entry with transom light occupies the center bay of the first story. Two cellar windows with four-pane fixed sash exist below the facade. The west side wall has three windows in the second story and two in the first story, all with 6/6 double-hung sash. The north opening of the first story of the west elevation has a door with plain trim and a four-pane transom (**photo #7**). The east elevation has two 6/6 double-hung sash on either story. Facade and side-wall windows measure approximately 33" x 60". Attic windows in the side-gable peaks are 6/6 double-hung sash in the east and 6/8 in the west. Openings in the rear elevation are filled with 6/9 double-hung sash measuring 25" x 55". Windows in the second story of the ell are 6/6 double hung sash measuring 33" x 68". First story openings in the ell are less symmetrical, including six and 12-pane fixed sash and a door in the west end. A pedestrian door and boarded window opening pierce the second story of the ell at the banked east end. Windows appear to be original (**photo #8**).

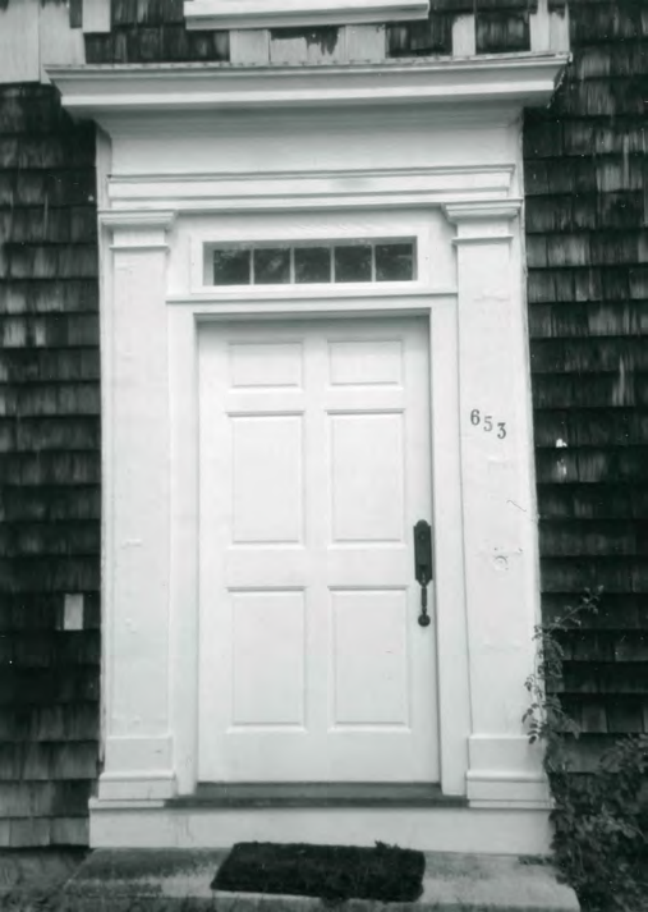
~~#2~~ Photo 5

Federal style decorative elements are restrained. Most striking is the symmetrical fenestration in the facade. The center entry has classical trim in the form of pilasters with Doric caps, a molded transom bar supporting the five pane transom light with architrave, frieze, and cornice above (**photo #5**). The roof-wall junction of the

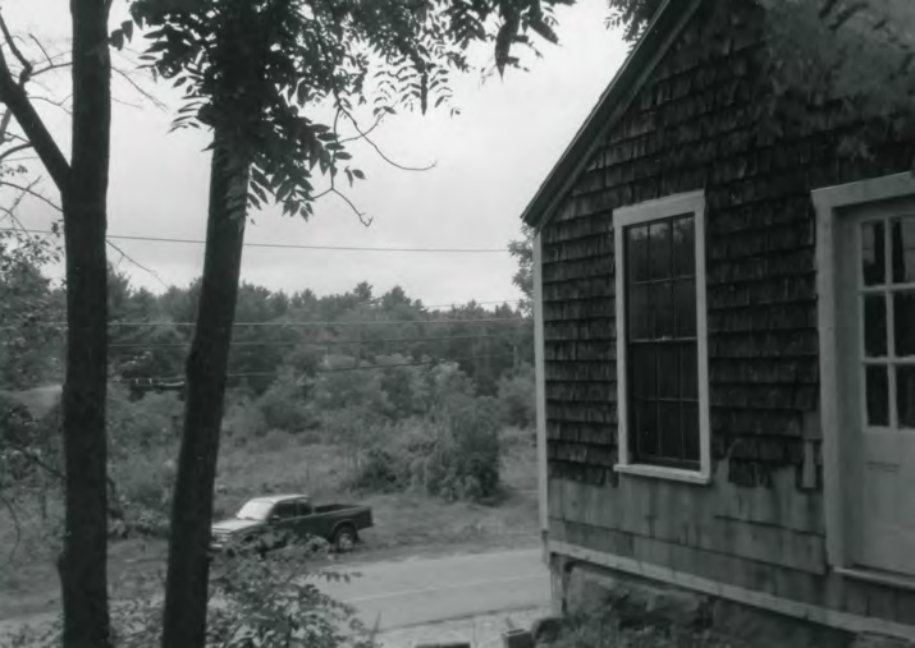
Bennett Shattuck House  
Middlesex Co, Groton, Mass  
photo: S. Johnson 9/03  
negs on file w/owner  
South view, East elevation, East addition  
Photo 9

The roof is sheathed in asphalt shingles. Exterior walls of the main block are sheathed in wood shingles applied over original wood clapboards. Walls of the ell are wood shingles and horizontal flushboard at the first story of the front elevation(**photo #9**). Foundation materials in the main block are rectangular slabs of split granite at grade with fieldstone construction below. Foundation materials in the ell are concrete with some brick and fieldstone.

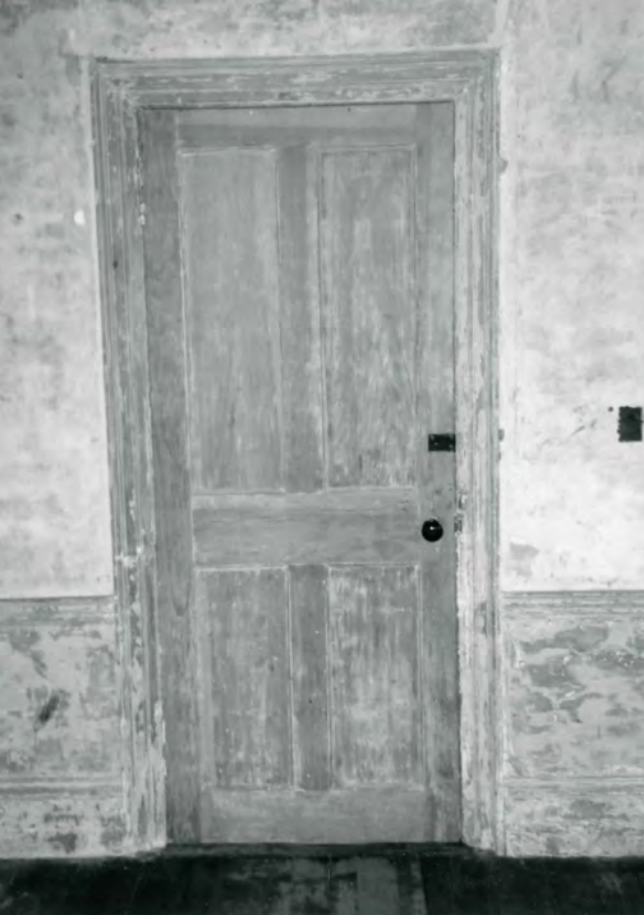
Negs on file w/ owner  
North view 1st Floor East Room  
Photo 11

Interior doors are four-panel designs that appear to be from the time of original construction and have flat panels on one side with feather-edged panels on the reverse (**photo #11**). Doors of this type exist in 13 locations on the first and second floors. Cabinets were built during original construction into the walls in some locations. Two by three-foot doors access the set of six-foot high recessed shelves adjacent to the fireplace in the east room on the first floor. A second smaller cabinet is on the opposite side of the fireplace and has a single door. Similar

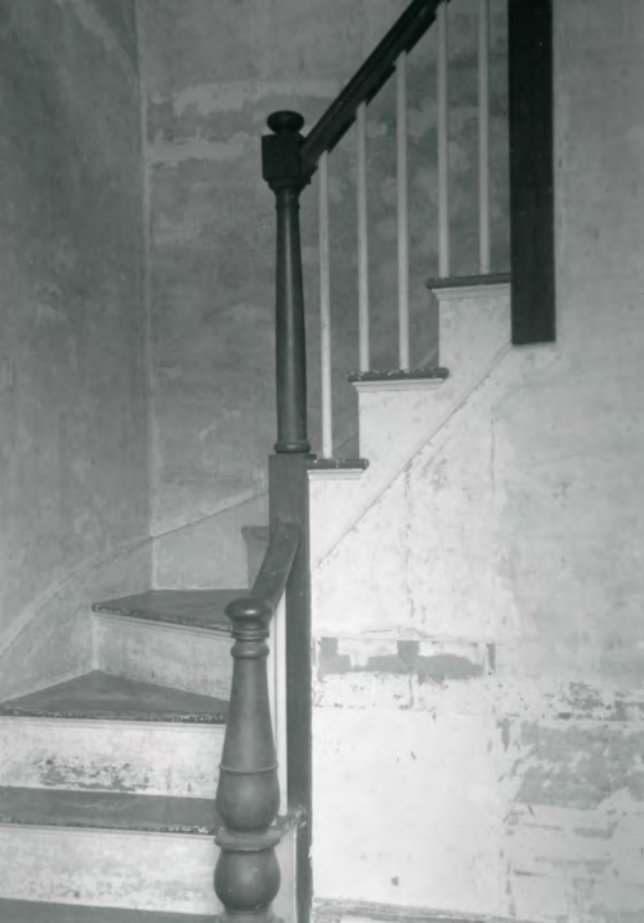
Photo 13

The center stair hall measures approximately nine feet by four feet and gives access to the main staircase. The rectangular staircase winds 180 degrees with two squared corners and three sections of handrail supported by three elongated columnar newel posts, the largest of which is located at the bottom. Posts, balusters, treads, risers and nosing appear to be original (**photo #13**).

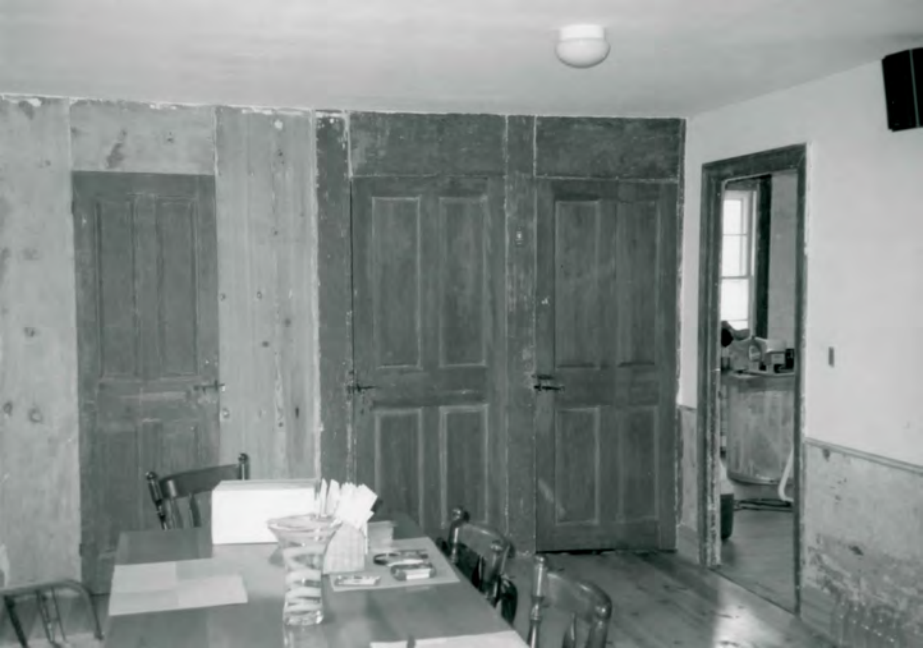
Bennett Shattuck House  
Middlesex Co; Groton, Mass  
Photo: S. Johnson 9/03  
negs on file w/ owner  
East view, 1st floor, North room  
Photo 14

The rear or north of the first floor plan consists of a 30'x12' recently remodeled kitchen which retains some historic trim around the west and east doors (**photo #14**). Historic trim also survives and around the fireplace which is larger than others in the house and retains its crane, bake oven and ash pit (**photo #15**).

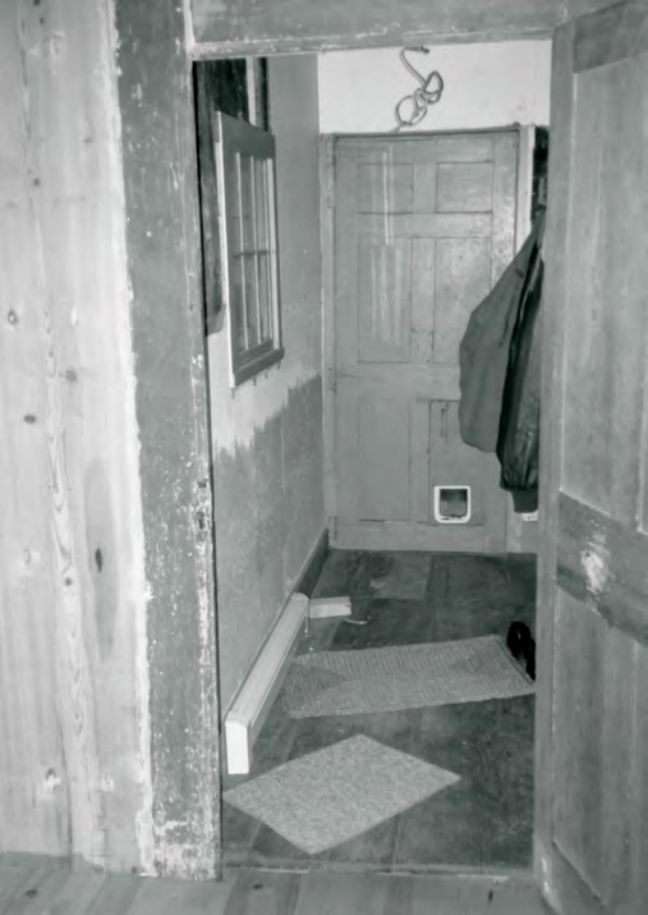
photo 16

The northeast corner of the first floor plan has a five by ten foot former pantry (now a bathroom), four by ten foot hallway connecting the kitchen with the east side ell and flights of stairs rising to the second floor and descending to the cellar (**photo #16**). These service areas are divided by wood plank walls that appear to be original and have evidence of the beaded trim found elsewhere in the house. The hallway has two layers of historic wallpaper. The outer layer has mid 19<sup>th</sup> century Moorish arch designs that frame scenes dominated by leafy vegetation and onion-domed architecture. Remnants of vivid blue and red color survive in some places although it is mostly faded to a dark brown. Wallpaper below this has scenes of white classical statuary and architecture. The uneven nature of the hand-blocked prints and the subject matter suggest it was applied around the time of construction.

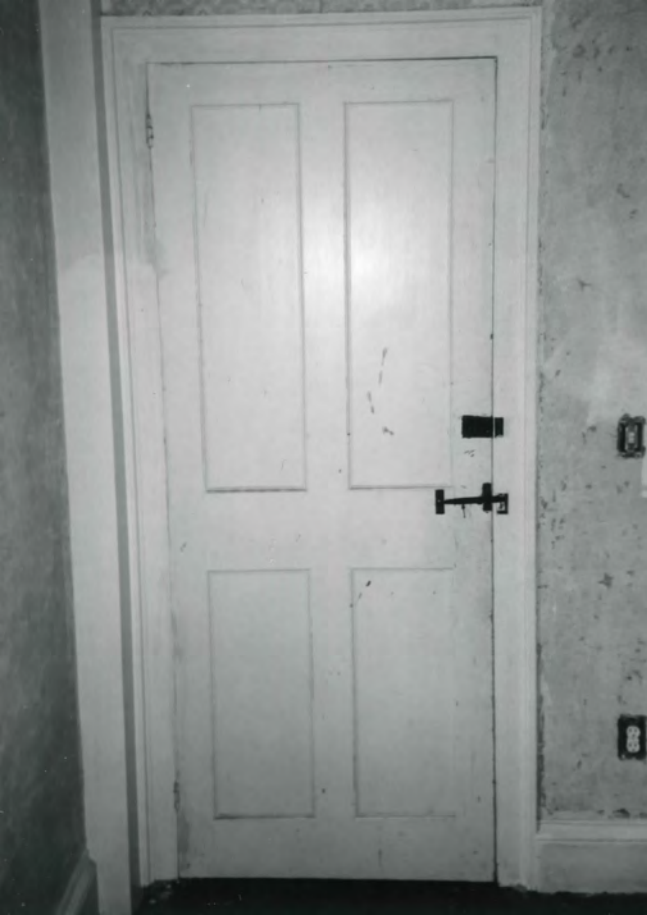
Photo 18

Floors in every room except the recently remodeled kitchen have historic wide pine boards. Several types of latches exist, the oldest of which appear to be hand-hammered wrought iron in a bean leaf form (**photo #18**). Some have been replaced with recycled Federal period iron latches. Hand riven lath is in evidence throughout the house and appears to retain original plaster.

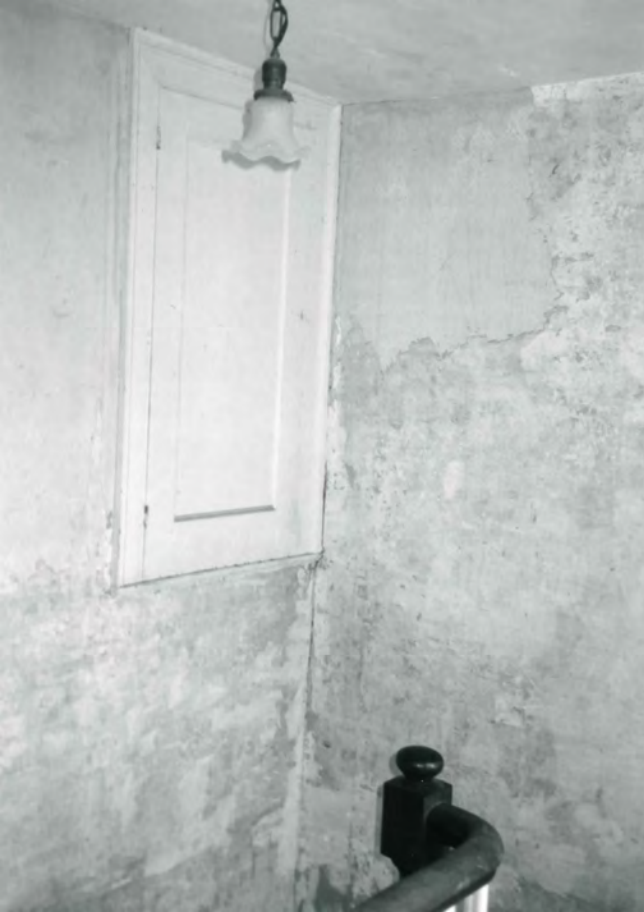
Bennett Shattuck House  
Middlesex Co. Groton Mass  
Photo: S. Johnson 9/03  
negs on file w/owner  
north view 2nd floor front hall  
photo 21

features are found in the west room on the first floor and in the front hall at the upper landing (**photo #21**). A full-size interior door gives access to a narrow closet in the east second floor room.
