Taylor-Chase-Smythe House  
Newport, Rhode Island  
South (front) elevation  
John R. Bowie, A.I.A.  
October 1986

Taylor-Chase-Smythe House  
Newport, Rhode Island

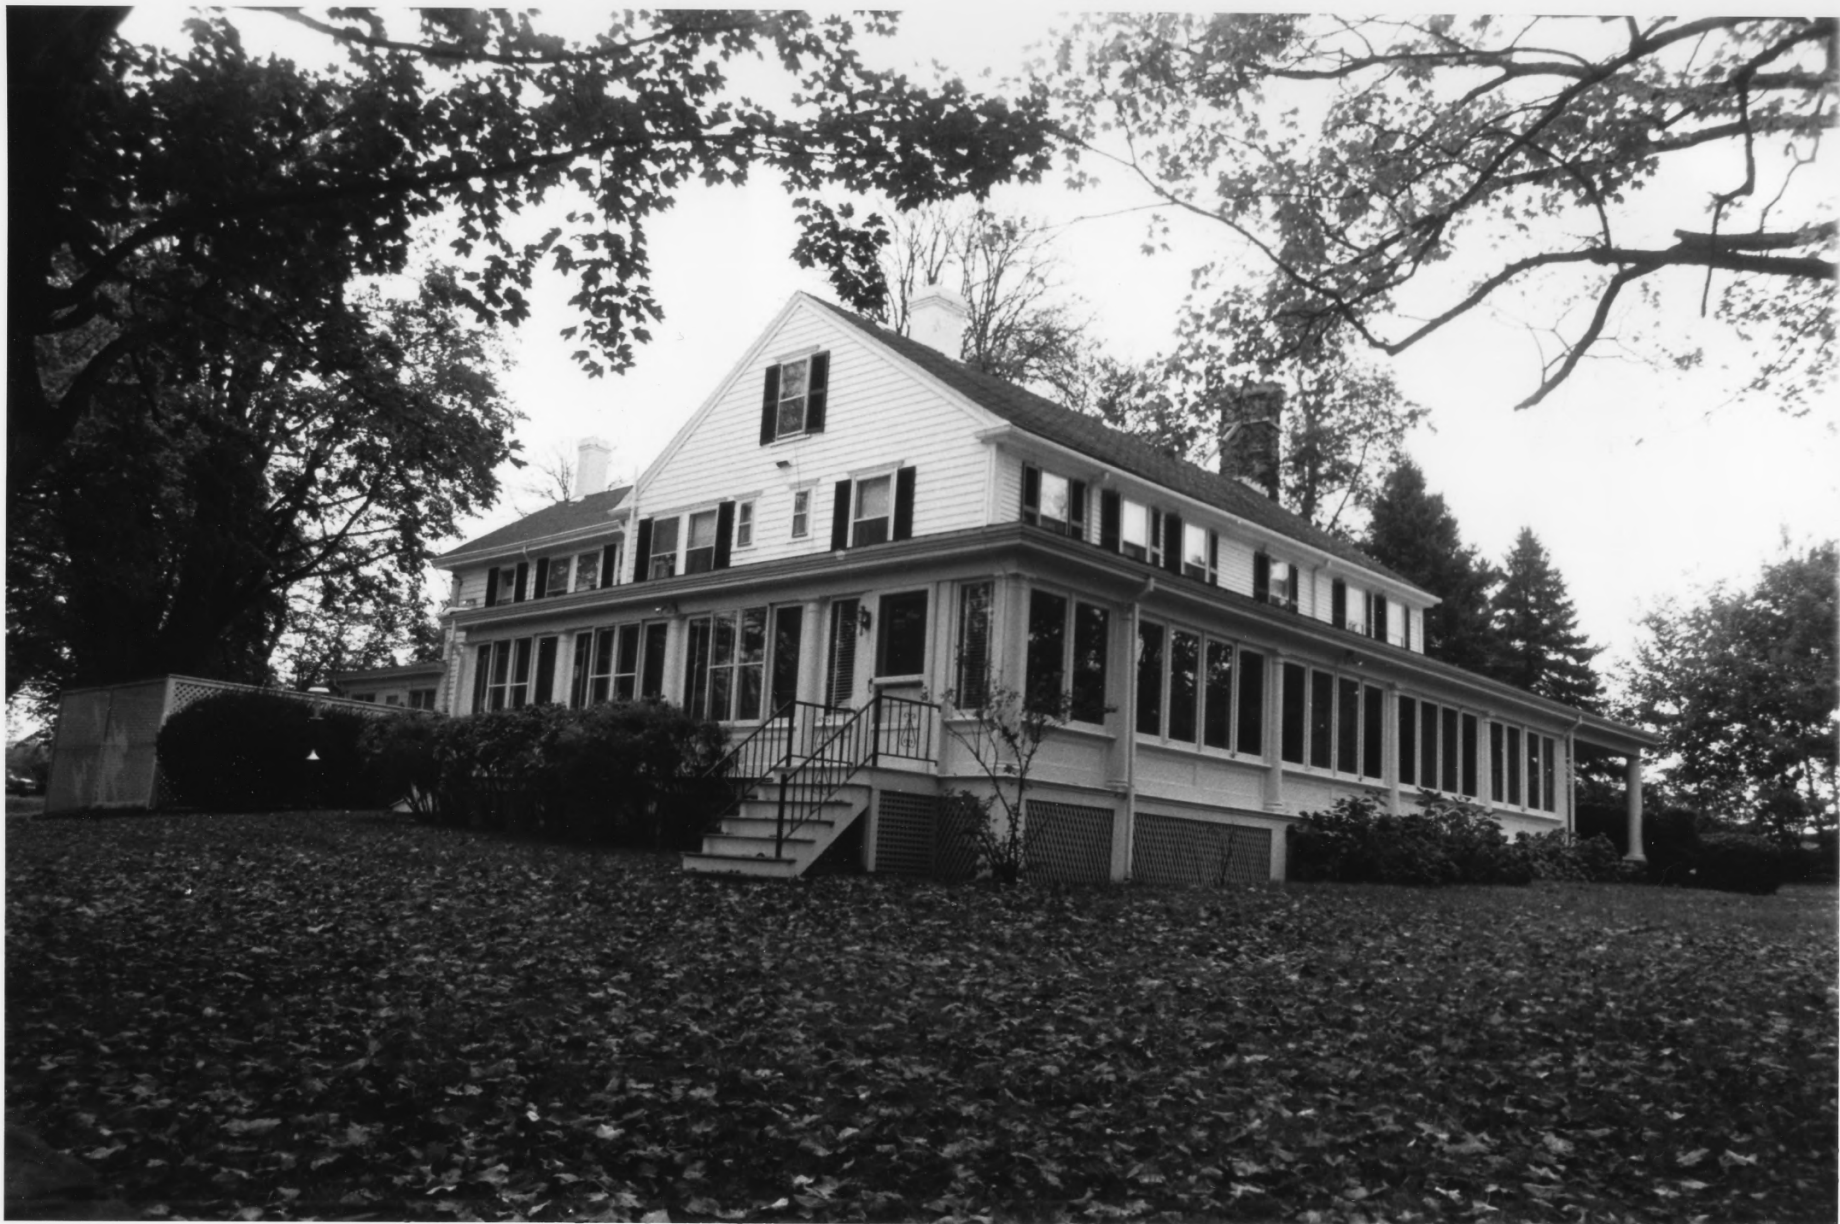
#2

North and East elevations; porte cochere is  
at photo left; note north two-story  
kitchen ell and one-story utility room  
addition

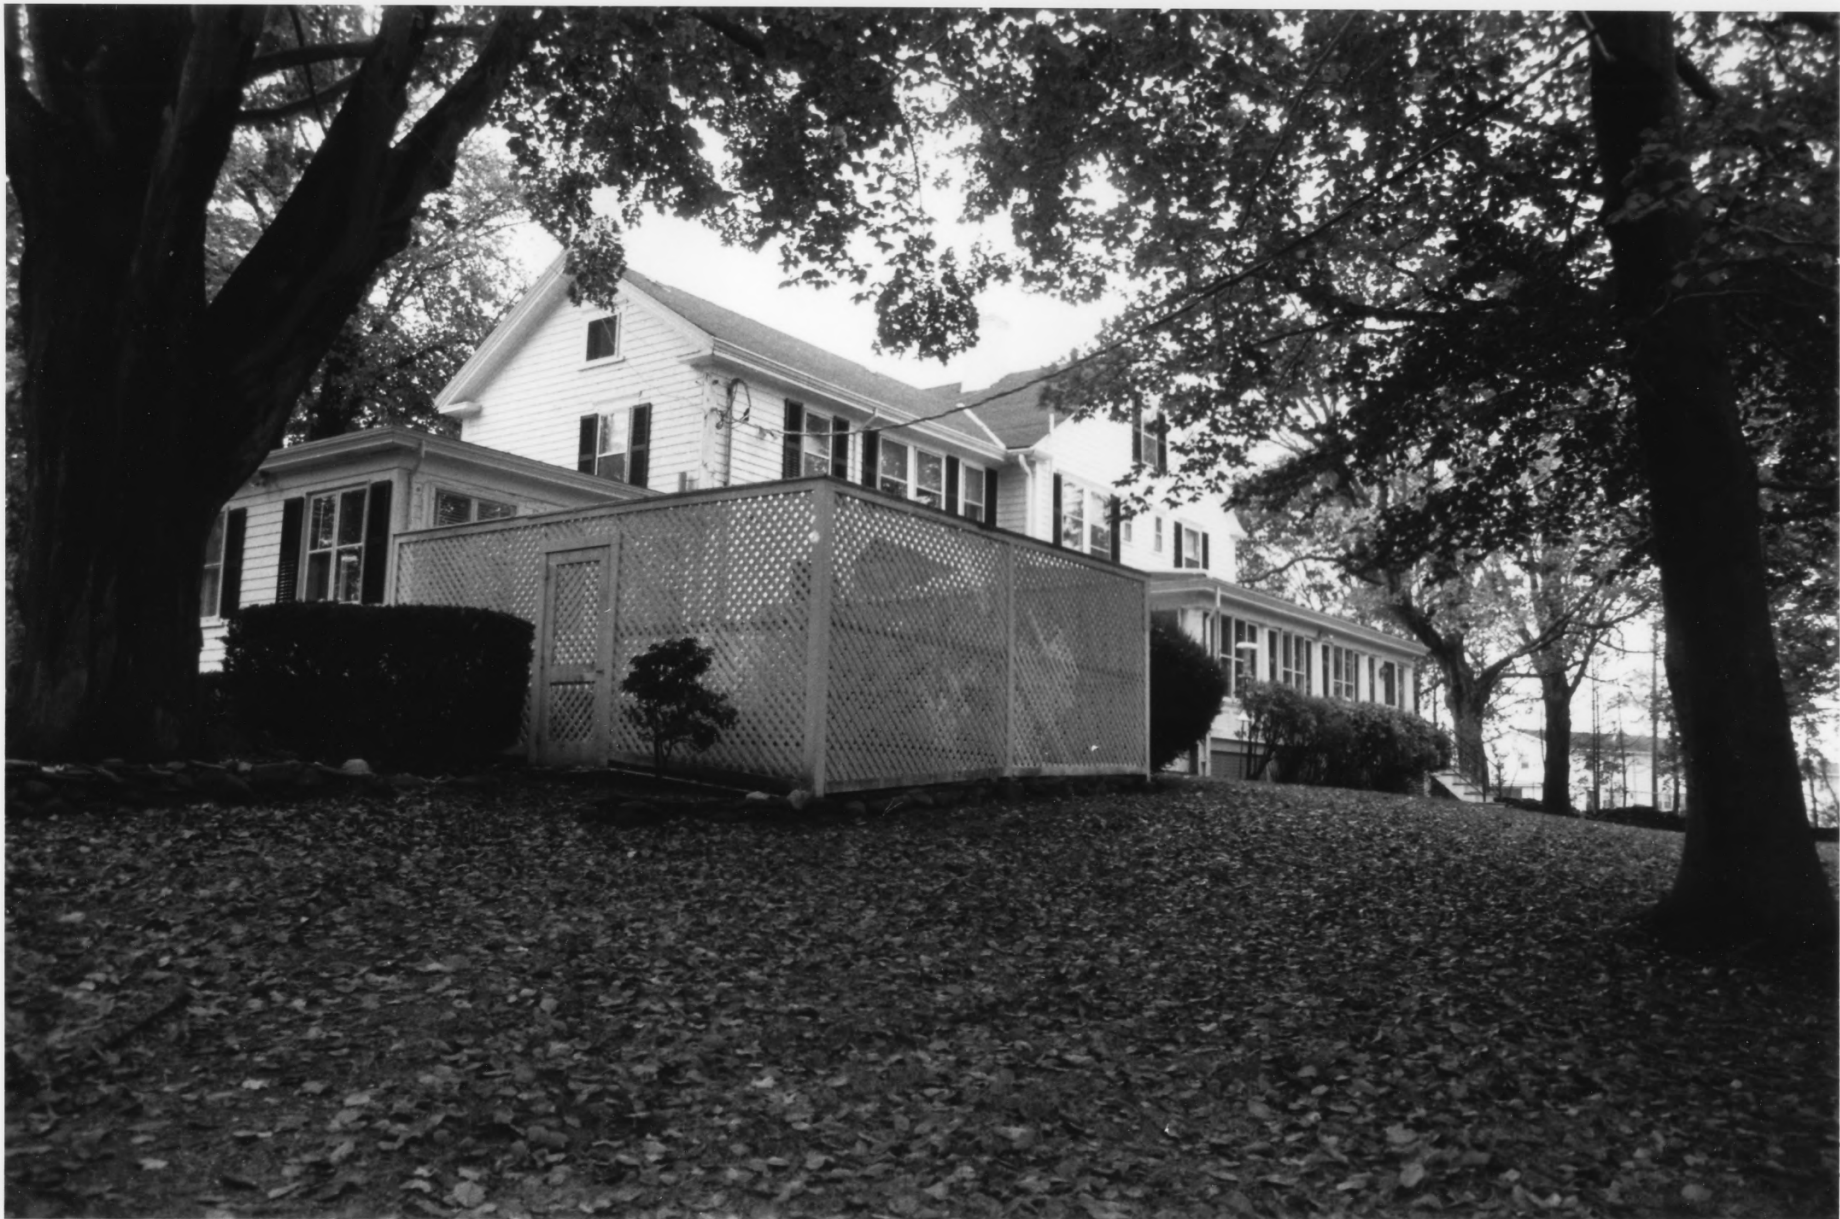
#3

North and West elevations; wood lattice  
provides an enclosure to privately hang  
laundry

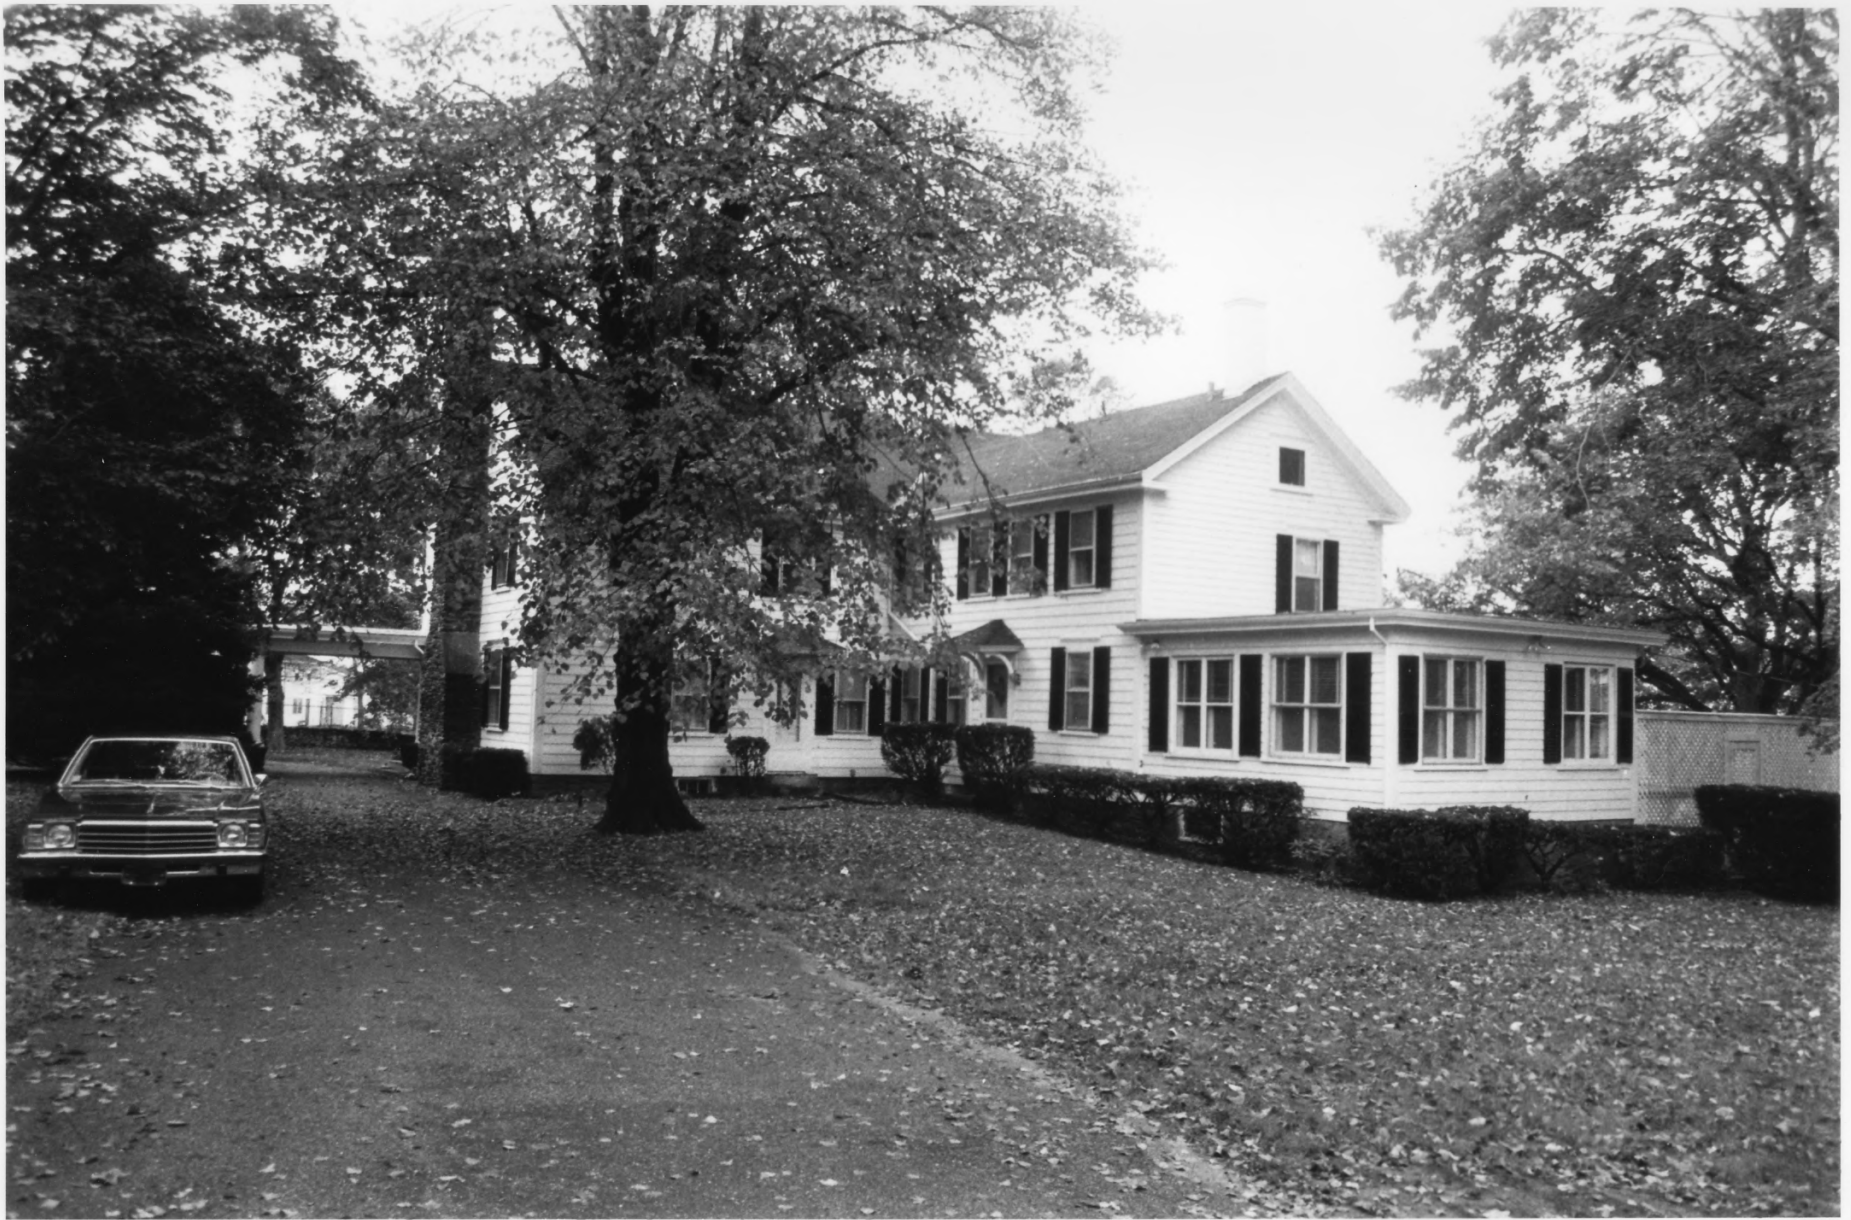
#4

Taylor-Chase-Smythe House  
Newport, Rhode Island  
West and South elevations  
John R. Bowie, A.I.A.  
October 1986

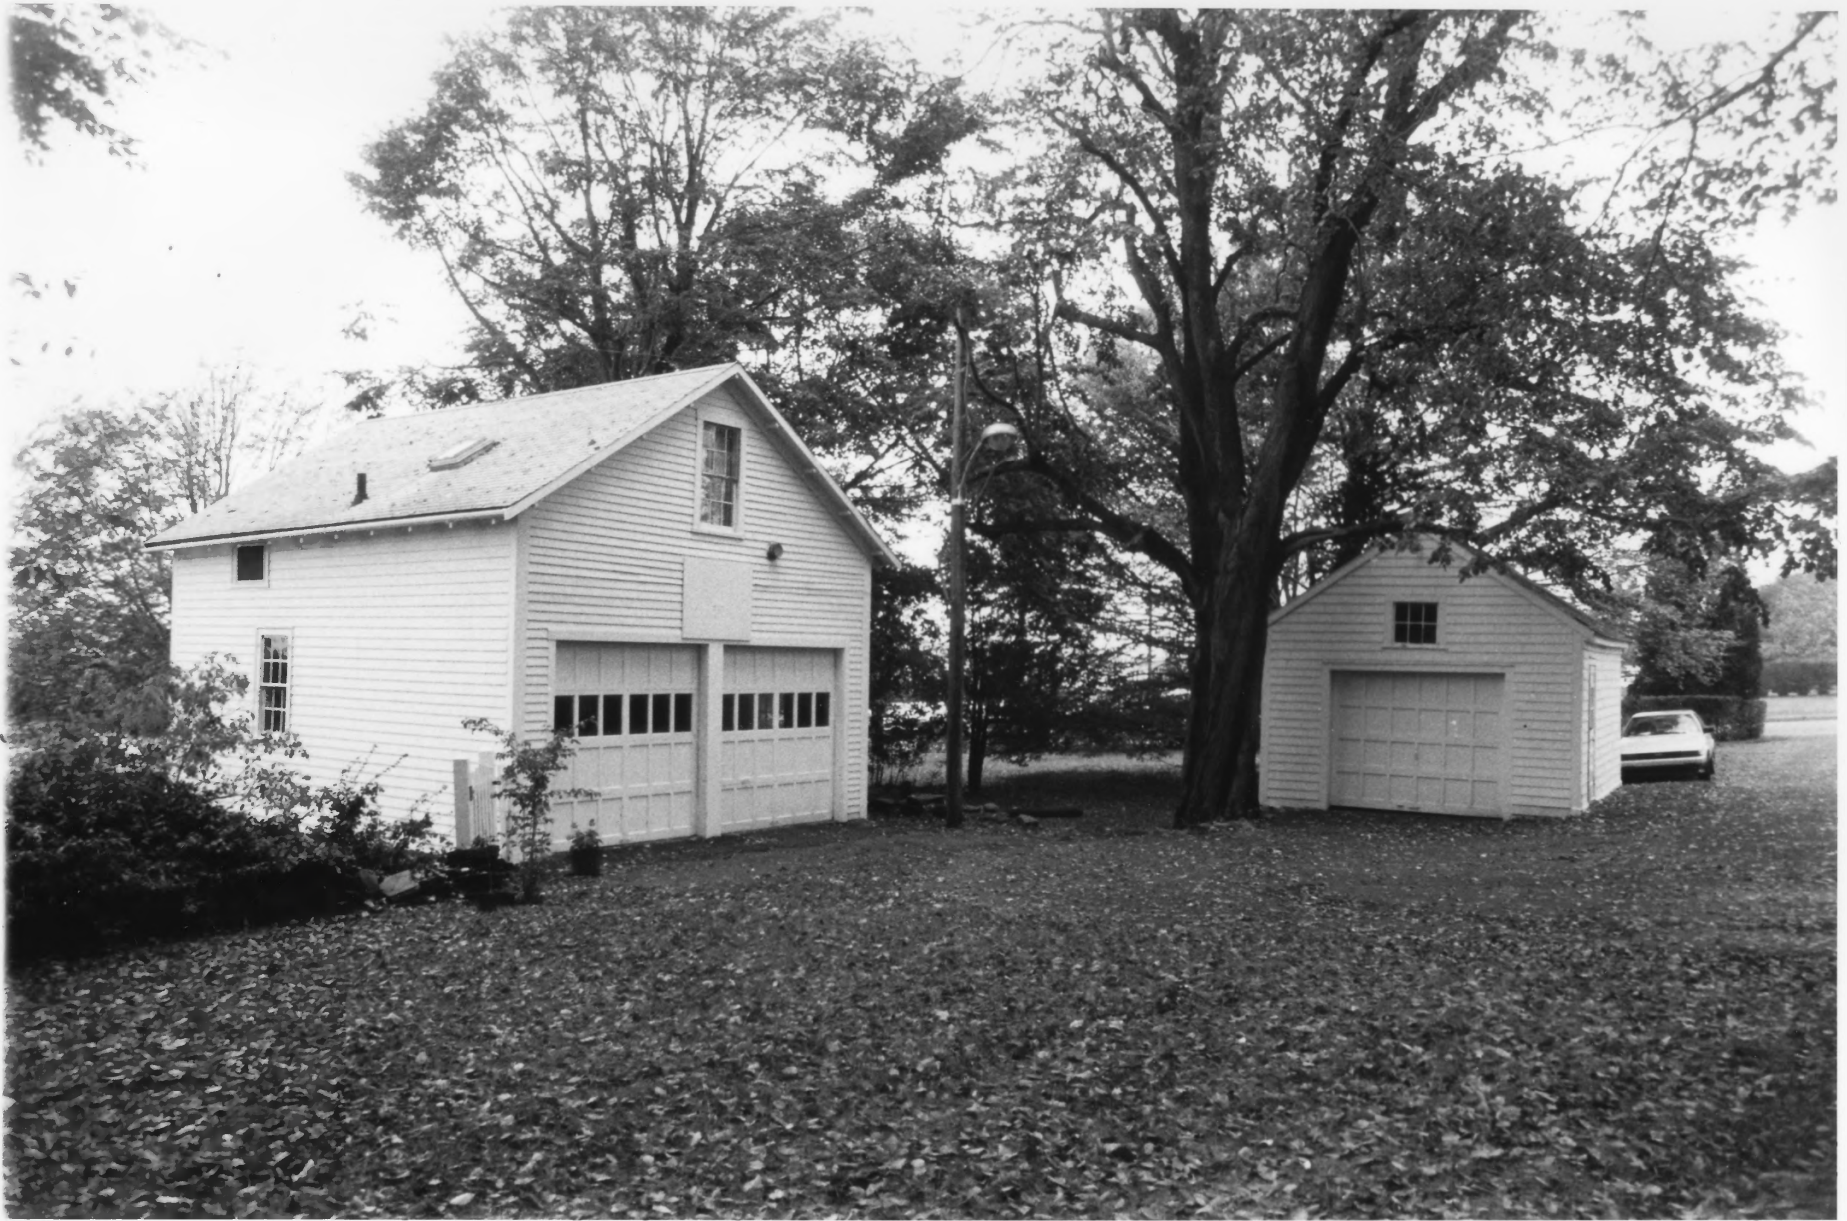
#5

Two bay, one and one-half story garage and  
single bay, one-story garage; view  
looks north

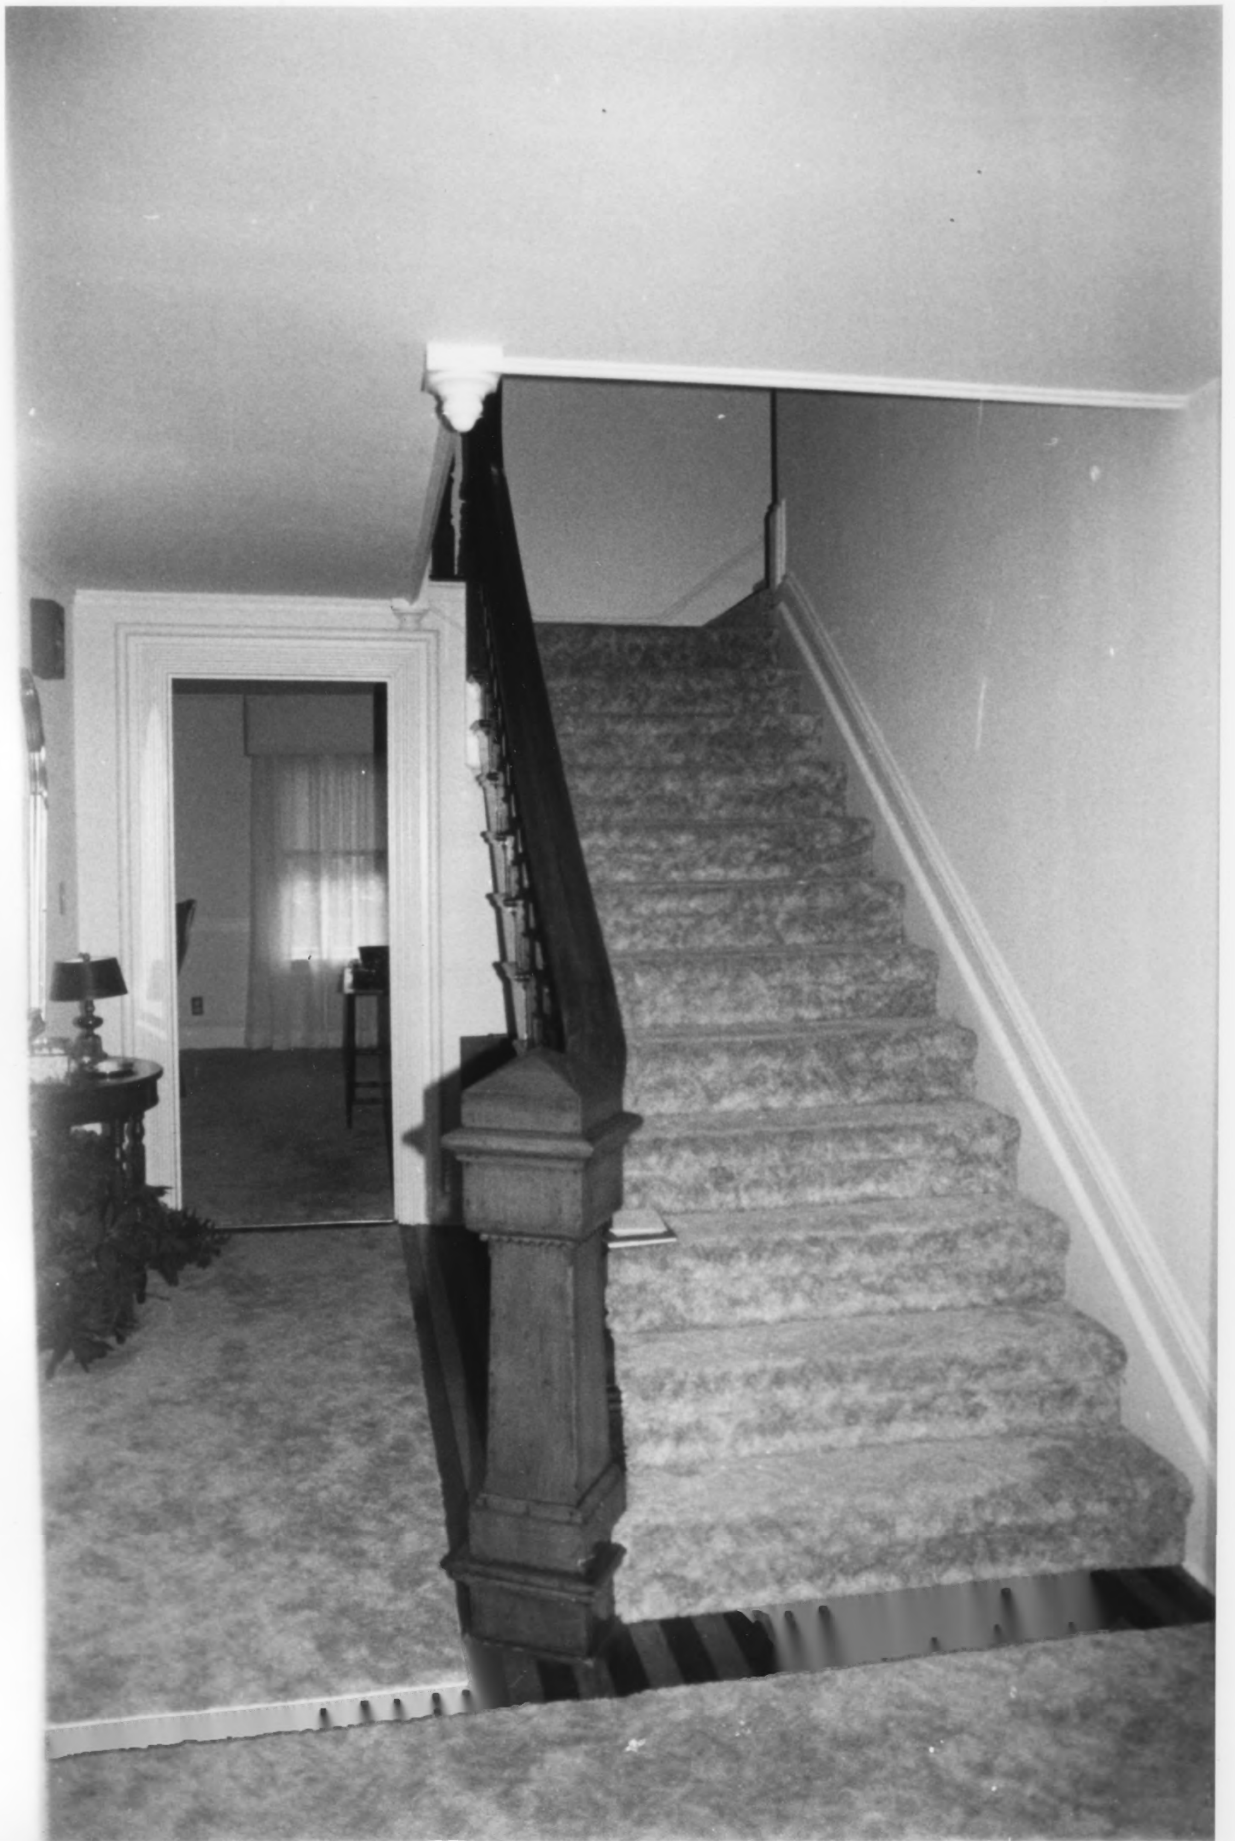
#6

Taylor-Chase-Smythe House  
Newport, Rhode Island  
Center Stair Hall, first floor, looking  
north; note alternating floor pattern  
and skewed built-up newel  
John R. Bowie, A.I.A.  
October 1986

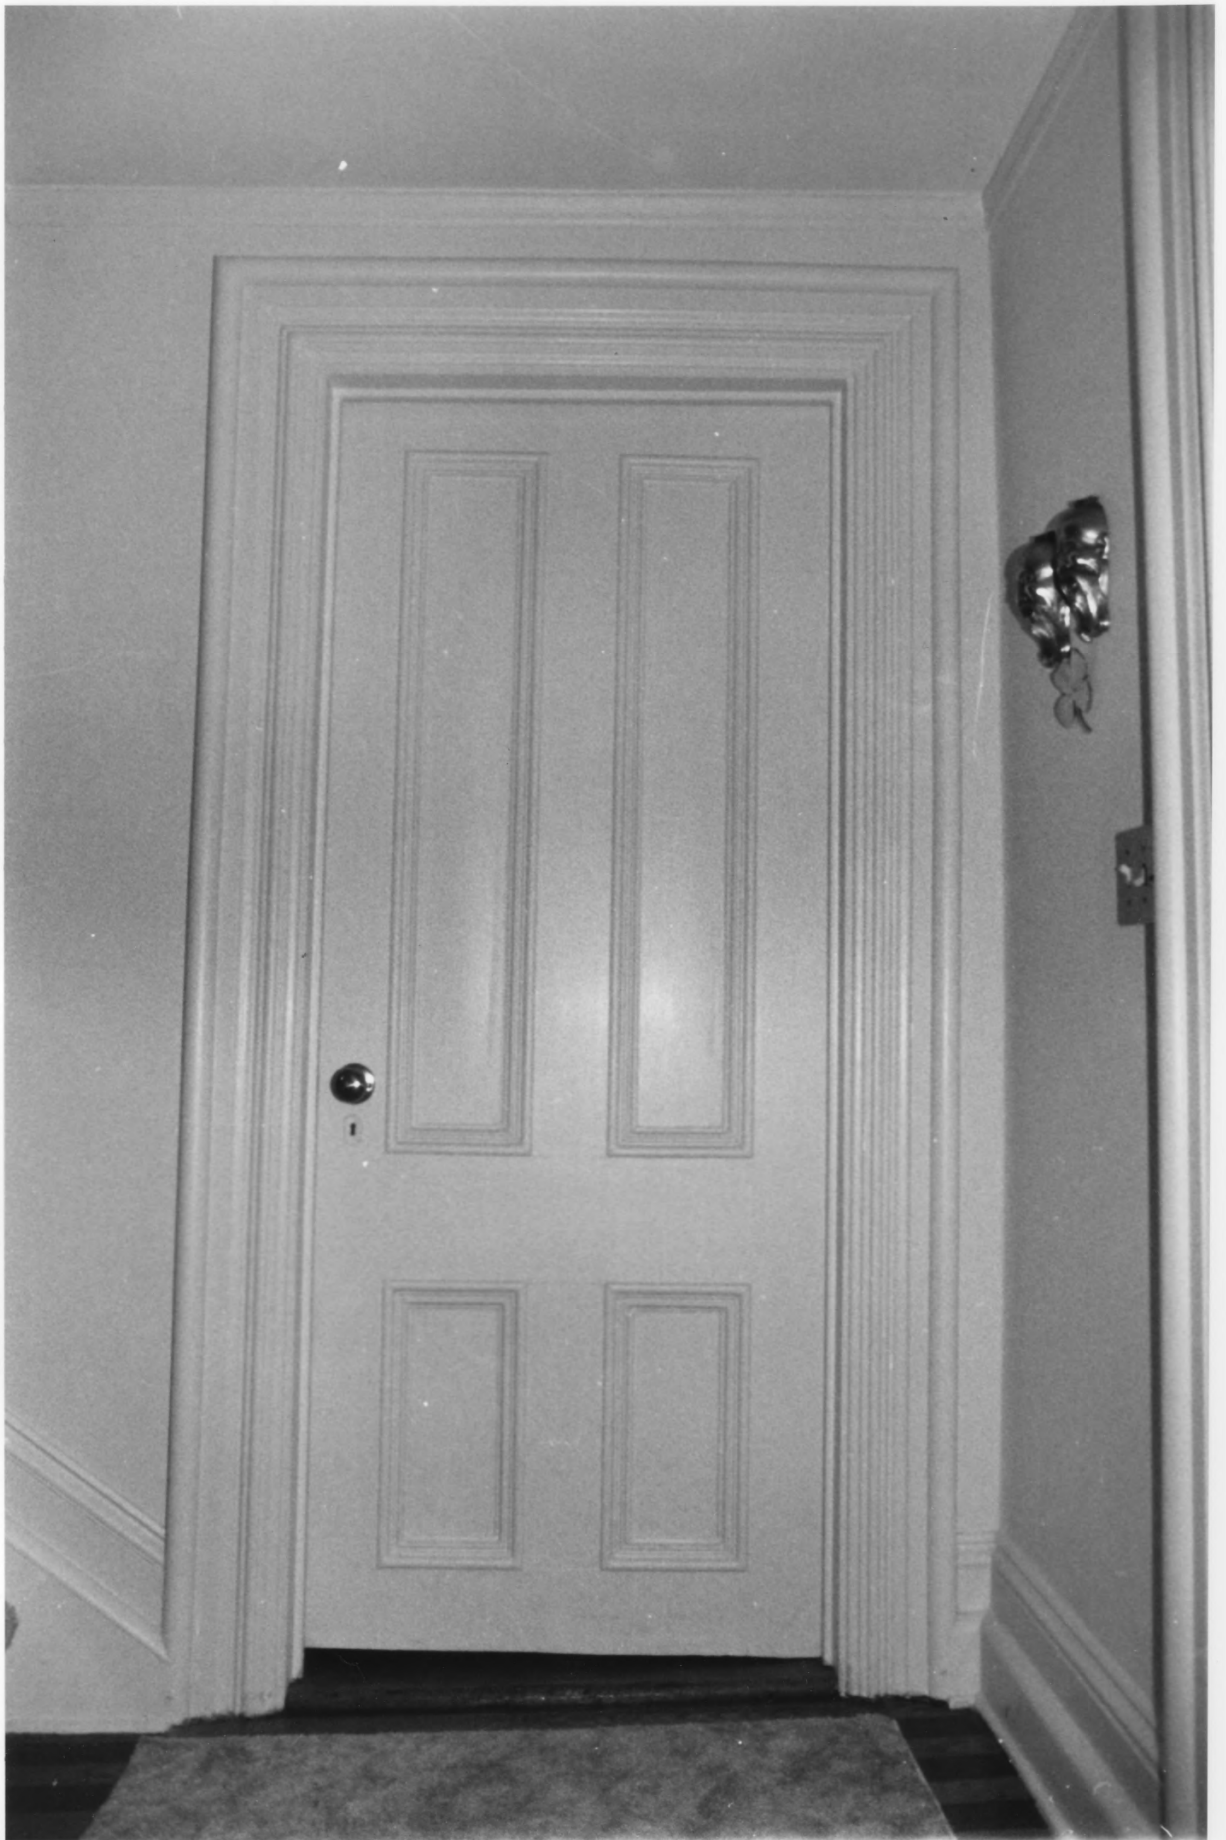
#7

Door connecting center stair hall and east  
room, first floor, looking east; note  
garnish door moulding and heavy baseboard,  
door leaf dates to mid-nineteenth  
century

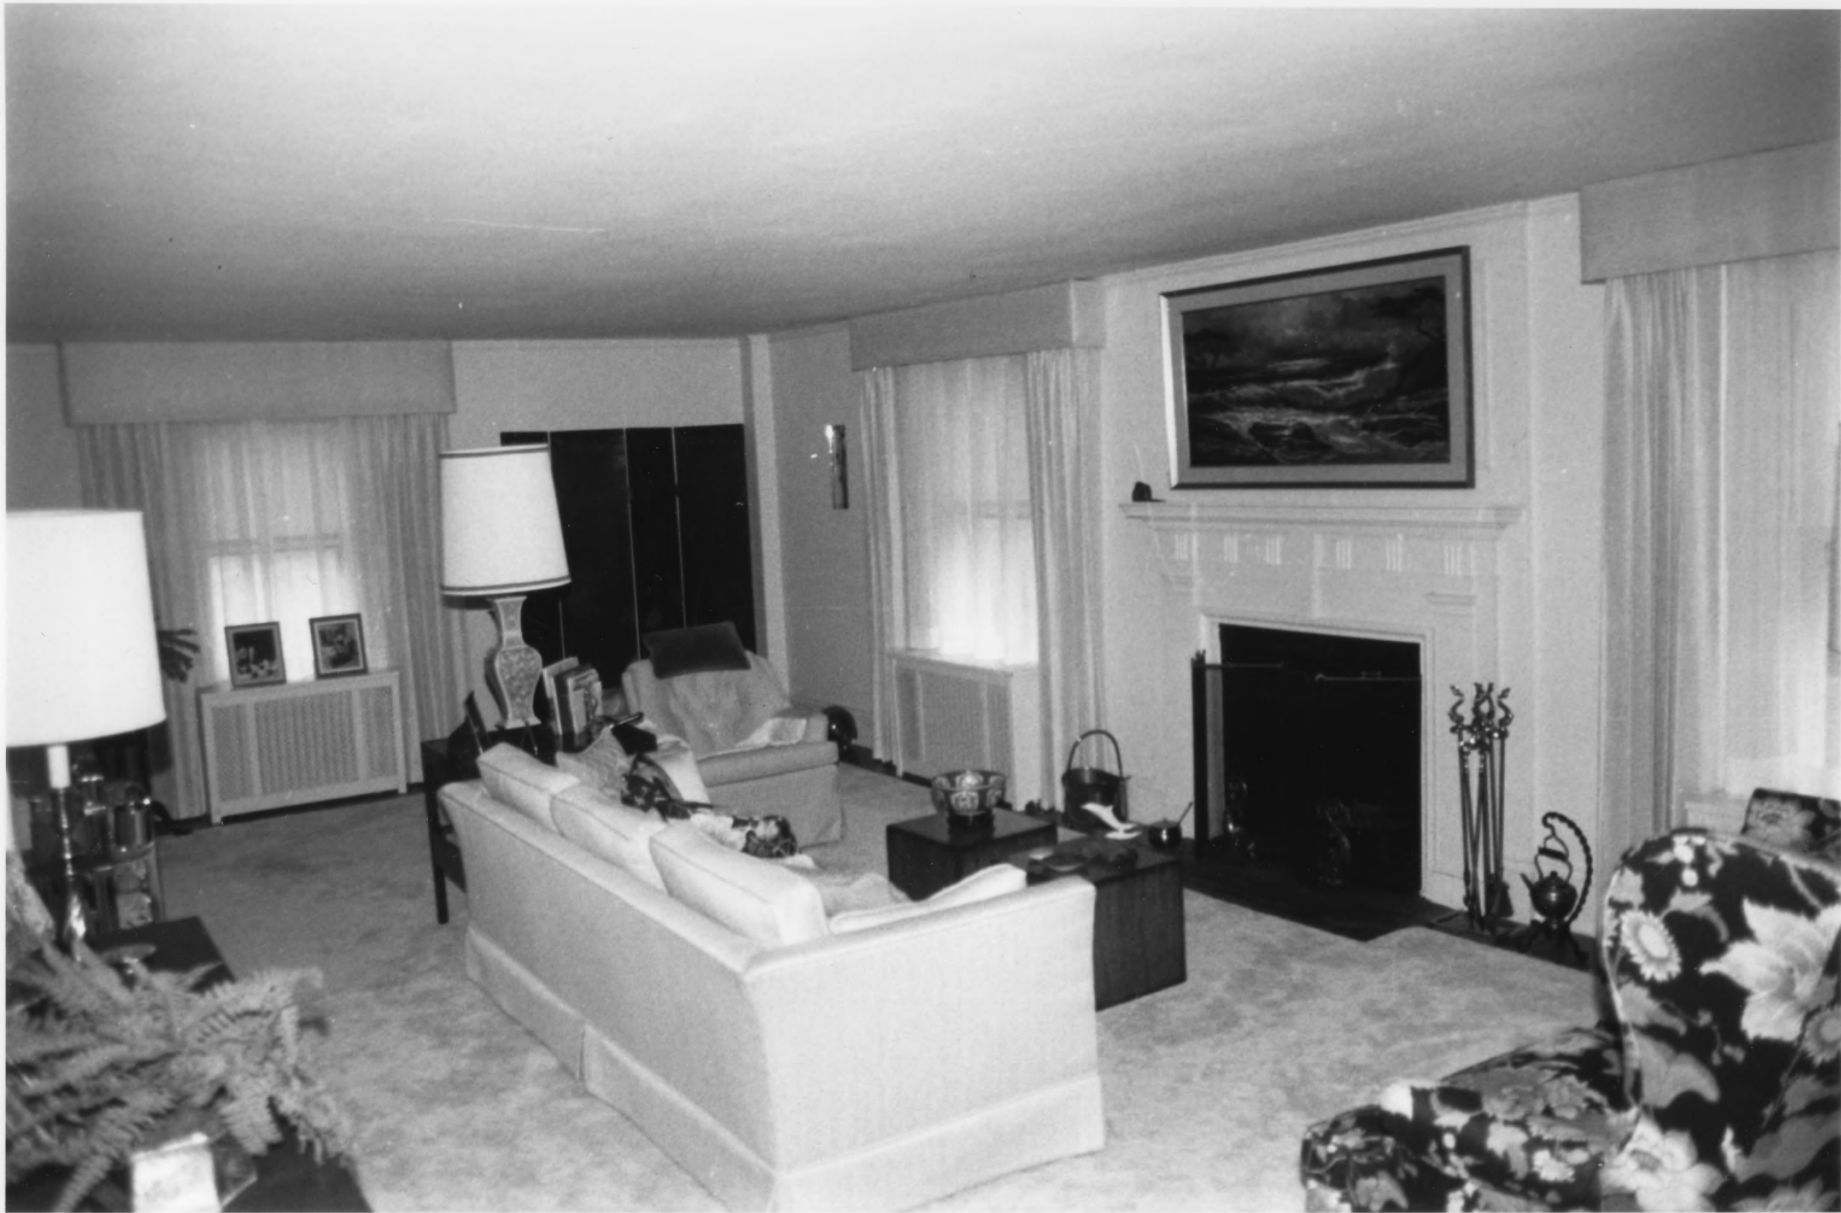
#8

View looking northeast into east room, first  
floor

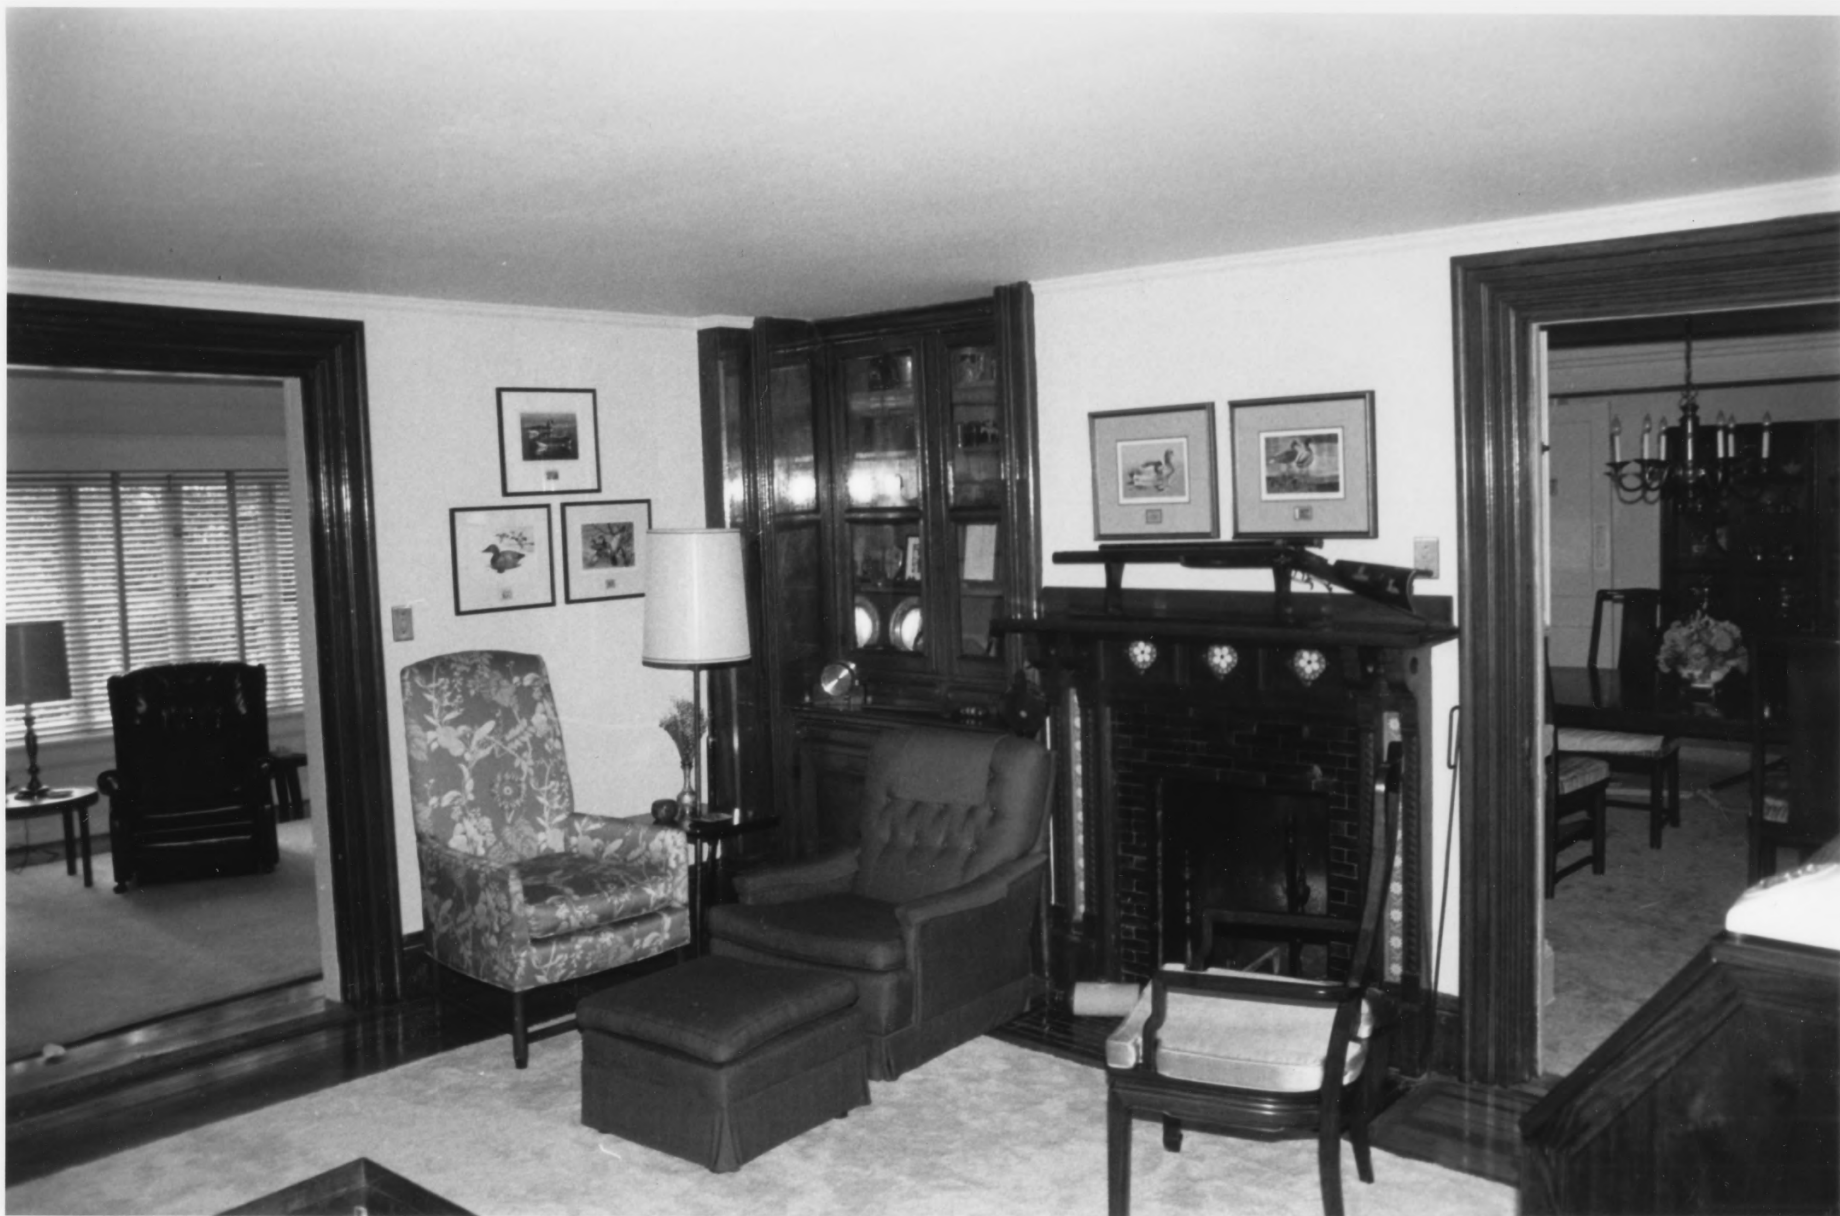
#9

Taylor-Chase-Smythe House  
Newport, Rhode Island  
View looking northwest into library  
John R. Bowie, A.I.A.  
October 1986

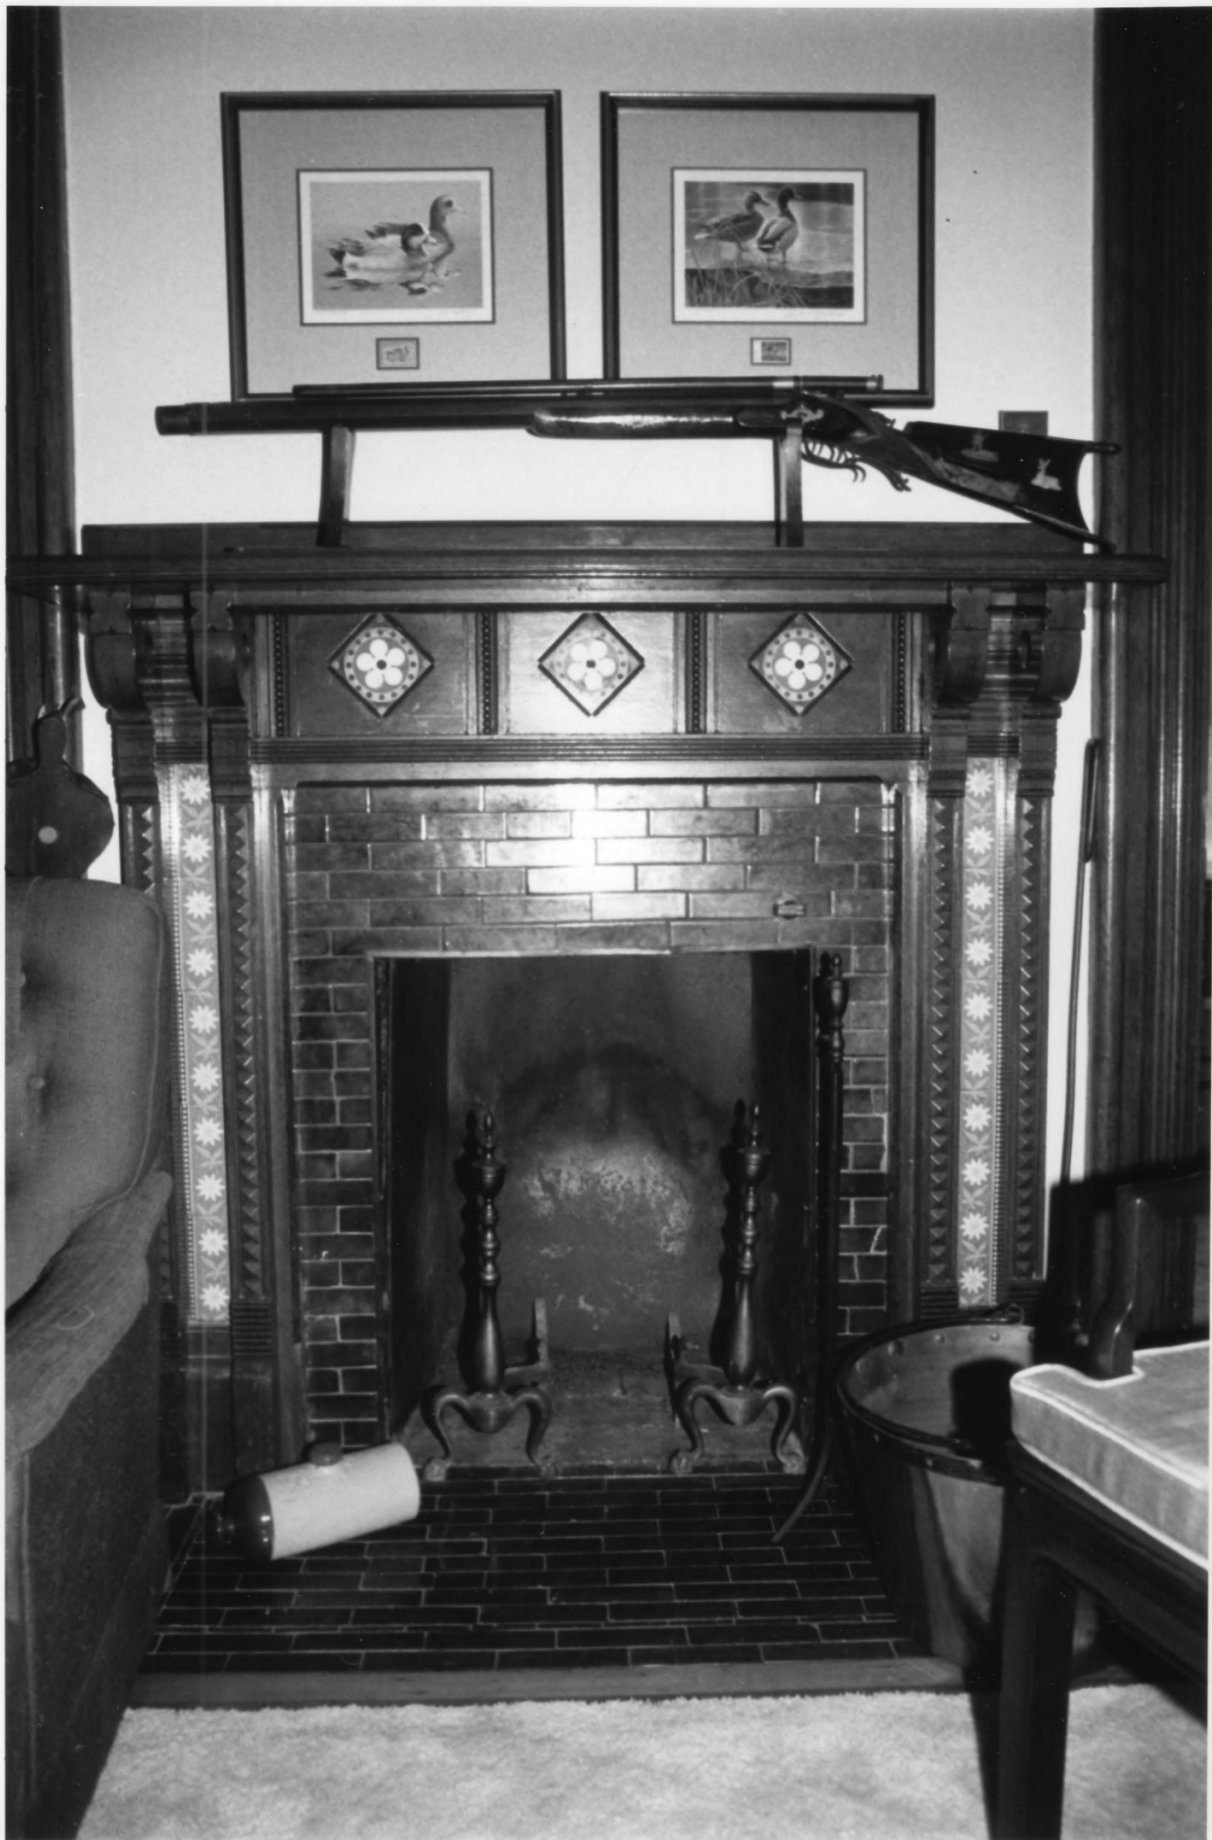
#10

Detail of fireplace in library; note geometrically bracketed mantel shelf and encaustic tile surround

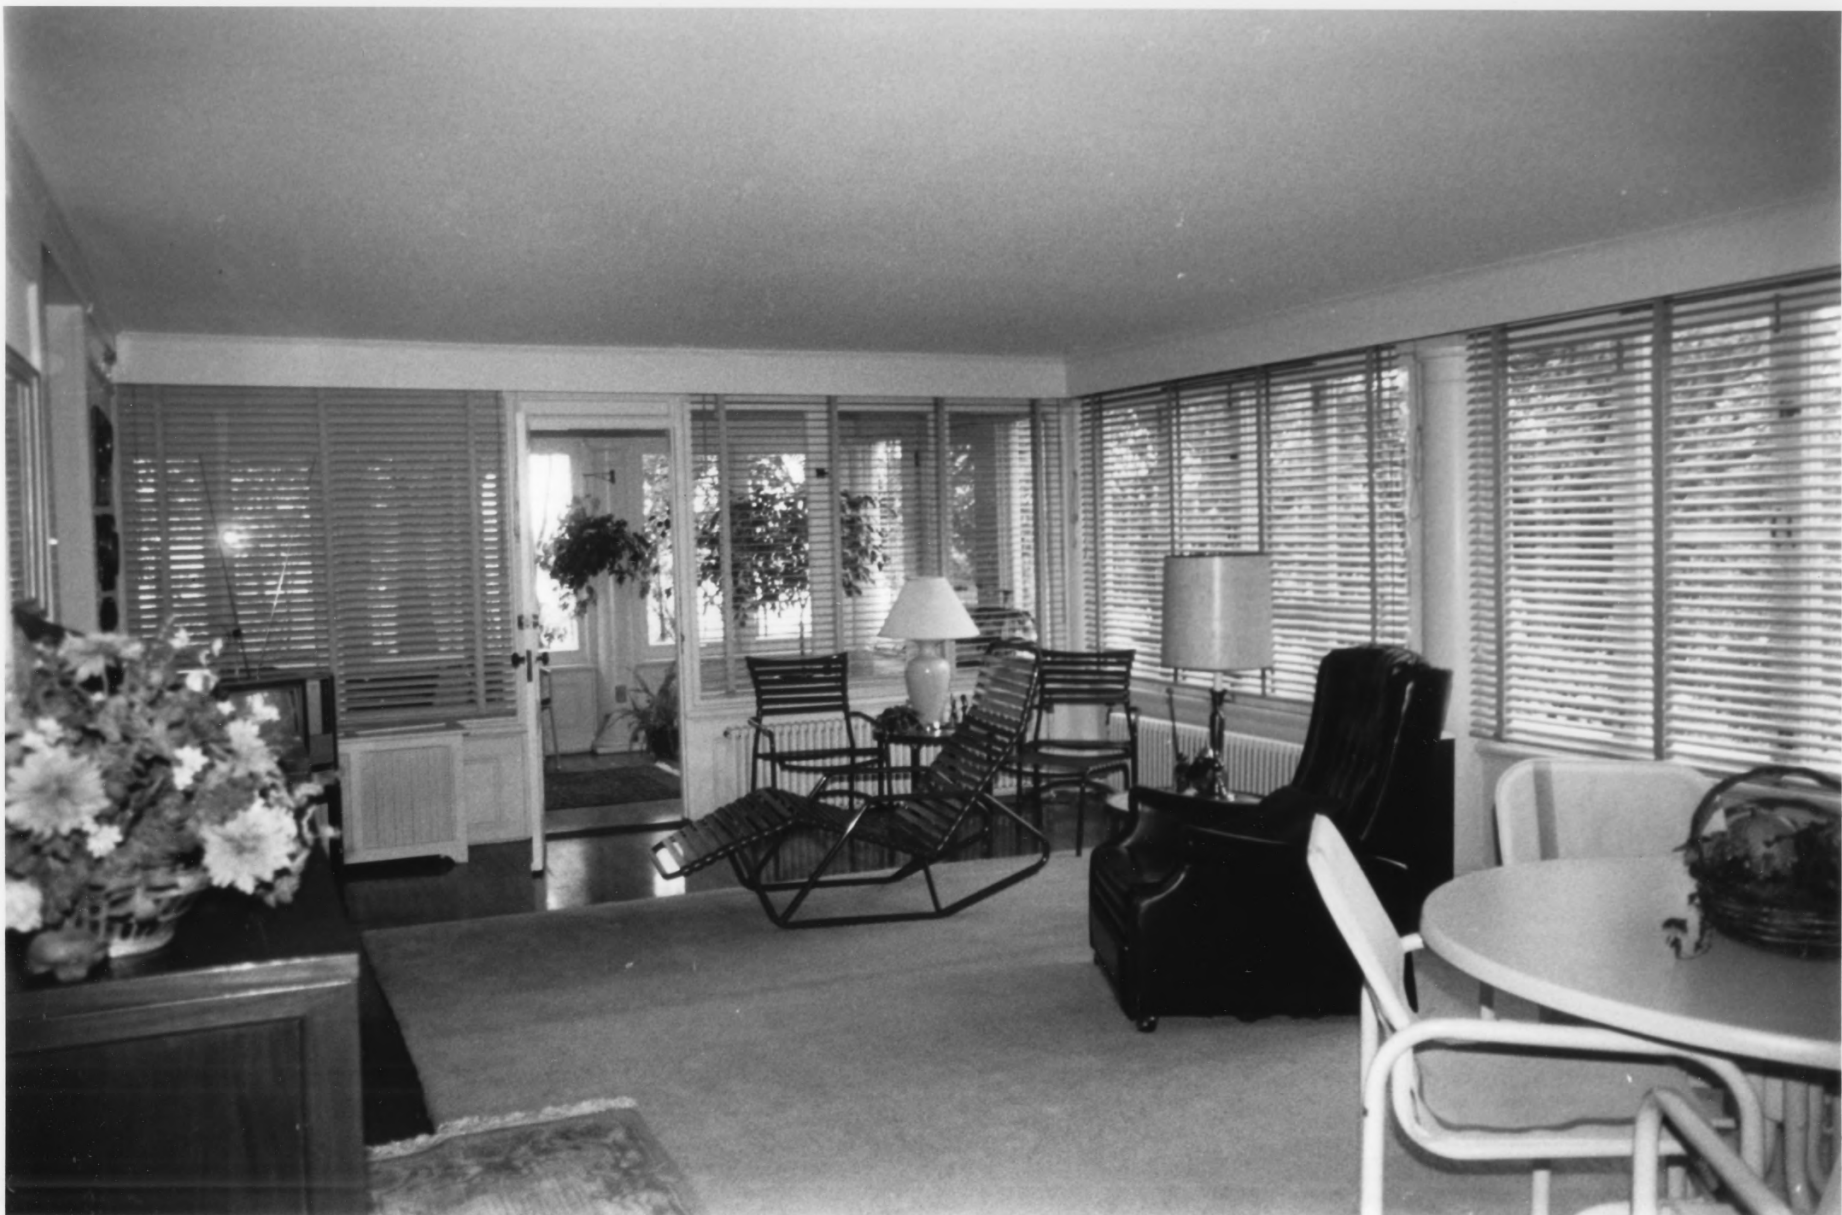
#11  
Negative on file at Louis Berger &  
Associates, Inc., East Orange, NJ

Taylor-Chase-Smythe House  
Newport, Rhode Island  
View looking southwest into west glazed  
porch
