Taylor-Chase-Smythe House  
Newport, Rhode Island  
South (front) elevation  
John R. Bowie, A.I.A.  
October 1986

Taylor-Chase-Smythe House  
Newport, Rhode Island

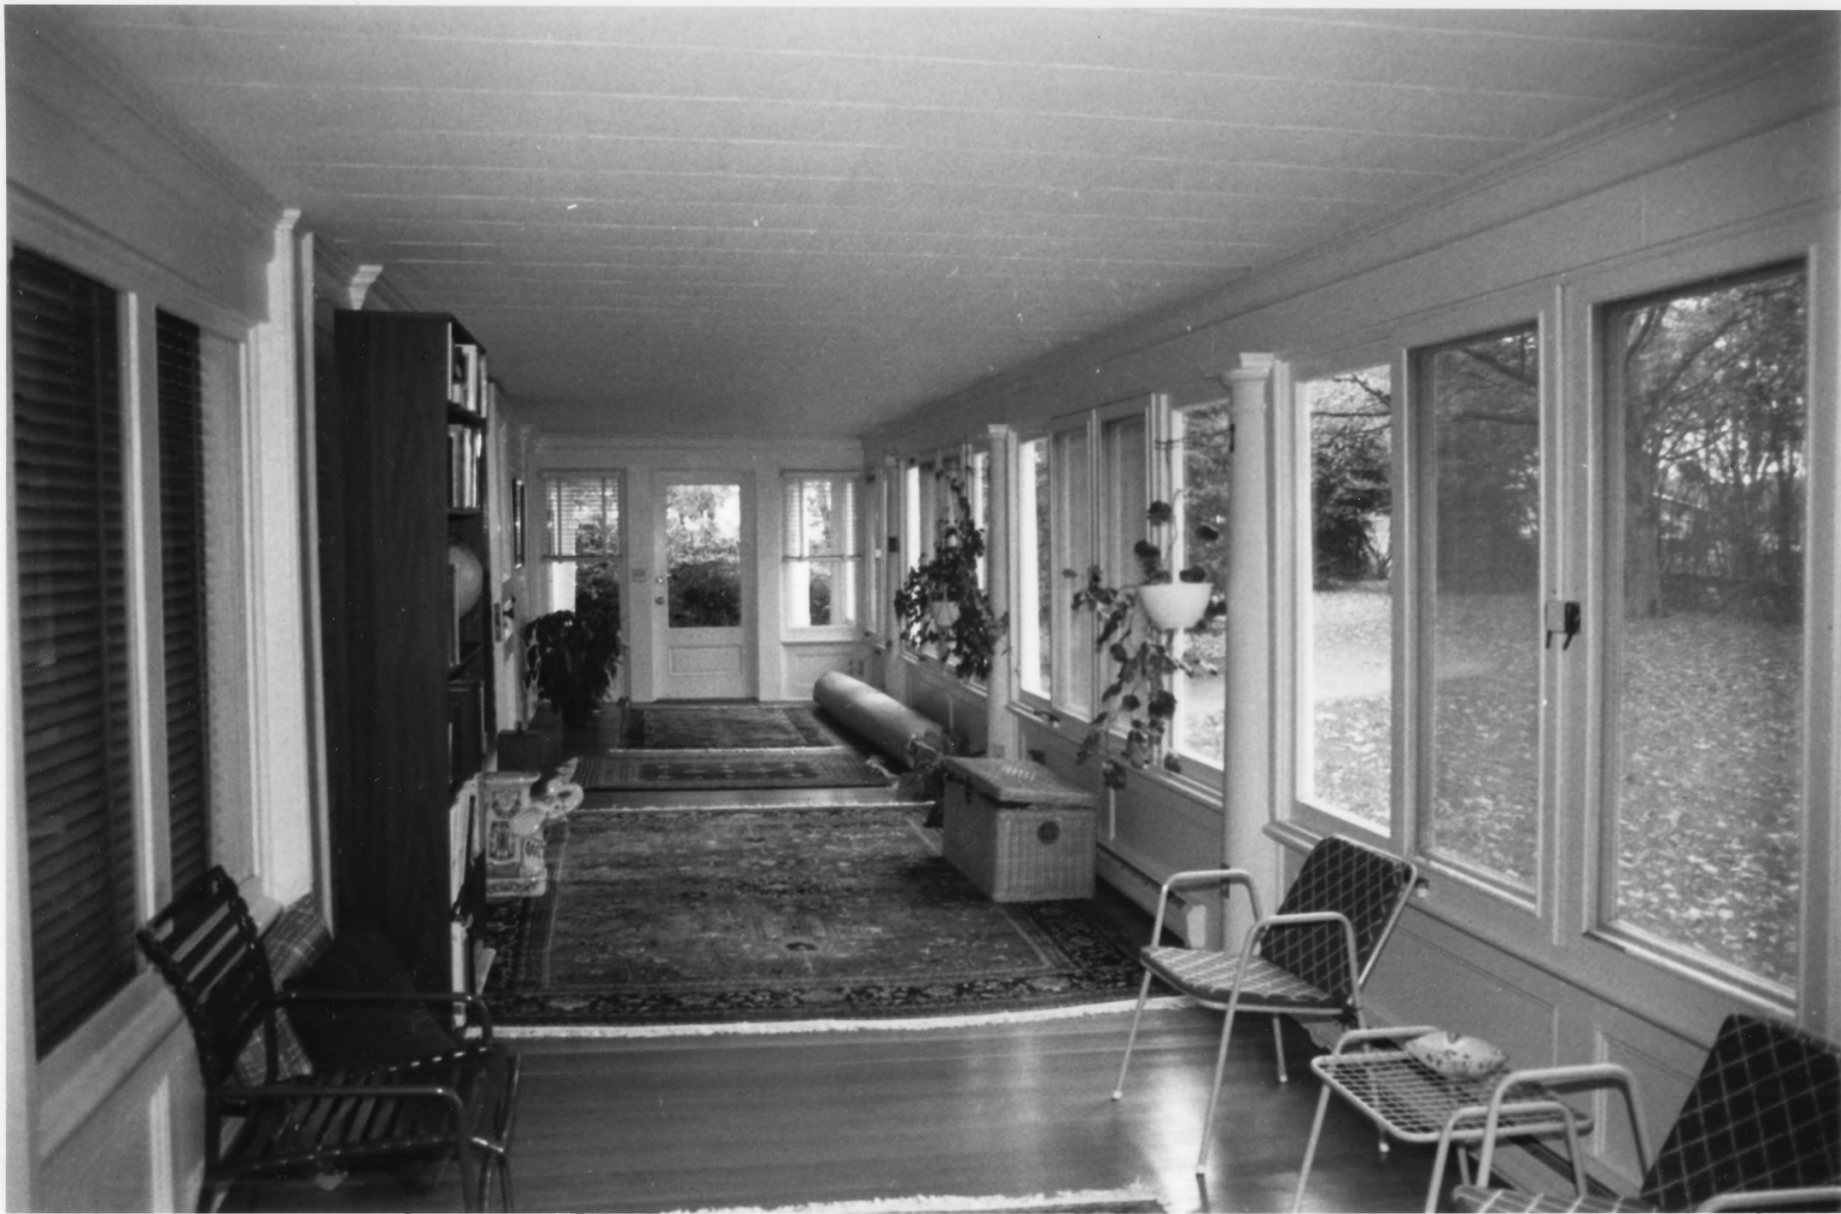
#12

Taylor-Chase-Smythe House  
Newport, Rhode Island  
View looking east into south glazed porch  
John R. Bowie, A.I.A.  
October 1986

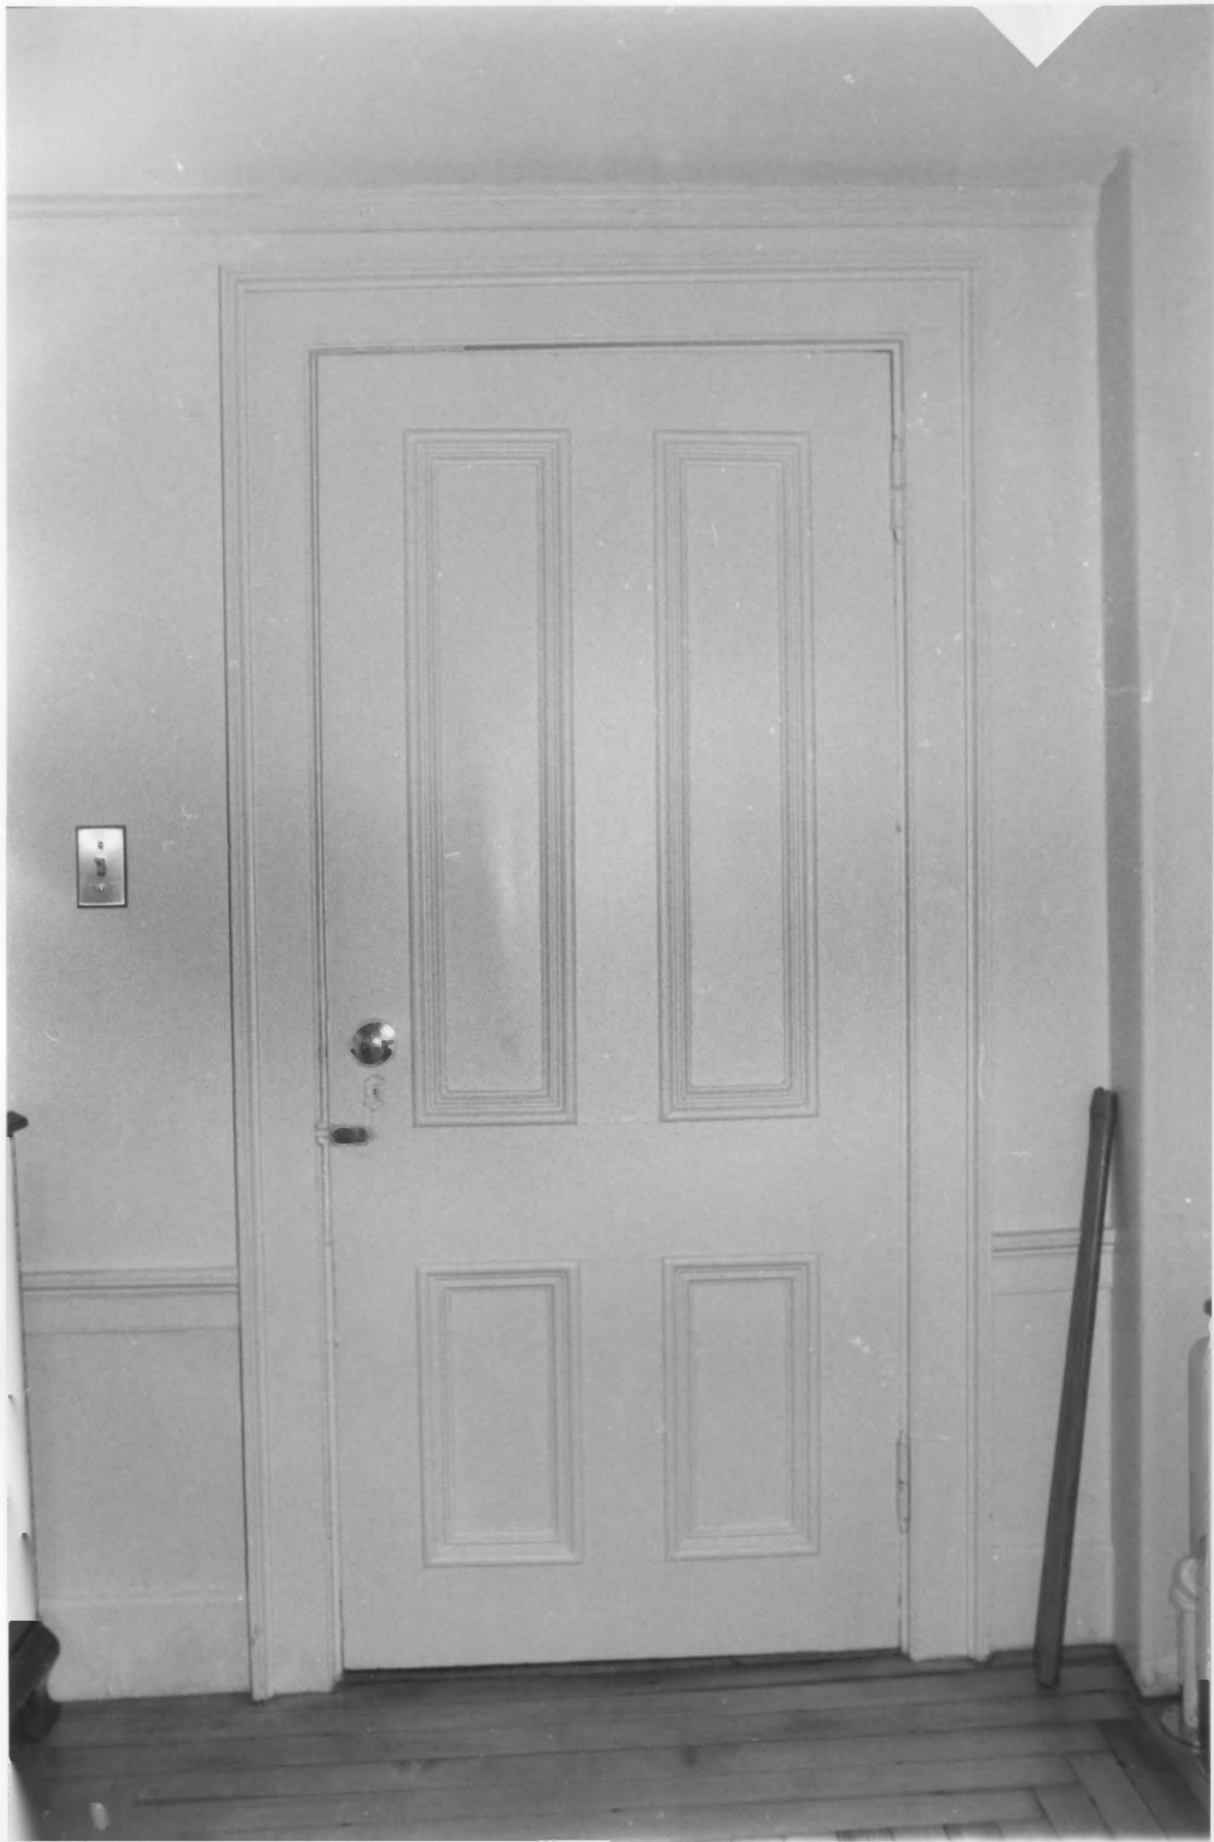
#13

Door connecting southwest bedroom and center  
stair hall, second floor; door leaf  
appears to date to mid-nineteenth century;  
baseboard, trim, and chair rail date to  
eighteenth century

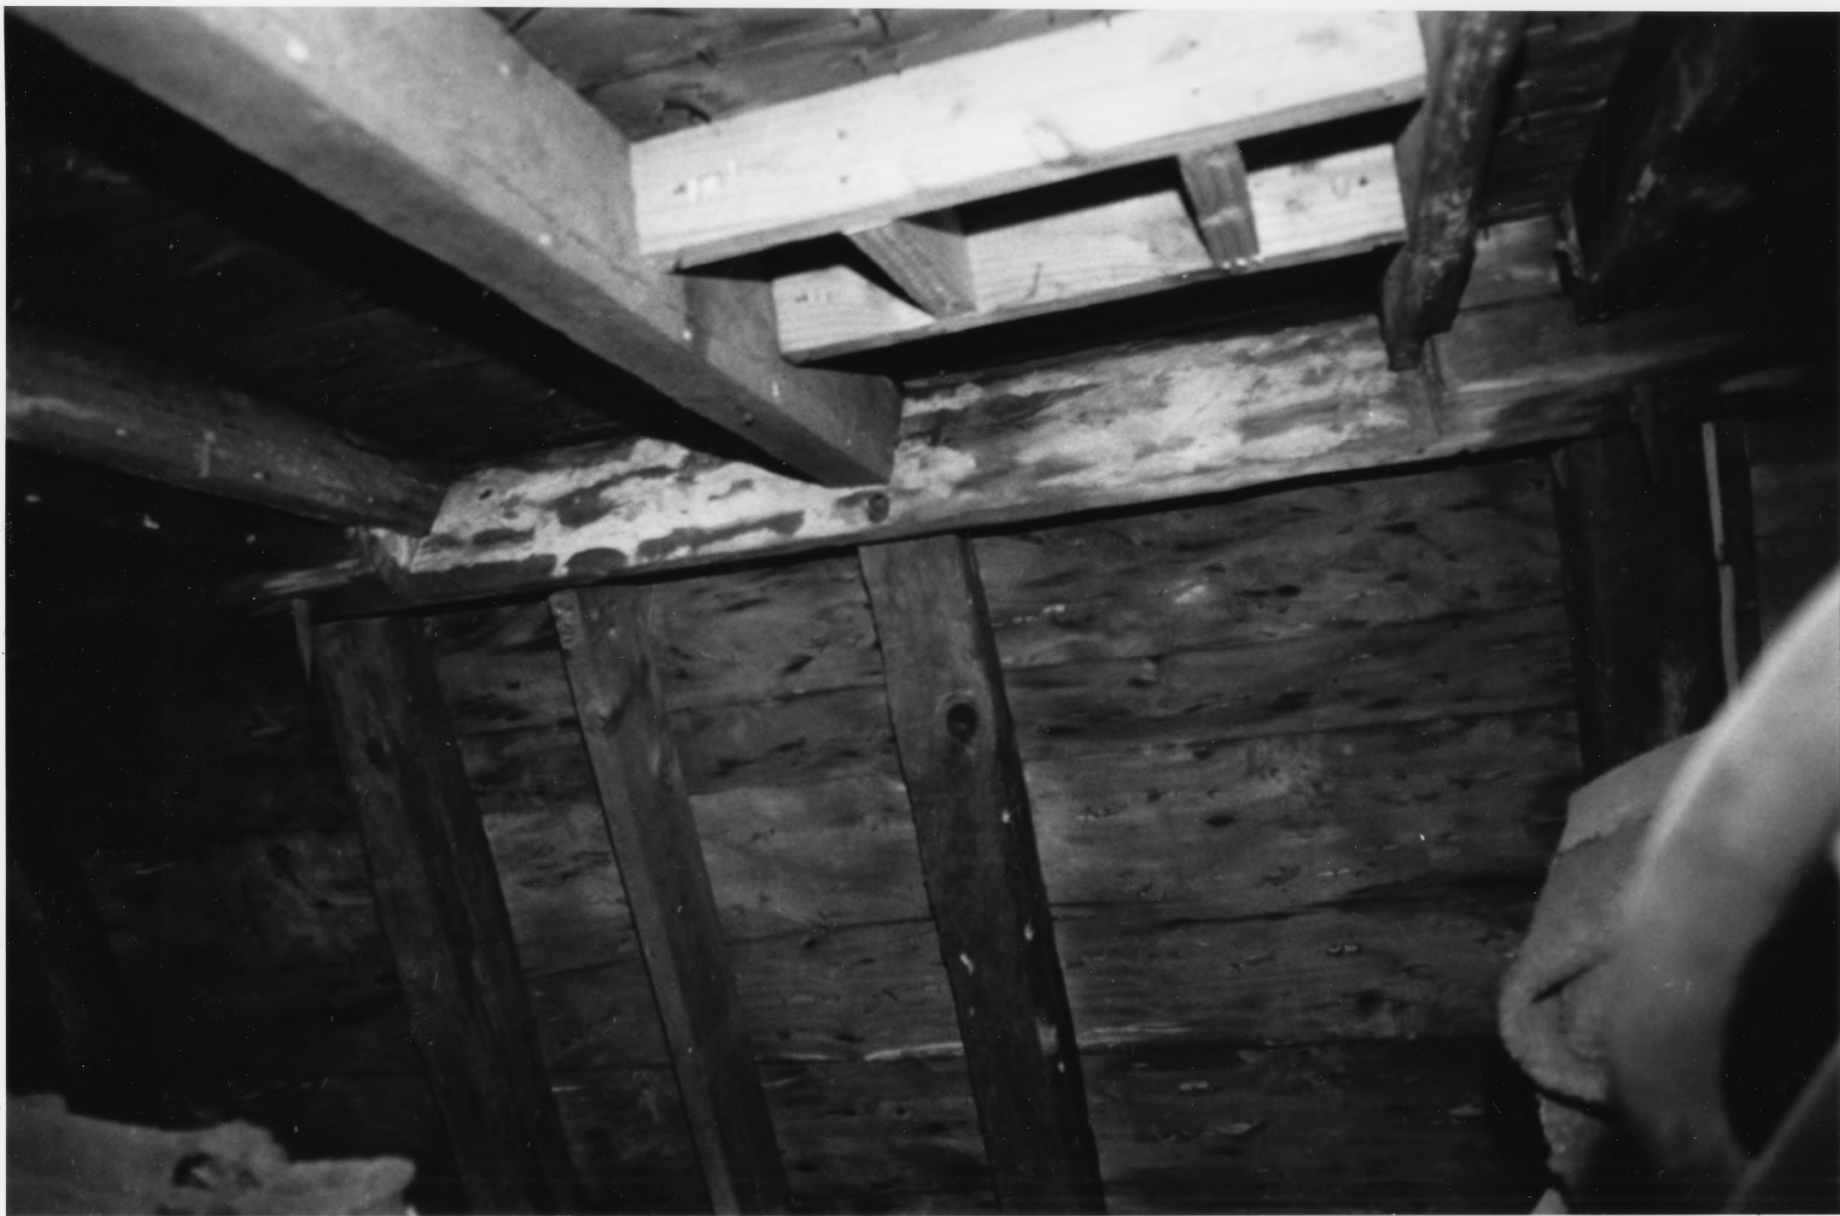
#14

Detail looking north in attic of original  
building at ridge beam and mortised  
principal rafters; note notch and calcium  
stains in ridge beam from now-removed  
stone chimney
