National Register of Historic Places Registration Form

Historic name: Ervin Homestead/Gist Bottom Historic District

Other names/site number: 24BL1546/24BL1547

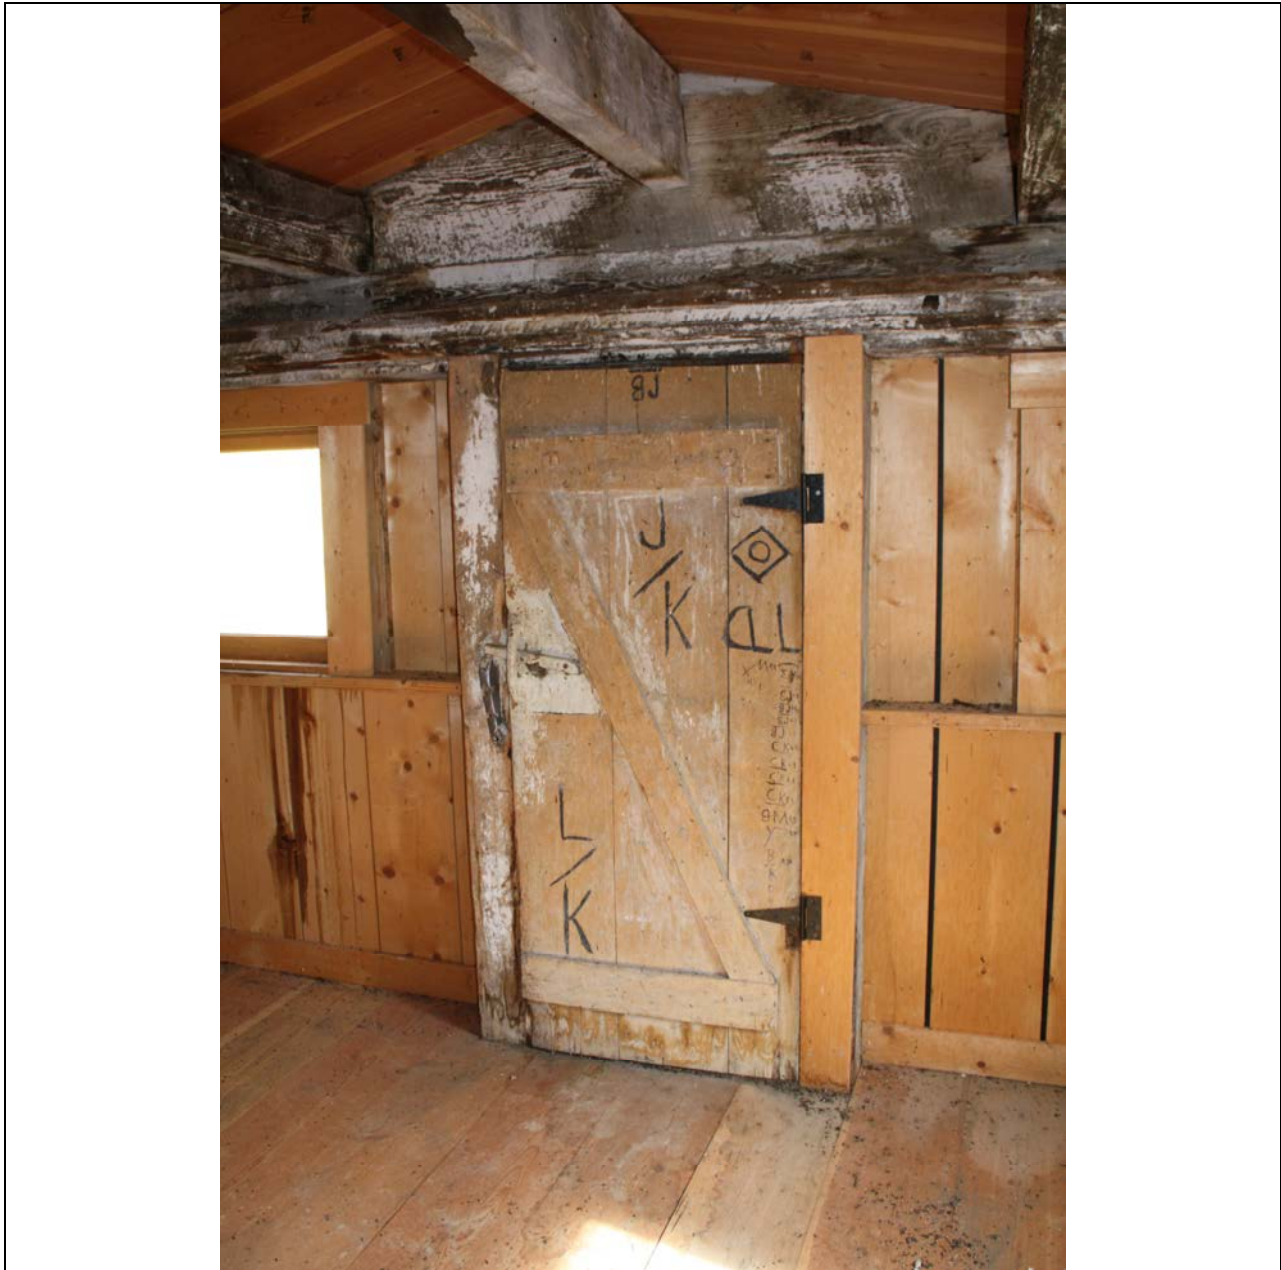
Page 49

MT_Blaine County_Ervin Homestead/GistBottom_HD_0006
Ervin Cabin interior door with Kinkaid brand marks. View to the east.

The east or front façade wall consists of a central entrance door flanked by identical 24-inch-square, fixed wood and glass windows with 1-inch by 4-inch trim. The door measures 31 inches by 6 feet and consists of three Z-braced vertical planks. Above the door, a 1-inch by 4-inch wood plank header displays the wood-burned inscription, “Thru this door pass the best dam’d cowboys in the world.”
