National Register of Historic Places
Registration Form

historic name Whitland Area Neighborhood
other names/site number Whitland Realty Company's Subdivision, Myrtlewood Subdivision

street & number Roughly bounded by Whitland Ave, Bowling Ave, S. Wilson Blvd, and a tributary of Richland Creek. N/A not for publication
city or town Nashville N/A vicinity
state Tennessee code TN county Davidson code 037 zip code 37205

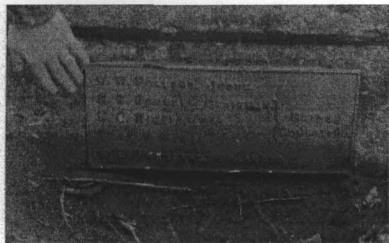
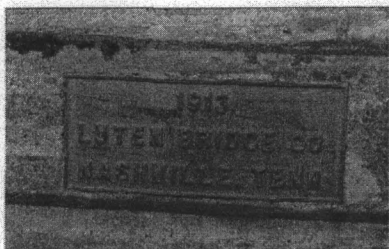
Plaques on the Luten Bridge

The Luten bridge was completed by year-end 1913. In the January 1914 Davidson County Quarterly Court Minutes it states under the County Bridge Committee Report: "We the Bridge Committee, beg to report that we have completed all bridges which we ordered built, ... The chairman has inspected all bridges carefully and found them all in first-class condition."²⁴

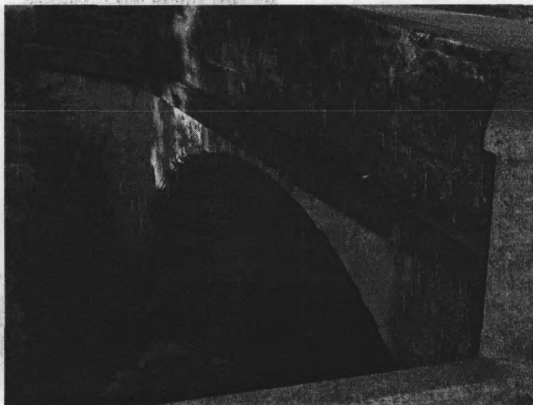
Luten Bridge on Wilson Blvd. So.

The engineer selected to do the work of constructing this bridge was F. Eugene Freeland. Freeland, after graduating from Vanderbilt University with an engineering degree, joined forces with Martin Smith Roberts to begin a practice. In 1920, both men merged with Russell Eason Hart who had re-located to Nashville in 1910 to serve as field supervisor and resident architect during the construction of the Hermitage Hotel. The joining of the three men's talents created one of Tennessee's first architectural/engineering firms, known today as Hart, Freeland & Roberts, Inc. These founding partners made significant contributions to Nashville early architecture. Some of the more noteworthy projects in the city include the replica of the Parthenon (NR 2/26/1972), Vanderbilt University's first football stadium, the Leslie Cheek residence, the Governor's Executive residence, and the Christ Episcopal Church bell tower.²³
