United States Department of the Interior
National Park Service
National Register of Historic Places
Registration Form

historic name Hopkins Farm

street & number 4400 E. Quincy Avenue [N/A] not for publication

**National Register of Historic Places  
Continuation Sheet****United States Department of the Interior  
National Park Service**Hopkins Farm  
Arapahoe County/ ColoradoSection number 7 Page 1**DESCRIPTION**

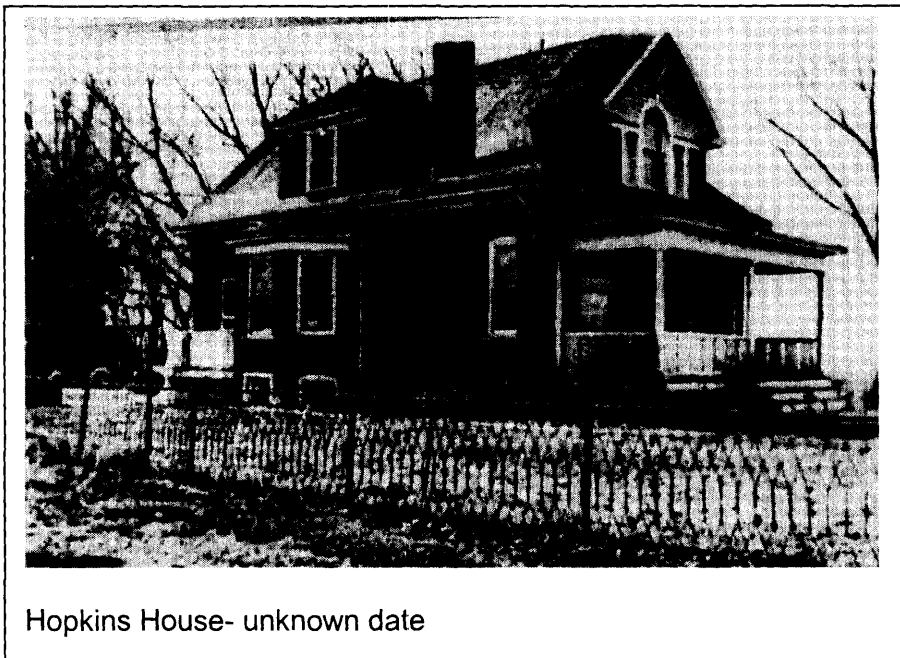
Hopkins House- unknown date

The original red brick exterior and stone foundation, sills and lintels were painted white at some unknown date. (see historic photo at right)

The historic photo shows the small east entry porch with a door that leads into the dining room. This porch had a wooden balustrade and wooden steps. Today there is a non-original side porch without

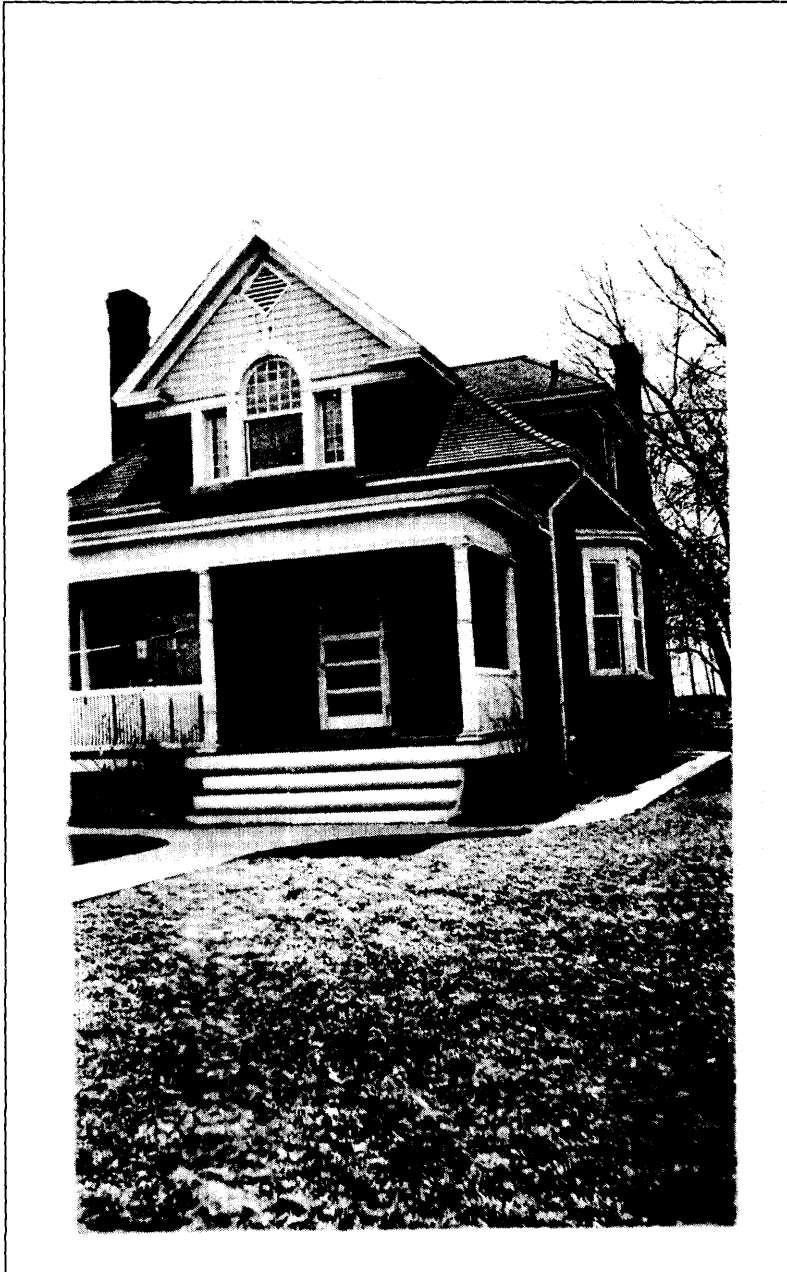
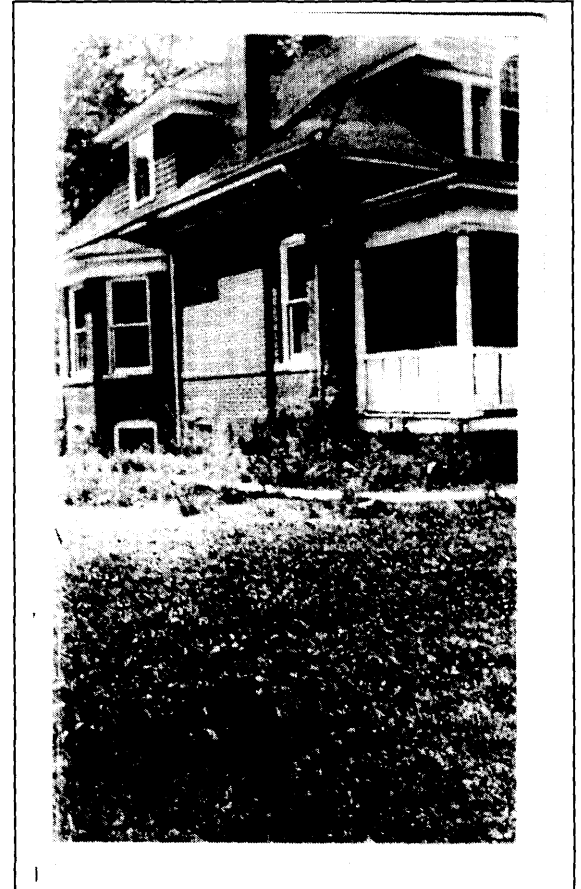
Historic Images- Hopkins House, circa 1920-1934  
Images courtesy of Jack Kadlecek

North façade (left) and east side (above) of the Hopkins House.

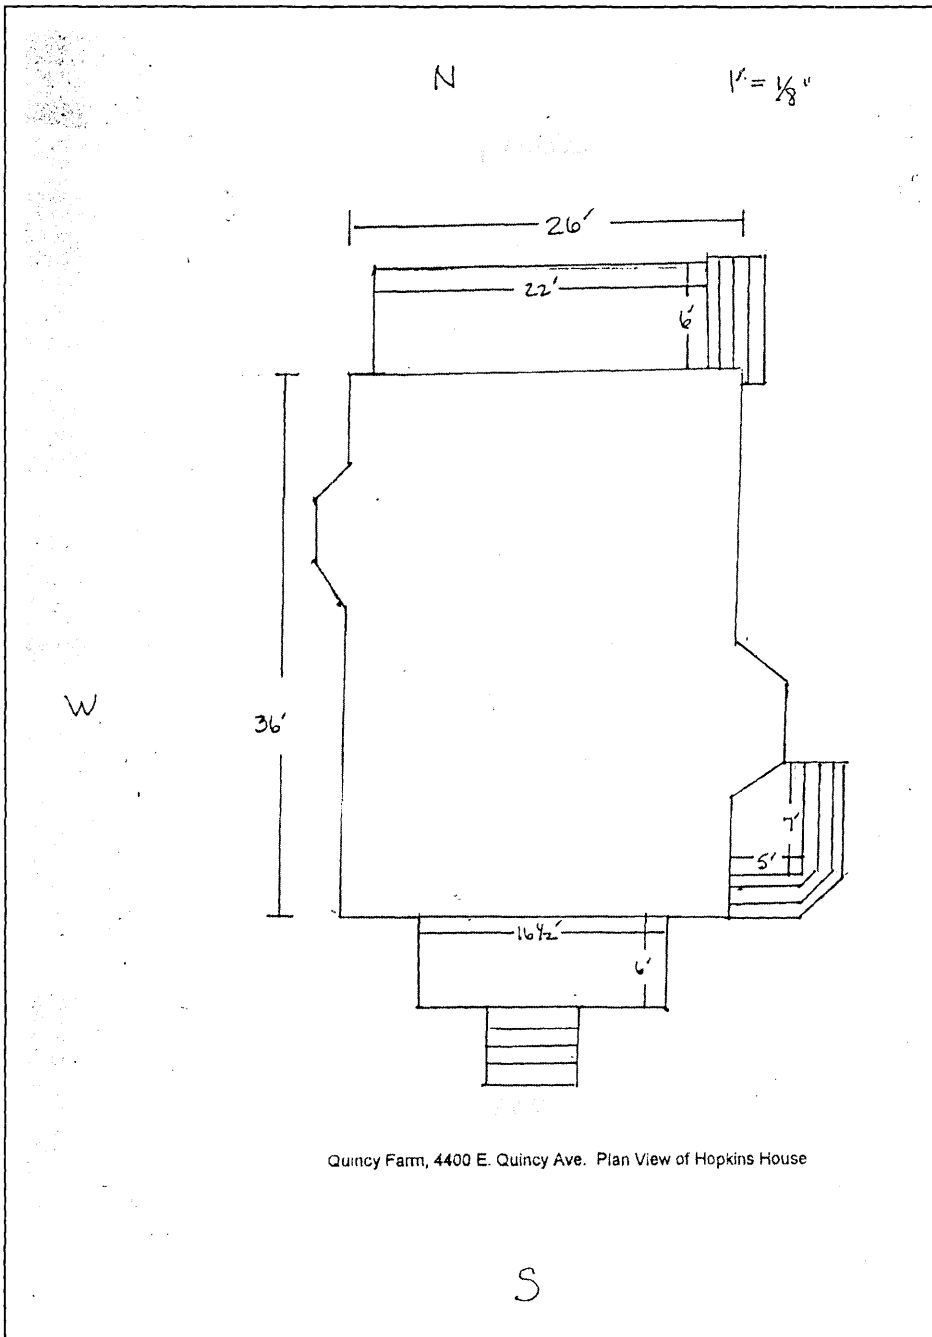
## Hopkins House footprint

The hipped roof becomes a gabled roof at the rear of the house, consisting of square cut wood shingles on the gable face and gable returns. In the peak of the gable is a diamond shaped louver. A wooden back porch with a stone foundation and concrete floor runs across the south (rear) side. It has a flat roof and a central entry door with a divided light transom. There are multi-pane windows in the upper sections on all three sides of the porch and wood bead board panels on the lower sections and ceiling. The flat roof supports a balcony, accessed by a door in the gable face. An architrave surround shelters a 1/1 double hung window to the west and the balcony door to the east. It is unclear if this door is original or a window converted to a door. The trim surrounding the door and window matches the rest of the house. Non-original railing made up of wooden boards forming large X's makes up the balcony's balustrade. Basement steps and a door into the kitchen are accessed from inside the porch. The wooden steps on the rear and side porches were rebuilt in 2001.

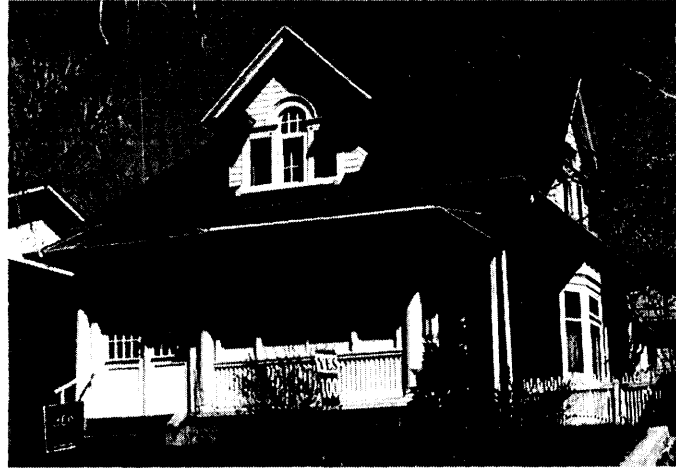
This High Style Classic Cottage in Denver exhibits facade and side dormers, Palladian-style dormer windows, multiple bay windows and a pediment over the entry stairs.

A subtype developed which depicts the various elements that define the Classic Cottage but elevates the style with several design embellishments. The first sign that might classify a Classic Cottage as high style is the presence of multiple dormers that convert the standard single-story residence to a story-and-a-half. More common to the basic Classic Cottage is a hipped-roof front dormer with a single window opening. In this subtype the front dormer is more often gabled and frequently contains a triple window. Other stylistic embellishments found in this subtype are a pediment over the entry stairs, a Palladian window pattern in the front and side dormer windows, and a full-width front porch with a shed roof and dentil molding at the cornice. Many feature either bay or bow windows on more than one elevation.
