# National Register of Historic Places Registration Form

Historic name MILLERSYLVANIA STATE PARK

street & number 12245 Tilley Road not for publication

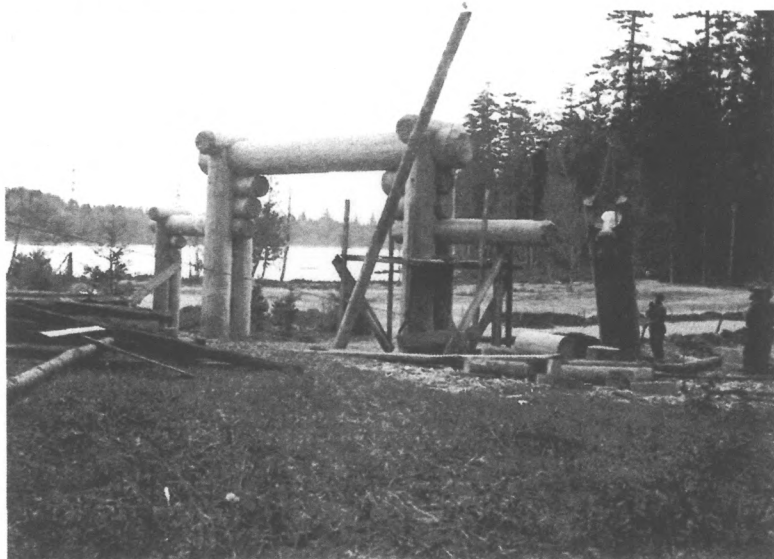
Construction of Park Entrance Sign, May 1935. WSPRC Photo H74.SP-6-119.

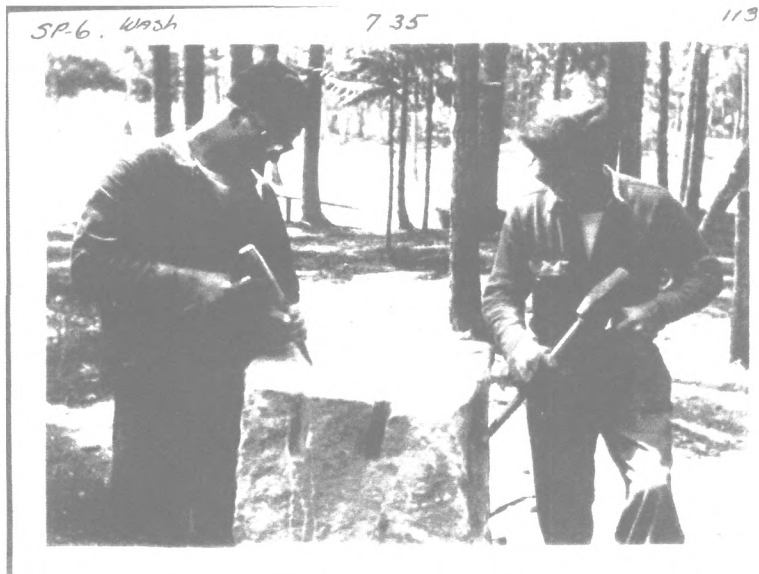
Carving drinking fountain, July 1935. WSPRC Photo H74.SP-6-113

**Description:** A number of small-scale features developed as part of the park master plan continued to add richness and texture to the designed park landscape. These features contribute strongly to the historic character of the park structure and clusters. These elements reflect the craftsmanship, native materials, and naturalistic principles of design found in the larger built features of the park. The Depression-era cultural landscape of the Millersylvania State Park Historic District has nine drinking fountains which still remain as indicated on the 1939 plan. Constructed of hand carved Tenino Sandstone and worn from years of use, these fountains are approximately three feet in height with stone steps leading up to the fountain for children at some locations. Either one or two steps are present leading up to the monolithic fountains. The fountains also feature a smooth bowl shape carved into the top to provide a drainage basin and collection area. These fountains were featured in Good's Park and Recreation Structures as model prototypes for stone fountains nationwide.

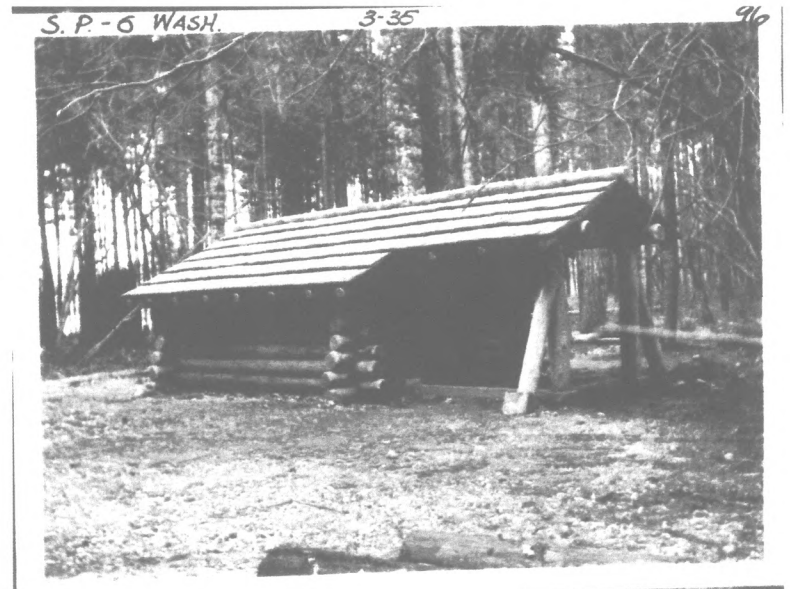
Completed Pump House, March 1935. WSPRC Photo H74.SP-6-96

**Description:** The Pump House is centrally located within the park's day use area just east of Comfort Station #1. The building rests on a concrete foundation that extends approximately 4 ½ feet below grade to the floor. The building was constructed to house a small tank and well pump feeding the park's original reservoir. The building is approached by a stair leading down to the floor, which is covered by an extension of the main gable. The building sits low on the landscape, constructed of horizontal logs set on the concrete foundation. The roof is clad with cedar shakes.

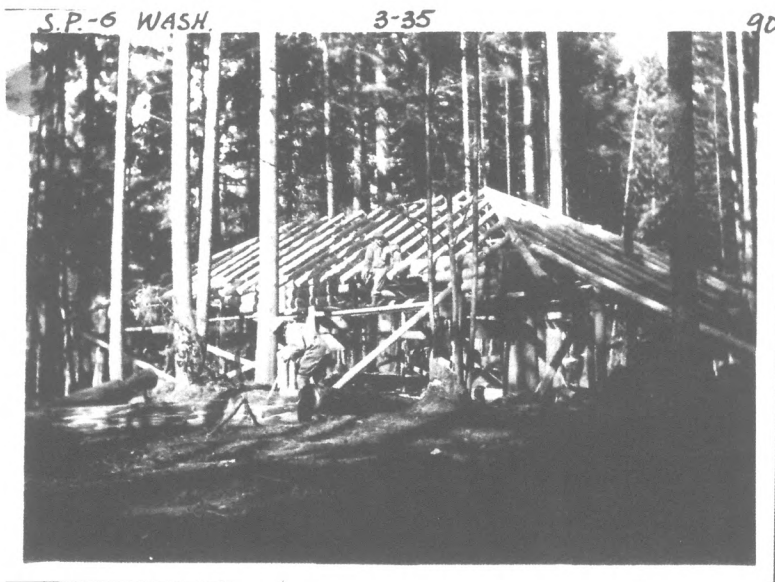
Kitchen #1, framing rafters, March 1935. WSPRC Photo H74.SP-6-90

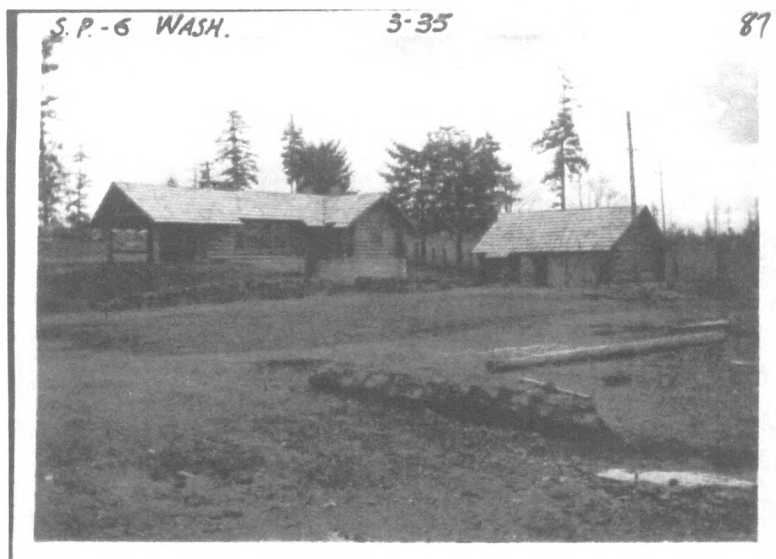
Completed Caretaker's House and Garage, March 1935. WSPRC Photo H74.SP-6-87

**Description:** The Caretaker's Shop and Garage was inspired by Elsworth Storey's "Garage/Shop – Type A", but specifically modified for this park as it was used in combination with the standard Caretaker's Residence. It is located adjacent to the Caretaker's Residence close to the entrance of the park, and also close to the maintenance area of the park, and was built in 1935.<sup>2</sup> The Office/Garage utilizes similar log joinery as the Manager's Residence, and is constructed of native and natural materials upon a concrete foundation. The original wood garage doors and multi-paned windows are still intact. The gable roof and roofing substrate have been replaced, but the roof remains clad in cedar shakes.

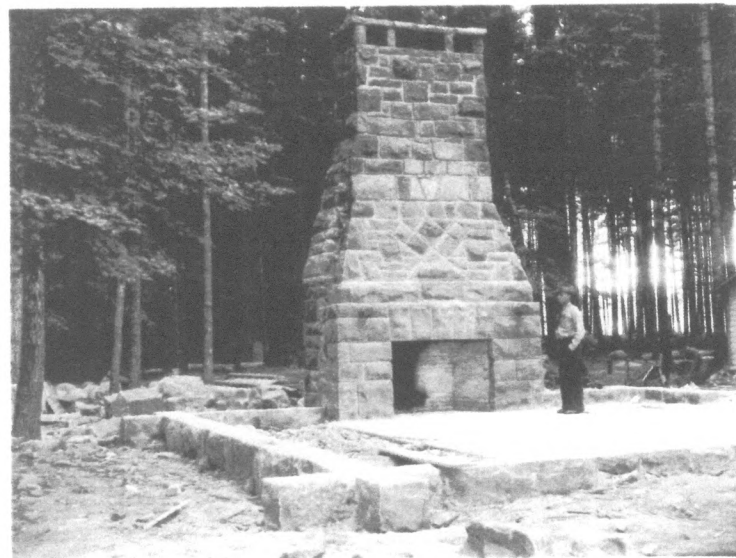
Completed fireplace for Kitchen #2, July 1936. WSPRC Photo H74.SP-6-126

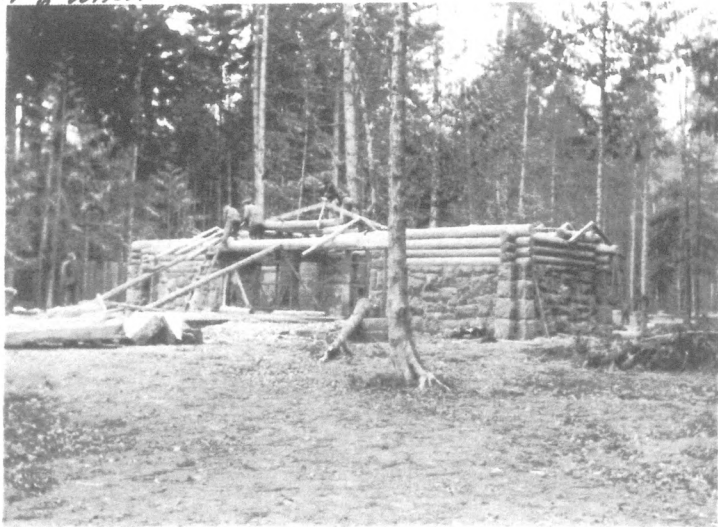
Placing rafters on Bathhouse #2, November 1935. WSPRC Photo H74.SP-6-55

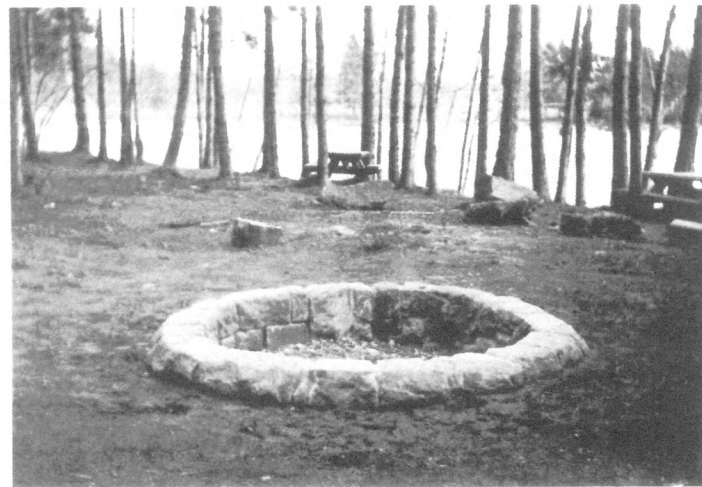
Completed Fire Ring, March 1936. WSPRC Photo H74.SP-6-193

**Description:** There are five fire-rings still existing within the Millersylvania State Park Historic District. Two of the fire rings (one near Kitchen #3 and one near Kitchen #4) retain their original stone bench supports surrounding the ring. Constructed of hand split, pitched faced Tenino sandstone and worn from years of use, these fire rings are all located in the day use area of the park. The stones are laid in a circle approximately six feet in diameter, and extend beneath the surrounding grade approximately one to two feet.
