1. Name of Property historic name: HOPEFUL	LODE	
	r: Currently referred t	o as the Parsons Mine
		784 AML 7, and for the U.S. Forest
Service, FS Site #AR-0		0
The state of the s

2. Location		
street & number: Along	Forest Road 108	/ /not for publication
.6 miles north of FR 1	07/ FR 108 intersection	north of Bonito Lake
city or town: Noqal		/x /vicinity
state: New Mexico co	ode: NM county: Lin	ncoln code: 027 zip code: 88341

-			
6. Function or Use			
Historic Functions (enter categories	Current Functions (ente	er categories from	
from instructions	instructions)		
<pre>INDUSTRY/PROCESSING/EXTRACTION</pre>	VACANT/NOT IN USE		
Gold mining and processing site

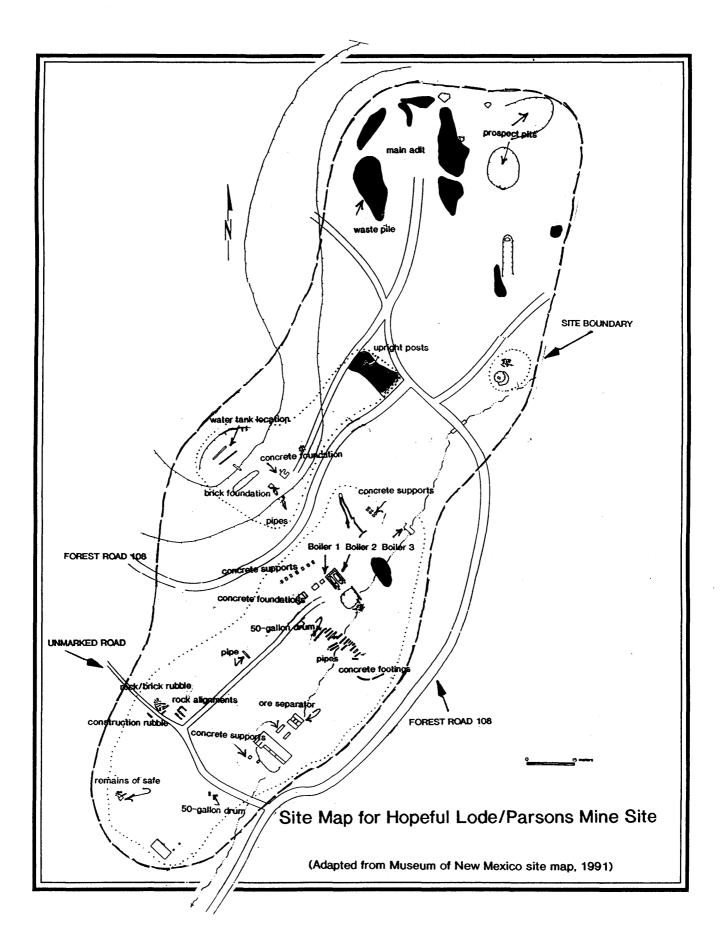
A field inspection by Lynne Drake with the Museum of New Mexico on May 14 and 15, 1991, located a third boiler, two upright posts, the remains of a wooden chute, aqua-colored glass fragments, and other artifacts. As a result of vandalism and/or heavy vegetative ground cover, only the boiler was visible two years later (See site map, page 3a).

Three pieces of mill machinery, four mine adits, numerous concrete footings, ponds, and long sections of pipe are nearly all that visibly remain of the Hopeful mill site. Two saw mill boilers sit atop crumbling brick fireboxes. One of the boilers is labeled "Erie Ironworks." Both boilers are missing their smokestacks. A concentration of coal fragments measuring 7m x 4m is situated below the boilers. A 7.6cm-diameter pipe protrudes 37cm out of the center of the coal deposit. The third piece of machinery was used to separate the ore. Its three large, shaft-driven wheels measure six feet in diameter. Although heavily scavenged for scrap metal, the ore separator remains essentially intact.

Of the dozen or so buildings pictured in historic photographs of the Parsons Mine site, only several concrete footings and scattered artifacts remain. Wood, brick, ceramic, and glass fragments are strewn along an old roadbed south of the separator pond. The remains of a metal safe and a 6m \times 2.5m concrete foundation are located at the southern boundary of the site.
