PHOTO NO. 1 ***** The Travelers Hotel Sacrament**S**, California Eldon W. Jacobsen 7/8/77 928 Second Street Sacramento, California

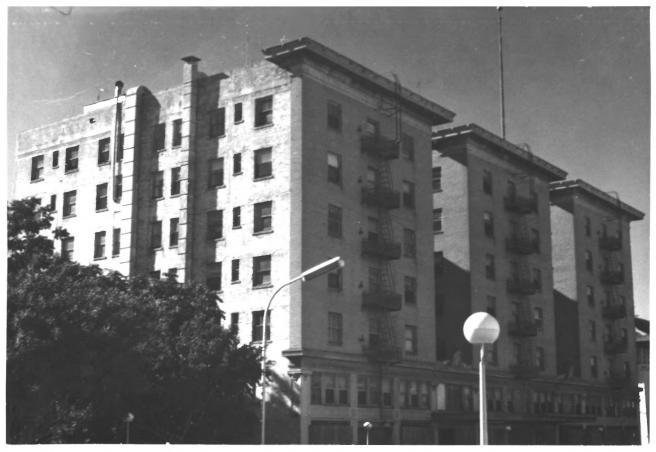
Westerly - Exterior of building showing "E" plan configuration.

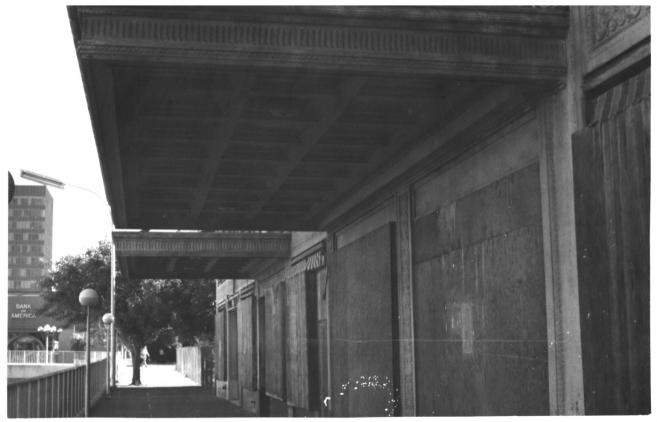
PHOTO NO. 2 0.8 The Travelers Hotel Sacramento California Eldon W. Jacobsen 7/8/77 928 Second Street Sacramento, California

South - Along 5th Street -Building now boarded showing detailing on facade and canopies.

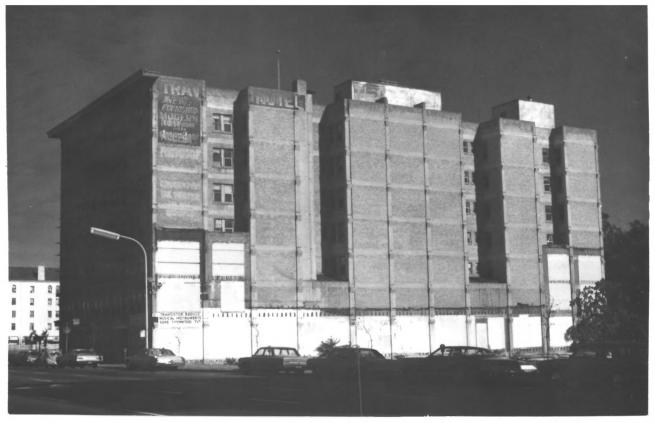
PHOTO NO. 308 The Travelers Hotel Sacramento California Eldon W. Jacobsen 7/8/77 928 Second Street Sacramento, California

West Elevation - Rear wall showing the grid structure network.

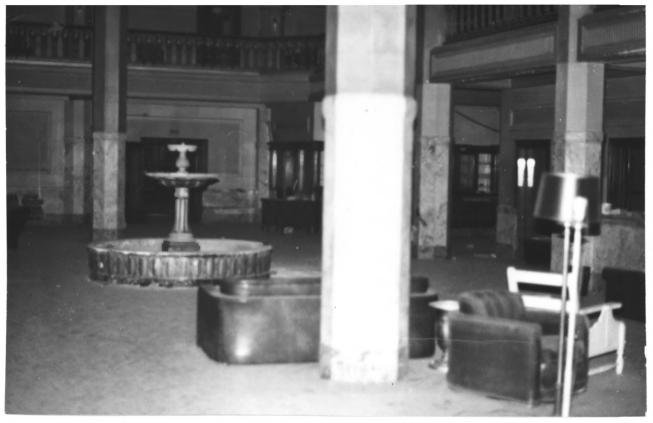
PHOTO NO. 4 5 The Travelers Hotel Sacramento, California Eldon W. Jacobsen 7/8/77 928 Second Street Sacramento, California

Southwest - Interior scene of lobby with marble floor, columns, fountain, etc. Expanded view showing how the detail shown in Photo No. 5 related to "grand" lobby.

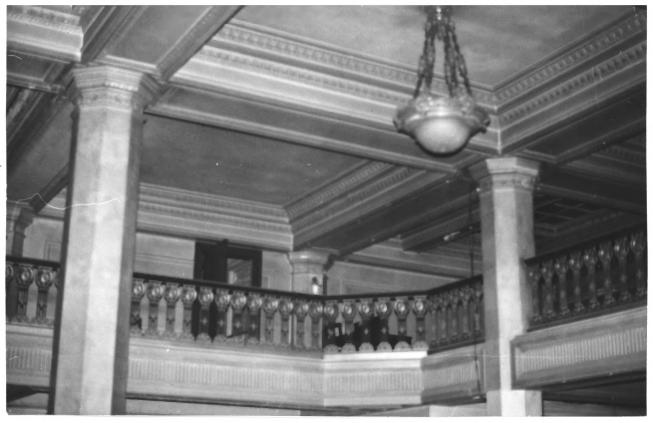
PHOTO NO. 5 98 The Travelers Hotel Sacramento, California Eldon W. Jacobsen 7/8/77 928 Second Street Sacramento, California

Southwesterly - Lobby ceiling, columns, light fixtures.

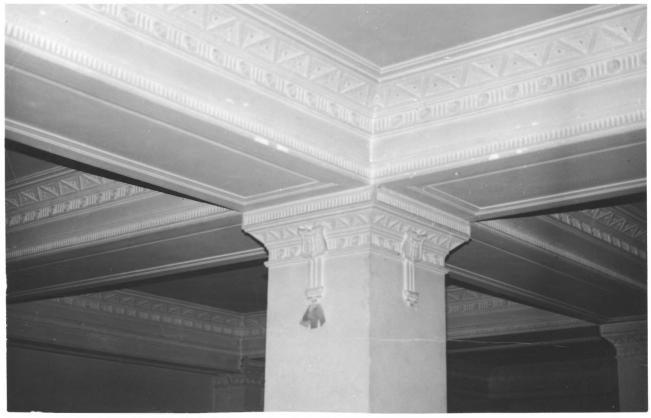
- PHOTO NO. <u>6 2 8</u> The Travelers Hotel Sacramento, California Eldon W. Jacobsen 7/8/77 928 Second Street Sacramento, California
- Southwesterly Hotel grand ballroom, column, and ceiling.

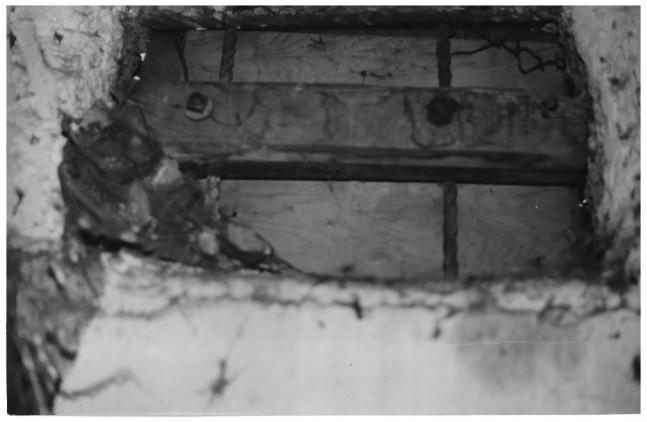
PHOTO NO. 7 68 The Travelers Hotel Sacramento, California 7/8/77 928 Second Street Sacramento, California

West - Exploratory hole in west wall interior basement showing twisted reinforcing steel patented by Ransome as first deformed reinforcing steel.

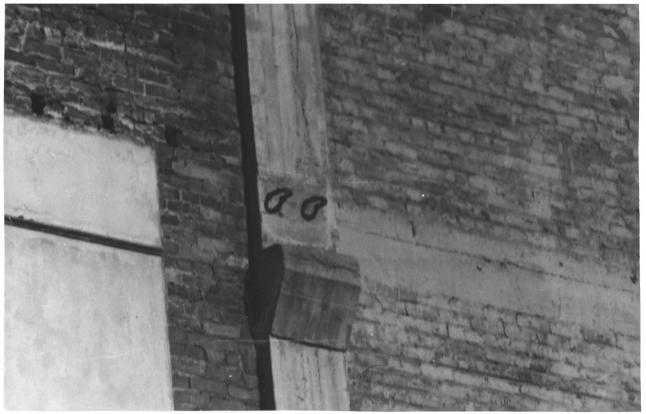
PHOTO NU. 8 08 The Travelers Hotel Sacramento California Eldon W. Jacobsen 7/8/77 928 Second Street Sacramento, California

East - Corbel constructed as part of original building for party wall for adjacent site. Never used.
