**HISTORIC RESOURCES INVENTORY  
BUILDING AND STRUCTURES**

1. BUILDING NAME (Common) (Historic) Icabod Bradley House	
2. TOWN/CITY Southington	VILLAGE Southington, CT 06489
3. STREET AND NUMBER (and/or location) 537 Shuttle Meadow Rd. (map 212, parcel 51) 3 acres

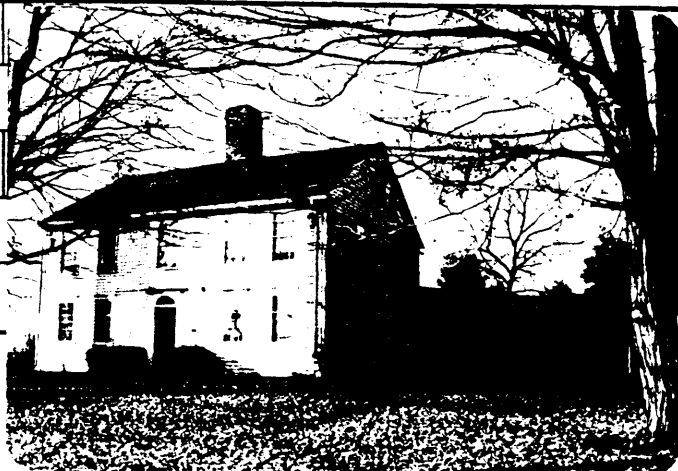
VIEW

11. NUMBER OF STORIES 2	APPROXIMATE DIMENSIONS 38 x 28 + 1-story ell
12. CONDITION (Structural) (Exterior) <input type="checkbox"/> Excellent <input checked="" type="checkbox"/> Good <input type="checkbox"/> Fair <input type="checkbox"/> Deteriorated <input type="checkbox"/> Excellent <input checked="" type="checkbox"/> Good <input type="checkbox"/> Fair <input type="checkbox"/> Deteriorated

The distinctive feature of the 5-bay front elevation is the doorway. It has narrow fluted pilasters and a fanlight under dentil course and flat cap. The 12/12 windows have similar molded flat caps. A dentil molded course, similar to that under the doorway cap, runs under the eaves. The central brick chimney is massive.
