National Register of Historic Places Registration Form

historic name Whitaker-Motlow House

street & number 740 Lynchburg Hwy

Description

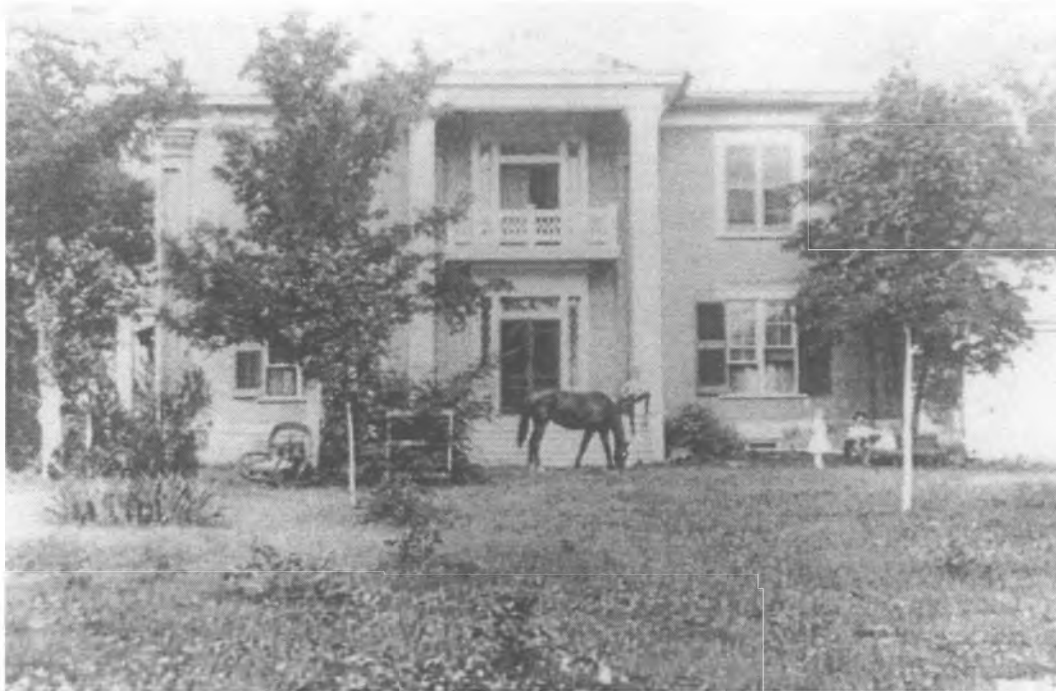
Figure 1. Circa 1905 photo of house.

The most prominent feature of the south façade is the two story, one bay pedimented portico. Large rectangular fluted wood columns with molded wood capitals and bases support the pediment. Molded trim and dentils are seen on the cornice of the portico and the façade of the house. The raking cornice of the pediment has sawn wood brackets. Below the portico there are double-leaf doors that lead into both stories of the house. The first floor entry is through circa 1840s glass and wood double-leaf doors. Multi-light transoms and sidelights surround the entry. Dentil molding and an unusual sawn "floral/leaf/scroll" design outlines the door surrounds. (See figure 3.) A cantilevered balcony with sawn wood balustrade is located at the second floor level. As on the first floor, there is a double-leaf door with an elaborate surround. Paired four-over-four double-hung windows flank the portico on both stories. The windows have a simple wood cornice and wood shutters. Brick pilasters with brick capitals are located at the corners of the façade and flank the entry. A circa 1905 photo shows the façade to be much as it is today although there would have been major rebuilding after the 1909 tornado. (See figures 1 and 2)

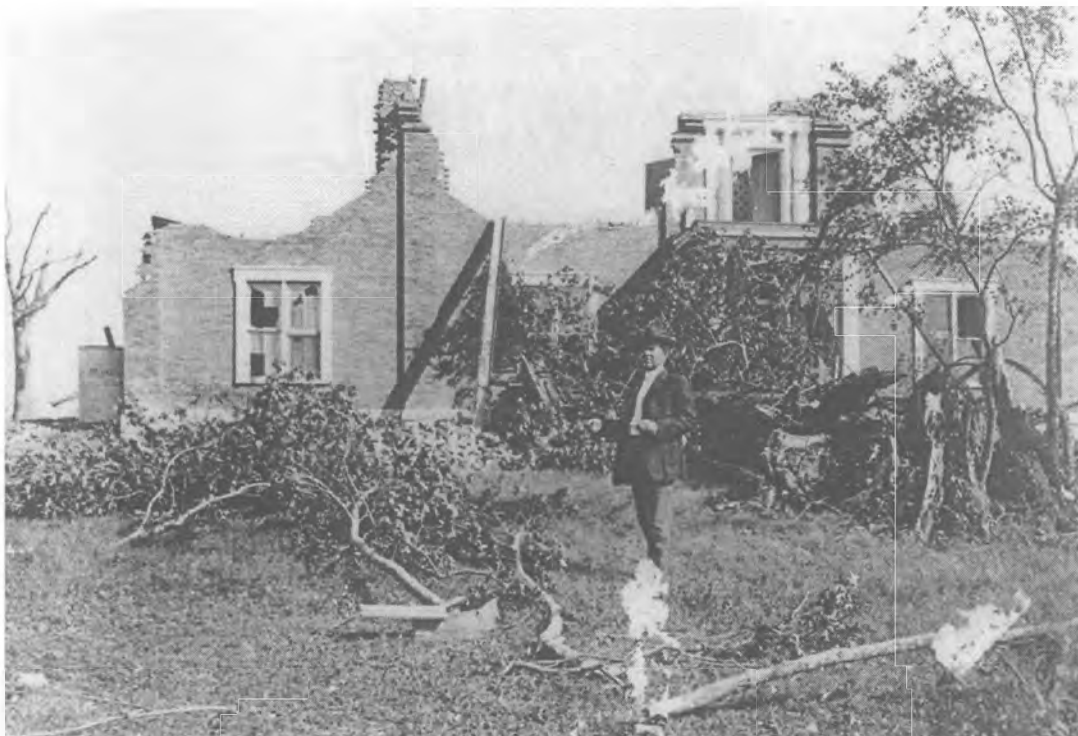
Figure 2. Post tornado photo of house, side elevation.

The gable roof part of the west elevation has the sawn wood brackets found on the façade. Paired windows on each story of this section are exactly like those on the façade. A brick pilaster delineates this section from the rear ell. North of the pilaster is the west elevation porch. Stone steps lead to the one bay, one story flat roof porch. Behind the porch is a historic wood double-leaf door flanked by paired columns and capped with a transom window and a simple entablature. The entry to the second story is the same. Three additional pilasters delineate the two remaining bays and the edge of the west elevation. Windows on both stories of this elevation are circa 1910 replacements. The four-over-four double-hung windows are smaller than the historic windows throughout the house and are topped by blind panels. A post tornado photo shows that this part of the house received much damage.

The 1909 tornado brought overwhelming destruction to the house, ripping away about two-thirds of the second story, although part of the façade remained intact. Motlow was able to rebuild the house close to its original design. He reportedly hired a construction crew out of Nashville, Tennessee, and had the men camp on the property until the house was rebuilt.²¹ According to Bob Motlow's daughter, during reconstruction, he replaced the long wooden panels in the front door with long panes of glass.²² The only real indication of reconstruction is seen in the brick variances found on the upper portions of the exterior walls. (See figure 2.)
