NATIONAL REGISTER OF HISTORIC PLACES  
INVENTORY - NOMINATION FORM

COMMON:  
"Guilford" *use this*

**NATIONAL REGISTER OF HISTORIC PLACES  
REGISTRATION FORM**

historic name Guilford

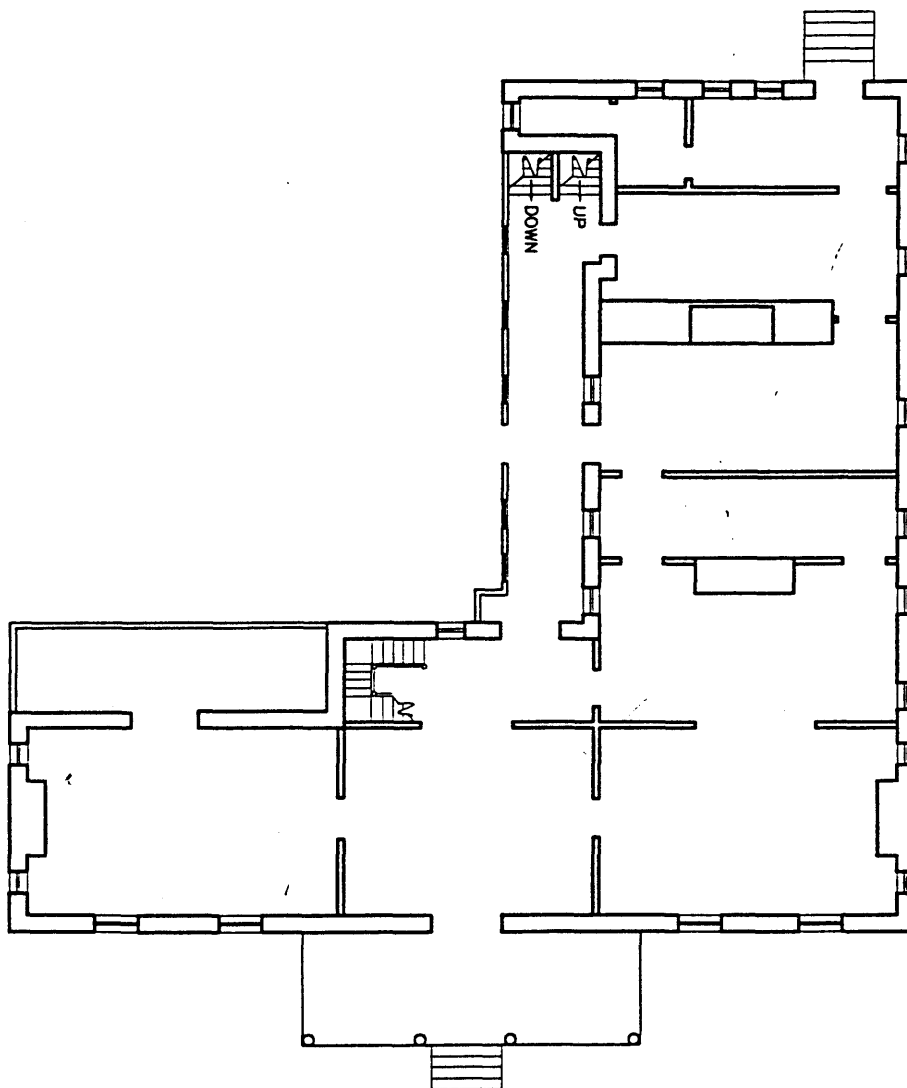
First Floor Plan, Main House

The main farmhouse is a two-and-a-half story, side-gabled, brick dwelling raised on a half-story basement. The main block is five-bays wide and two-bays deep, with a five-bay ell-wing extension. The building is constructed with stucco finished brick walls that rise from a stone foundation. The roof is clad with slate shingles and is punctuated by gable dormers. Parapet walls and interior double-chimneys are located at the gable ends of the principle block.

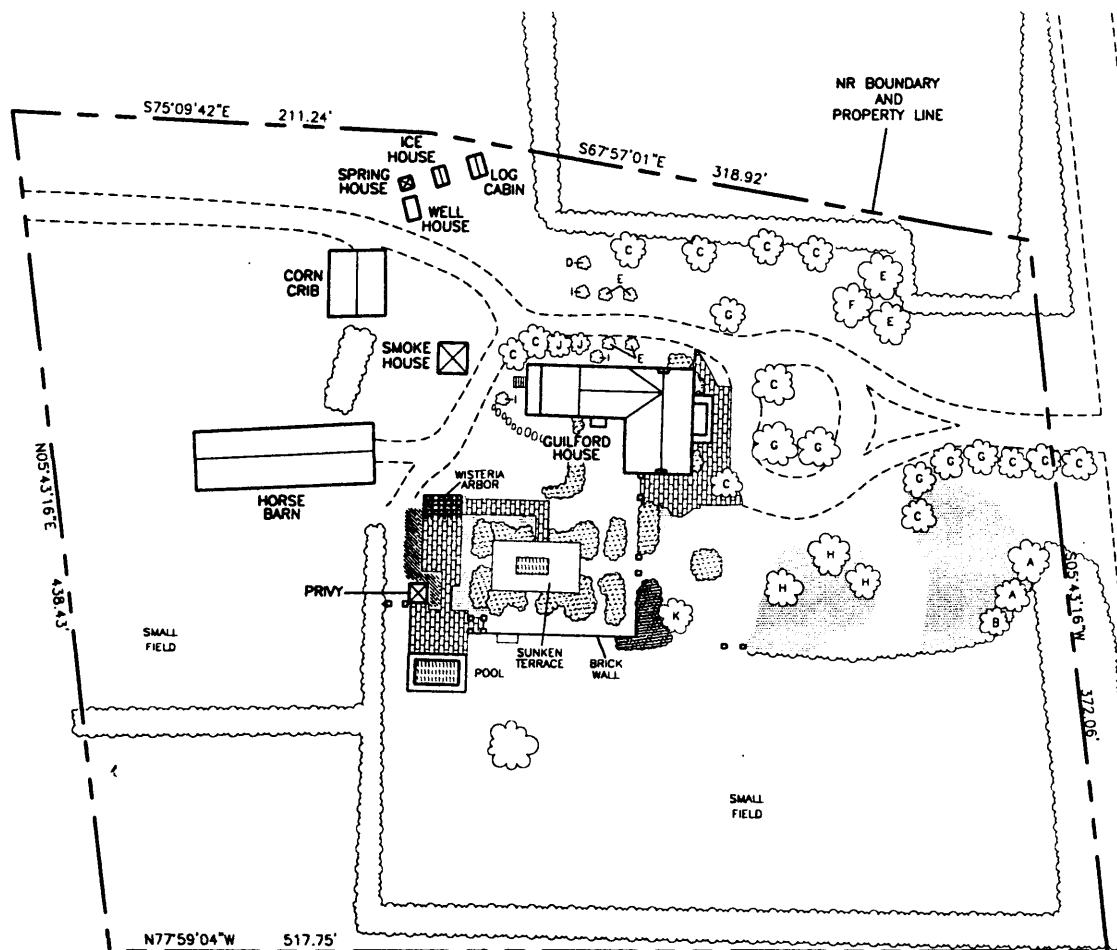
Site Sketch Map; broken line indicates National Register boundaries

Verbal Boundary Description: The nominated property is indicated by the broken line on the accompanying map entitled "Guilford Property, Site Sketch Map" (see continuation sheet, Section 7, Page 18).
