National Register of Historic Places Inventory—Nomination Form

historic Widrick, George, House and/or common Widrick, George, House Location Ballenger Creek Pike street & number n/a not for publication Frederick Sixth X vicinity of city, town congressional district 24 Maryland Frederick 021 code county code state Classification 3. Category **Ownership** Status **Present Use** X___ occupied public district agriculture museum X private X building(s) unoccupied commercial park X ___ structure both work in progress educational private residence **Public Acquisition** Accessible entertainment religious _ site X yes: restricted _ object in process government scientific being considered yes: unrestricted industrial transportation X not applicable no militarv other: 4. **Owner of Property** name Mrs. Peggy Kinsey street & number P. O. Box 8 n/a vicinity of Maryland city, town state 21701 Frederick **Location of Legal Description** 5. courthouse, registry of deeds, etc. Frederick County Courthouse North Court Street street & number Frederick city, town state Maryland 21701 **Representation in Existing Surveys** 6. Maryland Historical Trust title Historic Sites Inventory has this property b

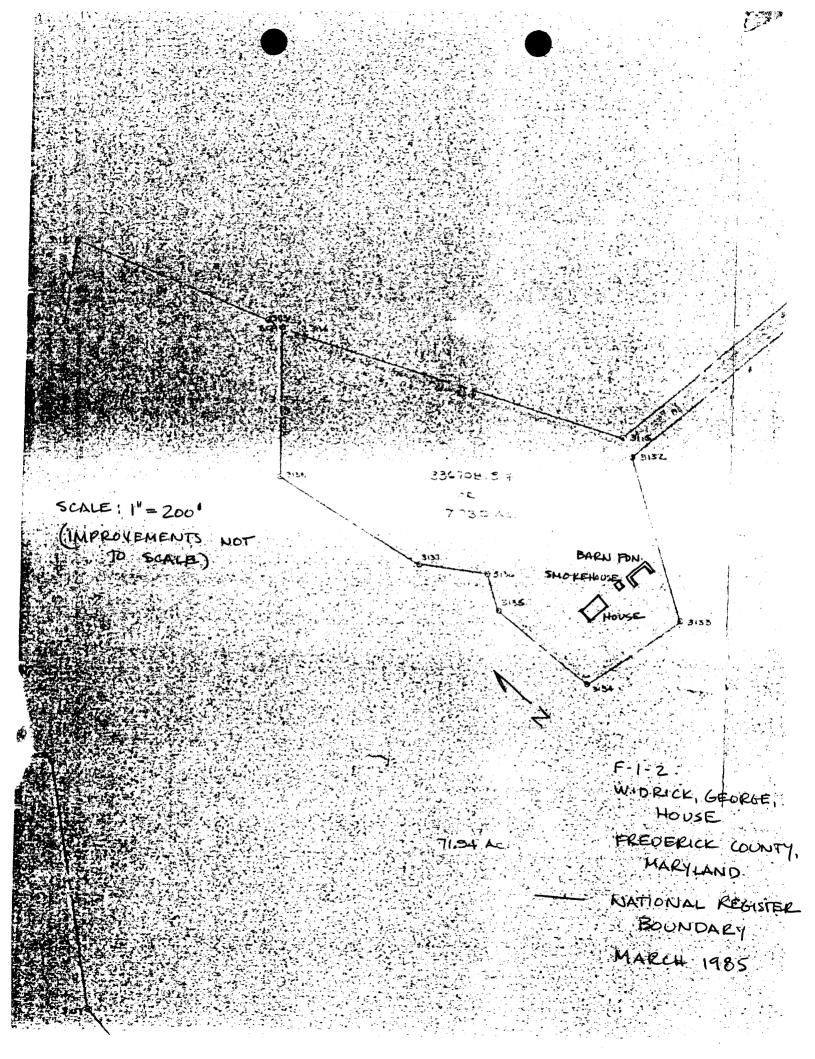
Verbal Boundary description: Boundaries are depicted on the attached plat.

Boundary Justification: The nominated property, approximately 8 acres, comprises the resource within its immediate setting. The surrounding area is predominantly open agricultural land, much of which is under development as a local recreation area.
