**National Register of Historic Places
Inventory—Nomination Form**

Historic Resources of South Louisville
Louisville, Jefferson County, Kentucky
Continuation sheet

SOUTHERN HEIGHTS - BEECHMONT DISTRICT

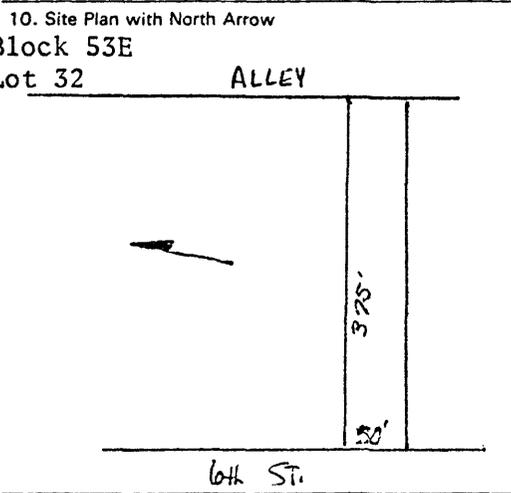
18. Description A central facade dormer contains a three-window grouping. Two simple windows are located on the second floor facade and a window and entrance on the first. The entrance has sidelights and a transom. A classical porch extends across the facade and wraps around the side of the house.

20. Significance
This vernacular residence displays a particularly fine classical porch, and is typical of the vernacular architecture found in this district.

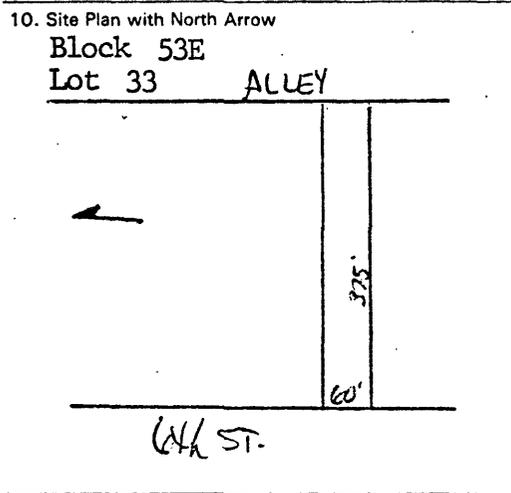
18. Description
 This one-and-one-half-story duplex has a central domer with three windows. The facade is symmetrical with the central entrance containing sidelights and transoms, and flanked by two windows. A full classical porch protrudes from the center with double columns. A decorative cornice lines the porch and includes dentils.

20. Significance
 This small residence is an excellent example of the simple Colonial Revival, with a particularly fine porch.

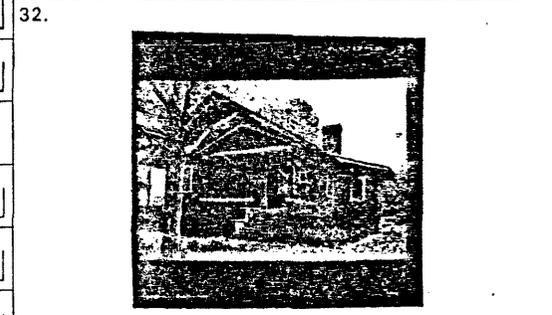
Roll No. 106
 Picture No. 11A
 Direction _____

20. Significance
Few Western Stick style residences are found in Louisville. This is an excellent example of the style on a small scale.

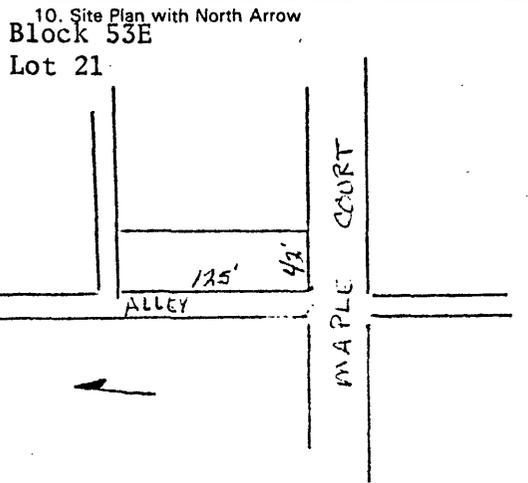
18. Description The second floor facade has a bay window and small square windows on the sides and above the bay. The full front porch is contained under the facade gambrel roof, with French doors on the east side, a large window in the center and the entrance on the west. The windows and doors have simple layered lintels. The porch piers and enclosed railing are sheathed in clapboard. On the east side of the first floor is a cantilevered

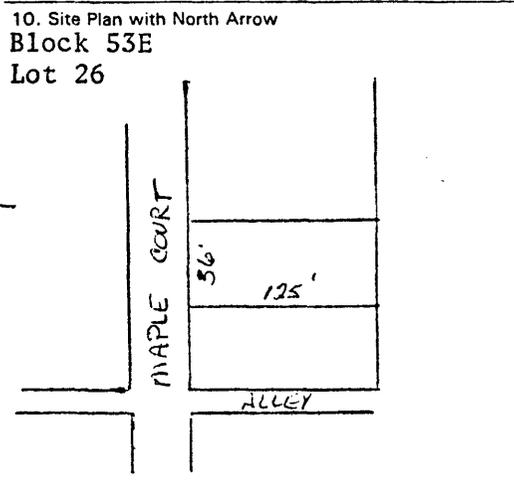
18. Description The facade gable is filled with shake shingles. The wide eaves contain four projecting purlins with diagonal braces. Two windows are located in the gable. One window and a multi-paned door are found on the first floor facade, enclosed by a full porch. The porch roof is also gabled, with clapboard filling the gable. Simple piers support the porch roof and a solid railing between piers is clapboard. All windows have simple layered lintels.

20. Significance
This residence is an example of the simple vernacular style residence found on the court.

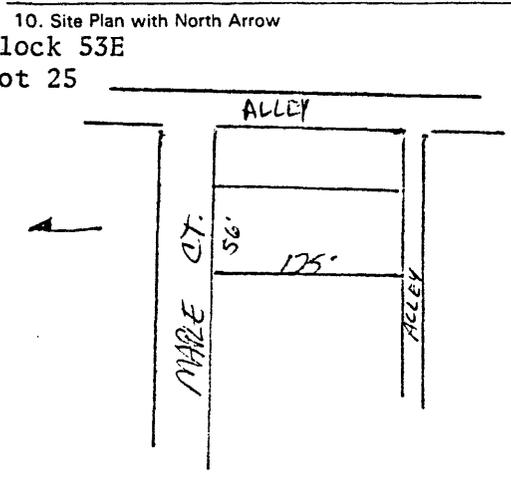
20. Significance This is one of the finest Shingle Style residences on Maple Court, with particularly fine window and gable treatments.

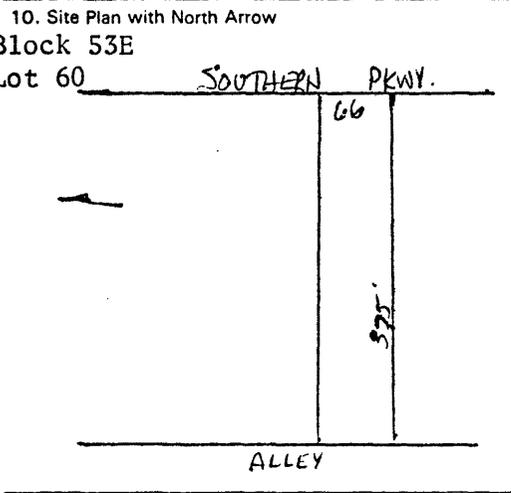
19. History
4512 Southern Parkway was constructed in ca. 1925 in the 4400 block of Southern Parkway and moved to its present site in the 1960s when an expressway was constructed over the original site.

20. Significance
This residence is an example of the later construction period of the district and of the various Colonial Revival styles used in the district.

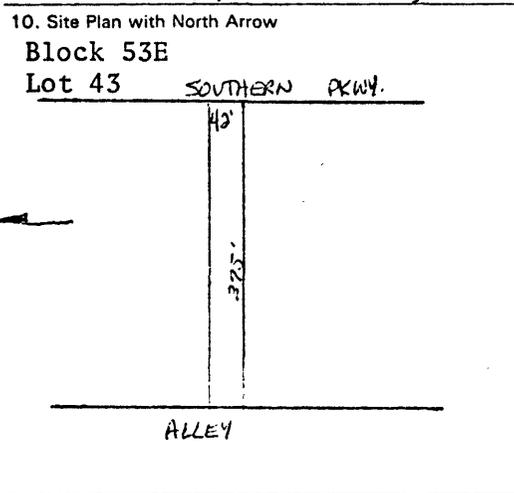
18. Description
 The large facade gable contains fish scale shingles and two multi-paned windows. A classical porch with ionic columns extends across the first floor facade. The multi-paned entrance with a transom is not central. A bay window is located on the south side of the entrance and a single window on the north side. Gabled dormers are found on both sides of the house. A garage is located on the north side of the front (OVER)

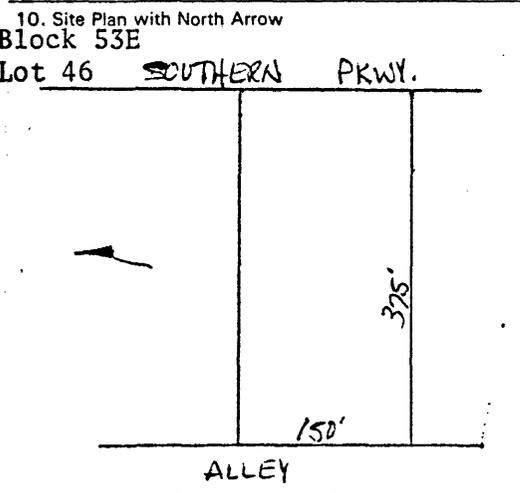
18. Description The roof of this residence is steeply pitched with two large dormers on the facade which extend below the cornice line into the second story, and project from the facade. They are gabled dormers with semi-circular windows in the attic level and six-over-one, double hund windows on the second floor with pedimented lintels. Shingles cover the second floor and dormers. A screened-in porch extends across

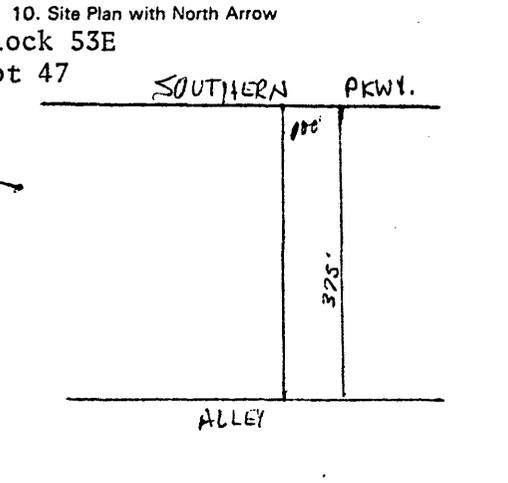
18. Description The hipped roof is red tile. The facade is symmetrical with a central projecting bay, three windows on the second floor facade and central entrance with flanking windows on the first floor. A porch extends across the first floor facade with a red tile hipped roof supported by octagonal columns and simple pilasters. A side gabled porch projects from the northern side of the house and contains the same architectural treatment as the front, on a smaller scale.

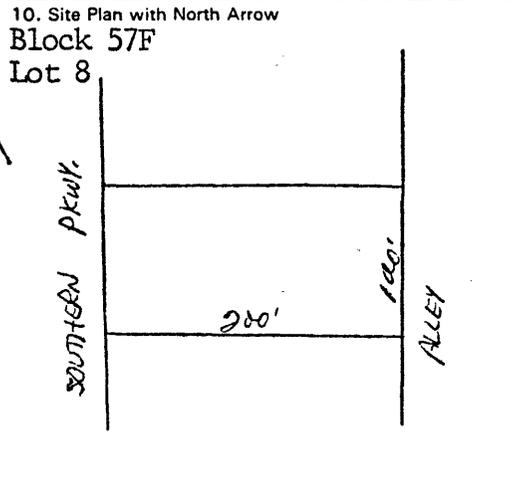
11. Architect _____
 12. Builder _____
 13. Date 1906 61
 14. Style A. Bungalow 18
 B. _____
 15. Original Use residential 1
 16. Present Use residential
 17. Condition excellent 1

18. Description This residence is a large bungalow on a raised base-ment with three jerkinhead dormers, the front central dor-mer being brick and the others frame. The front dormer has a Palladian window. The wide overhanging eaves are found on all sides of the house and on the dormers. A full brick porch extends across the facade. The central entrance has sidelights and is flanked by windows with vertical panes. A carport is located on the north side.

20. Significance
This is an example of the design excellence found in this district. It is a fine example of the bungalow.
