# National Register of Historic Places Registration Form

Washington Trust Company Building	Washington County, PA	
Name of Property	County and State	
7.Description		
Architectural Classification		
(Enter categories from instructions.)		
LATE 19TH AND 20TH CENTURY REVIVALS/Beaux Arts		
-

The Washington Trust Company Building is a Beaux Arts style commercial building located in central downtown Washington, PA. Set among smaller-scale commercial buildings and across Main Street from the Washington County Courthouse, it is the largest commercial building in Washington. The Washington Trust Company Building has a rectangular footprint and is of steel frame construction clad in brown and buff brick and buff sandstone. It is six bays wide on its primary (west) facade, five bays wide on its rear (east) facade, and 14 bays deep, with the three easternmost bays belonging to a 10-story addition constructed in 1927. The original, 1903 section of the building is six stories tall. The Washington Trust Company Building's construction on a sloping site means that the ground floor is at grade on the eastern end of the building, but submerged (though exposed behind an areaway) on the western end. T

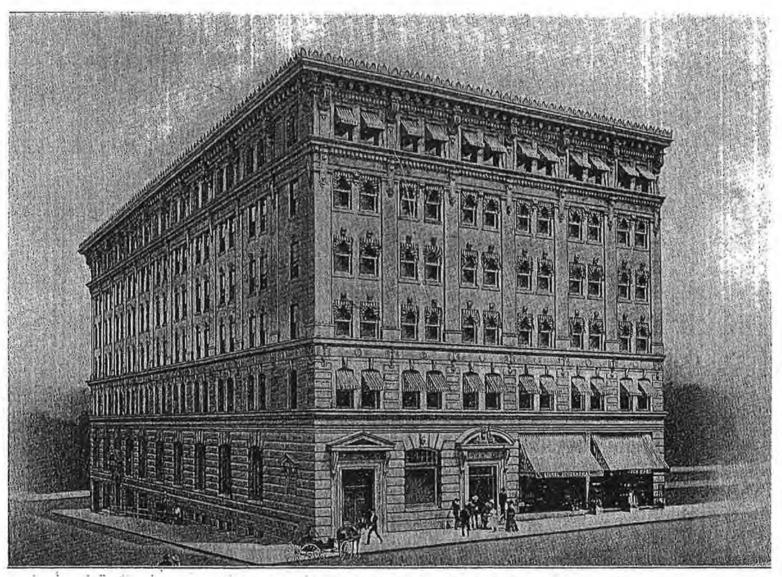
Figure 1: 1905 Rendering of the Washington Trust Company Building (from Pittsburgh Architecture Club, Yearbook of Pittsburgh Architectural Club, Vol. 3, Pittsburgh, 1905).
