# National Register of Historic Places Registration Form

Historic name Pacific Hardware & Steel Company Warehouse

street & number 2181 NW Nicolai Street  not for publication

Pacific Hardware & Steel Company Warehouse – Floor Plans

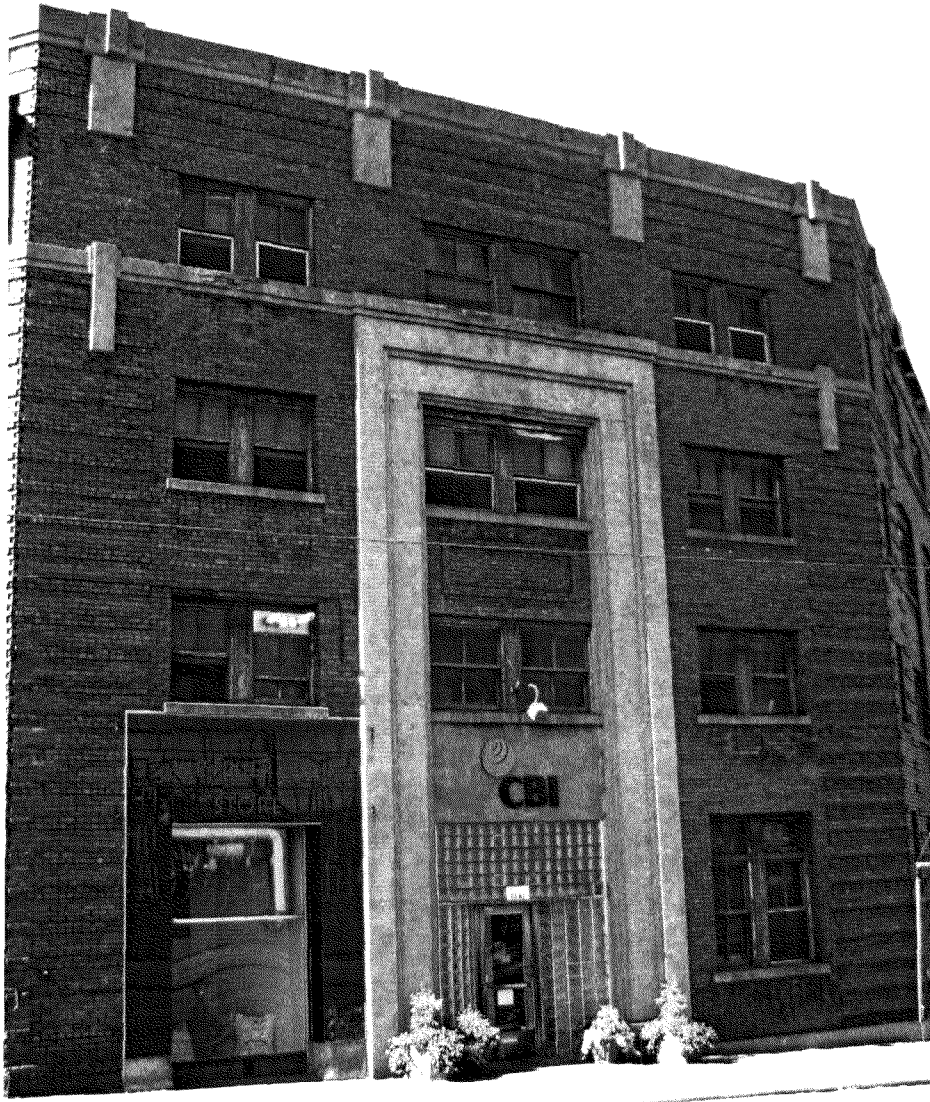
Photo 1 of 23: Entry/south façade. View to N.

The windows on this entry façade are all grouped in pairs. Originally there were three pairs on floors two, three, and four, with two of these being within the cement entry frame. The two ground floor window pairs—one on either side of the entry door—are larger than those on the upper floors due to transoms above the two-over-two sashes. The ground floor window to the west of the door was replaced with a second entry door probably around 1923.<sup>4</sup> The doorway was surrounded by green structural glass with a thin metal frame—a common building material in Art Deco buildings of the 1920s. The structural glass extends as high as the second story windowsills and is confined to the brick facade area between the cement entry frame and the quoin-like brick pilasters. The area above the doorway reads "Fuller & Co.," and this was likely an entry to a small retail branch that sold paint and other products manufactured by Fuller & Co. At a date unknown, the door was removed and this opening was converted to a glazed window display.

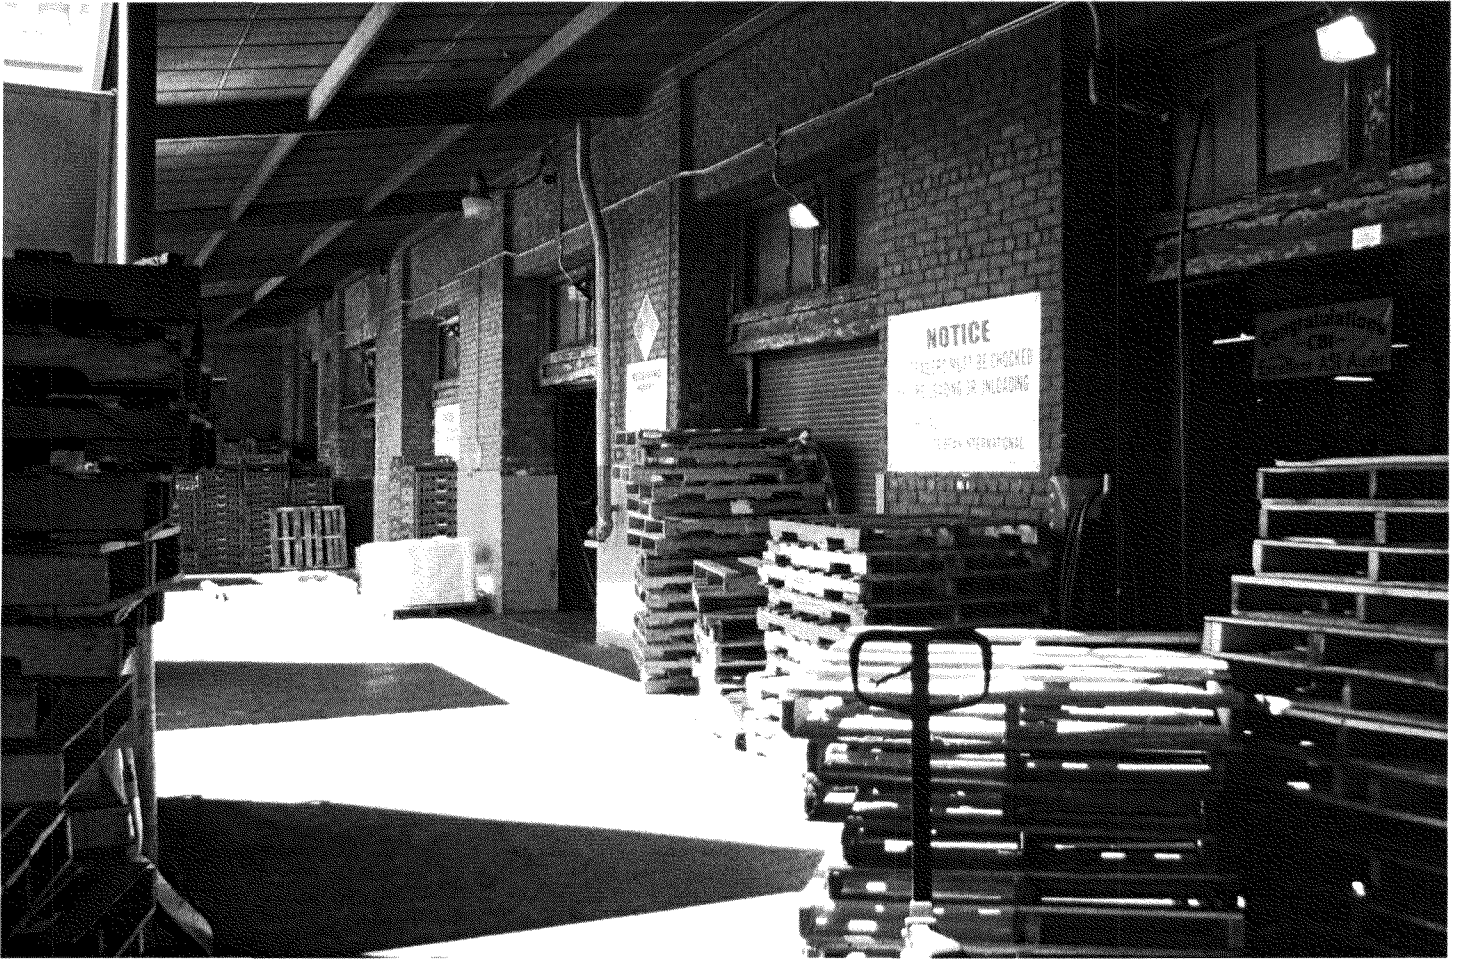
Photo 8 of 23: Southwest façade: loading dock. View to NW.

The southwest façade is where the shipping and receiving from trucks occurs, though, at the time the building was constructed this would have been primarily horse and wagon traffic. The façade is comprised of ten bays, eight of which have window pairs. There is a concrete loading dock that extends almost the entire length of this façade. Truck traffic enters off of NW Nicolai, near the intersection with NW Yeon St., and proceeds through a parking lot to reach the loading dock. The dock was originally made of wood and was replaced in 1937.

On this façade, there were originally five roll-up loading dock doors and two freight elevator doors at the loading dock level. The original doors have been replaced with newer metal doors. All of the loading door openings have transoms above (the same hollow metal fire windows as the rest of the building). One of the

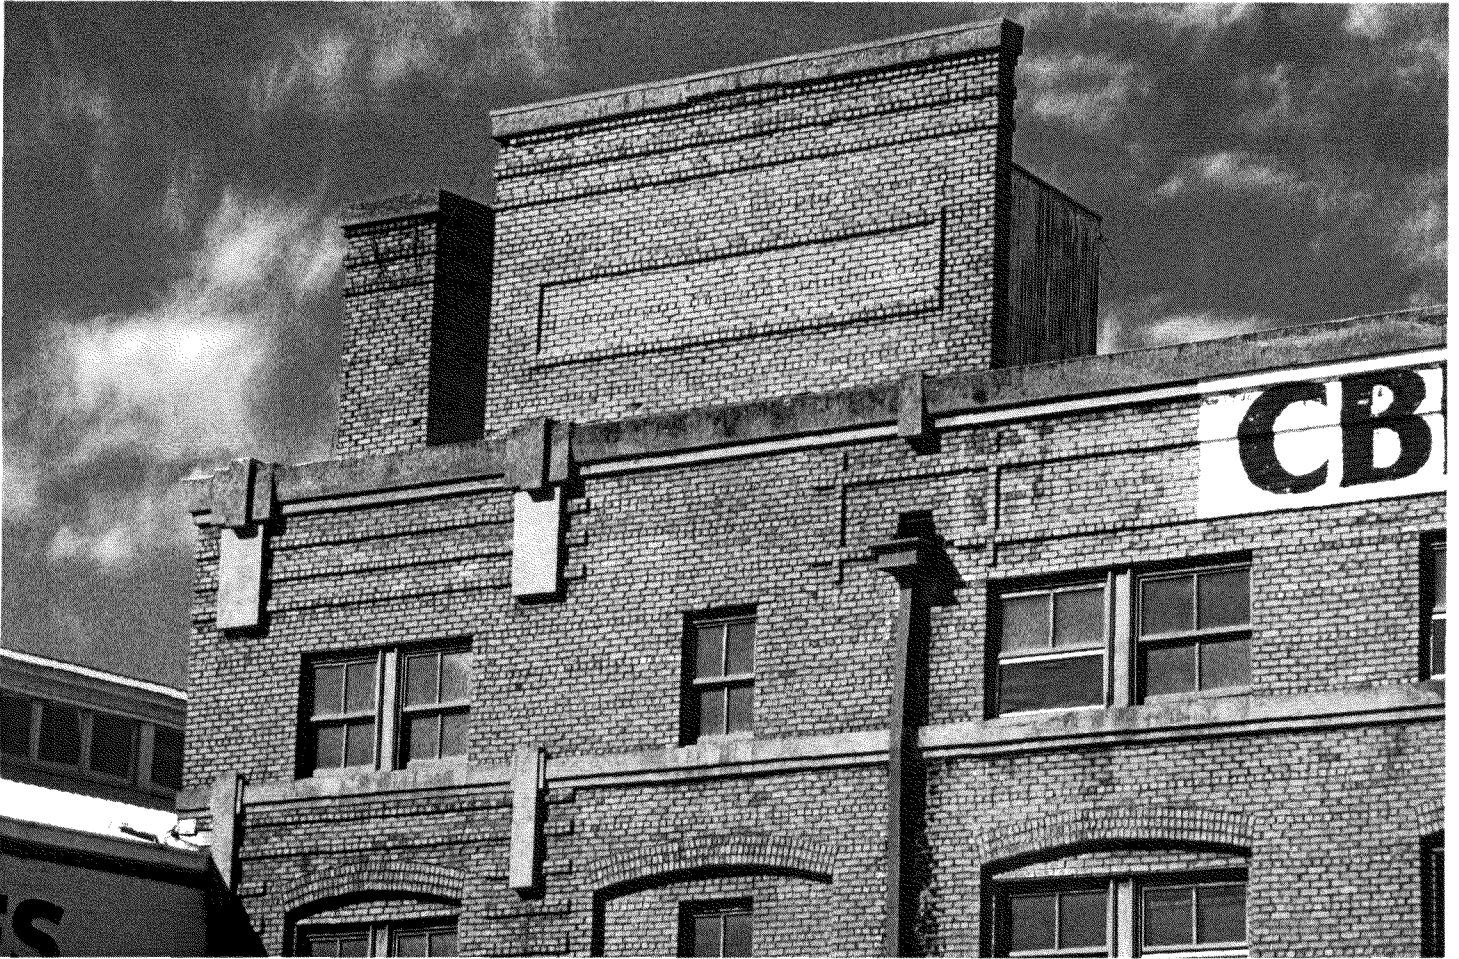
Photo 9 of 23: Southwest façade: parapet, chimney, and elevator overrun detail. View to NE.

A flat roof was also considered essential—preventing the tendency for fire to travel up pitched roofs and towers. A parapet wall 2½ feet above the roof and capped with vitrified coping laid in Portland cement mortar was recommended.<sup>56</sup> These are both features of the subject warehouse.

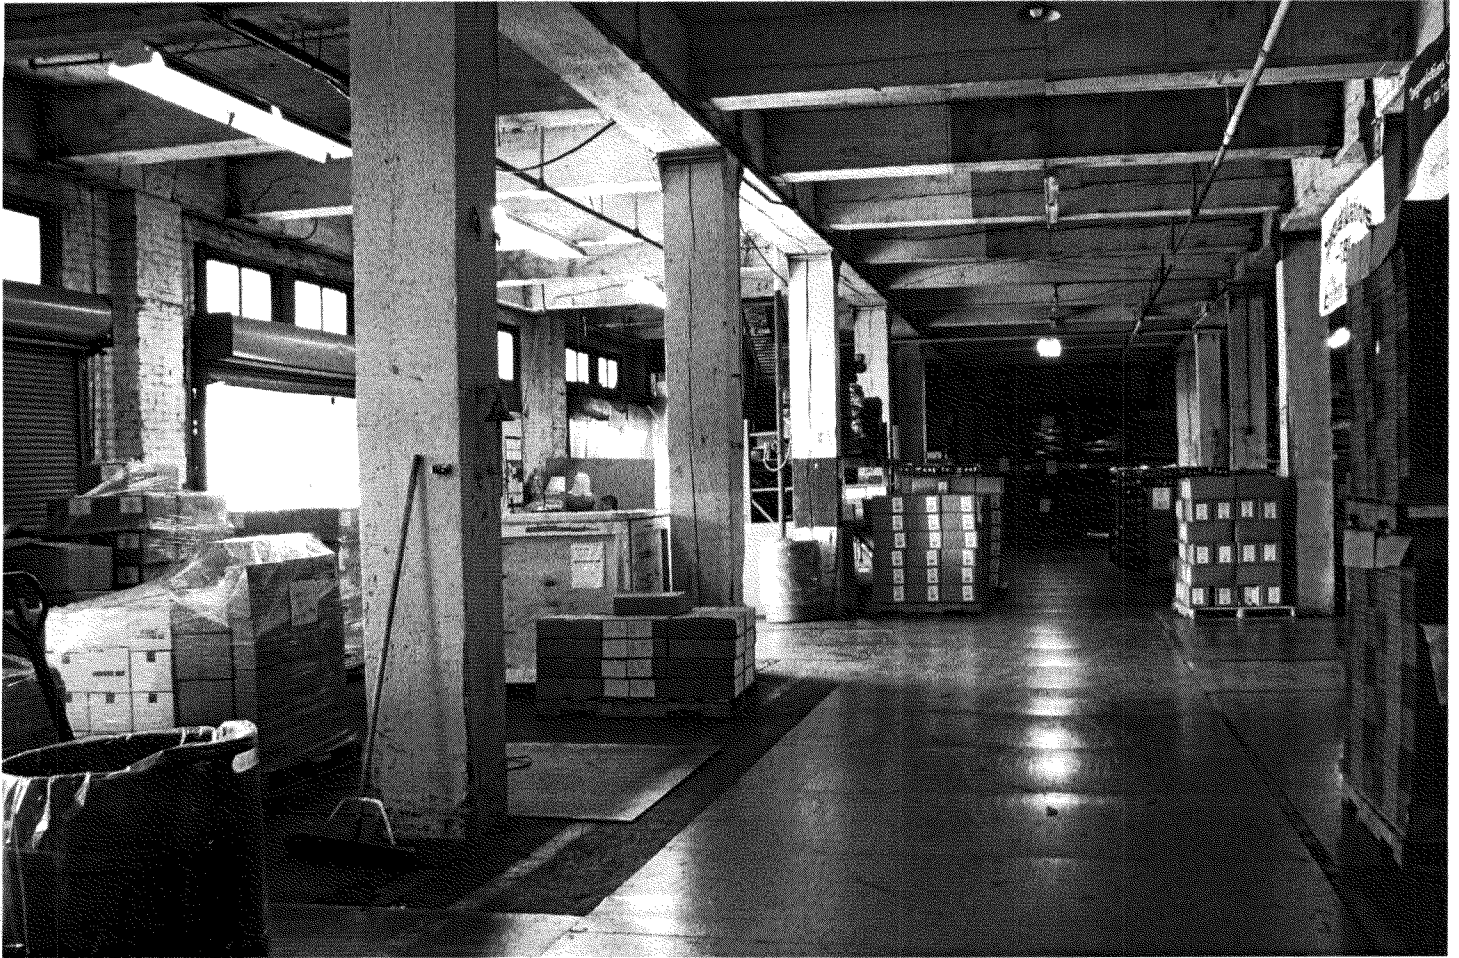
Photo 15 of 23: First floor: warehouse. View to NW

Mill construction gets its "slow-burning" characteristics from erecting the timbers in "heavy solid masses as to expose the least number of corners or ignitable projections to fire, to the end also that when fire occurs it may be most readily reached by water from sprinklers or hose."<sup>50</sup> Timbers with large dimensions are slow to ignite and do not burn rapidly due to a lack of oxygen. Specifications required that timbers (sometimes call "sticks") be no less than six inches in width. When large timbers were not available, two small timbers could be bolted together, ensuring that no air or dust could get between them. This was not usually necessary in the Pacific Northwest where huge timbers were readily available. In the case of the PHSC Warehouse, the largest posts and beams (in the basement) measure 20 inches square and 24 by 20 inches, respectively. The smallest posts are on the fourth floor, measuring 10 inches square.

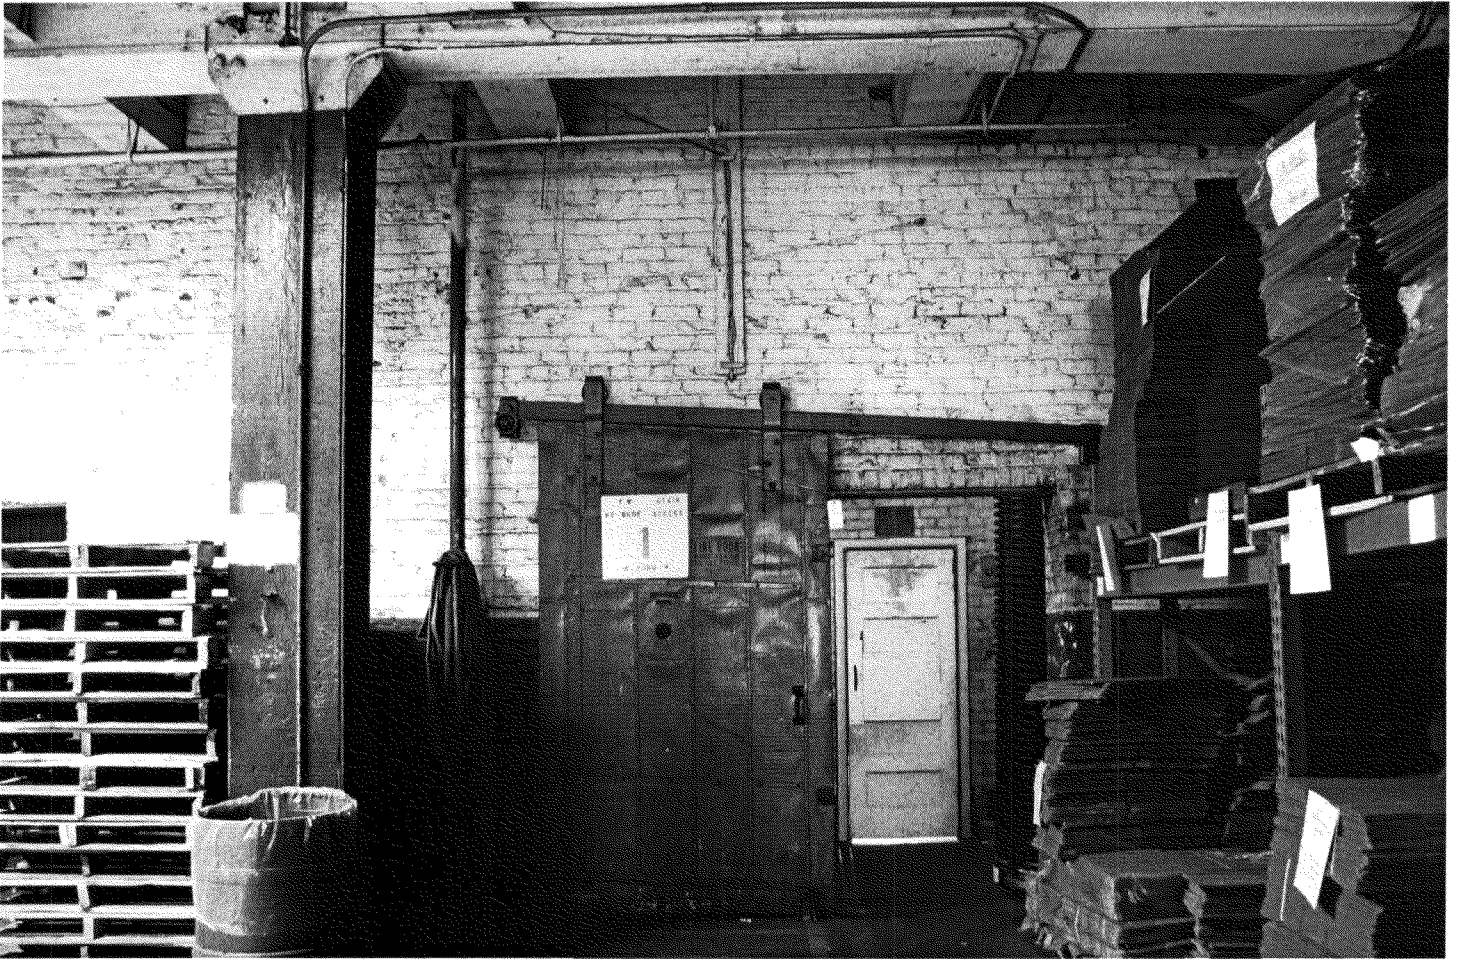
Photo 16 of 23: First floor: warehouse fire door. View to SE.

Slow-burning construction also aimed to prevent the spread of fire using of solid brick interior walls to separate major uses, stairs and elevators shafts encased in brick, and tin-clad fire doors to close off all passages. All interior partitions were to be made with incombustible materials such as metal lath and plaster. Wire glass was recommended for windows. Experts strongly suggested that boiler rooms be located in a one-story building separated from the rest of the building by a firewall.<sup>57</sup> The PHSC Warehouse followed these specifications with a masonry wall separating the offices and warehouse space, brick enclosures around elevators and stairs, tin-clad doors throughout, metal lath and plaster used in the bathrooms (later partitions would be of wood), metal sash fire windows with wire glass, and what appears to be a separate boiler room.

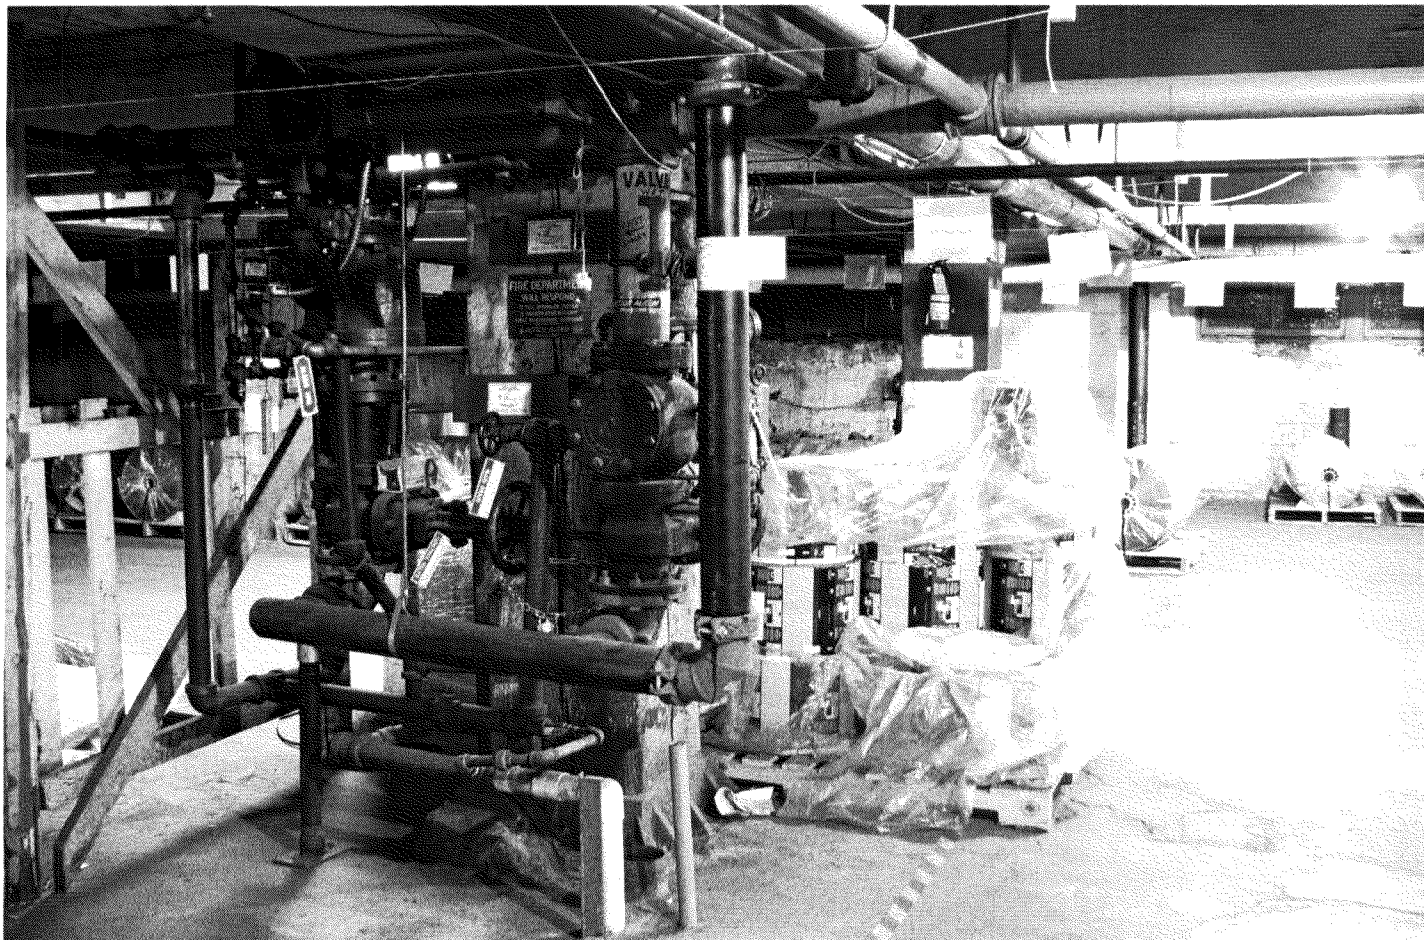
Photo 22 of 23: Basement: sprinkler equipment. View to SE.
