National Register of Historic Places Registration Form

Historic name: First National Bank
Other names/site number: Exchange Bank of Skiatook
Name of related multiple property listing:
N/A
(Enter "N/A" if property is not part of a multiple property listing)

Street & number: 123 East W.C. Rogers Boulevard
City or town: Skiatook State: Oklahoma County: Tulsa
Not For Publication: N/A Vicinity: N/A

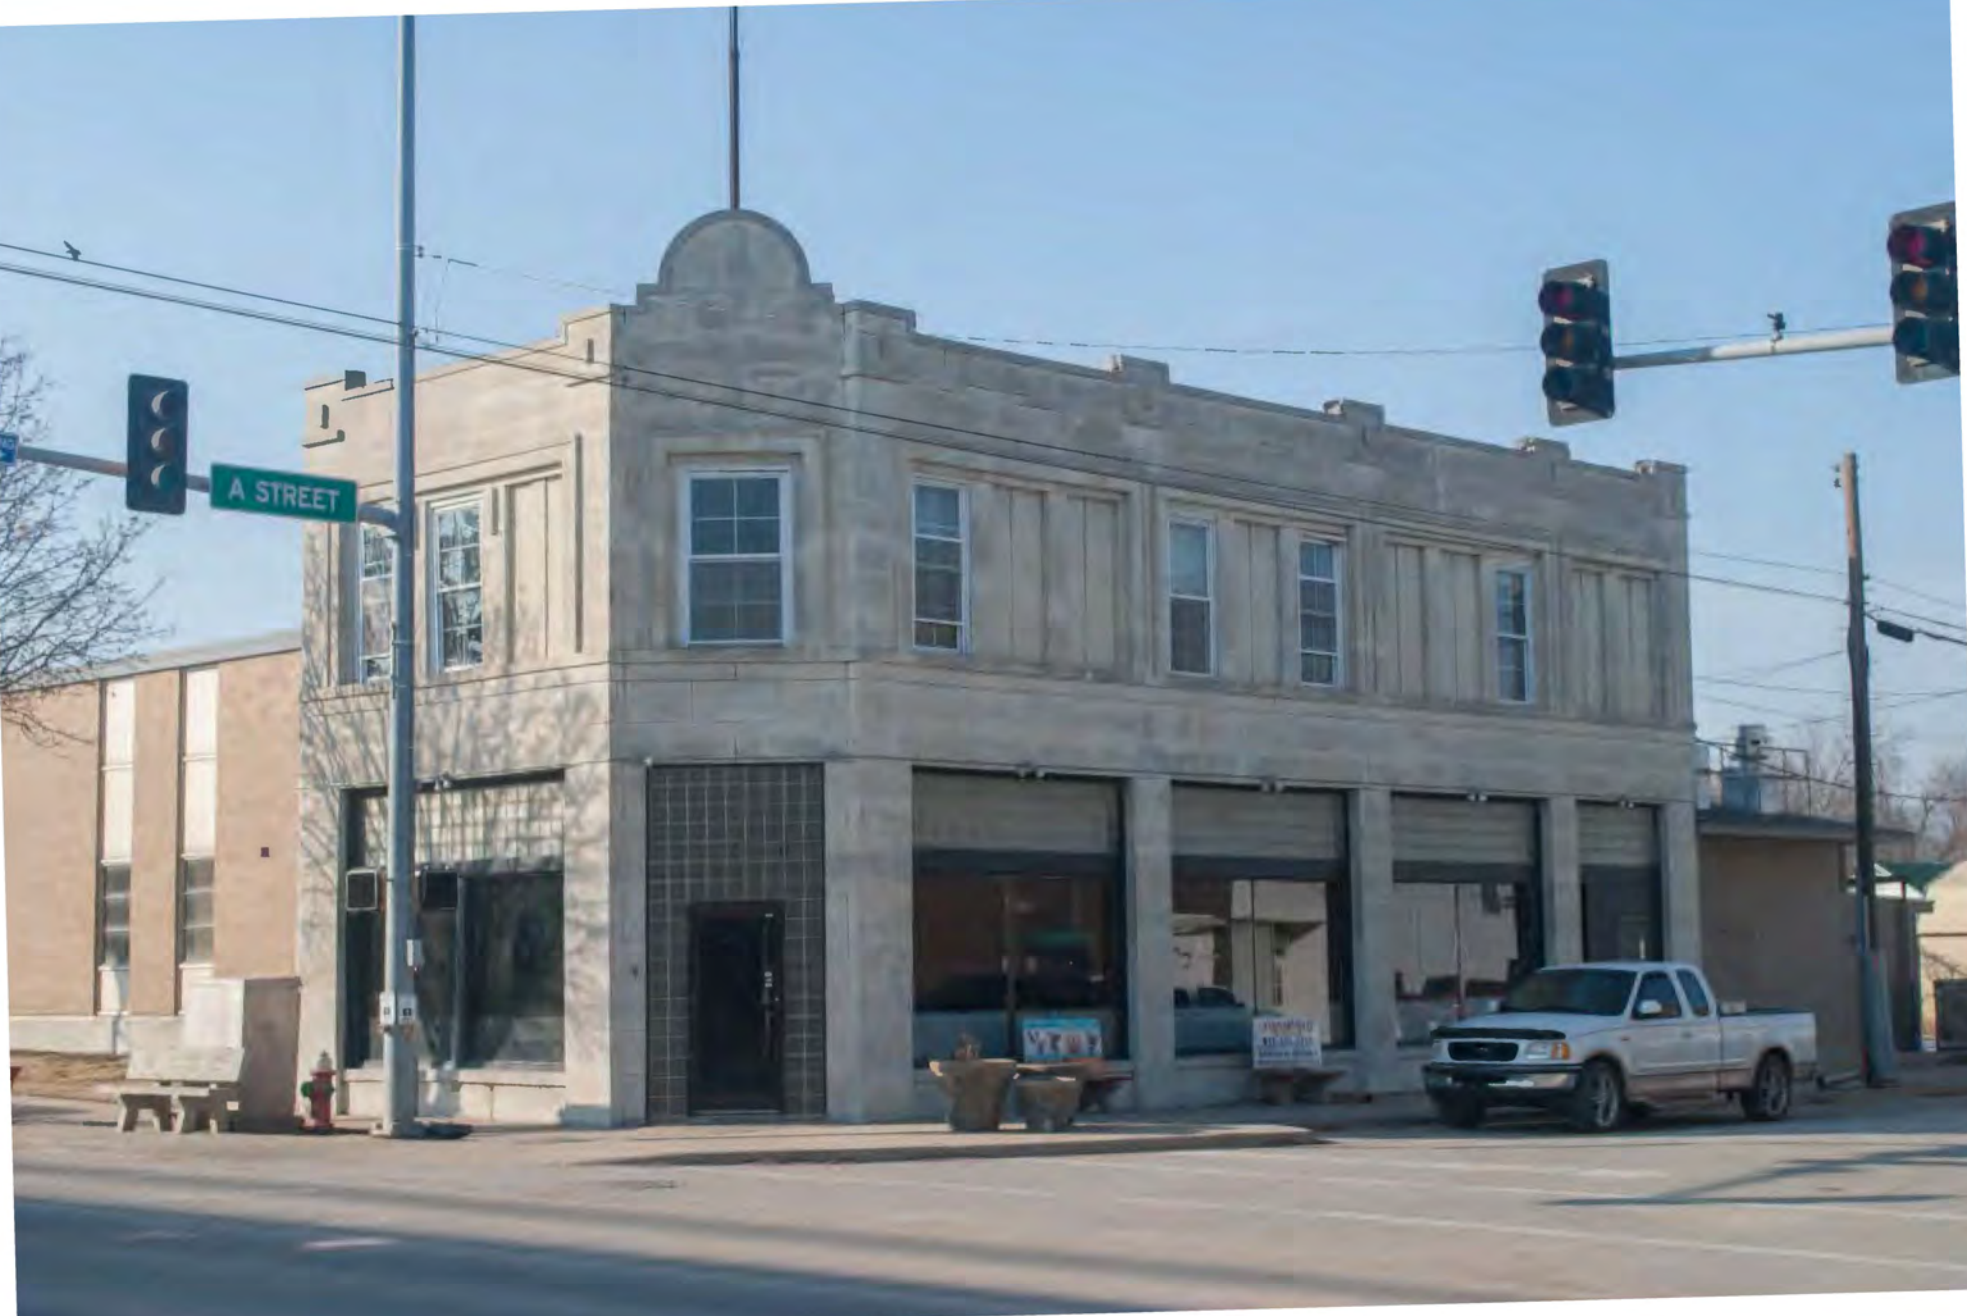
The two-story two-part commercial block building has a rectangular plan with a canted southeast corner facing the primary streets (*Photo 1*). It rises from a reinforced concrete foundation to a flat roof. Smooth stone clads the primary (south and east) brick walls. A cluster of one-story rectangular additions extends north from the north elevation. The additions are clad in smooth stucco and vertical siding and have shed roofs.

The main entrance fills the canted southeast corner (*Photos 1, 3*). Glass block surrounds the glazed aluminum-frame door. On the second story, a single opening filled with a non-historic double-hung vinyl window pierces the wall above the entrance.

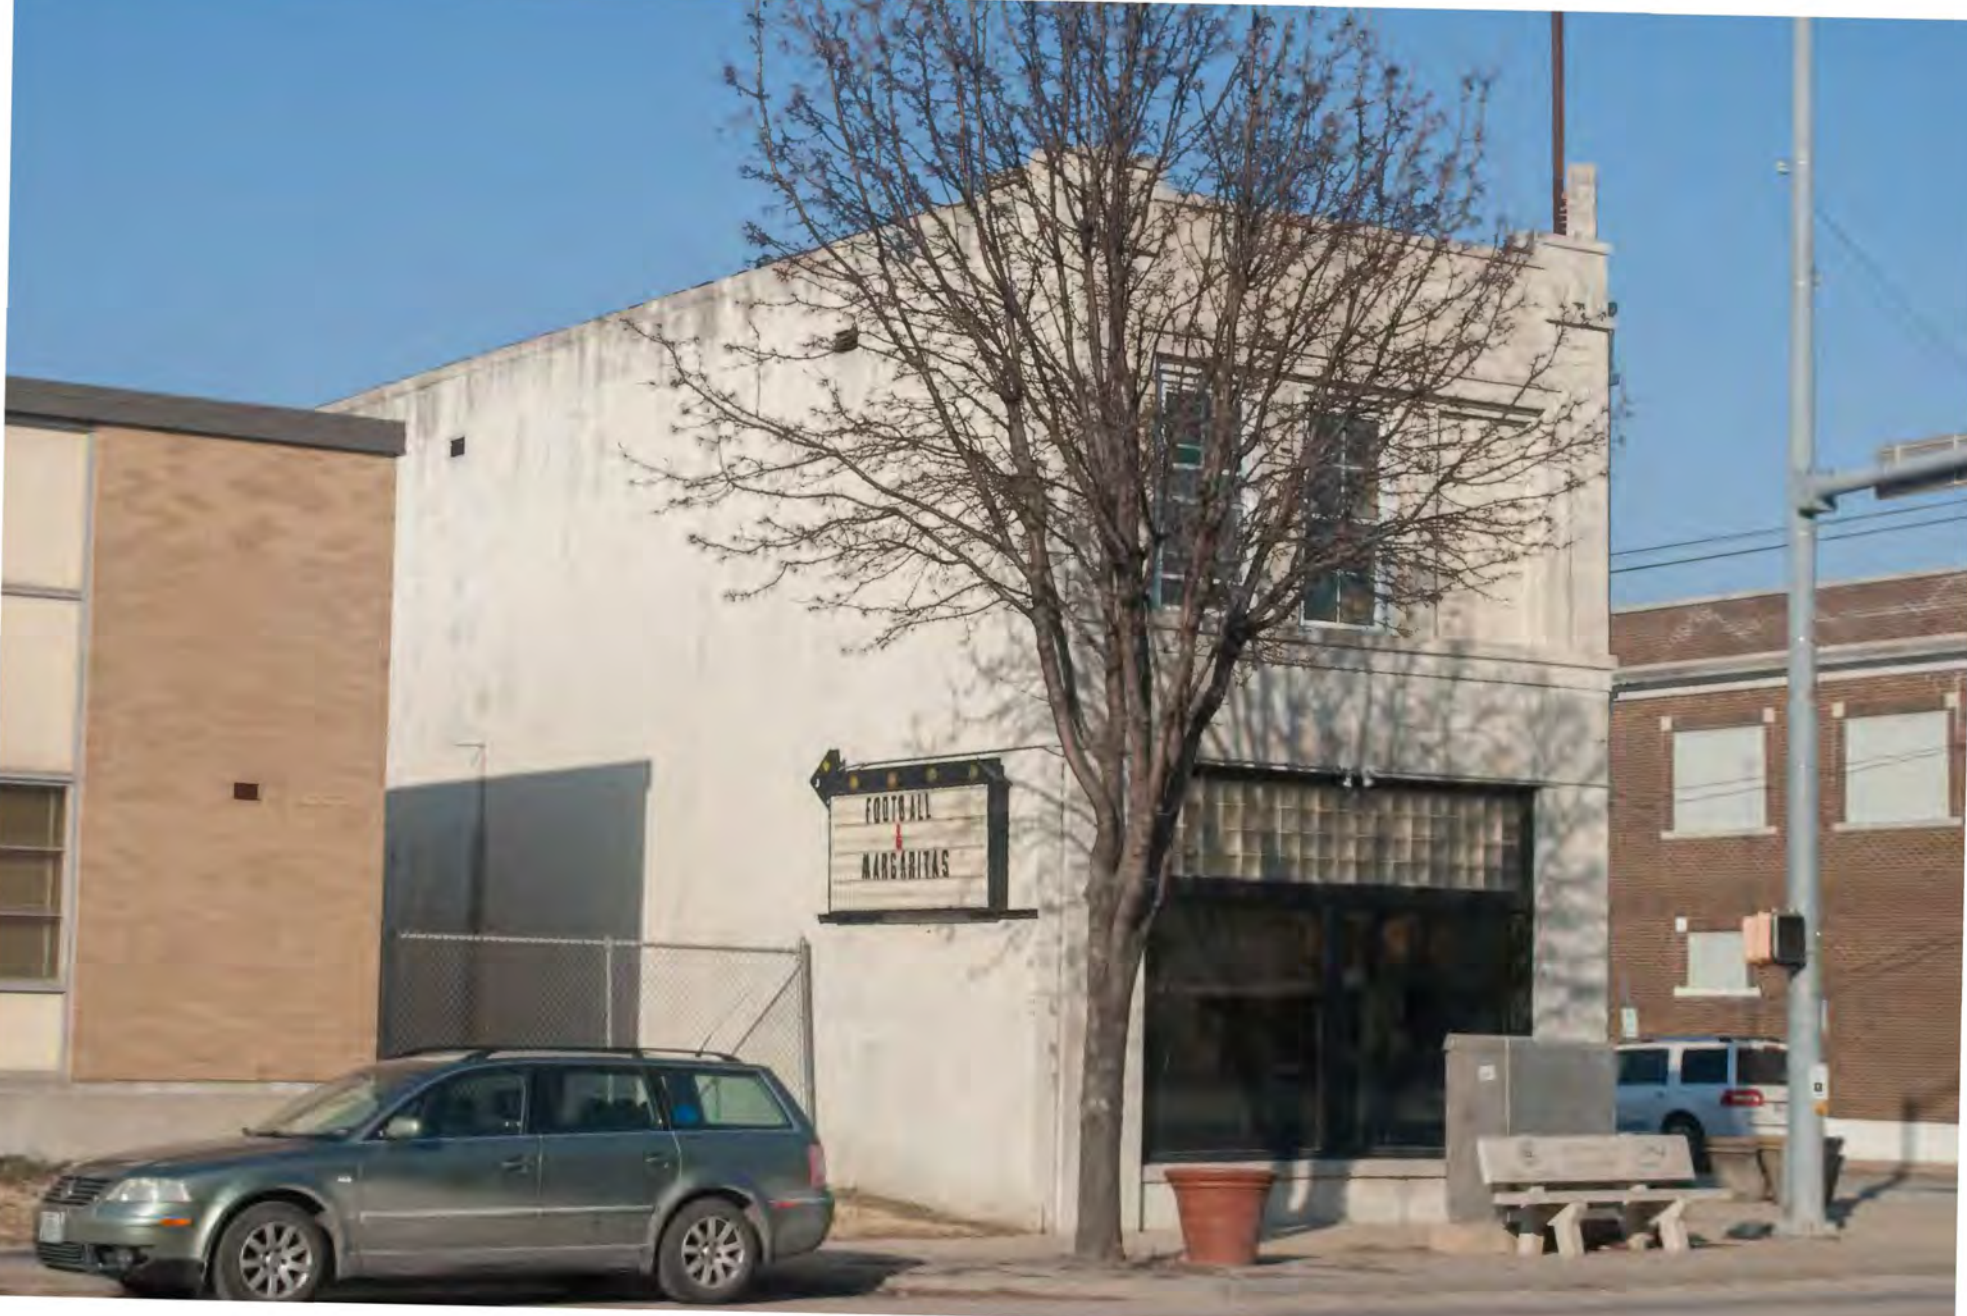
The primary elevations face south and east. The south elevation has a single bay on the first story filled with paired storefront windows set in historic wood frames (*Photos 2, 3*). The storefront has a historic glass block transom and sits on concrete block-faced kneewalls. The east elevation has four bays (*Photos 1, 4*). Bays 1-3 have the same storefront configuration as the south elevation on the first story. An opaque panel fills the slightly smaller Bay 4. A tall narrow fixed window pierces the south side of this panel. A replacement wood pedestrian door pierces the north side. The same glass block transoms cap this bay.

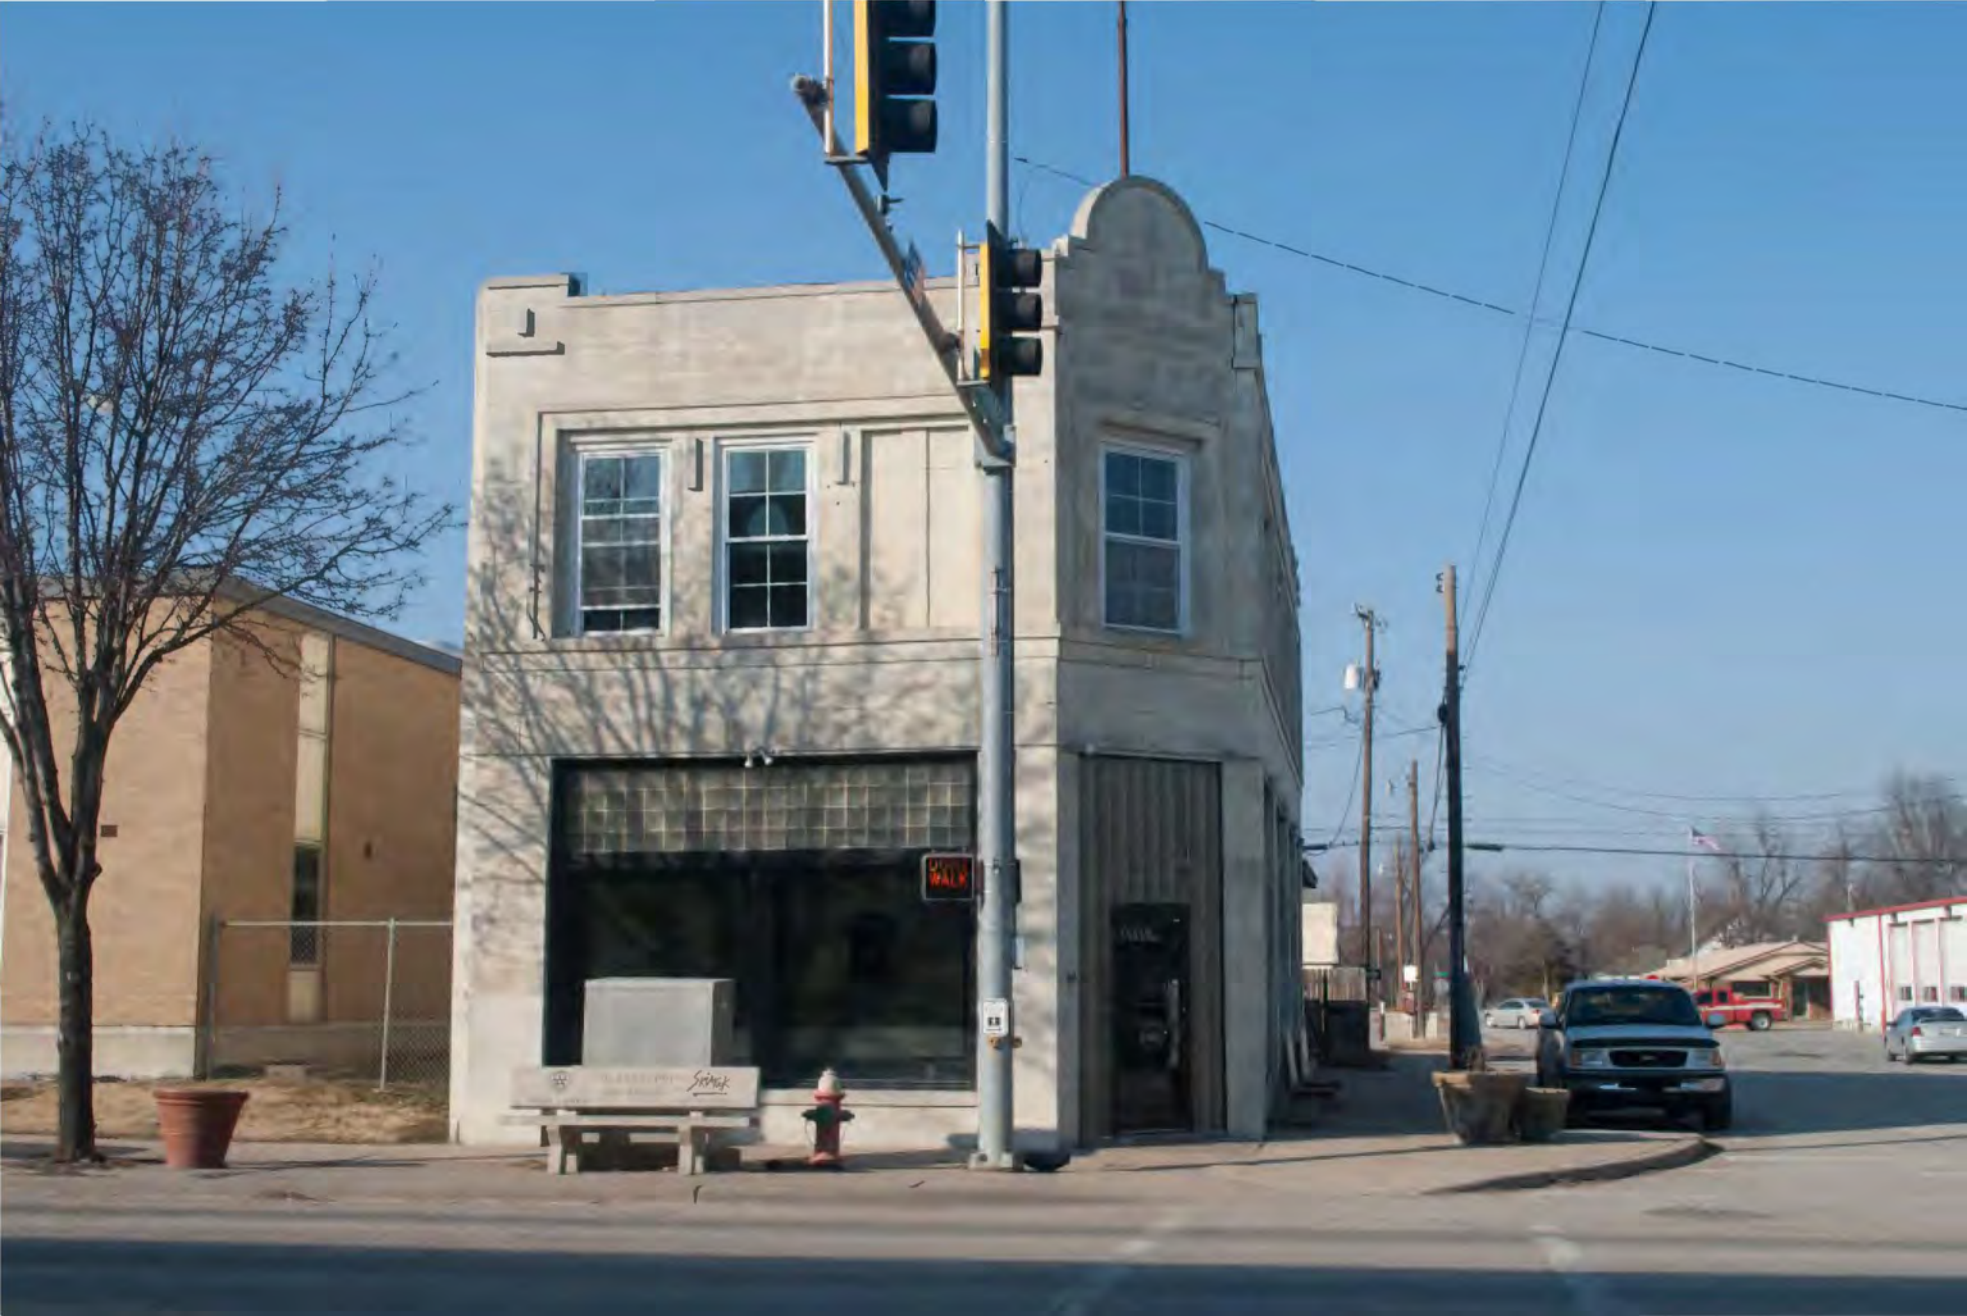
On the second story, two stone mullions divide the wide openings into thirds. These openings define the single bay on the south elevation and Bays 1-3 on the east elevation. Bay 4 on the east elevation is narrower; it has a single mullion and paired windows. A simple dressed stone frame surrounds each opening. Varying combinations of narrow, non-historic four-over-four double-hung vinyl windows and dressed stone blocks fill each opening between the mullions. A continuous two-part stone sill spans the length of each elevation beneath the openings.

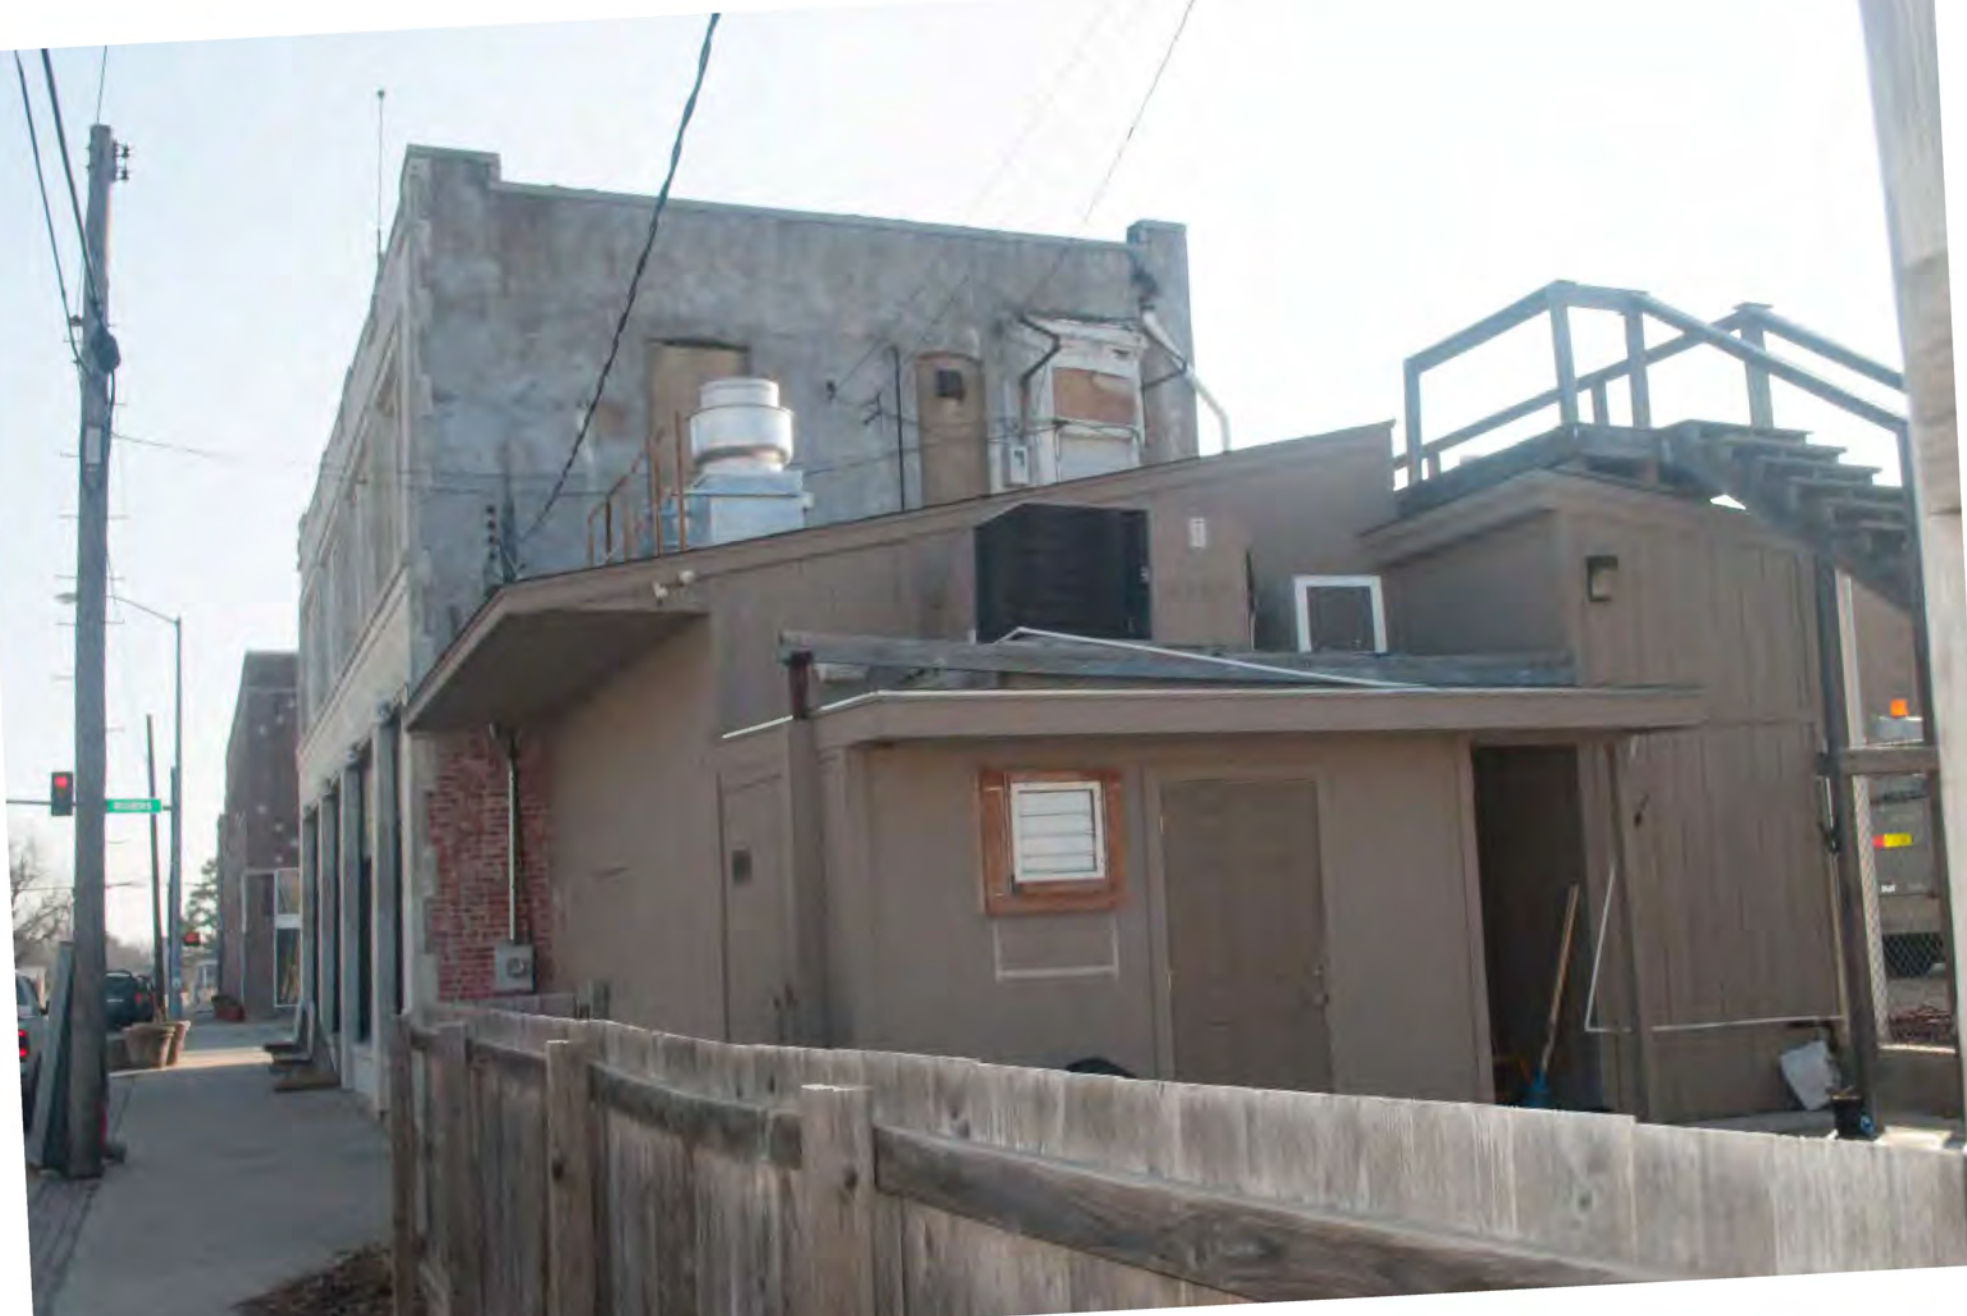
On the north elevation, a single non-historic paneled pedestrian door accesses one of the addition blocks on the first story (*Photo 5*). Extending north from the west side of this elevation, a wood staircase rises to a wood deck that continues over the one-story block to an entrance in the main building wall. A non-historic slab door fills the slightly projecting entrance. Left of this door, concrete masonry units faced with stucco fill two openings near the center of the elevation. The west elevation formerly abutted an adjacent building. It is void of fenestration.

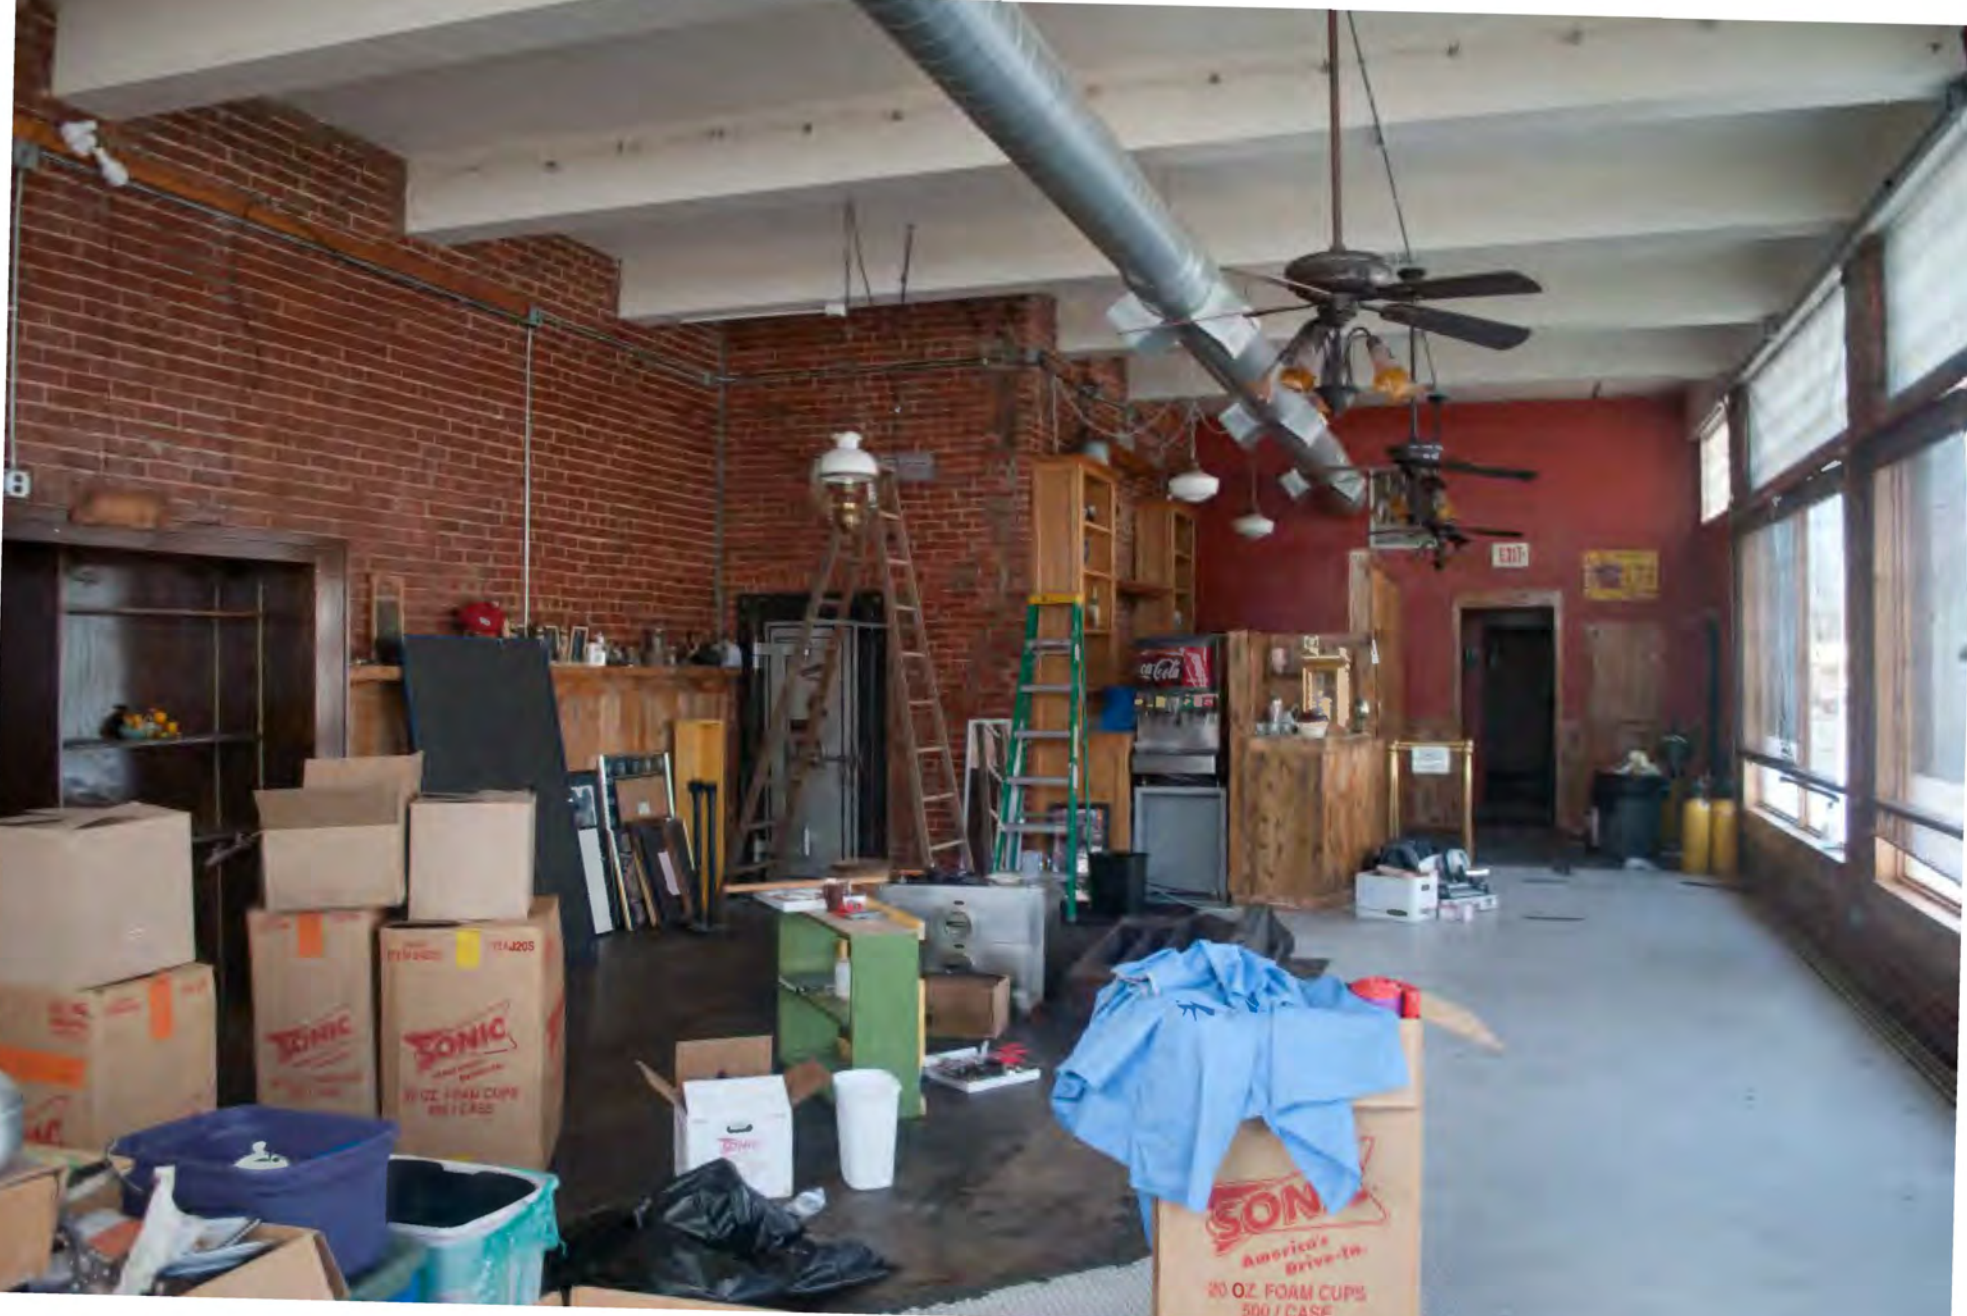
A single commercial space occupies the first floor (*Photos 6, 7*). The west, south, and east walls have exposed brick. Plaster covers the north wall. There are two historic brick bank vaults in the northwest corner of the space accessed via historic metal doors. Historic white ceramic hexagonal floor tile with a decorative green border defines the historically public areas of the banking lobby (*Photo 8*).
