historic name: REDDING CENTER HISTORIC DISTRICT

Description (continued) Redding Center Historic District Page 7-1
Redding, Fairfield County, Connecticut

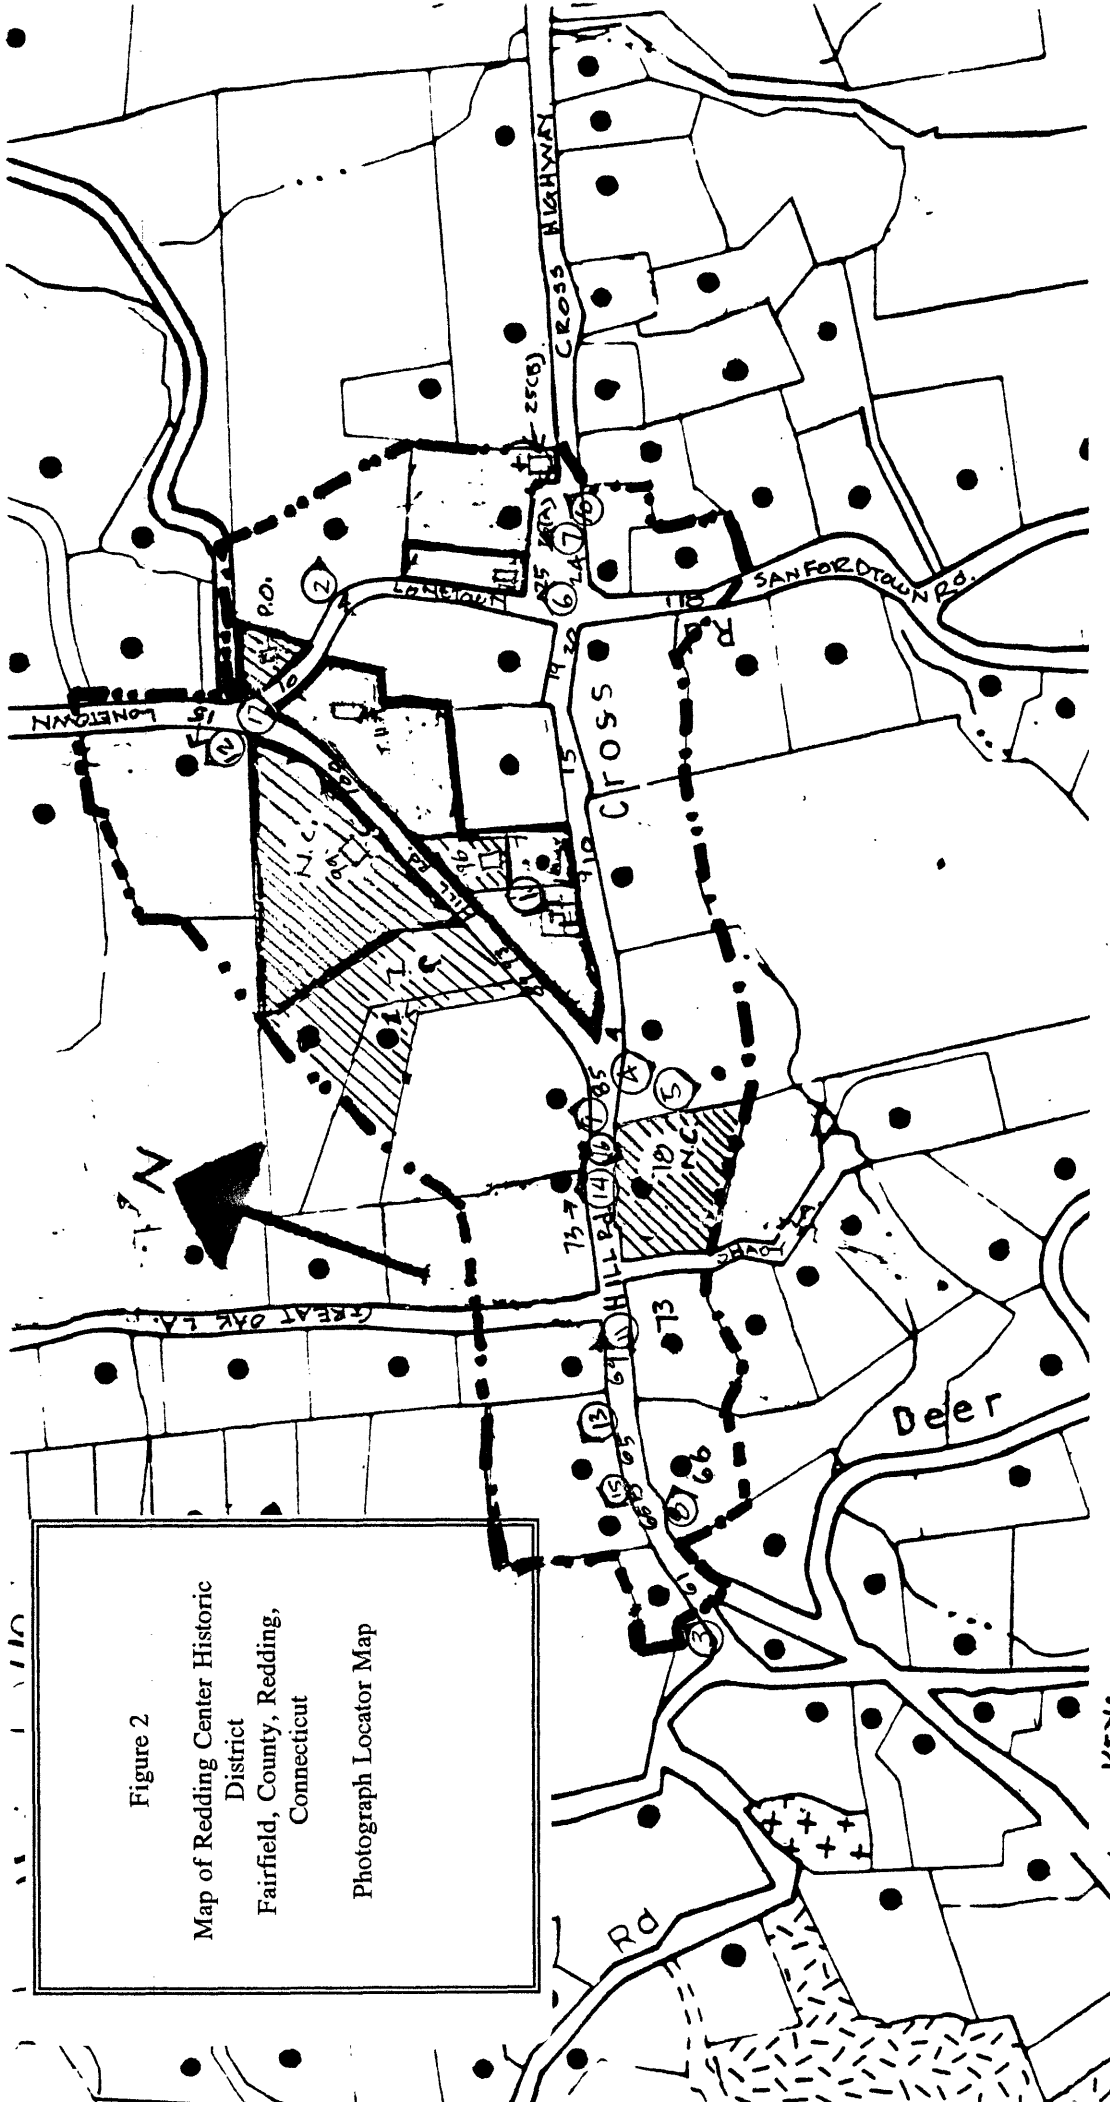
Figure 2
 Map of Redding Center Historic District
 Fairfield, County, Redding,
 Connecticut
 Photograph Locator Map

- DISTRICT BOUNDARY
- 65 = STREET ADDRESS
- N.C. = NON-CONTRIBUTING PROPERTY
- = PROPERTY w/ BUILDING IN 65
- ③ = PHOTOGRAPH

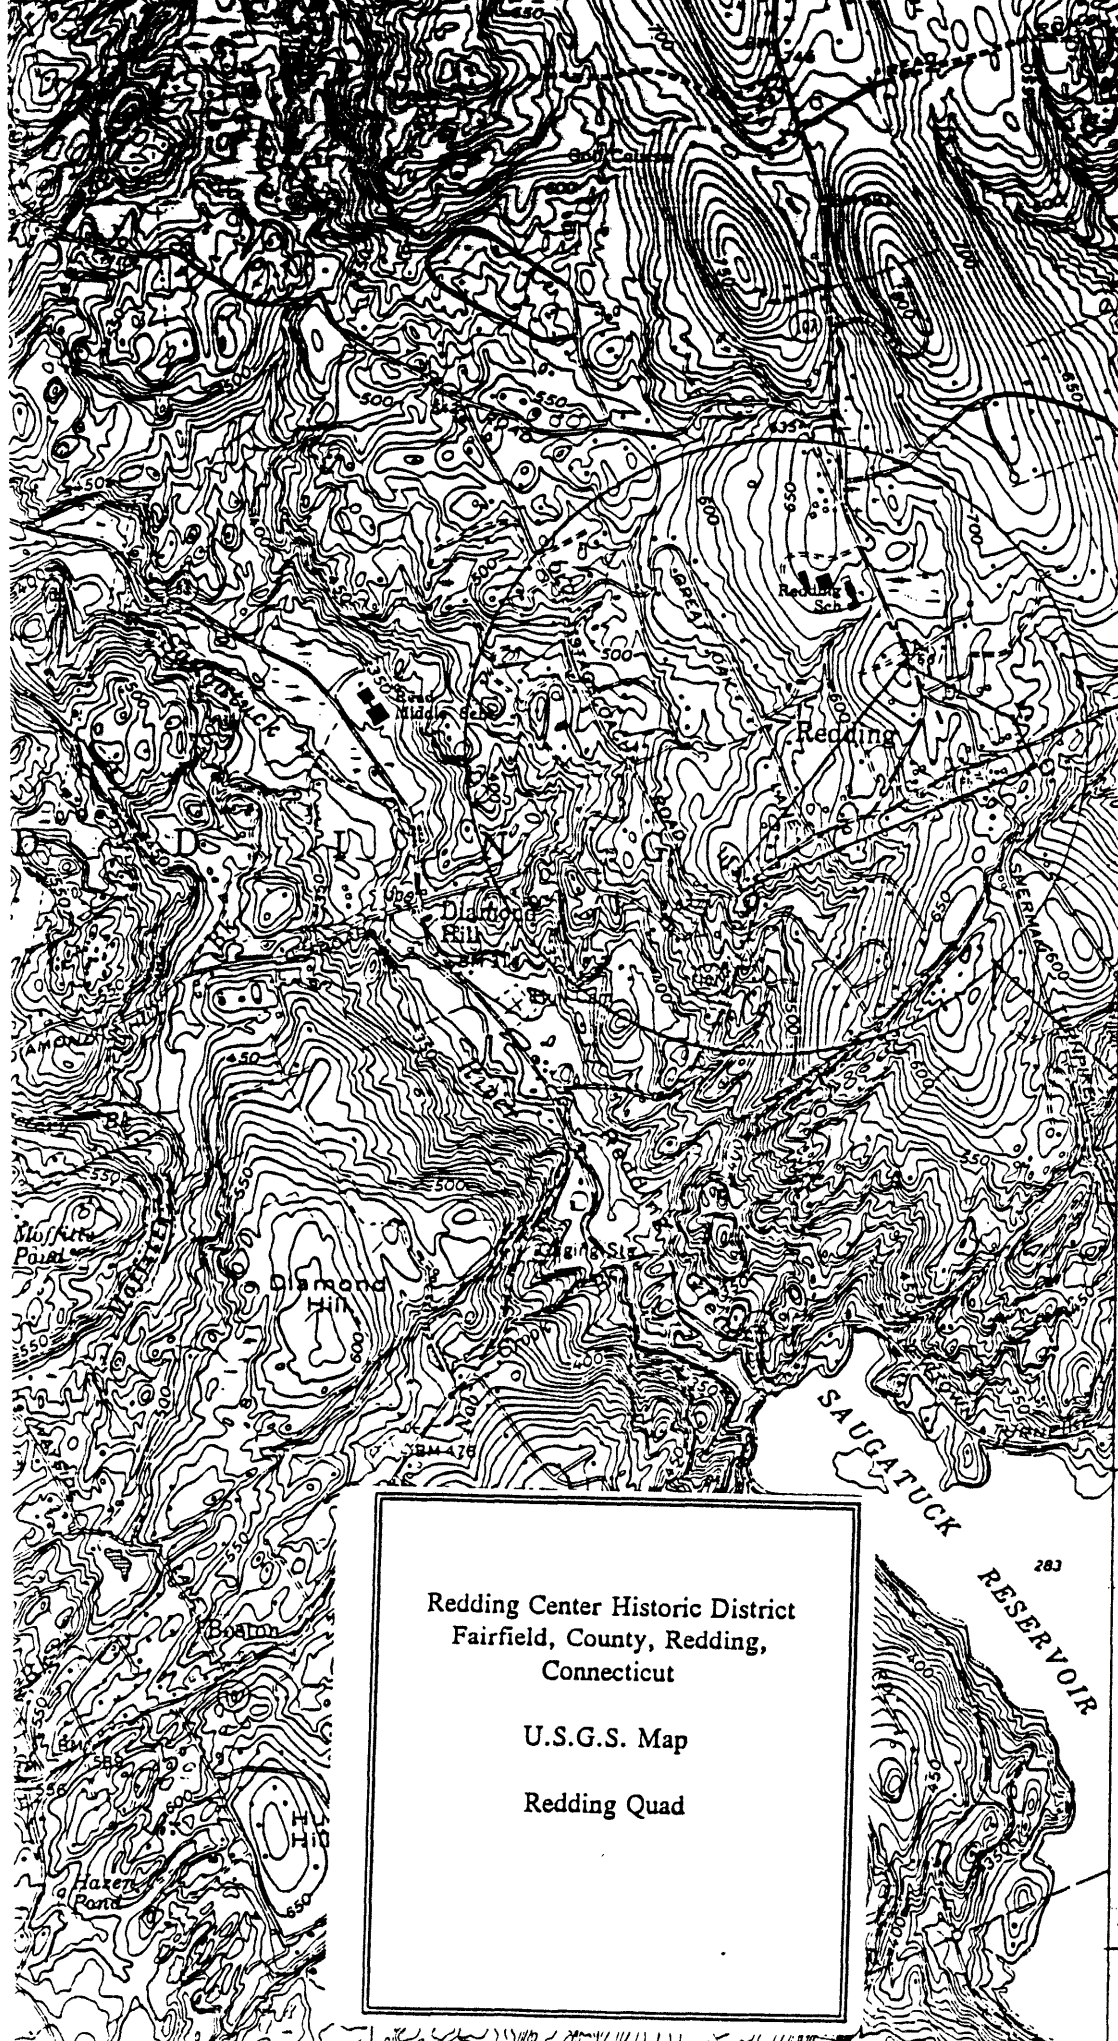
Redding Center Historic District
 Fairfield, County, Redding,
 Connecticut
 U.S.G.S. Map
 Redding Quad

REDDING CENTER H. D.
 UTM CO-ORDINATES
 A 18635500 184573880
 B. 18635820 184573710
 17'30" C. 18635900 184573570
 D. 18635000 184573170
 E. 18634990 18453240
