**National Register of Historic Places
Registration Form**

historic name Lindstrom, John, Round Barn
other names/site number

Lindstrom, John, Round Barn
Town of Balsam Lake, Polk County, WI

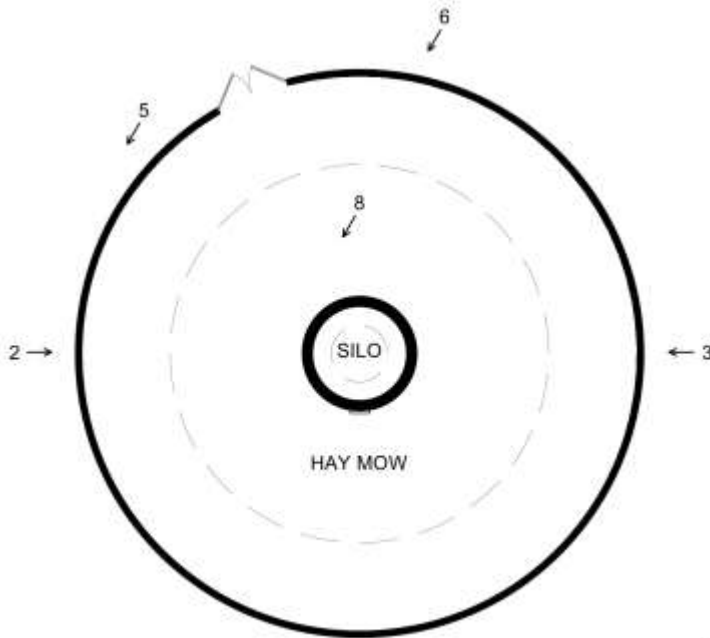
SECOND LEVEL PLAN

The hay mow second level is a large open space intended to hold and store hay and feed. The floor is constructed from the form boards used to build the concrete silo and foundation, nailed down on the floor structure below. The walls are the exposed wood frame of the second level with the back side of the vertical wood boards seen on the exterior. The walls are reinforced and braced with v-shaped

members parallel to the curving wall for lateral stability. There is a single, large barn door and a couple of rough cut, hinged openings in the hay mow space, but no windows. The central silo sits in the center and rises up to near the peak of the roof with the cupola resting at the very top. The roof structure is a series of rafters resting at a low point on the top of the exterior frame walls and at a high point on the upper wood frame walls of the silo. The rafters rest at only a few inches on center on the high silo end and approximately three feet on center at the low exterior wall. Large Red Elm horizontal boards span two rafters at a time, spiraling up in a continuous line on the rafters. This unusual construction serves as the roof decking for the various shingle types above. A set of six pulleys, spaced equally, hang from the roof at its hip to assist in the moving of hay bales around the interior along a non-extant circular track.

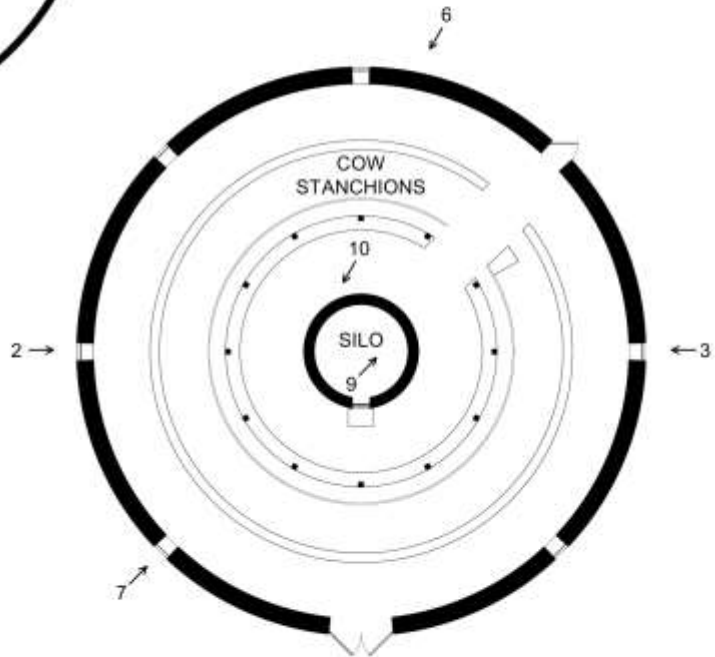
FIRST LEVEL PLAN

Cow milking and feeding stanchions occupied the first floor of the Lindstrom Round Barn, currently used for storage and recreation. The floor is bare concrete cast in place to allow for curbs, troughs, and drains, and the floor plan is arranged in concentric rings based on use in the feeding of cows. Along the perimeter, adjacent to the bare fieldstone exterior wall on the interior, are between fifteen and twenty cow stanchions all the way around the central silo. There is a narrow walkway to provide access to the central silo and equipment. The stanchions are arranged so that cows face inward for milking and feeding with their backs to the windows. A gutter runs along the entire circumference of the barn in the floor directly below the stalls. A manger is the next concentric ring for feeding and holding hay followed by a feed alley adjacent to the silo. Much of the original equipment still exists. The width of this working ring of space is approximately twenty-two feet. The ceiling is the exposed wood structure, mostly 2x dimensional lumber, of the hay mow floor above. This floor structure is arranged with members radiating out from the central silo. There is one circular row of rough-hewn timber columns, near the mid-point of the span, to support and transition the joists from silo to the exterior wall. These joists are roughly one foot on center bearing on the silo masonry wall, and two feet on center bearing on the exterior wall. Some of these joists have been replaced since construction, and the concrete floor is cracking and heaving in a number of locations. The current owner has begun the process of repairing much of the interior on the lower level.

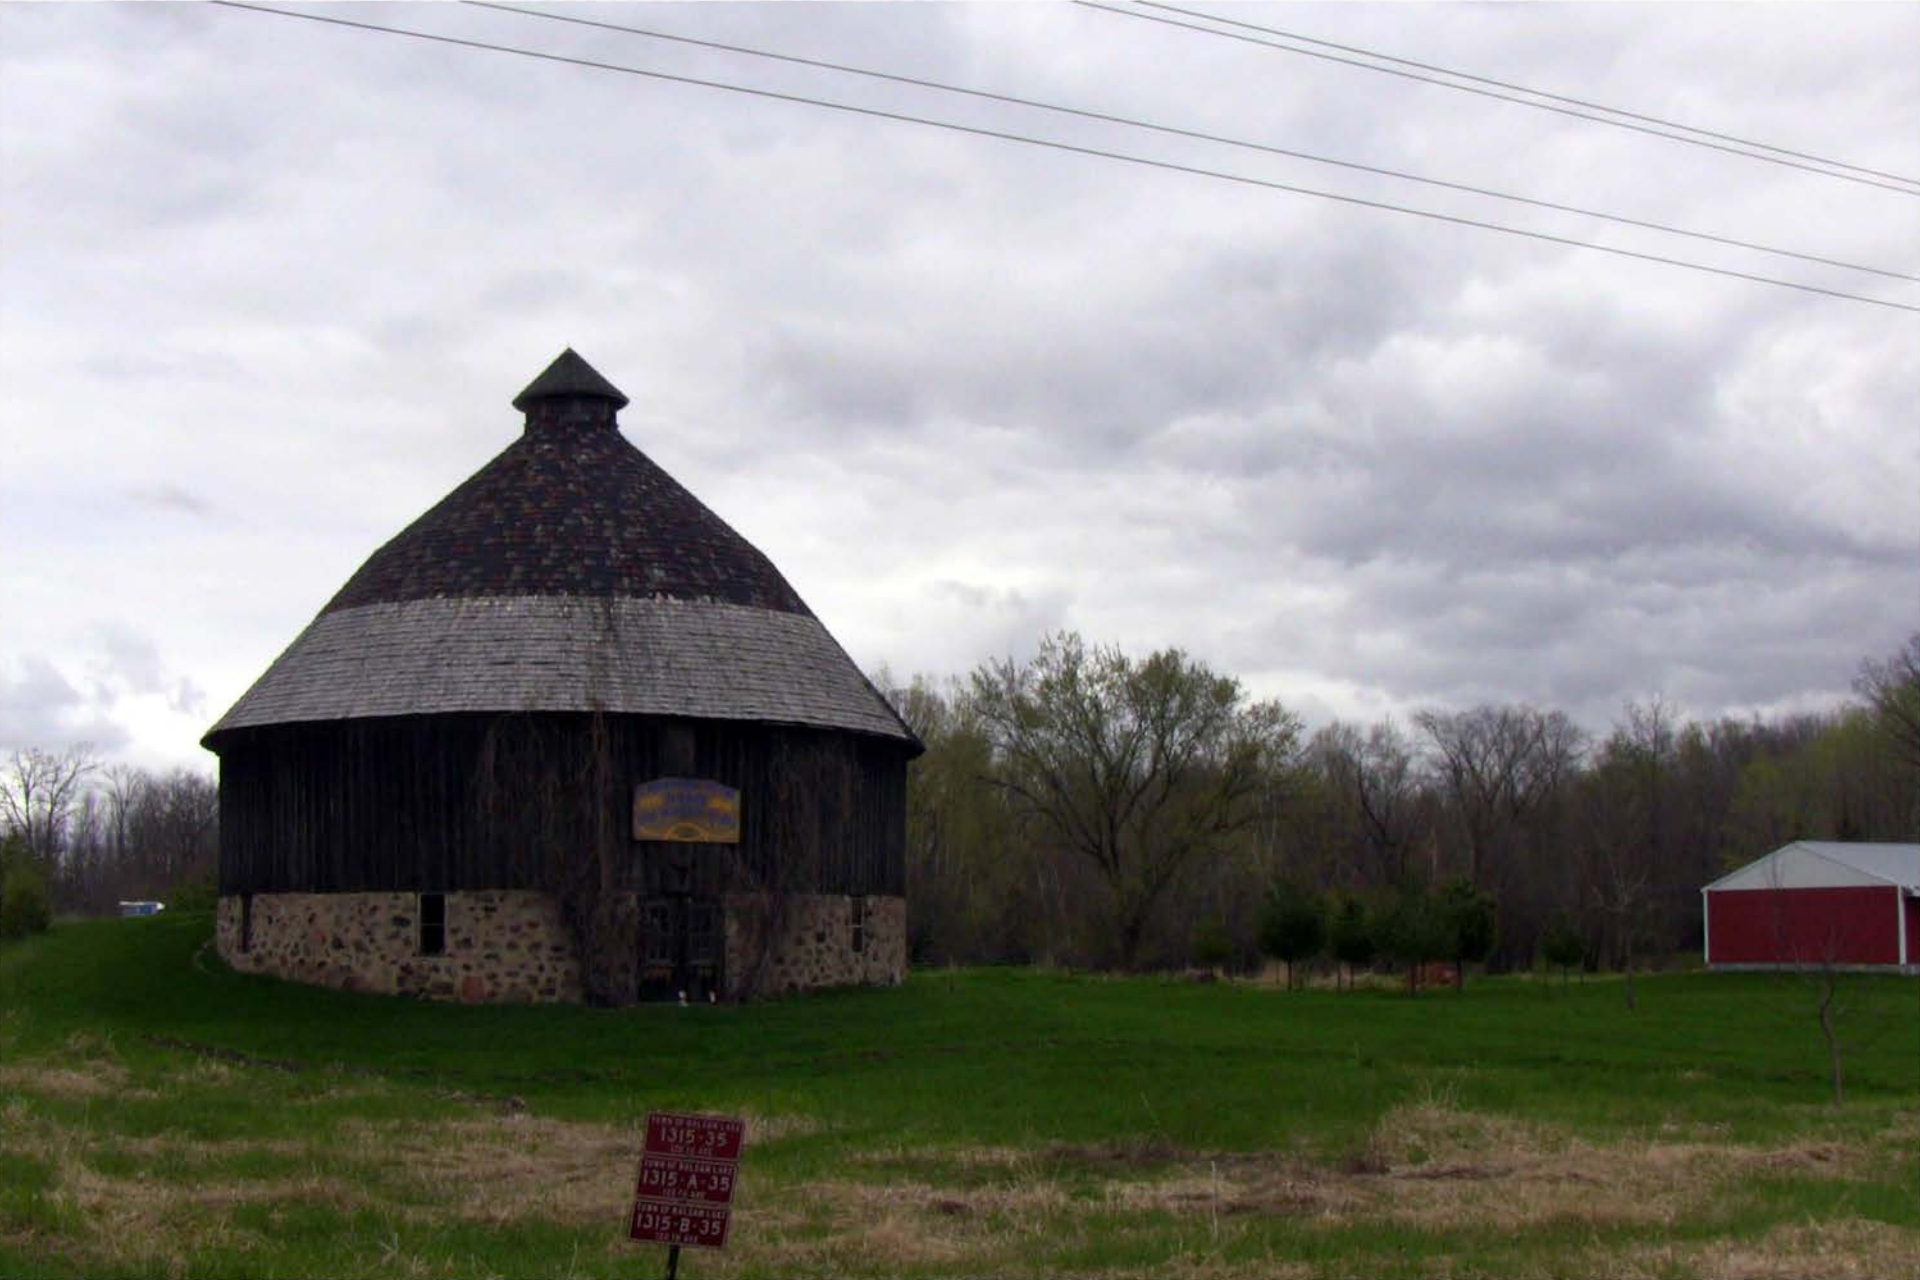
Photo #1 (WI_PolkCounty_JohnLindstromRoundBarn_0001)
Exterior, southwest façade

As a truly round structure the barn does not have clearly defined façades. The south side of the barn, facing 120th Avenue, consists of a clearly identifiable lower level with a fieldstone wall measuring roughly eight feet in height and extending around both sides of the barn. Above this section of wall is a timber frame structure resting on a timber plate along the curved stone wall. This entire wall section, also wrapping around the barn, is sheathed in vertical wood siding. The siding is unpainted and untreated and left completely bare to the elements. The wood siding consists of sawn lumber and varies in length and width. Many of the boards stretch the entire sixteen foot height of the vertical wall while others are much shorter, perhaps due to accumulated repairs during the life of the building. The boards appear to be 2x dimensional lumber, but some are 6 inches in width, while others are roughly 8 inches in width. All the boards are nailed directly to the wood structure underneath. The weathered gray appearance of this vertical wood siding contributes to rustic appearance of the round barn. The

lower level has a double hinged door facing due south. The two doors have been recently added and have large fixed windows in each; these windows are set in original sashes. Likewise, the pair is set in an older opening with the original frame intact, implying that the size of this lower level opening has been unchanged. The door is flanked on either side by a window, approximately twelve feet away to the east and west. These fixed windows, typical of those around the lower level of the Lindstrom Barn, are two feet in width and four-and-a-half feet in height with two equal sashes. There are a total of six of them at the lower level of the barn; along with two doors, these eight openings face in the cardinal directions and at forty-five degree angles to them. Some elements of the windows and frame have been replaced and repaired. The wood frame structure above acts as the header for all the windows and doors. There is a large sign, directly over the south-facing door, which is painted in blue and yellow to read: "The Lindstrom Round Barn, 1913-2013, One Hundred Years". The wood frame wall terminates with a wood plate for the attachment of the roof above, with radiating rafters that extend to an open eave and narrow fascia.

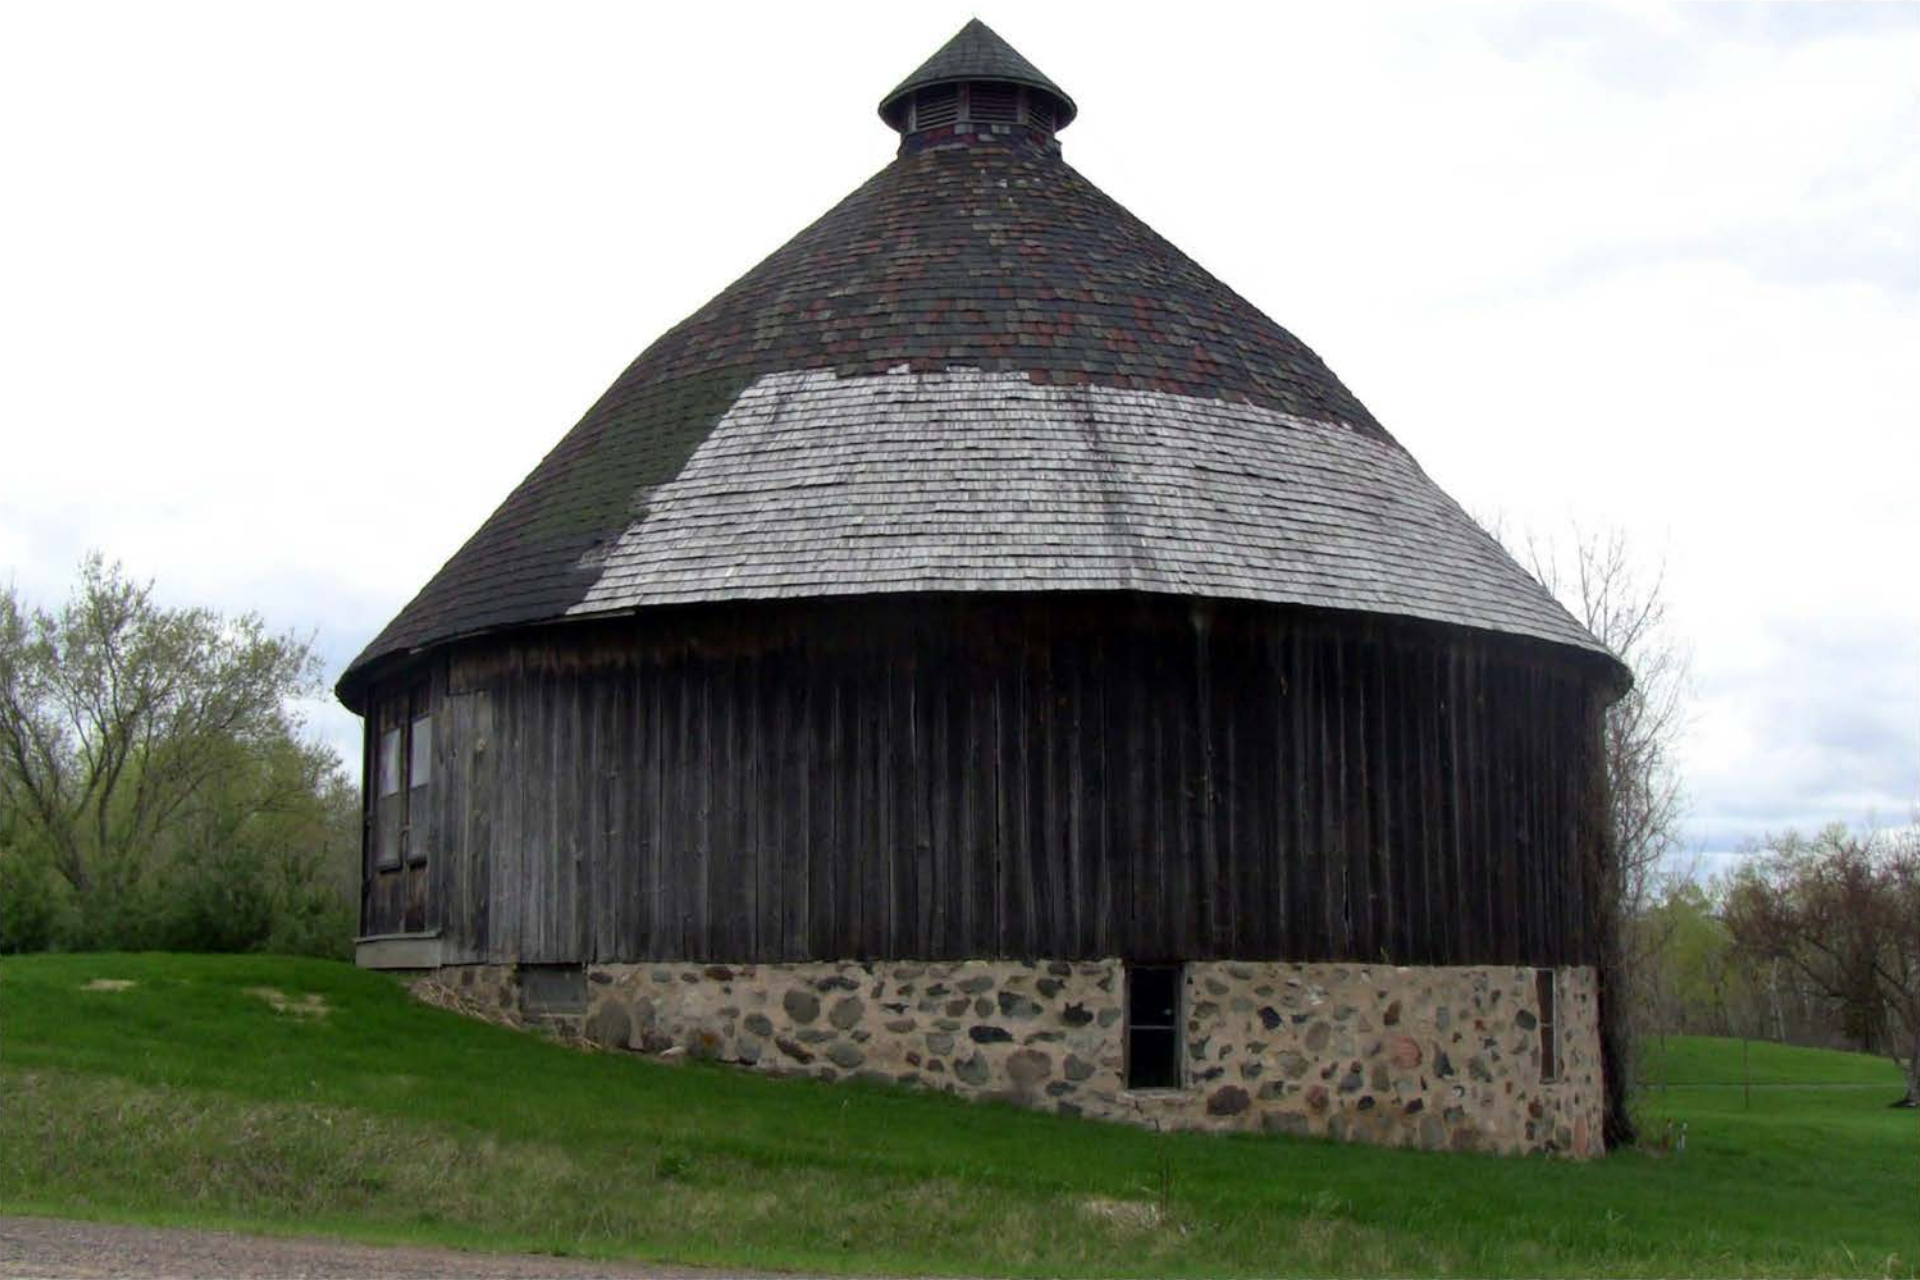
Photo #2 (WI_PolkCounty_JohnLindstromRoundBarn_0002)
Exterior, west façade

The western façade of the round barn is an extension of the design and materials present on the south side of the barn. The lower level consists of the fieldstone wall; however, in this location the grade slopes sharply to the north, covering much of the lower wall at an angle and rising from eight feet in height at the southern face of the barn to nothing at the far north end. This slope means that the third window visible to the northern end of the western façade is significantly smaller than the others. Approximately two-and-one-half feet in width and one-and-one-half feet in height, this fixed window has only one sash. There are no openings or variation of any kind in the vertical wood siding above.

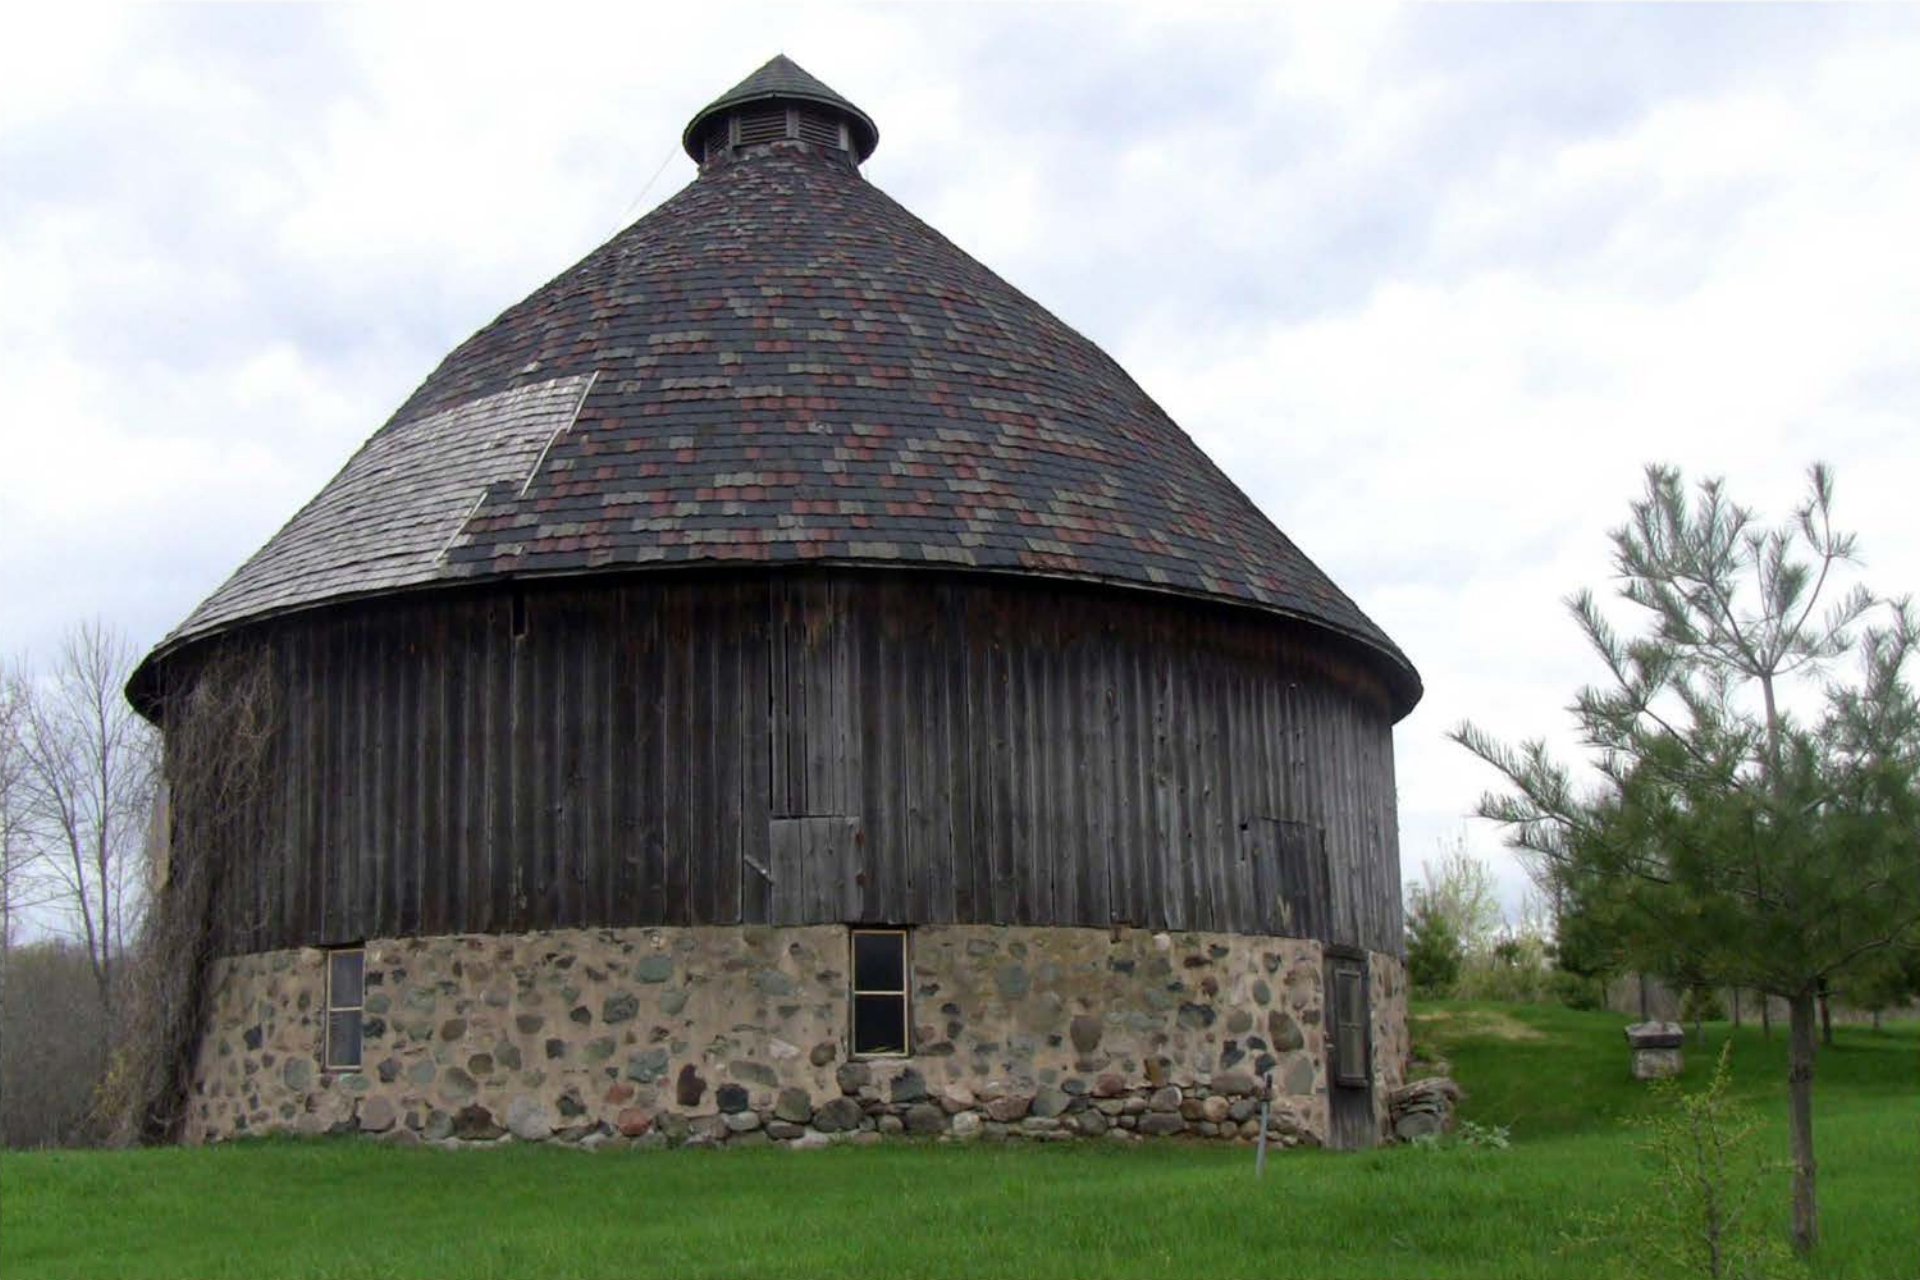
Photo #3 (WI_PolkCounty_JohnLindstromRoundBarn_0003)
Exterior, east façade

The appearance of the eastern façade of the Lindstrom Barn is in keeping with the other sides of the building. The lower level consists of the thick fieldstone wall set on a concrete foundation. Along the northeastern section, the grade has receded significantly revealing more of the stone wall and causing some crumbling due to the lack of mortar in this location that would otherwise be buried. Like the other façades, three openings face the east on the round barn. The first of these, towards the north, is a three feet wide by eight feet high single door to the lower level. Like the other doors on the barn exterior, this one is relatively new, though the frame is original. Two more windows spaced equally apart and facing due east and southeast, match the other fixed windows along the lower level of the barn. Above the lower level, the exterior wall continues with the wood frame structure above clad in vertical, unfinished wood boards. Unlike elsewhere on the barn, the boards on the eastern façade have more variation in size and width indicating that more repairs and alterations have been made at this location. Perhaps this is explained by the presence of two crude openings, sawn directly in the board siding with hinges added. These openings lead to the hay mow above and might have been used for machinery access.

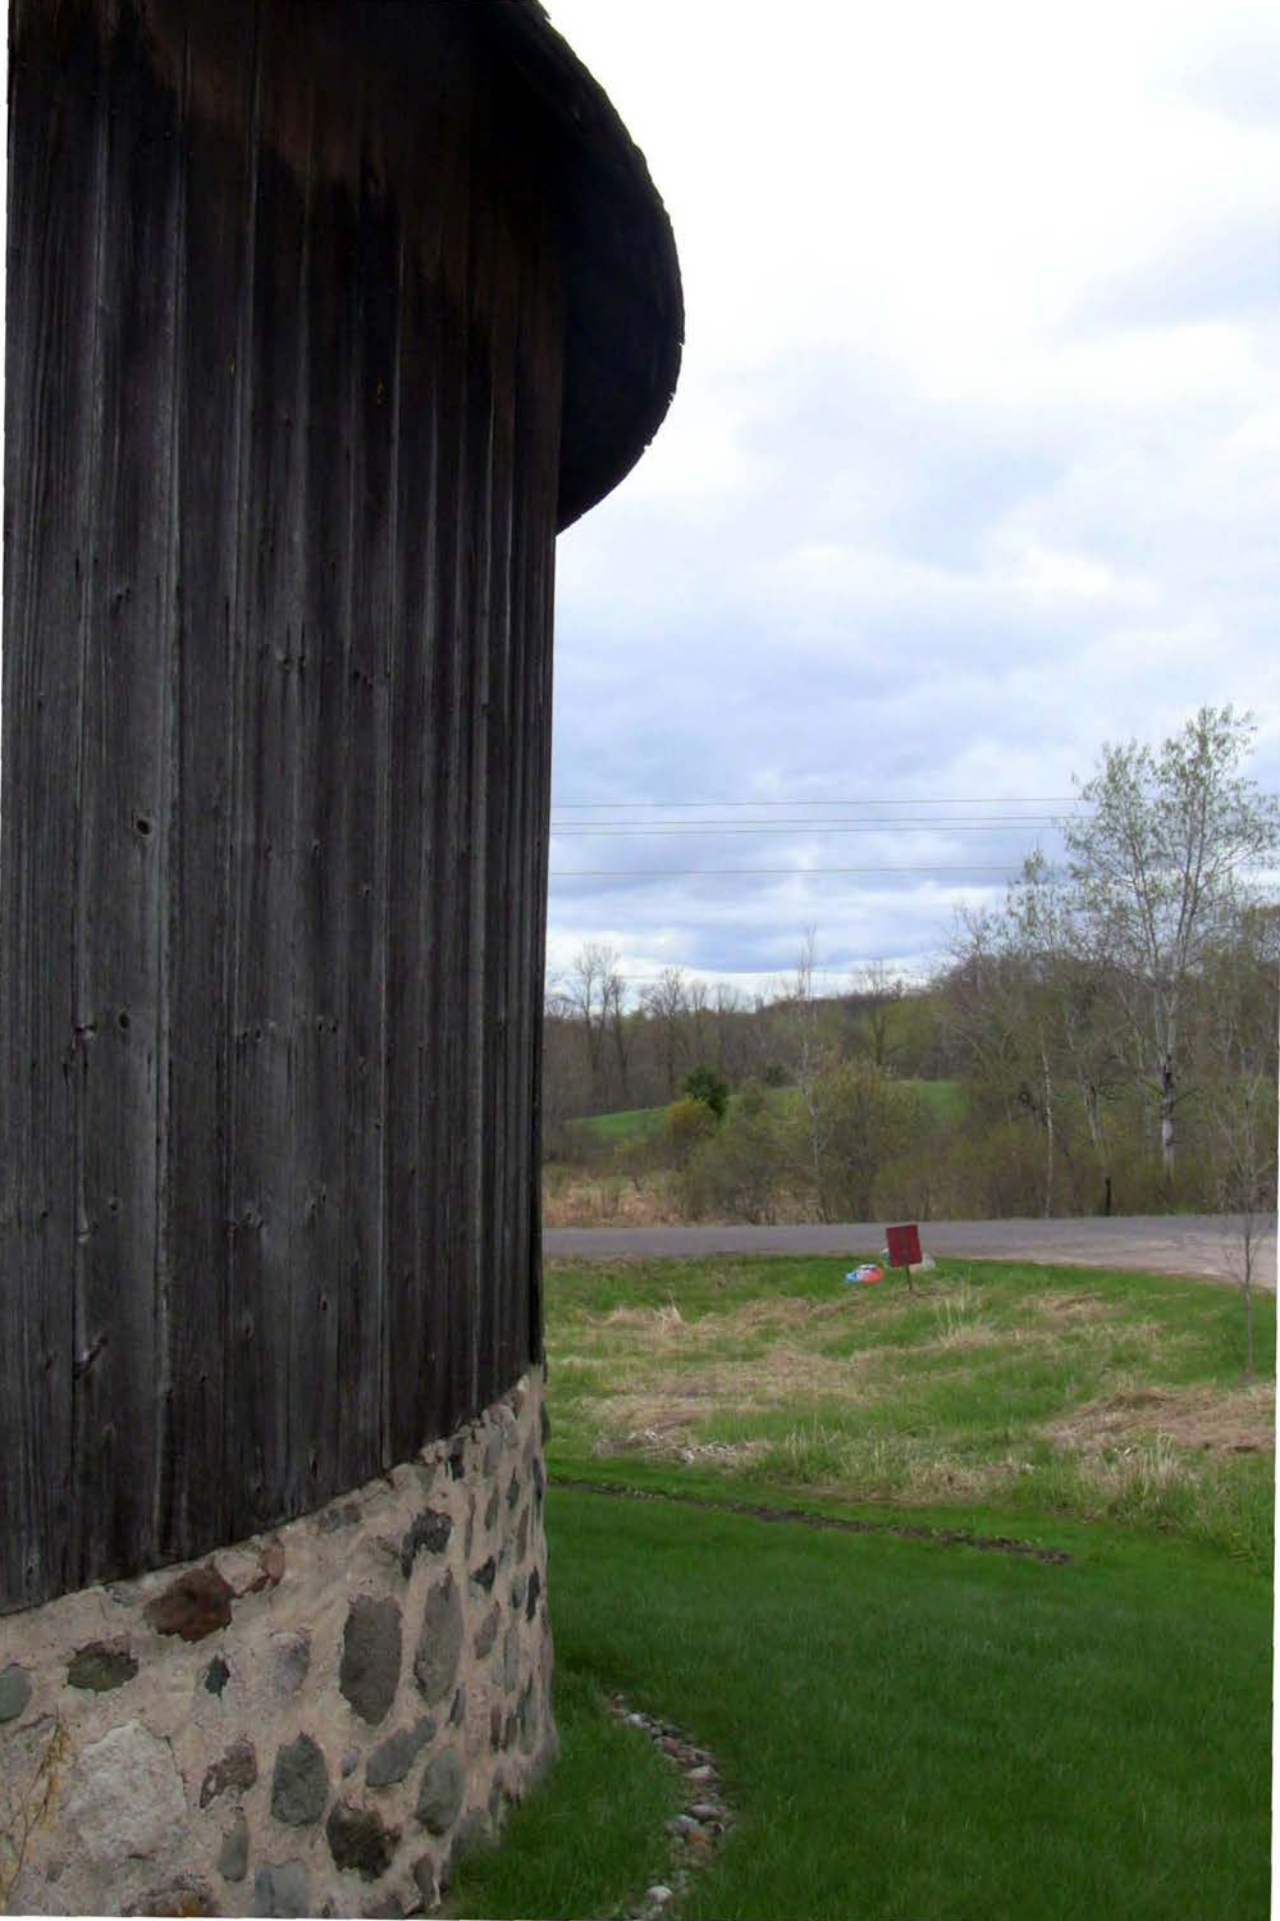
Photo #5 (WI_PolkCounty_JohnLindstromRoundBarn_0005)
Exterior, wall detail, northwest façade

The barn sits on a rubble fieldstone foundation and is built into a slope gently rising to the northwest. This configuration, often referred to as a “bank barn” is a common design element of dairy and other livestock barns and is designed to permit direct access to both floors from the exterior. The lower walls of the Lindstrom Barn are constructed of rough, uncut fieldstone. The stone varies considerably in size and some are crumbling and separating, though this condition is not extensive. The lower walls are roughly twenty inches thick and extend up the entire eight-foot height of the lower level. Grade level has subsequently lowered in many areas since the barn was constructed, exposing even more of the fieldstone foundation. This is especially the case near the sloping toward the northern and western sides of the barn. This settling has exposed the location where the concrete slab floor meets the lower foundation fieldstone walls. The use of fieldstone in the foundation and lower portions of vernacular round barns in Wisconsin is common; however, it is worth noting that almost all the round barns in the western and northern regions of the state that utilize such building methods are mortared with concrete.

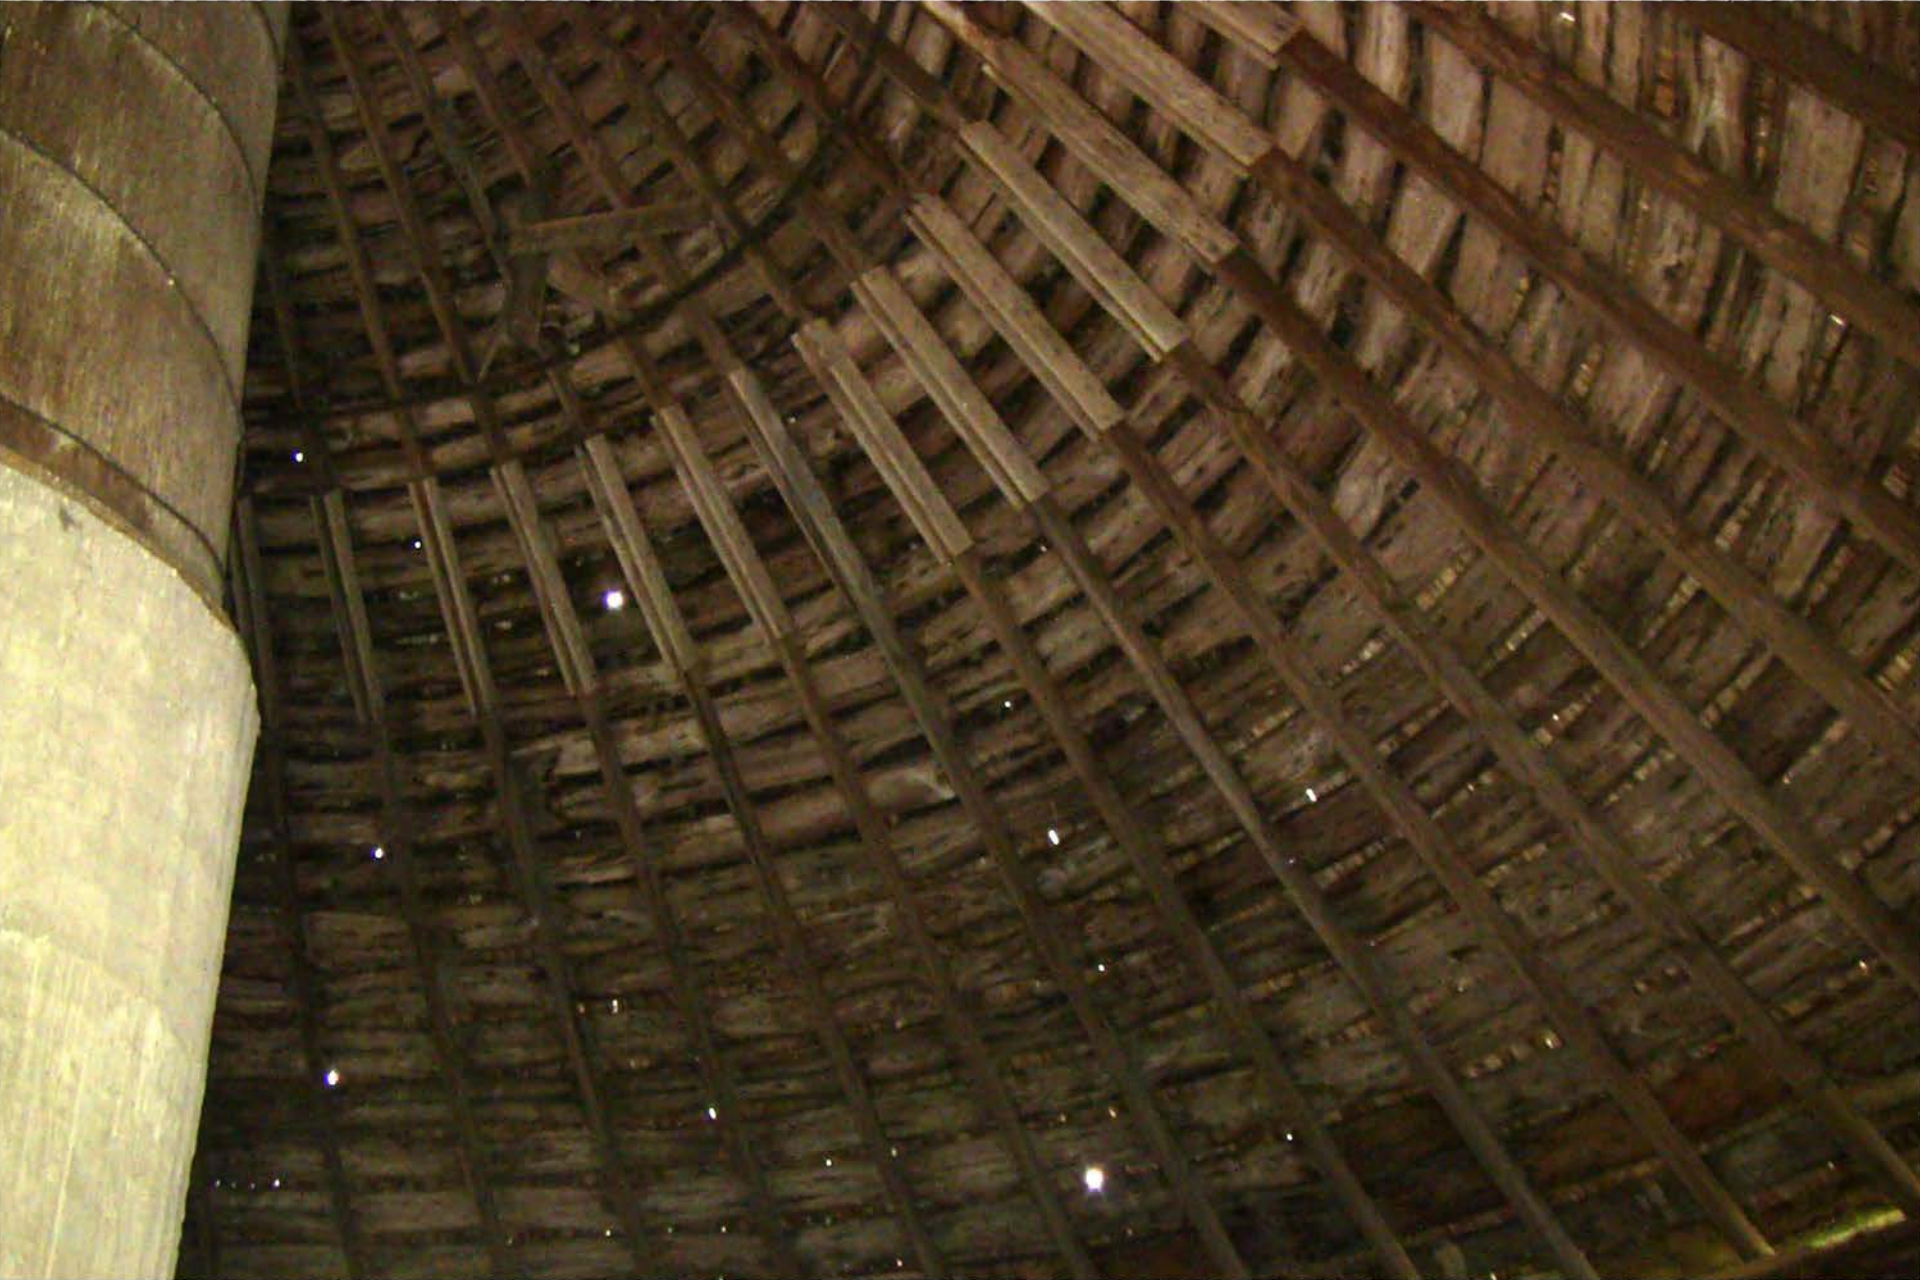
Photo #8 (WI_PolkCounty_JohnLindstromRoundBarn_0008)
Interior, hay mow roof and silo, facing southwest

The roof of the Lindstrom Barn sits on a double top plate that extends around the entire circumference of the round barn. Rafters, arranged in a radial pattern from the center, are simply extended and exposed with a narrow fascia board. The roof initially slopes sharply, and then adjusts in a slight gambrel shape to a lower pitch at two-thirds of its total twenty-foot height. The overall effect is conical in shape and is more tall and narrow than the roofs commonly seen on round barns in Wisconsin. The roof is currently sheathed in three different materials. Toward the top of the roof and on all sides is an old, multi-colored, diamond-shaped asphalt shingle roof. This material was likely installed in 1947 according to the present owner. A subsequent layer of asphalt shingles covers much of the lower portion of the roof on the north half of the building; a layer of cedar shake shingles, added recently by the present owner, covers the lower portion on the south side of the barn. The roof terminates in the high center point, where a large, four-foot high cupola sits directly above the central interior silo. The cupola has eight equal sides, each one with a louvered panel for ventilation, and is capped with a conical round roof matching the rest of the round barn's roof construction and materials.

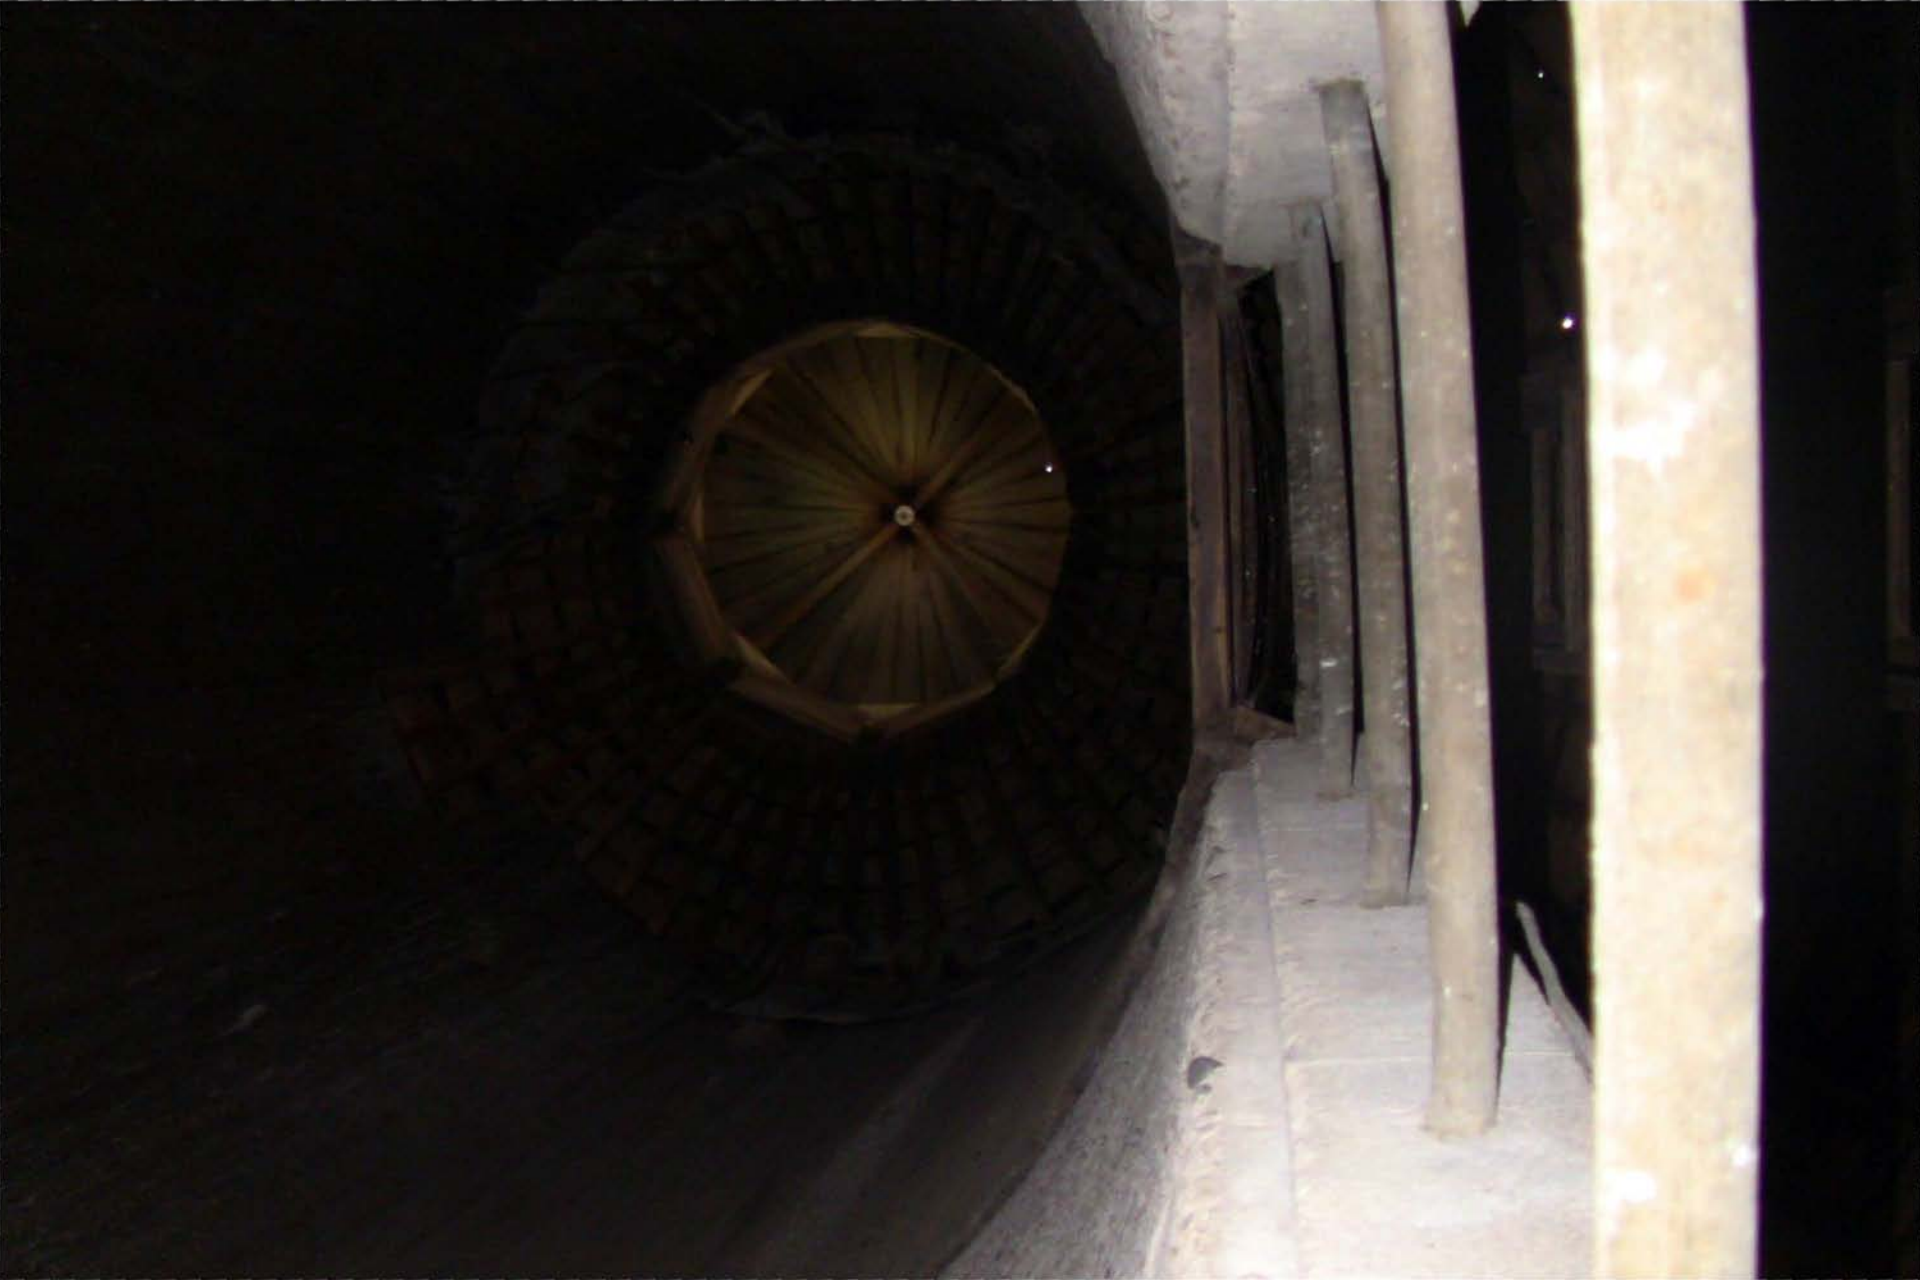
Photo #9 (WI_PolkCounty_JohnLindstromRoundBarn_0009)
Interior, silo, facing up

The silo in the center of the barn is completely hidden from view from the exterior and is constructed in a similar way to the round barn itself. A twelve-foot diameter concrete base extends down below grade approximately ten feet and above grade roughly twenty feet. At the top of the concrete base, about twelve feet off the floor of the hay mow, a wood frame structure rests on the concrete and extends the rest of the way up to the underside of the peak of the roof. The silo sits directly in the center of the round barn. Occasional openings are punctured in the masonry silo to permit access and ventilation at the top and bottom. A series of metal ladder rungs are imbedded along one long slit opening facing south to create a continuous integral ladder for the silo. The silo extends vertically and serves as the bearing wall for beams of the hay mow floor and rafters of the barn roof. The roof of the

silos are constructed of radial wood lumber with an opening in the central high point directly under the roof cupola. The date: "Sept. 21, 1913" is set in the concrete of the silo in the lower level; however, the date: "1918" is also written on the silo in the upper level. While it is common for the silos of centric barns to be constructed first and the barn built around them, the reverse, where the barn is built and then the silo subsequently, is unheard of and would likely be difficult. It is possible that the 1913 date set in the concrete applies to the silo and the 1918 date applies to the barn or possibly the roof was raised or the silo rebuilt or repaired, though these scenarios cannot be confirmed. The 1913 date for the Lindstrom Round Barn's construction, assumed in other documents, is given for this reason. To add to the confusion, the name: "R.L. Lindstrom" appears on the concrete of the silo in the lower level and the initials: "R.L." are painted in multiple locations on original materials in the upper level hay mow. Polk County records clearly indicate that the owner of the property during the 1900s, 1910s, and 1920s was John Lindstrom.³ One hypothesis could be that R.L. Lindstrom was the builder and a relative of John Lindstrom.
