National Register of Historic Places Registration Form

historic name Monte Vista and Diamond Mountain Vineyard

street & number 2121 Diamond Mountain Road

city or town Calistoga

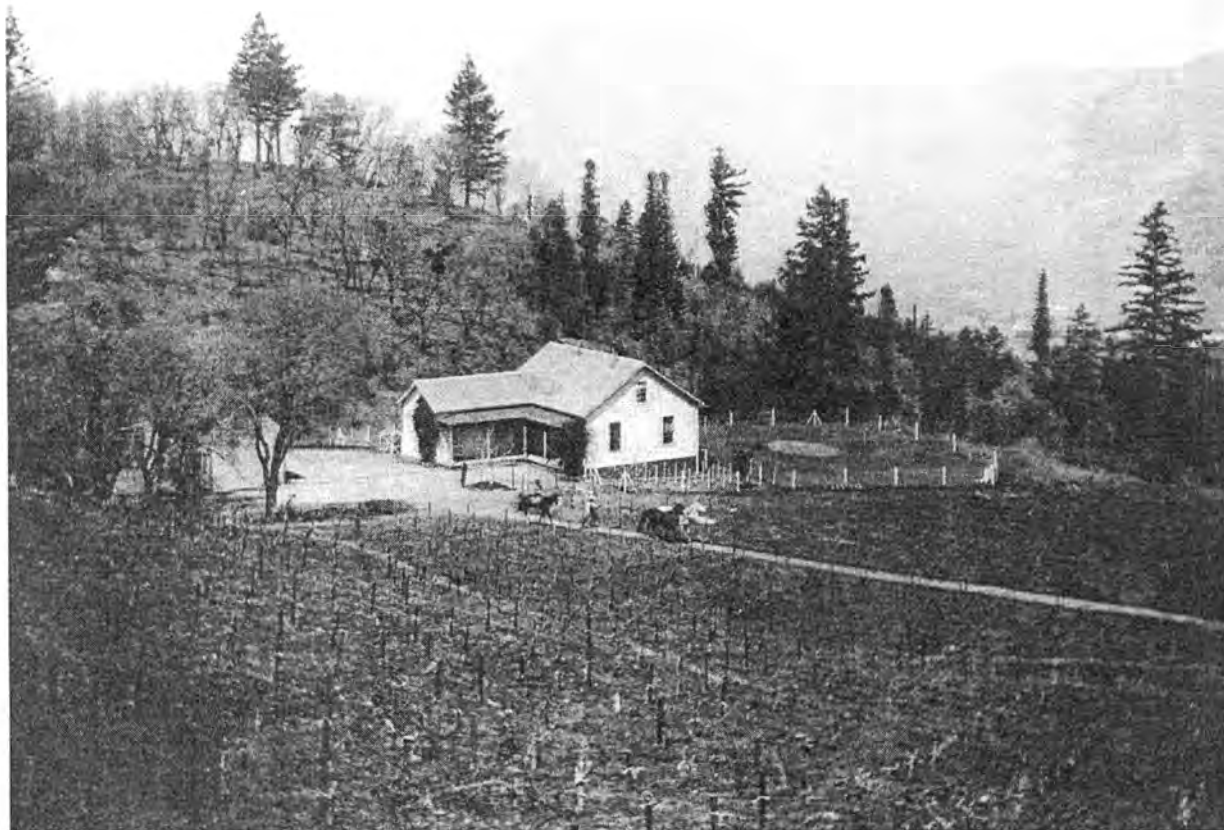
Figure 1. View of farmhouse and carriage house from vineyard looking northwest. (c. 1908)

This one-and-one-half-story, vernacular farmhouse, built in 1896, is L-shaped in plan. The house was constructed in two periods. The main block, being square in plan, was built first and with a one-story addition off the west elevation constructed a few years later to accommodate the growing family. The wood-frame building with horizontal wood shiplap siding stands on a raised foundation and has a metal-clad, gable roof. A brick chimney protrudes from the roof of the main block, just west of the ridge. The primary window type is wood-sash, two-over-two, double-hung with a similar six-over-six window at the attic level and fixed six-lite windows at the enclosed porch. An open porch wraps from the south elevation of the addition along the west elevation of the main block sheltering the four-panel entry door. A full-width porch, on the east elevation, with wood square chamfered supports shelters the rear entrance. The door has a transom and features more detailing than other four-panel doors on the structure. A porch added off the south elevation of the main block has been enclosed. The original foundation, constructed of firewood, has been replaced with concrete piers. Notable features include boxed eave overhangs, an interior brick chimney, and the large porches found on various elevations.

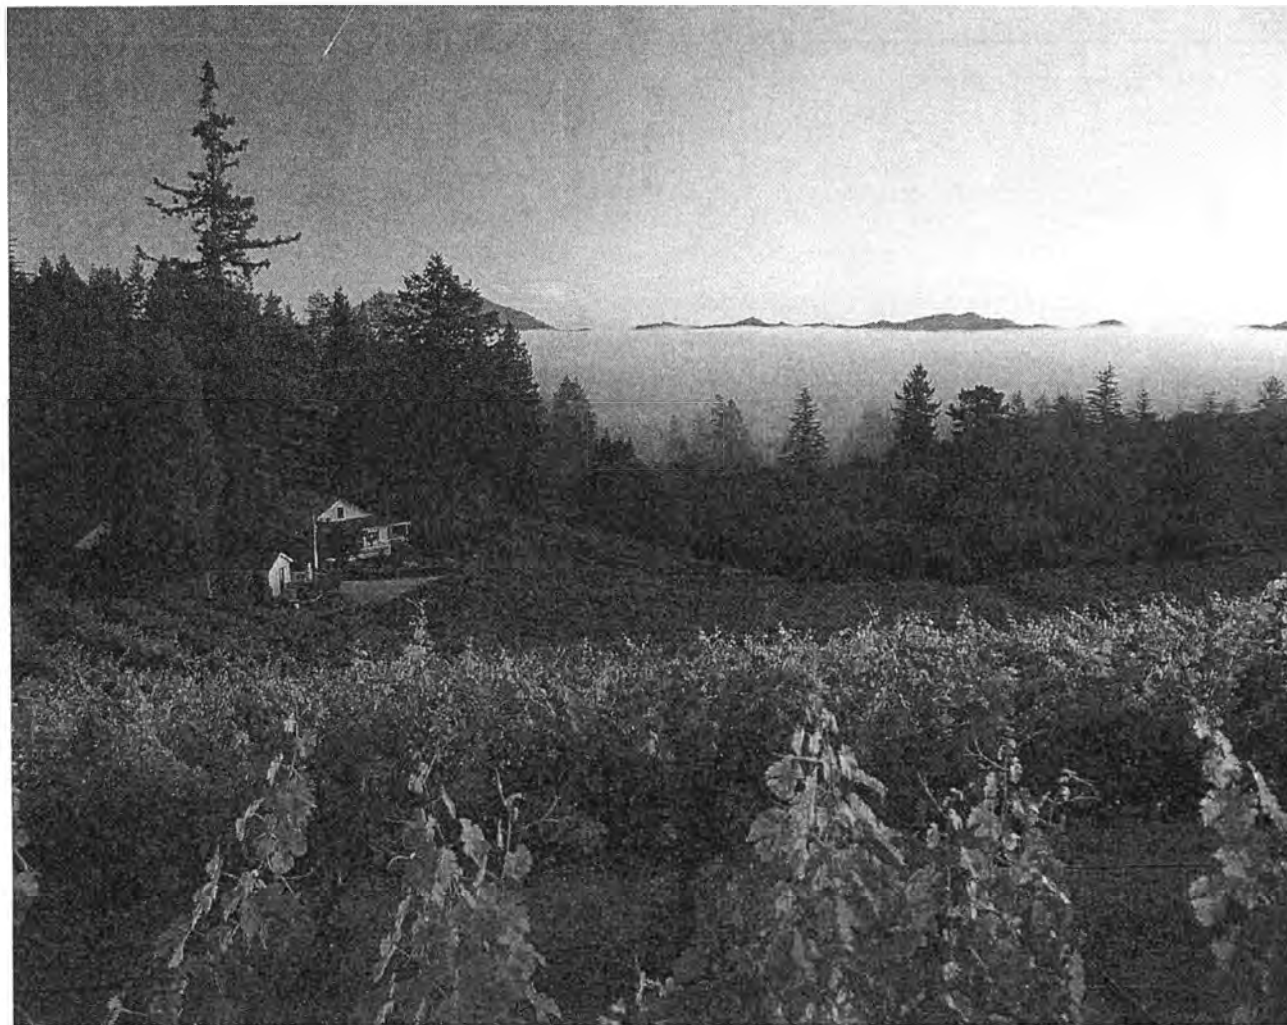
Figure 3. View of complex from vineyard looking northwest. (c. 2003, Fred Constant, photographer)
