National Register of Historic Places
Registration Form

historic name Tucker Home

street & number 110 Escobar St. not for publication

#7 Narrative Description:

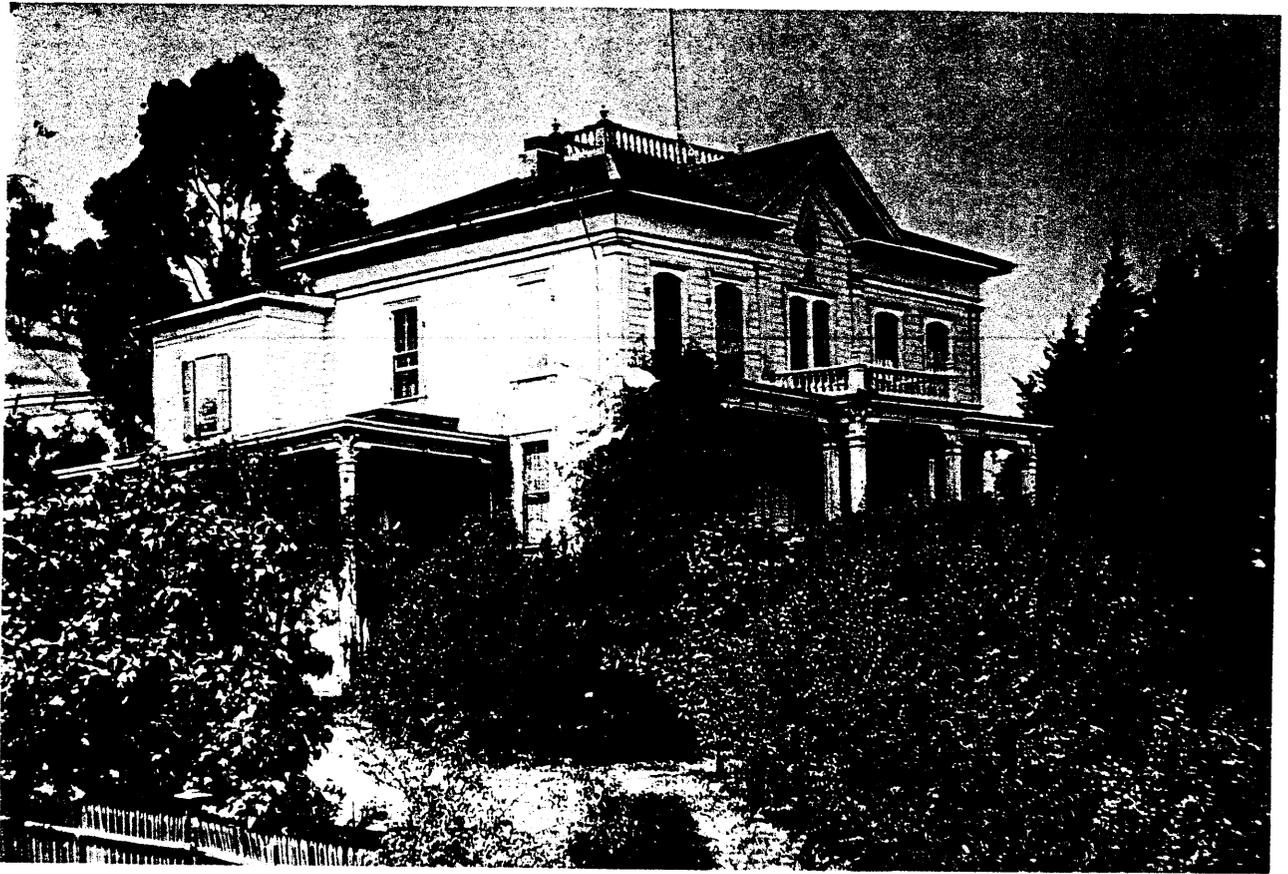
Tucker Home
Carrington, N.C.
Original site - Early 1920's
Photo owned by E. D. ...

The Tucker Home was originally built between lots 3 and 12 on block 15 of Rancho El Pinole between 1870 and 1877 where it faced downtown. Escobar Street was built in 1924 and the hill was subdivided. The house stood in the middle of 2 lots and was far from the street. So it was moved 100 feet down the hill to lot #5 with a team of horses. It was turned 90 degrees to face Escobar Street. At that time the cement foundation was poured, the garages and basement added on, as well as the present kitchen, and servants quarters added onto the 2nd and 3rd stories of the house. It is believed that this was the point at which the railing to the widow's walk was lost.

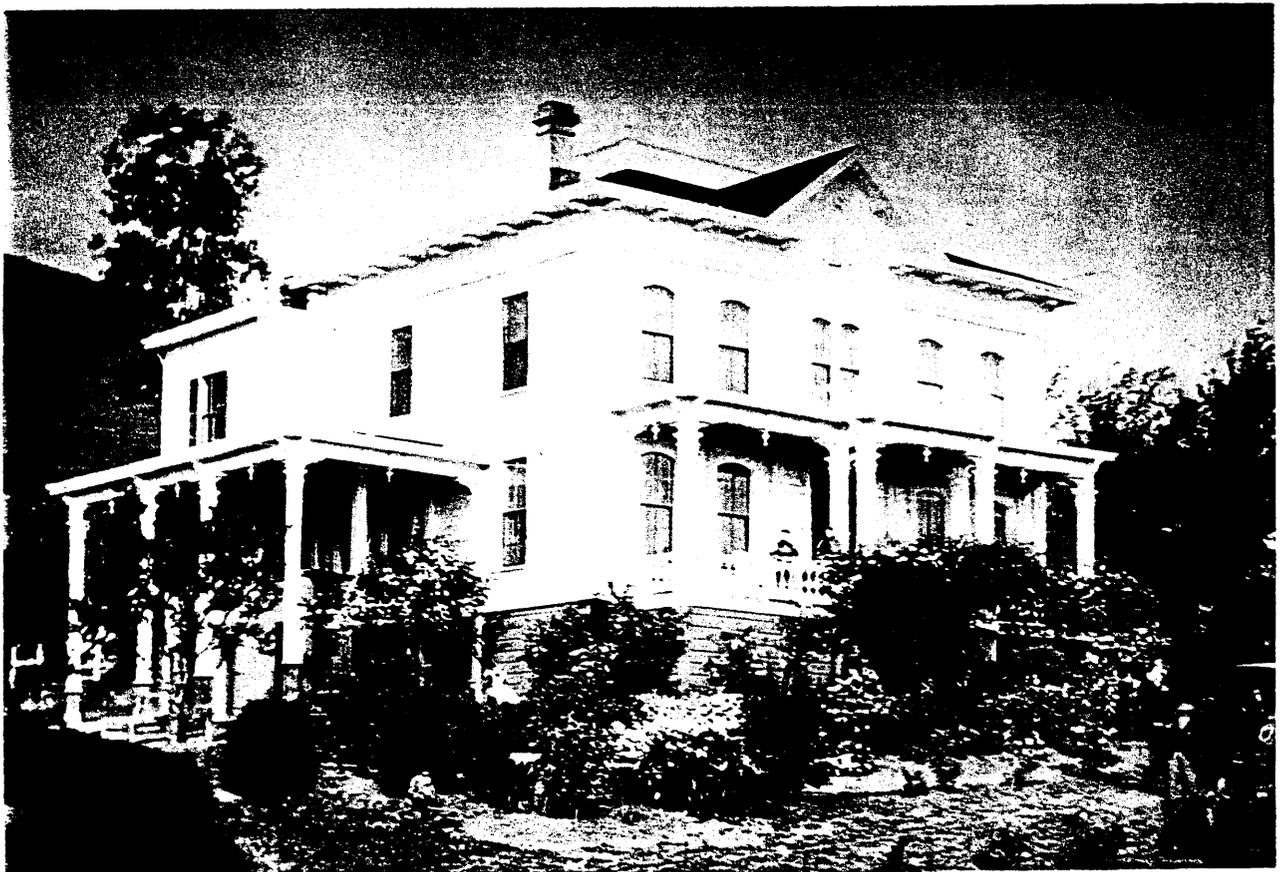
Tucker Home
Carrington, N.C.
Original site - Late 1800's
