National Register of Historic Places Registration Form

historic name Acacia Mutual Life Company Building

other names / site number Federal Home Loan Bank Board Building (preferred)

street & number 320 First Street, NW not for publication

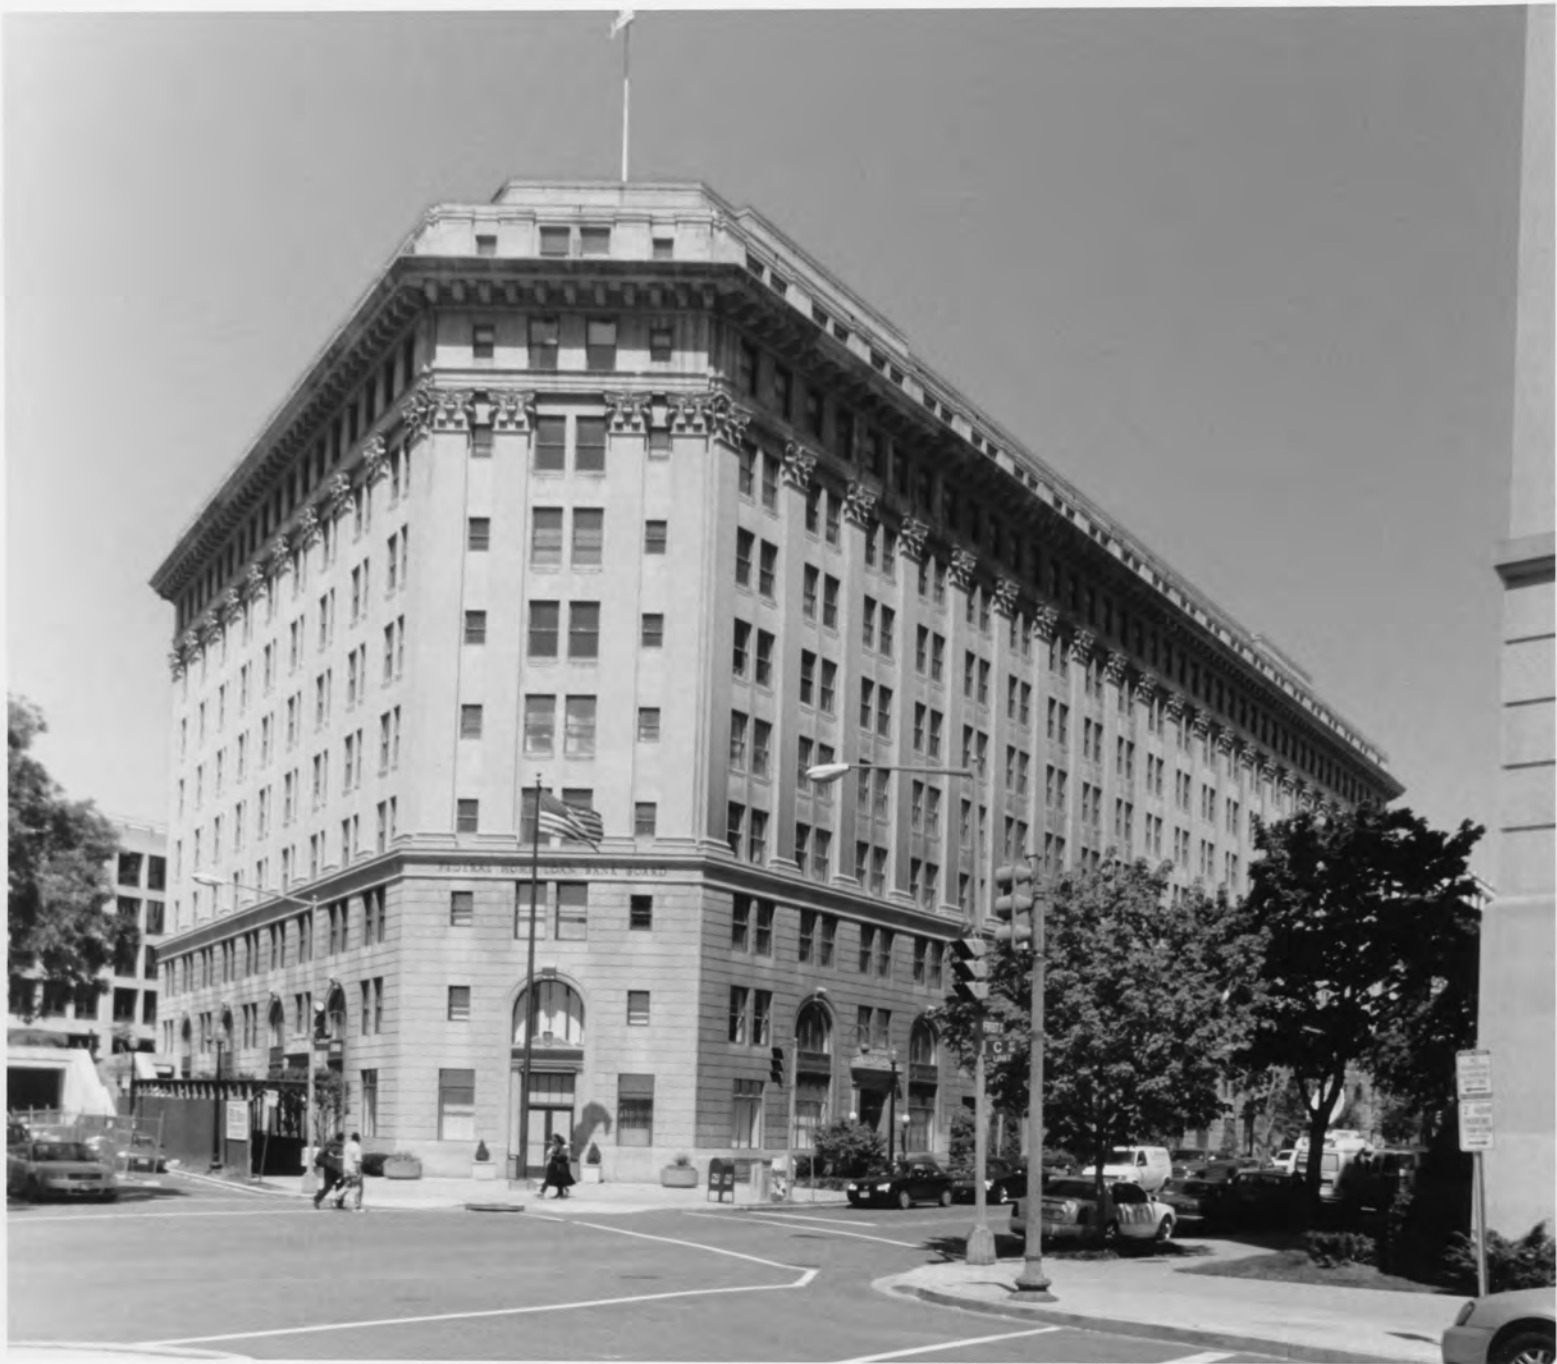
DC007522-1

View looking Northwest

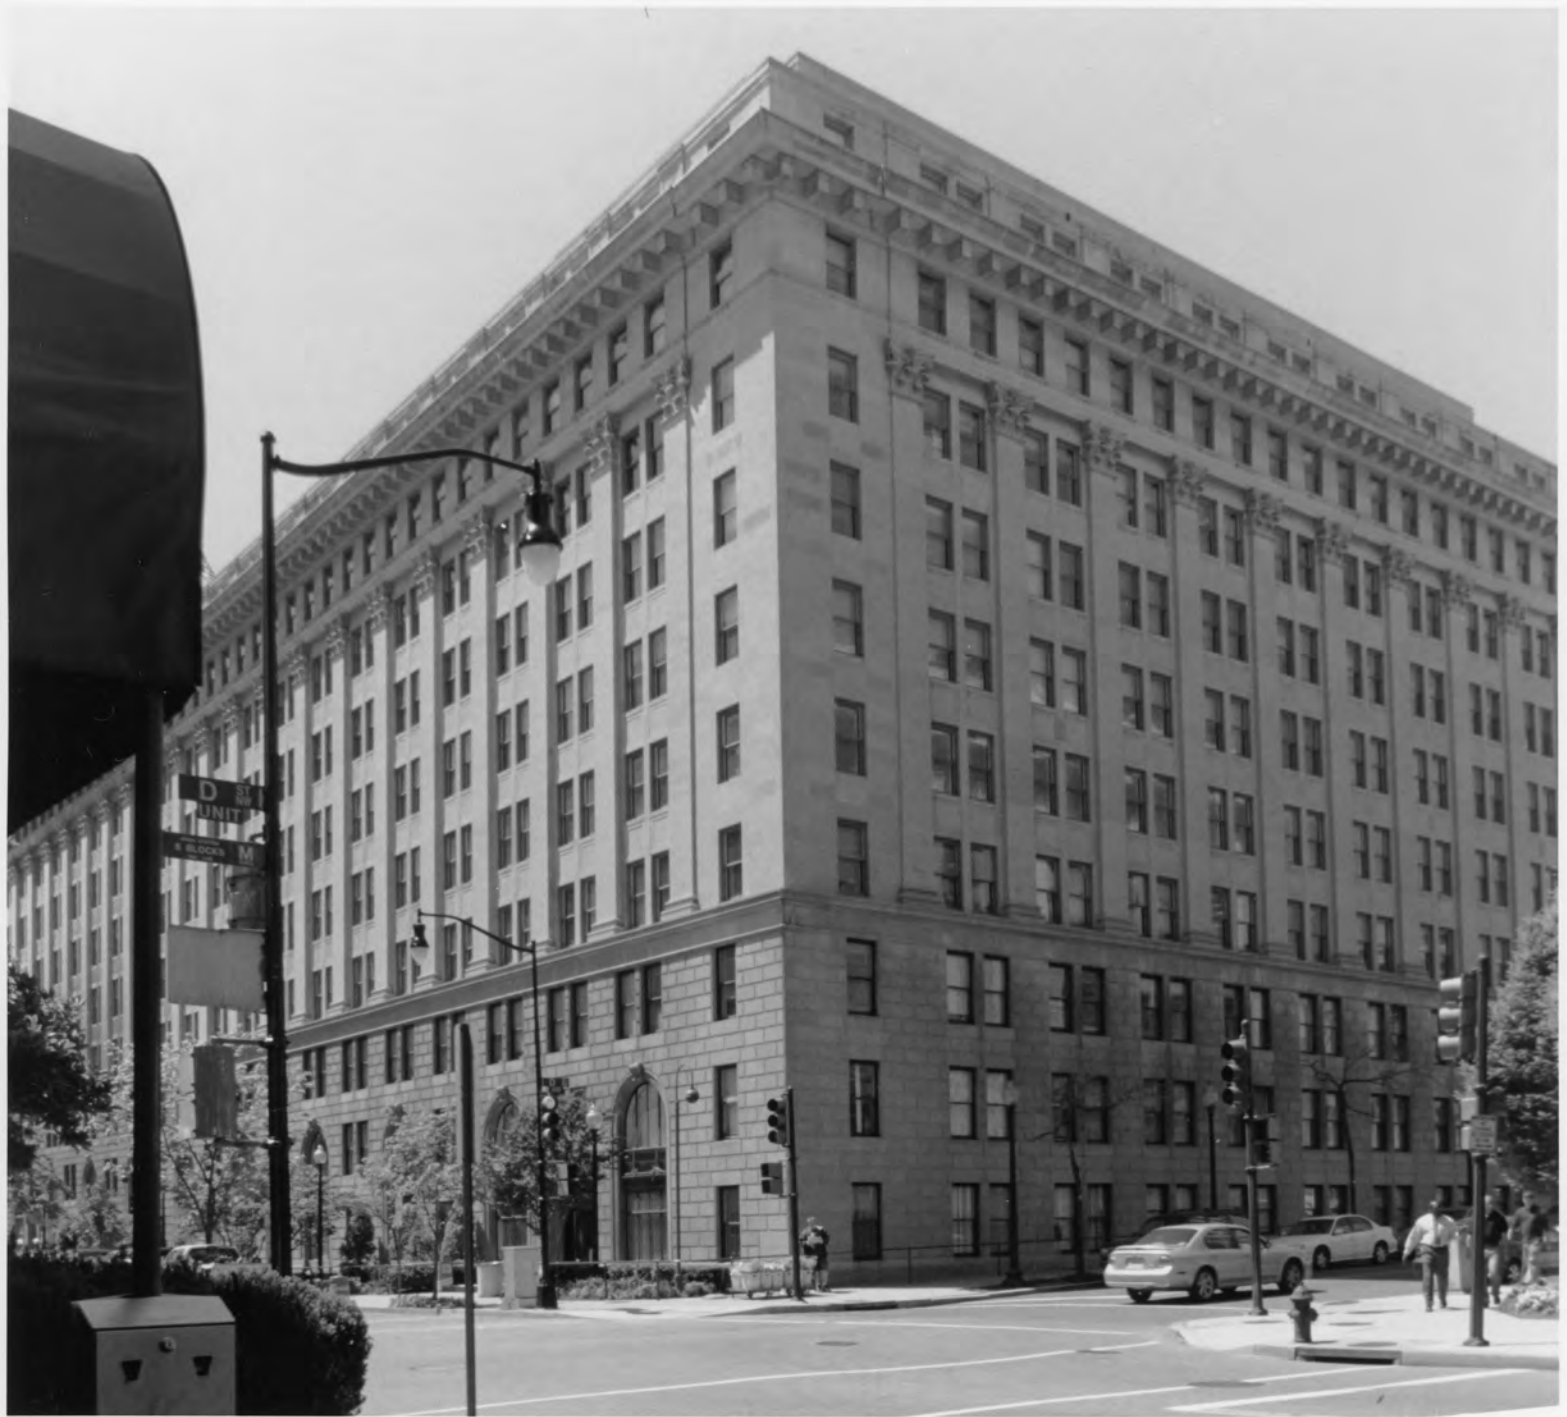
DC007522-2

View looking Southwest

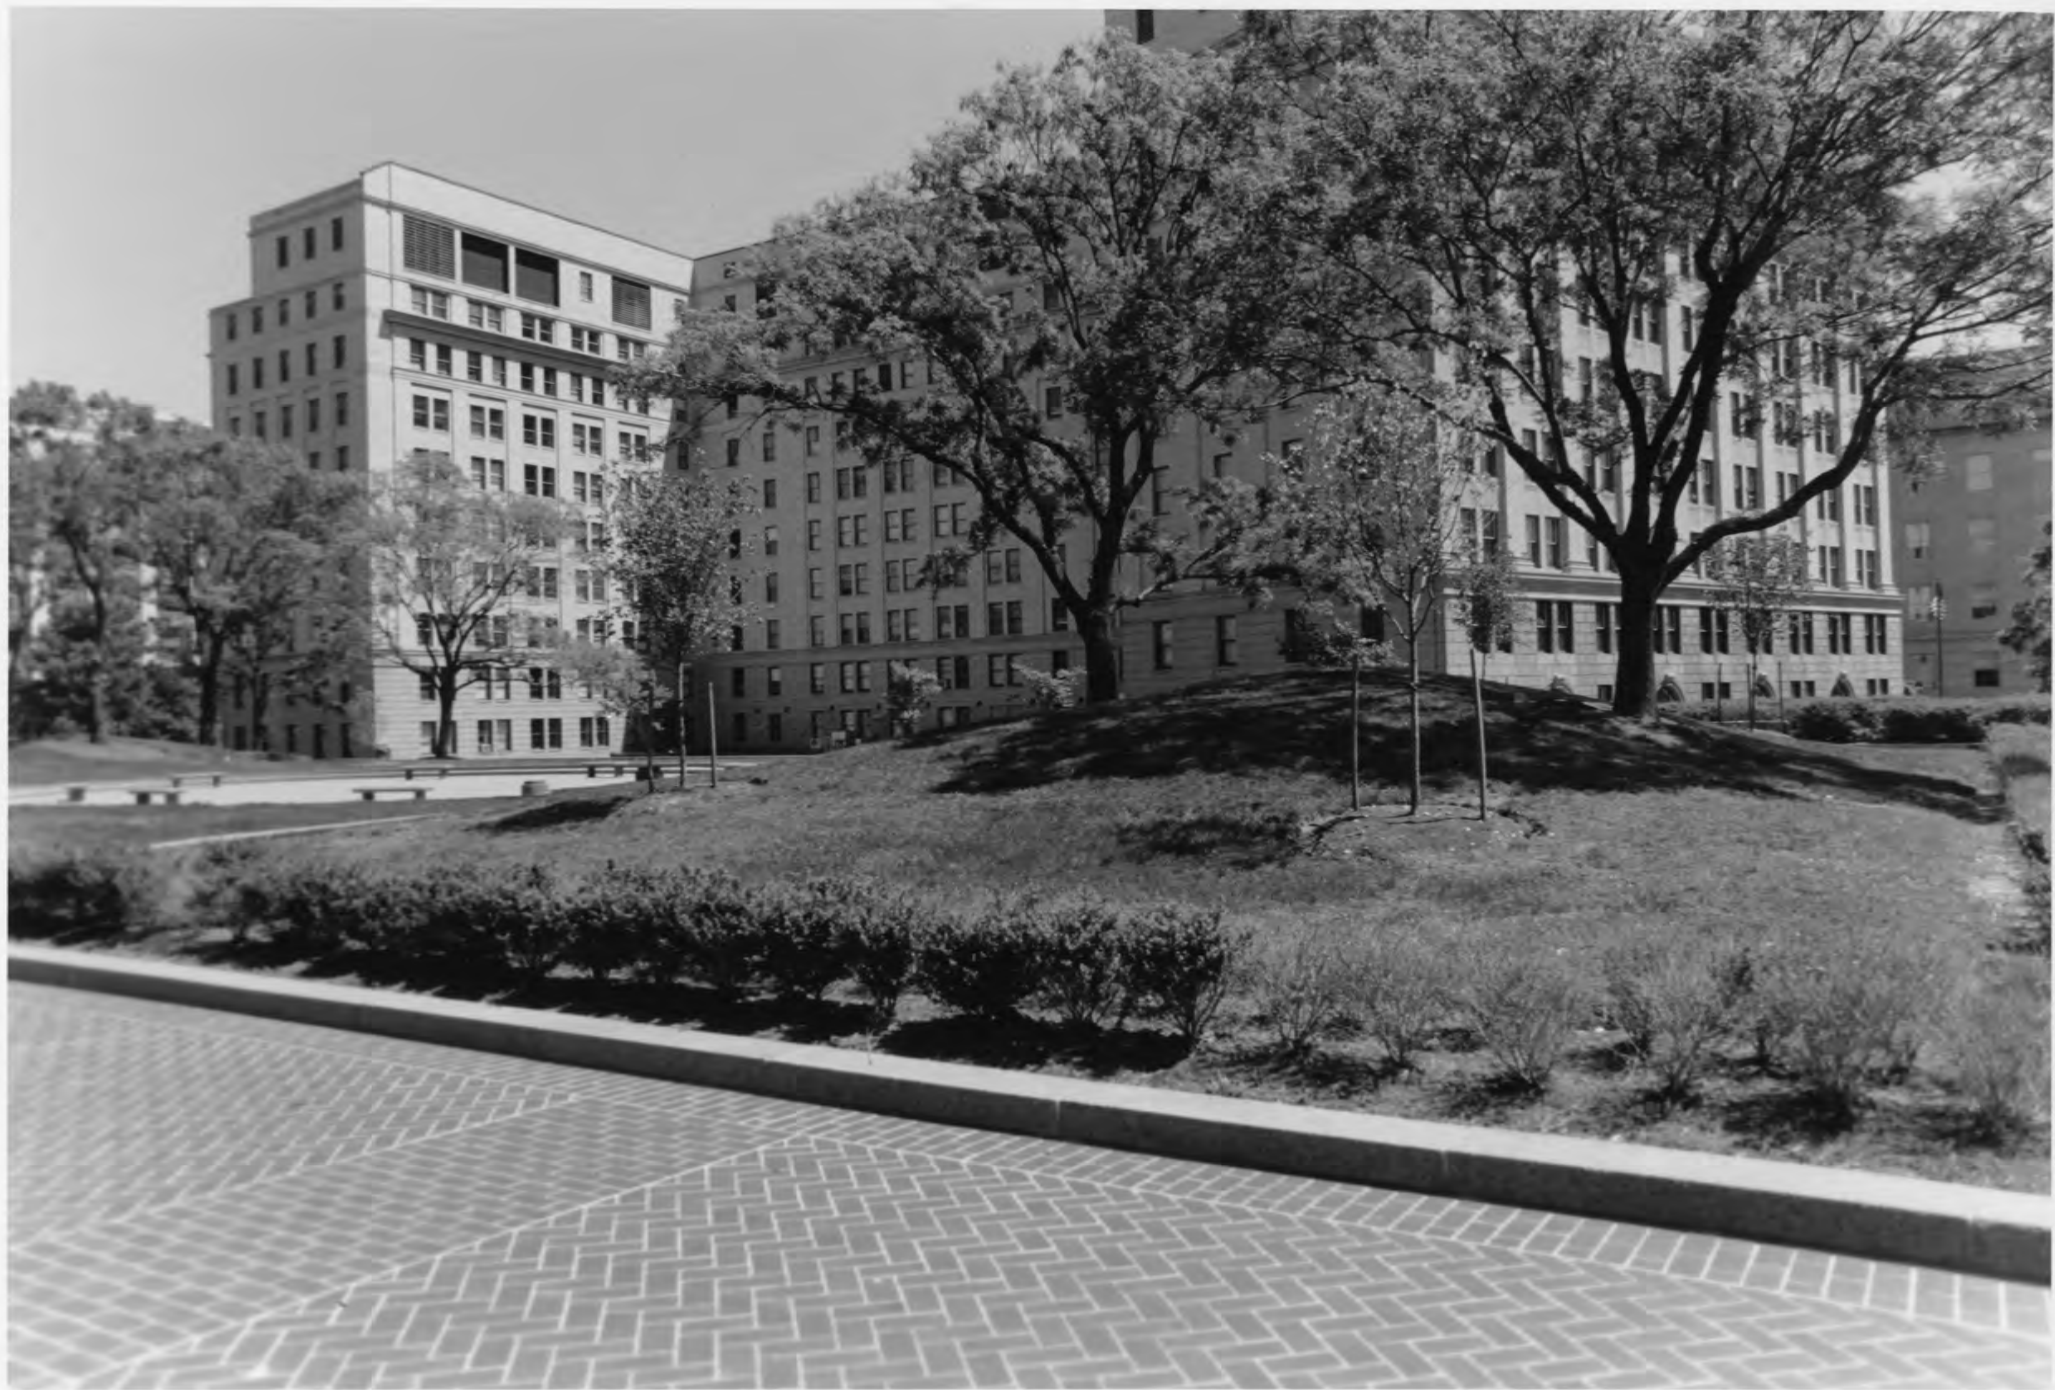
DC007522-3

View Looking Northeast
