NATIONAL HISTORIC LANDMARK NOMINATION

FORT CHRISTIAN

Historic Name: FORT CHRISTIAN

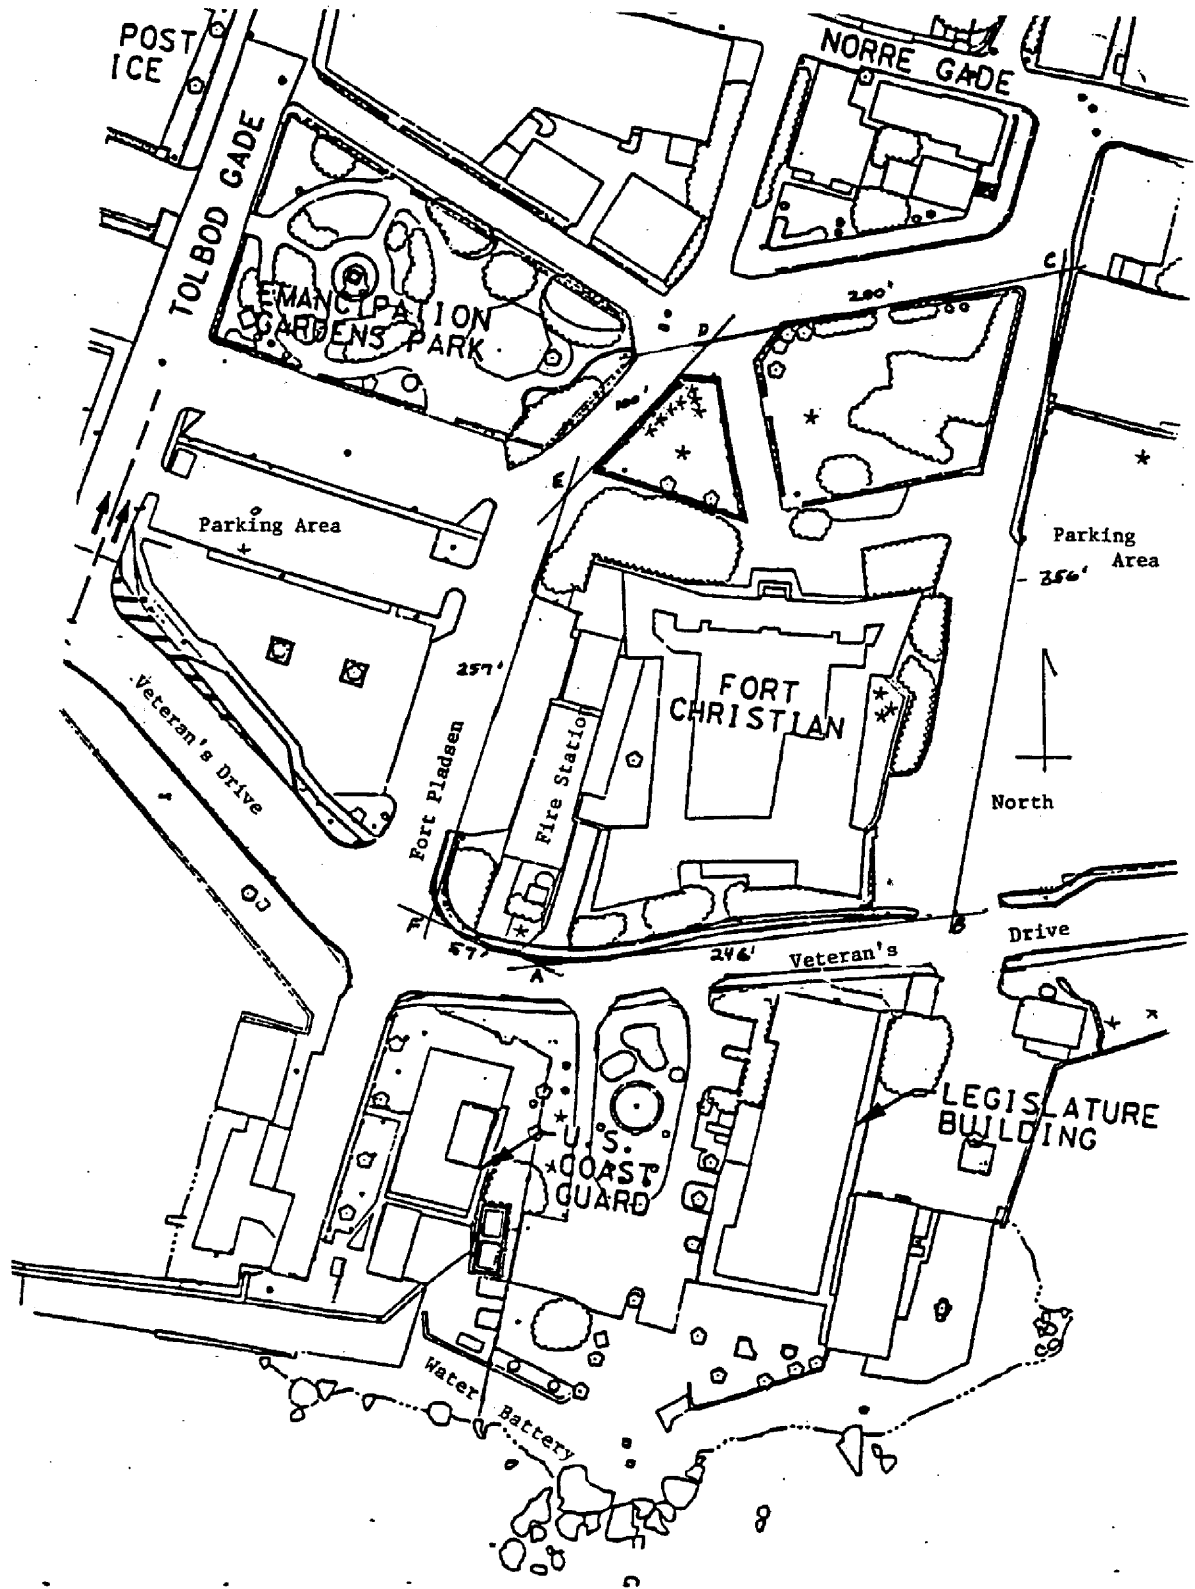
Figure 1. Site map showing the boundaries of Fort Christian and the layout of the surrounding area. ~ Provided by M. Slater.

Virgin Islands Fire Department Building
(1950s) noncontributing building

In 1874, Trygborg, the northern curtain wall, and northern ravelin were torn down. That part of the fort was replaced with a Gothic Revival style building featuring a prominent clock tower (photos 4 and 5). In the mid-twentieth century, further land filling occurred along the whole northern shoreline of the harbor upon which a two lane highway (Veterans Drive) was constructed. This road ran along the south side of the fort, separating it from the water battery and barracks. The reclaimed land on the west side of the fort became Emancipation Garden, while the reclaimed land on the east side of the fort became a parking lot. The northern approach to the fort, which once contained land side defenses became two small park areas (figure 1).

The land and sea areas surrounding Fort Christian have changed considerably through the gradual in-filling of the water areas on the west and east sides of the fort. The area to the north of the fort, where the Danish military once had a ravelin, is now open space. On the south side the open area between the water battery and the fort has been filled in with a 1820s barracks structure, three mid-twentieth century United States Coast Guard buildings, and Veteran's Drive. On the east side most of the ravelin was removed, as were numerous buildings constructed by the U.S. Navy (1917-1931). The area east of the fort is now a parking lot. On the west side, the ravelin has been removed and a fire station was built in the area in the 1950s (photo 6 and figure 1).

The only non-contributing building within the boundary of the Fort Christian National Historic Landmark is a 1950s fire station along the west side of the fort (photo 6 and figure 1).

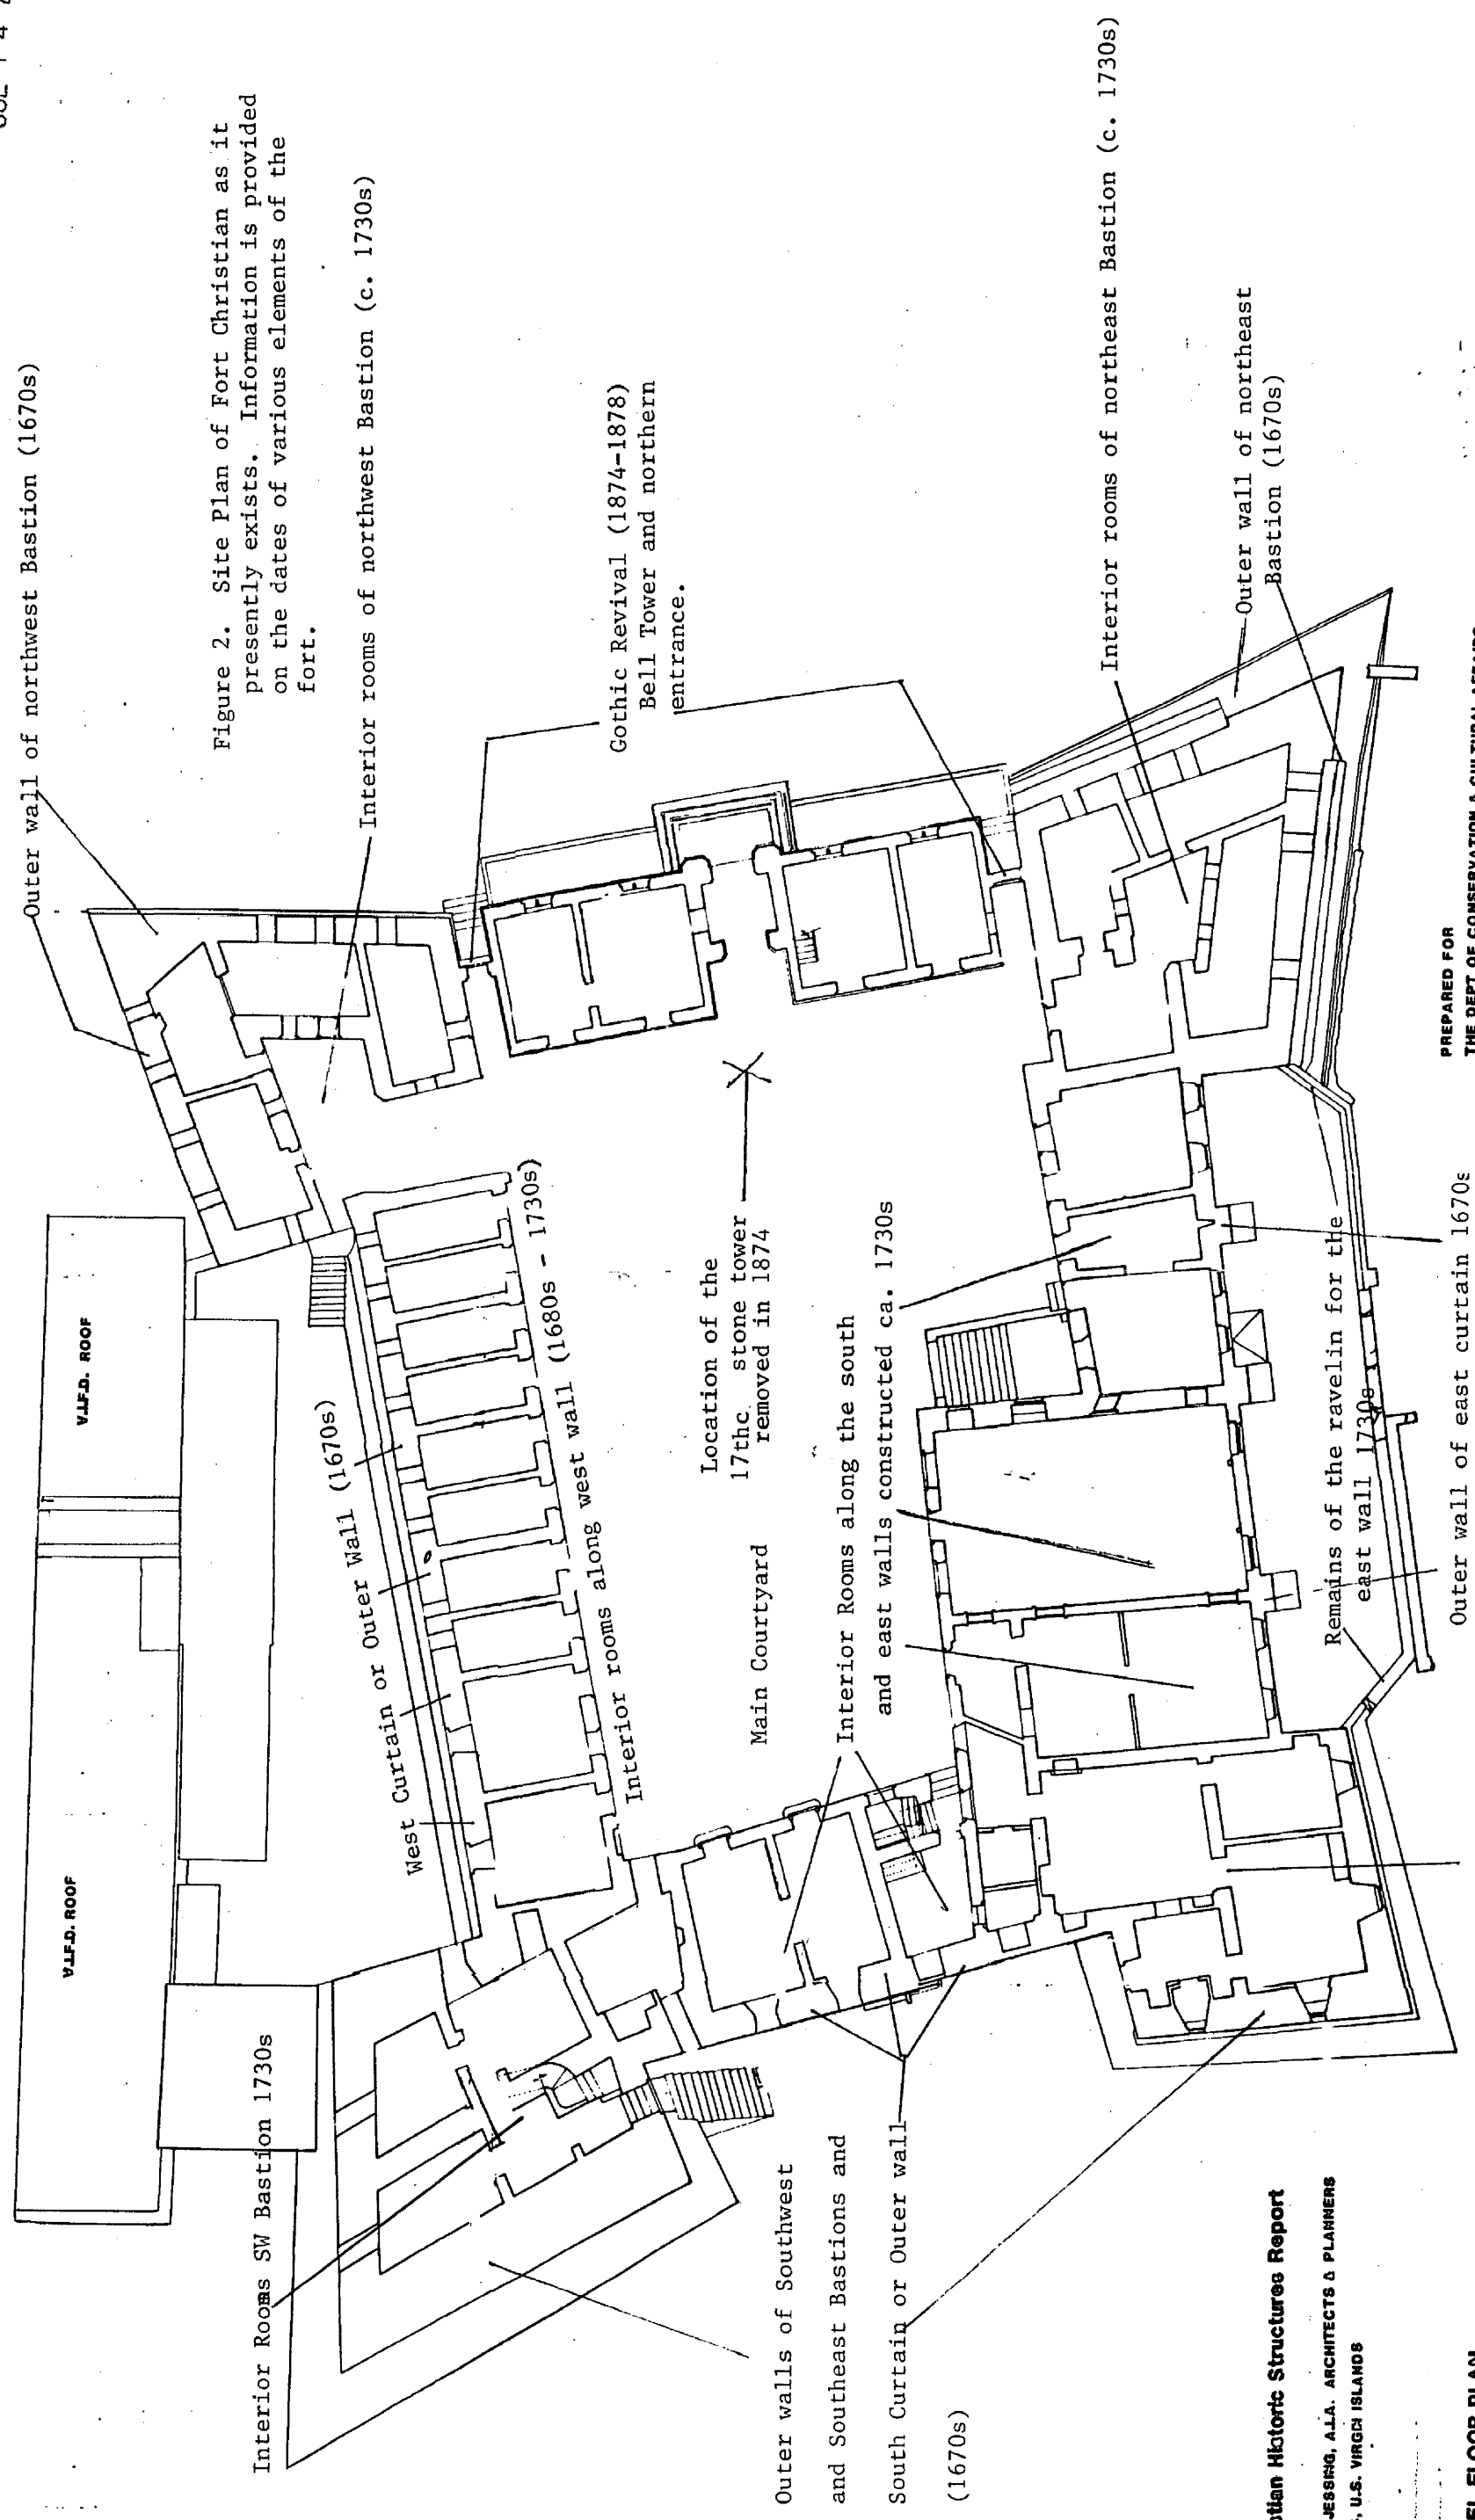
Figure 2. Site Plan of Fort Christian as it presently exists. Information is provided on the dates of various elements of the fort.

Introduction: Fort Christian, or Christians Fort, was constructed in the 1670s to protect the Danish colony on St. Thomas. The fort is a rubble masonry seventeenth-century fortress consisting of curtain walls enclosing a square, with an irregular diamond-shaped bastion on each corner. The fort is typical of fortresses of the Baltic area of that century. Behind the curtain walls and bastions are rooms formerly containing gun batteries, government offices, the residence for the colonial governor, and the colony's first church. The interior courtyard of the fort is a brick-paved open area that once contained a large thick-walled tower along the north side of the courtyard. In 1874, this tower was demolished and the northern curtain wall was replaced with a Gothic Revival style building incorporating a prominent clock tower (figures 1 and 2).

The extant portions of the seventeenth and eighteenth fort structure consist of: the east, west, and south curtain walls; all four diamond-shaped bastions; and the interior rooms built within the bastions and against the curtain walls. The nineteenth century portion of the fort consists of the northern curtain wall and rooms built behind this curtain wall, and the Gothic Revival clock tower. All of these historic features are intact (figure 2).

Four small apartments [the ones built by Adolph Esmitt against the inside of the west curtain wall] (photo 8 and figure 2). In the largest there are a large window and 3 doors, the one of which is cut through horizontally halfway up. This large room is tapestried with gilt leather which commences to wear out.

By 1875 the northern curtain wall had been "replaced by a new one in the then popular style of gothic revival" (photos 4, 5, and 14 and figure 2) (deJongh and Gjessing 1982:15).
