**National Register of Historic Places
Inventory—Nomination Form**

PROPERTY OWNERS - HISTORIC RESOURCES OF SOUTH HAMPTON, NEW HAMPSHIRE

TOWN CENTER HISTORIC DISTRICT *Main + Hilldale Aves., and Jewell St.*

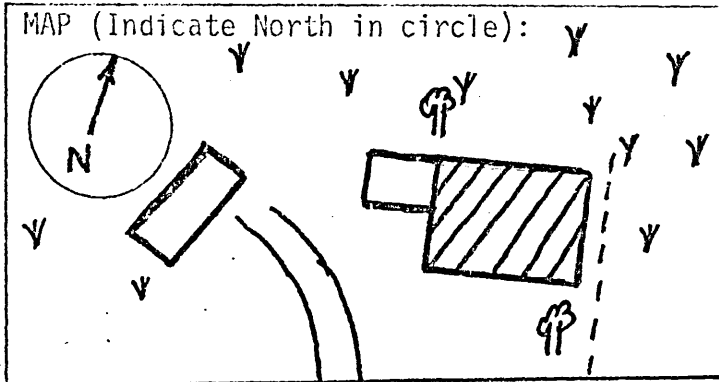
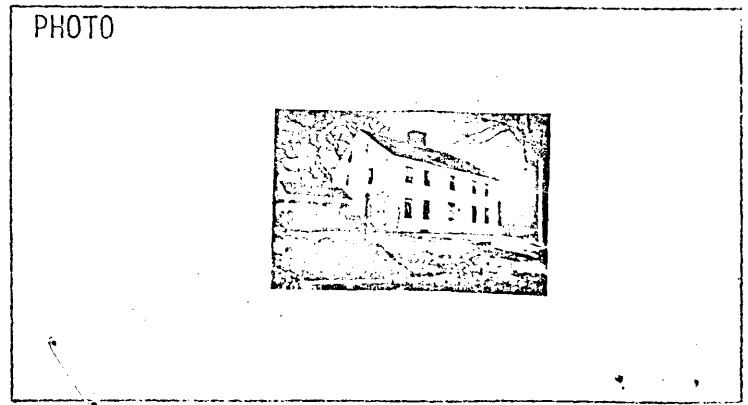
Description of View: Front (south)
 Side (west) elevations

A typical Georgian style, the Kiely house is characterized by its large prominent roof, massive central chimney, and plain ornamentation. The windows are all 12 over eight lights with wide, molded surrounds. The central entry door is topped by a transom with lights, and on either side of the door are pilasters supporting a full entablature. Treatment at the eaves consists of a boxed cornice with a wide molding applied to the frieze on the lateral eaves, and close raking eaves with fascia. The entire structure rests on a granite block foundation.

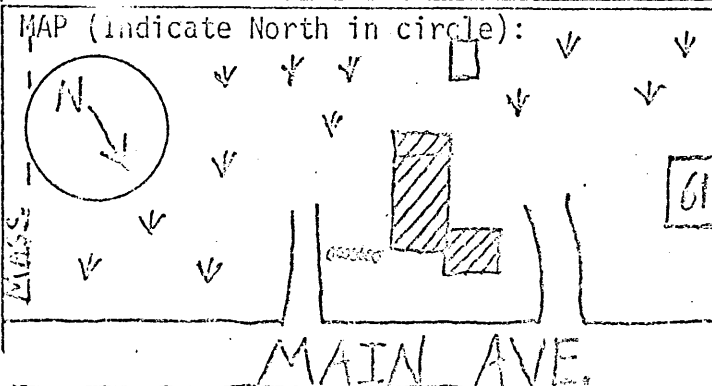
Description of View: Front (north)
Side (west)

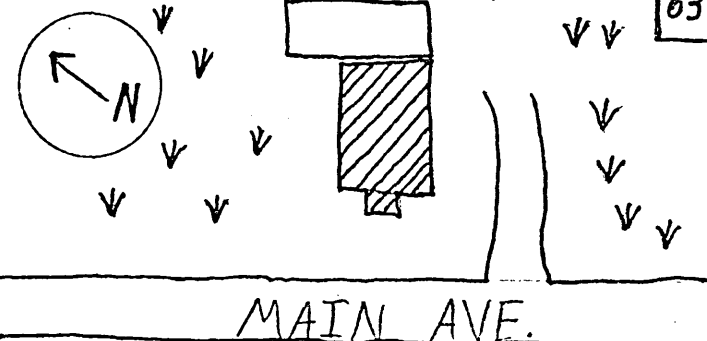
65

This early 20th century vernacular structure sits on a granite slab foundation. It has Greek Revival massing, gable end facing the street, and the main entry in the gable end. The entry door is located within a plain, one story, hipped roof porch. Treatment at the eaves consists of a boxed cornice with a wide molded frieze, and gable end returns. All windows are two over two with plain surrounds.

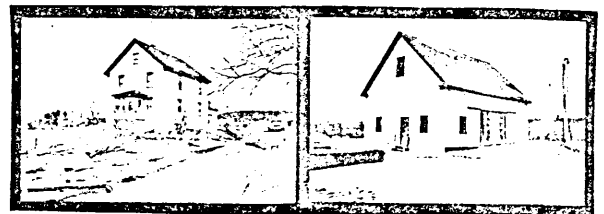
Description of View: Front (south)
 Side (east) (related barn)

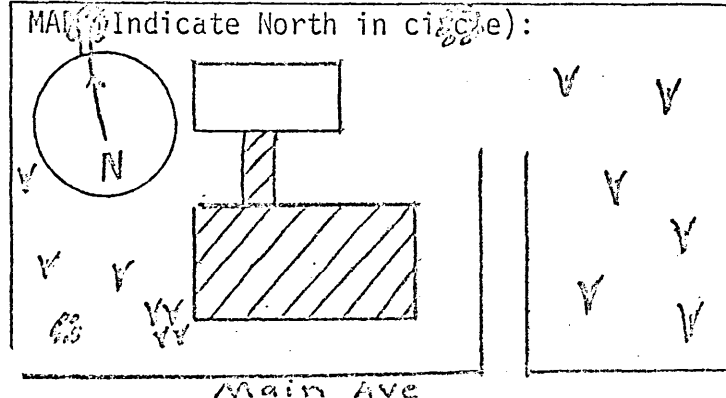
Description of View: Front (south)
 Side (west)

This superb example of a Georgian saltbox is characterized by its simplicity of ornamentation and massive central chimney. The main features of this two and one-half story structure include: a raised-panel center entry door which has a transom with lights; nine-over-six windows on the first story and six-over-six on the second; close raking and lateral eaves; narrow, plain corner boards; and a fieldstone foundation.

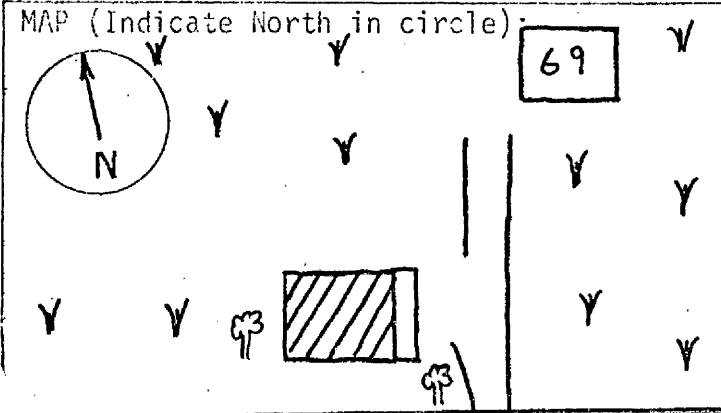
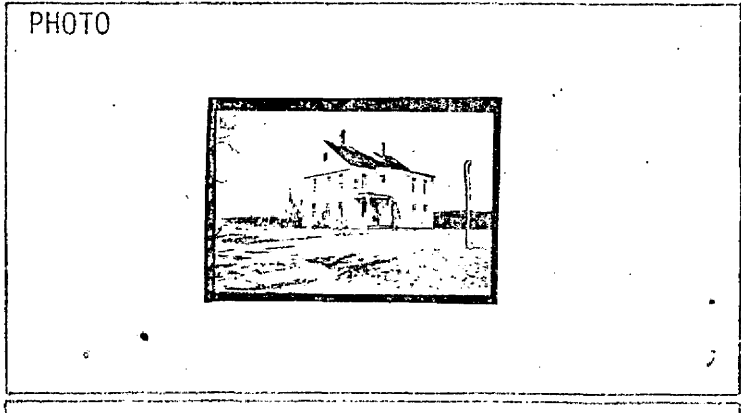
Description of View: Front (south)
 Side (east)

It is probable that the original door was a sidehall entry located on the gable end where there is now a window, and that the open porch was built at the same time as the wing. The house rests on a granite block foundation and has a medium pitched roof topped by two narrow chimneys, one of which has a corbelled cap.

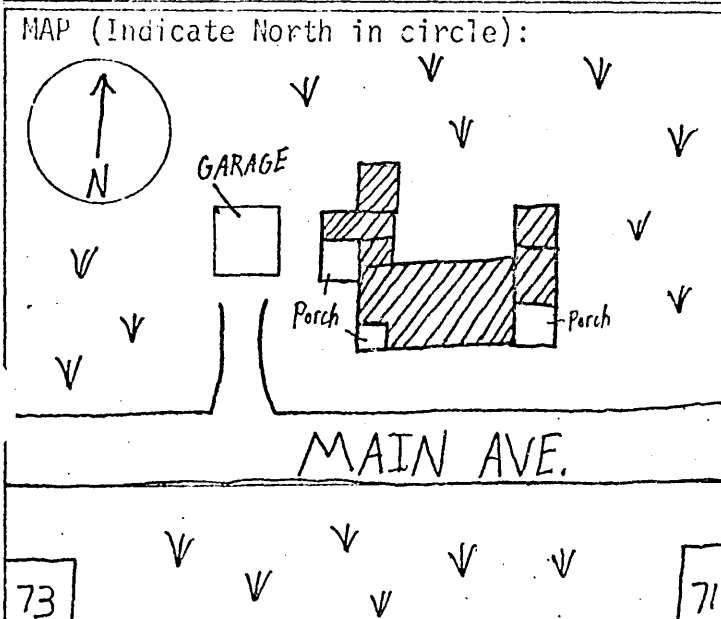
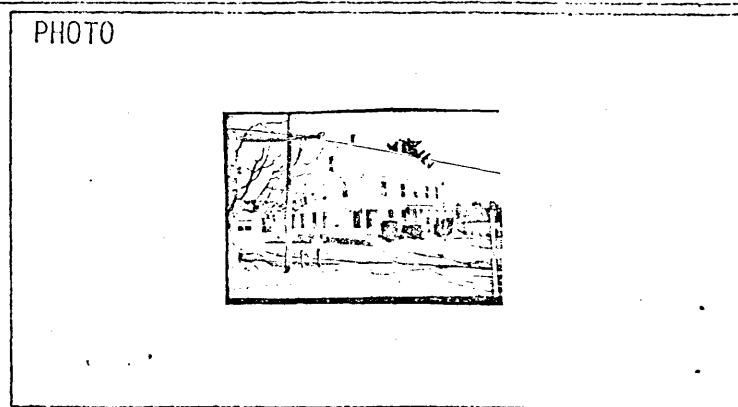
Description of View: Front (south)
Side (west)

The Sewell house is a good example of the Colonial Revival style characterized by its large portico, balustrades, and prominent roof. The center entry has a one story portico supported by square columns and topped with an ornamental balustrade. The same style balustrade can be found above the screened porch located to the east. Another feature is the recessed porch located on the west front facade. It has a free standing square column and a suspended balustrade. The medium pitched roof is topped by two narrow chimneys with corbelled caps. The treatment at the eaves is a boxed cornice with a wide molded frieze and gable end returns. The corner boards include one piece of molding at the top, suggesting capitals. All of the windows on the main block are two over two with plain surrounds. The house rests upon a stone foundation with a brick facing.

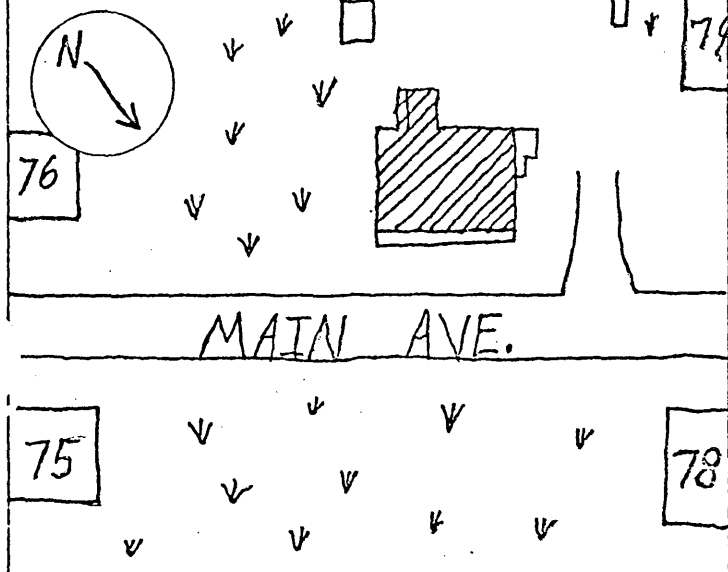
The Santosuosso house is a large twin chimney Federal style structure which has had many additions (dates unknown). All of the entrances to the house have been enclosed by porches with the most prominent being the five bay of the front facade. The low pitched roof is topped by two large inset chimneys and the treatment at the eaves is a boxed cornice with gable end returns. The front corner boards are polygonal in design. Most of the windows are two over two with architrave trim. The house rests on a granite slab foundation. A two story ell with a gable roof extends to the south and has a multi-bay enclosed porch.

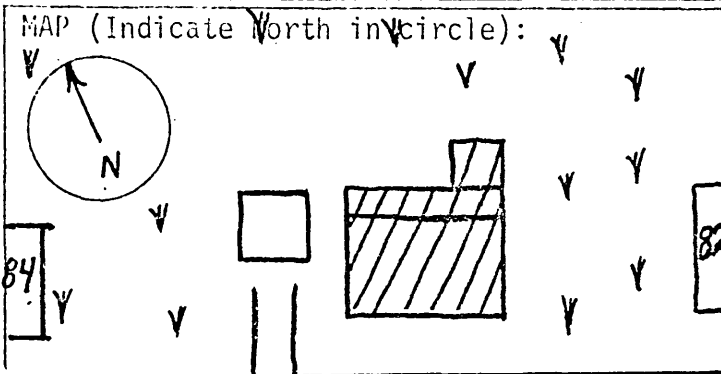
Description of View: Front (South)
 Side (West)
