National Register of Historic Places  
Registration Form

historic name BAKER CONGREGATIONAL CHURCH

street & number 760 SARATOGA STREET not for  
publication

city or town BOSTON (East Boston) vicinity

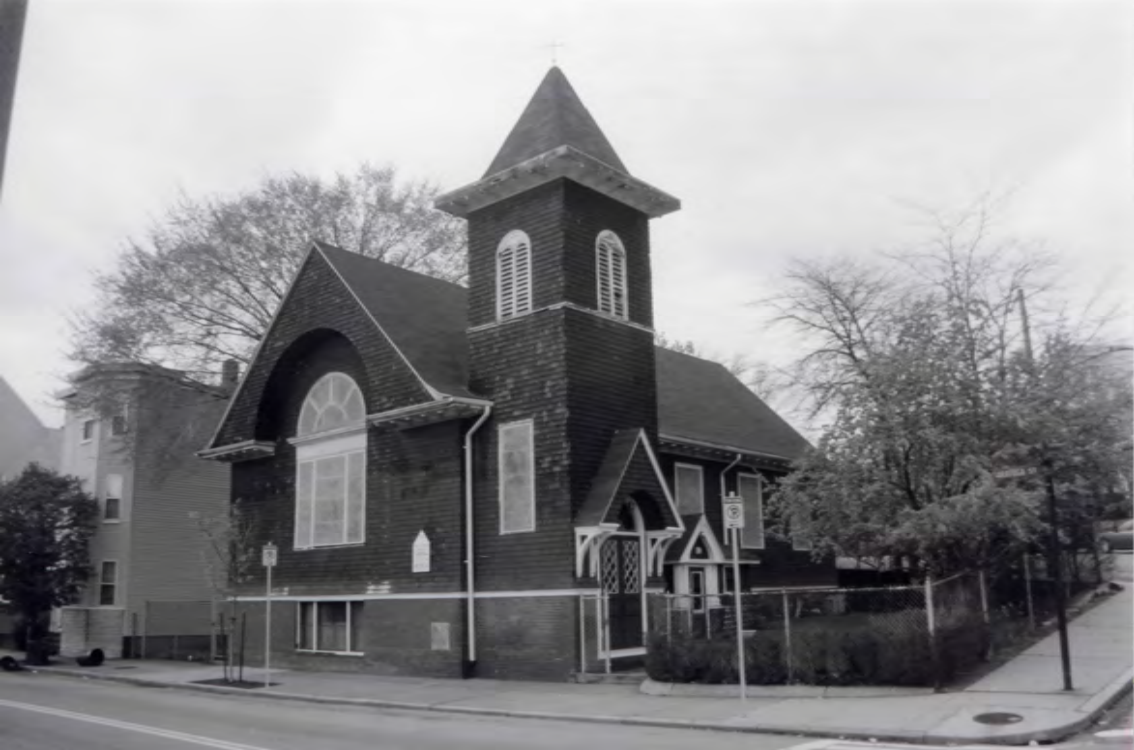
PHOTO 1

1. BAKER CONGREGATIONAL CHURCH
2. SUFFOLK COUNTY, MA.
3. TOBIN TRACEY, PHOTOGRAPHER
4. APRIL 24, 1998
5. TOBIN TRACEY, NEGATIVES
6. SOUTH AND EAST ELEVATIONS, LOOKING NORTHWEST

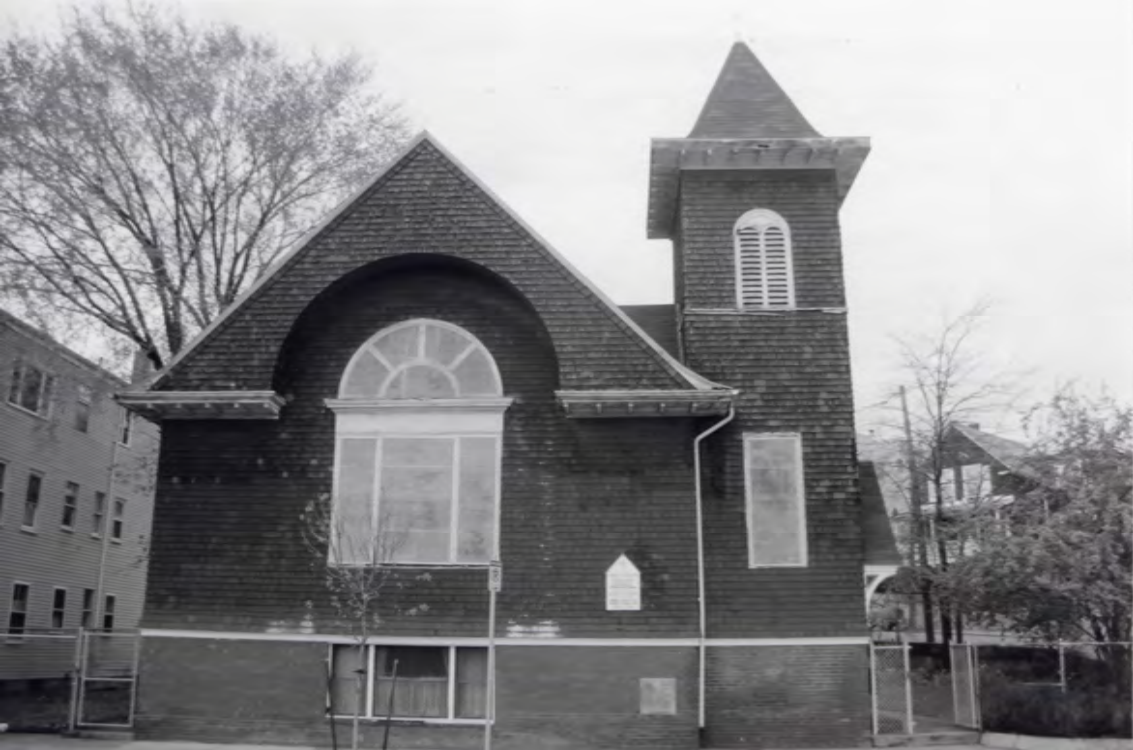
PHOTO 2

1. BAKER CONGREGATIONAL CHURCH
2. SUFFOLK COUNTY, MA.
3. TOBIN TRACEY, PHOTOGRAPHER
4. APRIL 24, 1998
5. TOBIN TRACEY, NEGATIVES
6. SOUTH ELEVATION, LOOKING NORTH

The brick foundation rises approximately six feet above grade and has large fixed pane windows that align with the windows above and emit light into the basement. The foundation is capped with a water table that catches the splayed wood shingle walls above. The south facade has a large round top window centered on it. The

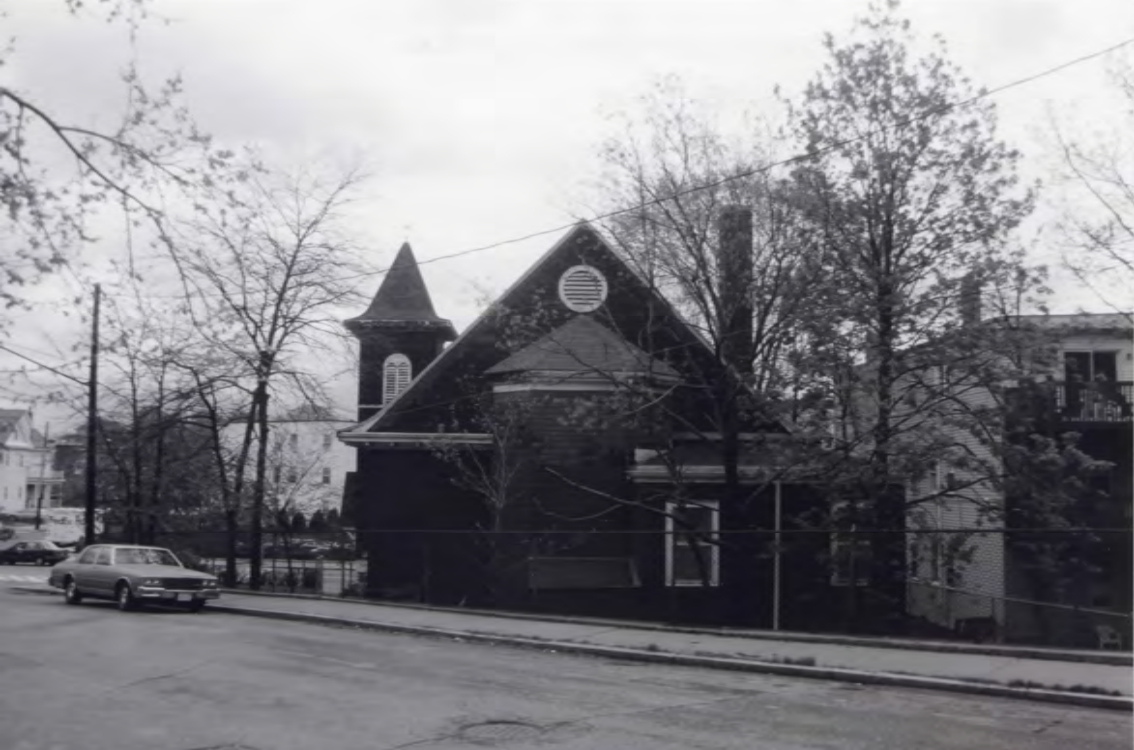
PHOTO 34

1. BAKER CONGREGATIONAL CHURCH
2. SUFFOLK COUNTY, MA
3. TOBIN TRACEY, PHOTOGRAPHER
4. APRIL 24, 1998
5. TOBIN TRACEY, NEGATIVES
6. NORTH ELEVATION, LOOKING SOUTH

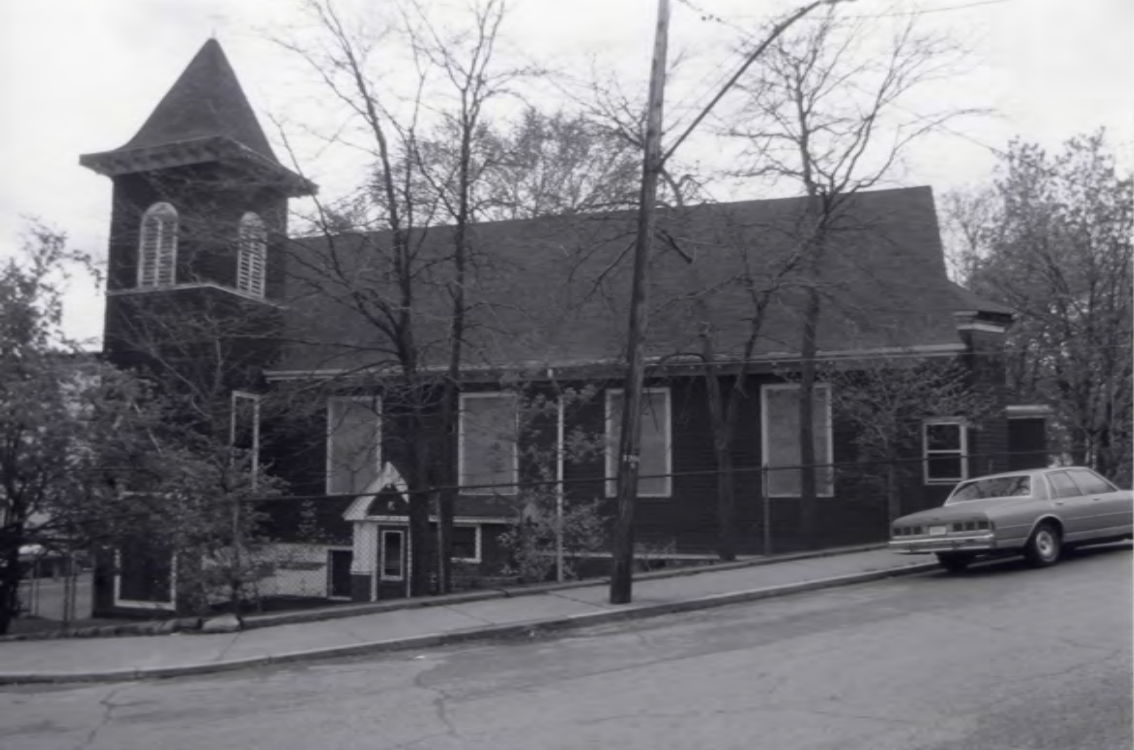
PHOTO 25

1. BAKER CONGREGATIONAL CHURCH
2. SUFFOLK COUNTY, MA
3. TOBIN TRACEY, PHOTOGRAPHER
4. APRIL 29, 1998
5. TOBIN TRACEY, NEGATIVES
6. EAST ELEVATION, LOOKING WEST

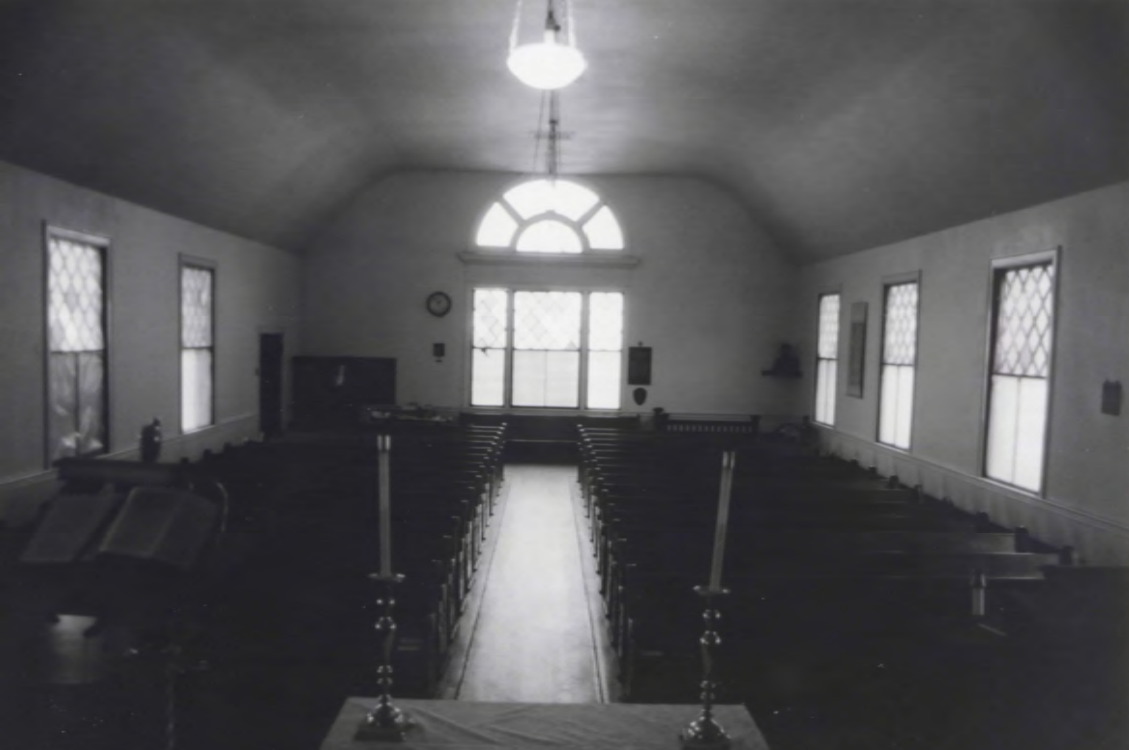
PHOTO 6

1. BAKER CONGREGATIONAL CHURCH
2. SUFFOLK COUNTY, MA
3. TOBIN TRALEY, PHOTOGRAPHER
4. APRIL 24, 1998
5. TOBIN TRACEY, NEGATIVES
6. SANCTUARY, LOOKING SOUTH

The main entrance doors to the building enter into a small vestibule that provides access to the sanctuary by nine steps. The doors to the sanctuary enter at the back and to the side. The interior is unadorned with painted plaster walls and wood floor. There is a center aisle with stained wood pews to each side. The pulpit is located at the northern end of the space on a raised platform. A door on the west side of the apse leads to a small minister's room. A small set of stairs in the southwest corner of the sanctuary and another set located through a door in the northwest corner of the sanctuary provide access to the basement.

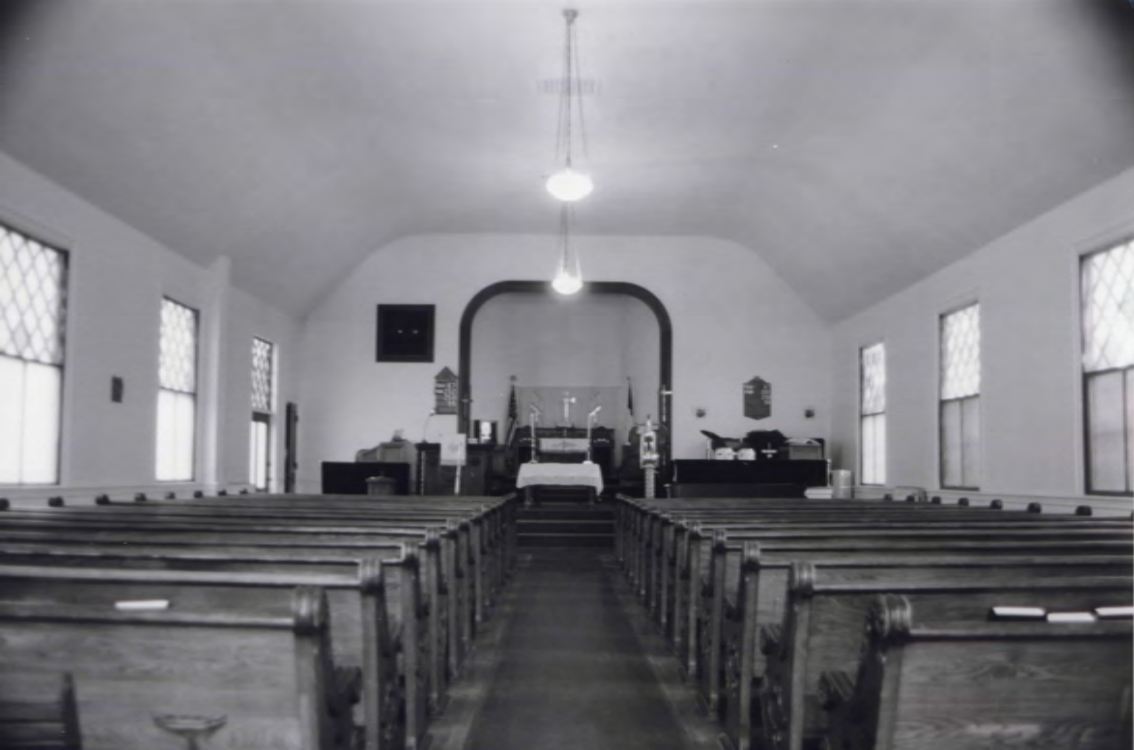
PHOTO 7

1. BAKER CONGREGATIONAL CHURCH
2. SUFFOLK COUNTY, MA
3. TOBIN TRACEY, PHOTOGRAPHER
4. APRIL 24, 1998
5. TOBIN TRACEY, NEGATIVES
6. SANCTUARY, PULPIT AREA, LOOKING NORTH

On the interior the church is a simple center aisle church with raised pulpit and small platform area for the choir. The main level consists of the sanctuary, a small apse at the north end and a ministers room to the west of the apse. The lower level contains a kitchen, a bathroom and a large meeting room with a raised stage. The meeting room has doors that can be closed to divide the room into two separate spaces.
