I. IDENTIFICATION	<p>PROPERTY NAME: First Presbyterian Church of Columbus HISTORIC NAME: First Presbyterian Church of Columbus STREET ADDRESS: 1100 1st Avenue CITY: Columbus COUNTY: Muscogee PRESENT OWNER: First Presbyterian Church of Columbus, c/o Dr. James V. Johnson MAILING ADDRESS: 1100 1st Avenue CITY: Columbus STATE: Georgia ZIP CODE: 31902 CURRENT USE: Church ACREAGE: approx. 1 acre U.S.G.S. QUADRANGLE: Columbus, GA-AL U.T.M. REFERENCE: 16-688755-3593760 V.B.D. OR TAX MAP NUMBER: 4/13/1</p>
II. DESCRIPTION	<p>ARCHITECTURAL DESCRIPTION AND PRESENT CONDITION: Romanesque, stucco over brick, gable roof is slate. Facade of church is divided into three sections—two square bell towers and the central entrance. Central entrance is three bays wide, with three rounded arch doorways; a complete entablature divides the first floor from the second, which has three rounded arch windows, the center one taller than its two flanking members. Gable is corbelled. The southern tower built in four graduated sections which end in a six sided slate roofed spire. Northern tower is three graduated sections which end in a low four sided spire. Both of these towers, like the remainder of the church, h

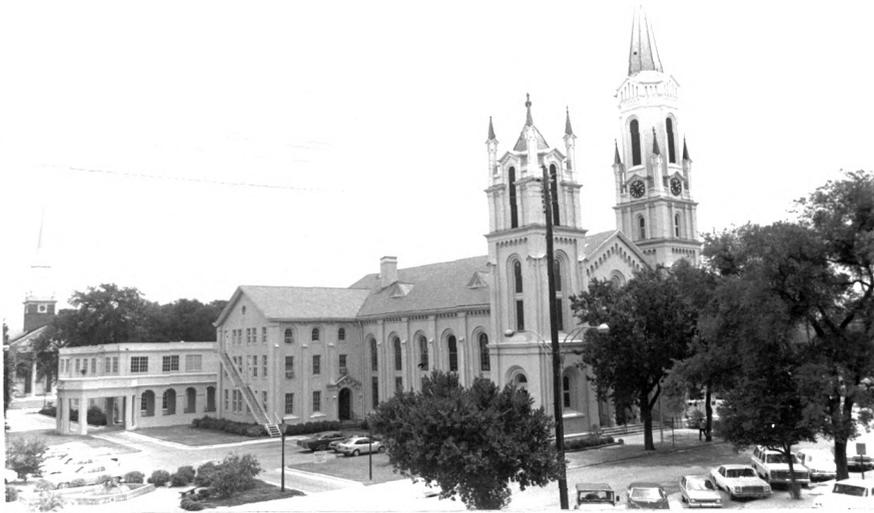
ROLL NO. 4 FRAME NO. 9 NEGATIVES FILED: Historic Columbus Foundation
700 Broadway

DIRECTION PHOTOGRAPHER FACING: Southeast Columbus, Georgia 31901
