National Register of Historic Places Registration Form

historic name Bald Eagle Ranch House

street & number 511 Crawford Road

city or town Modesto

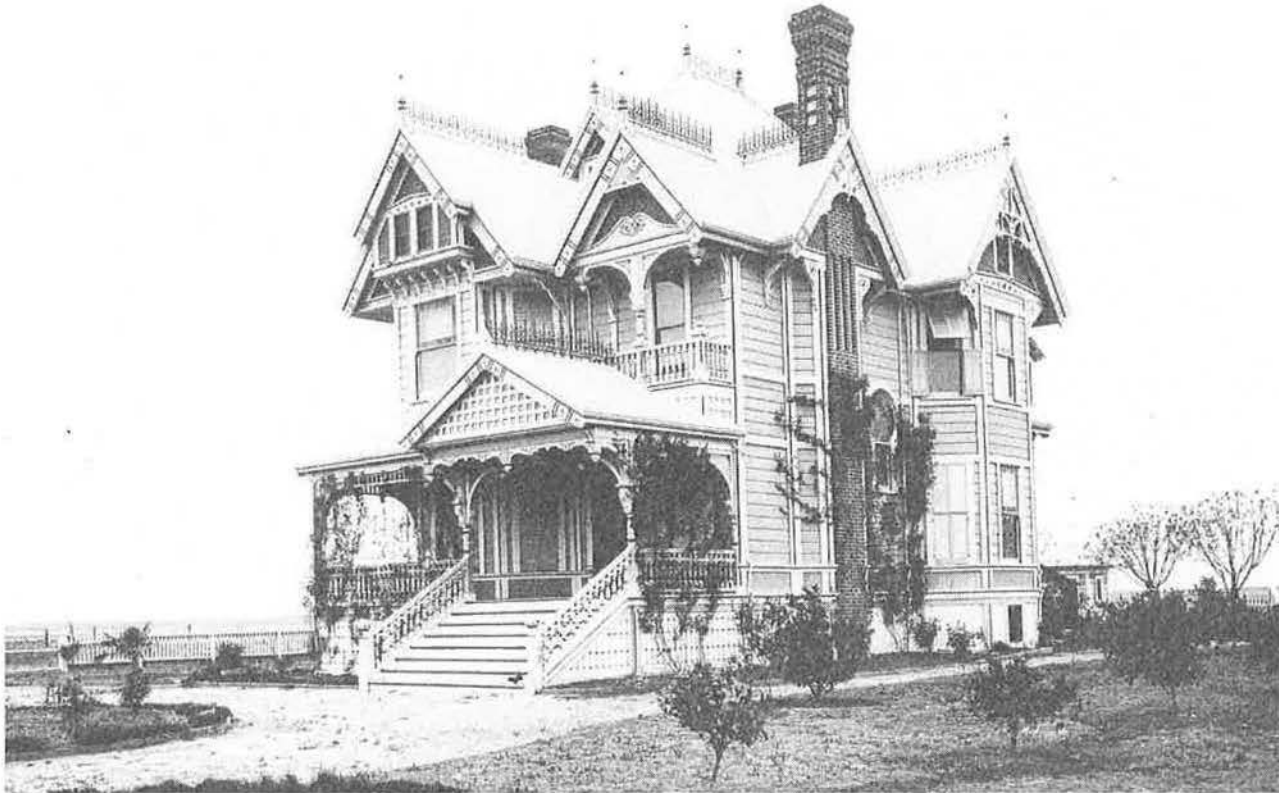
Figure 1: Historical photograph of the Bald Eagle Ranch House taken sometime after construction in 1893.

A feeling of age is expressed in the landscape and setting of the Bald Eagle Ranch House. This can be seen by again comparing Figure 1 and Photograph 001. In its original setting, photographs show that the house sits in a tree-less, flat area of the ranch; vegetation is sparse. But current photographs show tall, old trees and mature shrubbery, expressing an atmosphere of age and solidity. Together with its current large front lawn, curved driveway, and front water fountain statue, the setting of the Bald Eagle Ranch House expresses its historic character through both nature and architecture. Although the historic Bald Eagle Ranch operation is gone, the house still stands, a Victorian Queen Anne farmhouse that has been surrounded by fields and orchards for the last 120 years. The Bald Eagle Ranch House has retained its integrity in feeling and association, and as can be seen by comparing Figure 1 and Photograph 001, it looks very much the way it did in the 1890s. In its exterior and interior details, in both design and materials and workmanship, the Bald Eagle Ranch House is very much a product of its time and place. It is and has always been a gracious, grand place to live.

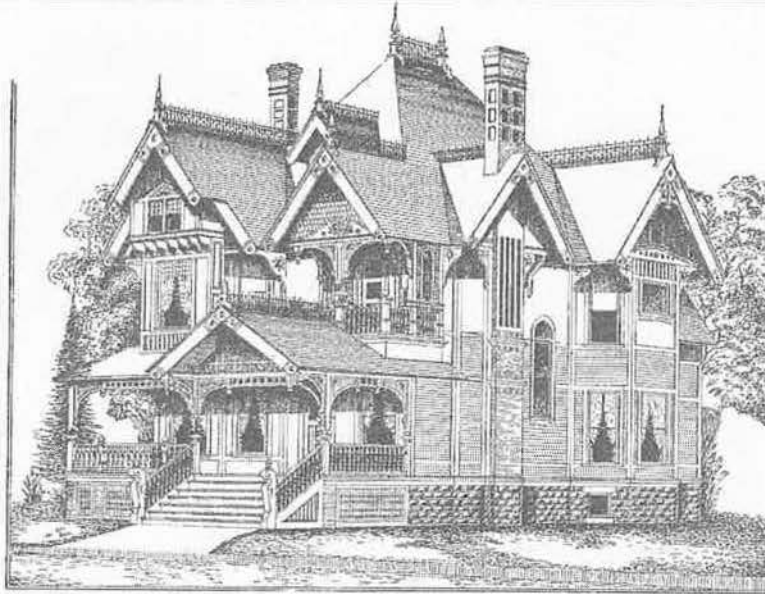
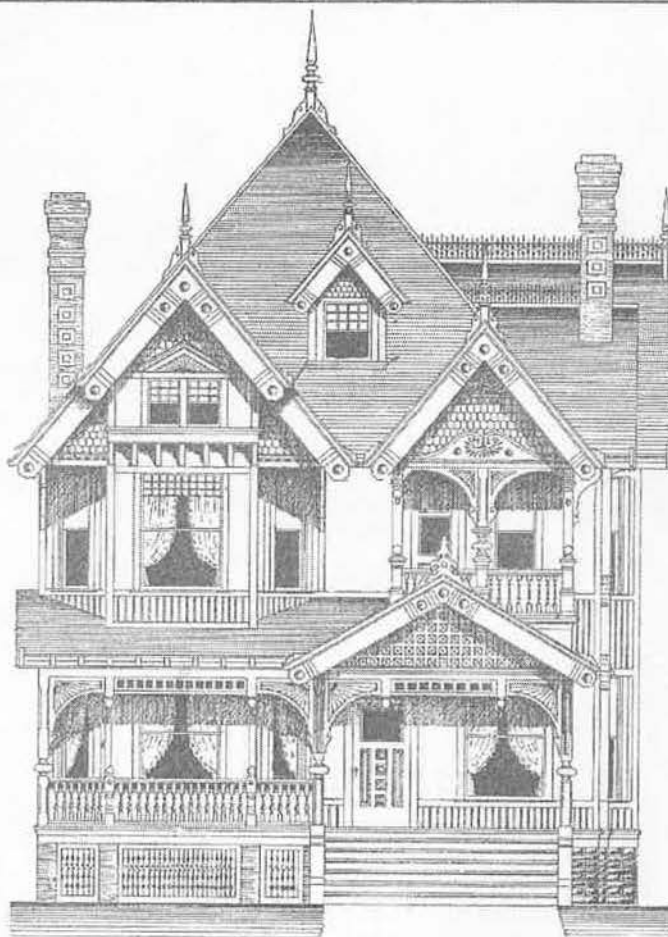
DESIGN No. 36.

The entire building, up to cornice, is weatherboarded; gables and roof shingled. Foundation of stone. Outside blinds. Painting, three-coat work.

The hall, parlor, dining and bed rooms are finished in oak or other desirable hardwood; all the rest is finished in pine or poplar, for painting. Plastering, three-coat work, hard finish. Plumbing consists of sink and pump in kitchen, bath tub and pump in kitchen, bath tub and bowl, with supply and waste pipe connections, and gas throughout.

Figure 4: "Design No. 36" from Barber's *Cottage Souvenir No. 2*. The house is almost identical to this front view and follows the floor plan closely.

The house follows the Barber First Floor and Second Floor plans for Design No. 36 with some changes. (See Figures 3 and 4 for the floor plans.) The main entry is through the porch (labeled piazza on the plan) on the south side of the house. According to the plan, the front entrance opened into a vestibule next to a nook which had seating on two sides and an arch entry, and both of these small rooms originally opened onto the sitting hall; however, it is not known if this was originally followed in the construction of this house. Currently the front door opens directly onto the sitting hall. As seen in the plan, the sitting hall opens west into the parlor, and north is a hallway with a north door to the bedroom. At the present time this hall is shorter and goes just to the base of the second floor stairs. The plan shows a west door to the dining room from this hallway, but this does not exist. From the parlor directly north is the dining room separated by pocket doors. West from the dining room is a sun porch, added onto the house early. According to the plan, a china closet was situated on the north wall of the dining room, but it exists on the west wall.

The Bald Eagle Ranch House is an excellent example of the Late Victorian Queen Anne style. The house closely followed Barber Design No. 36 in its construction. The sun porch (added by 1918) and back porch are the only additions. Most of the exterior trim elements and gingerbread details are original and match what can be seen in Barber’s line drawing for Design No. 36 (Figure 3); however, the roof cresting and shutters seen in Figures 1 and 3 no longer exist. Significant interior features such as the fireplace, pocket doors, built-in china cabinet with original leaded glass windows, and large keyhole shaped stained glass window are original to 1893 and convey the Late Victorian Queen Anne style. With the exception of needed repairs, paint, and some changes in flooring and lighting as were previously described, there has been very little alteration to the house since its construction.

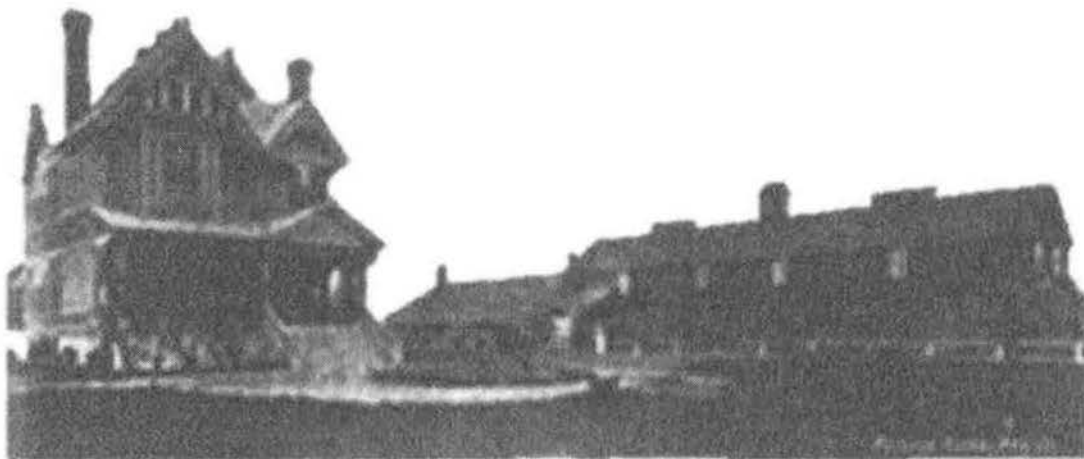
Figure 9: "Residence and Packing House, Bald Eagle Ranch." Photograph printed in article "Bald Eagle Ranch, Modesto, Cal." *Pacific Rural Press*. October 21, 1899, California Digital Newspaper Collection (PRP18991021.2.13.1).

The packing house can be seen right next to the house in Figure 9.
