National Register of Historic Places Registration Form

Historic name: Cedar Grove Bridge

Other names/site number: Indiana State Bridge #6625B

Camelback Pratt Through Truss

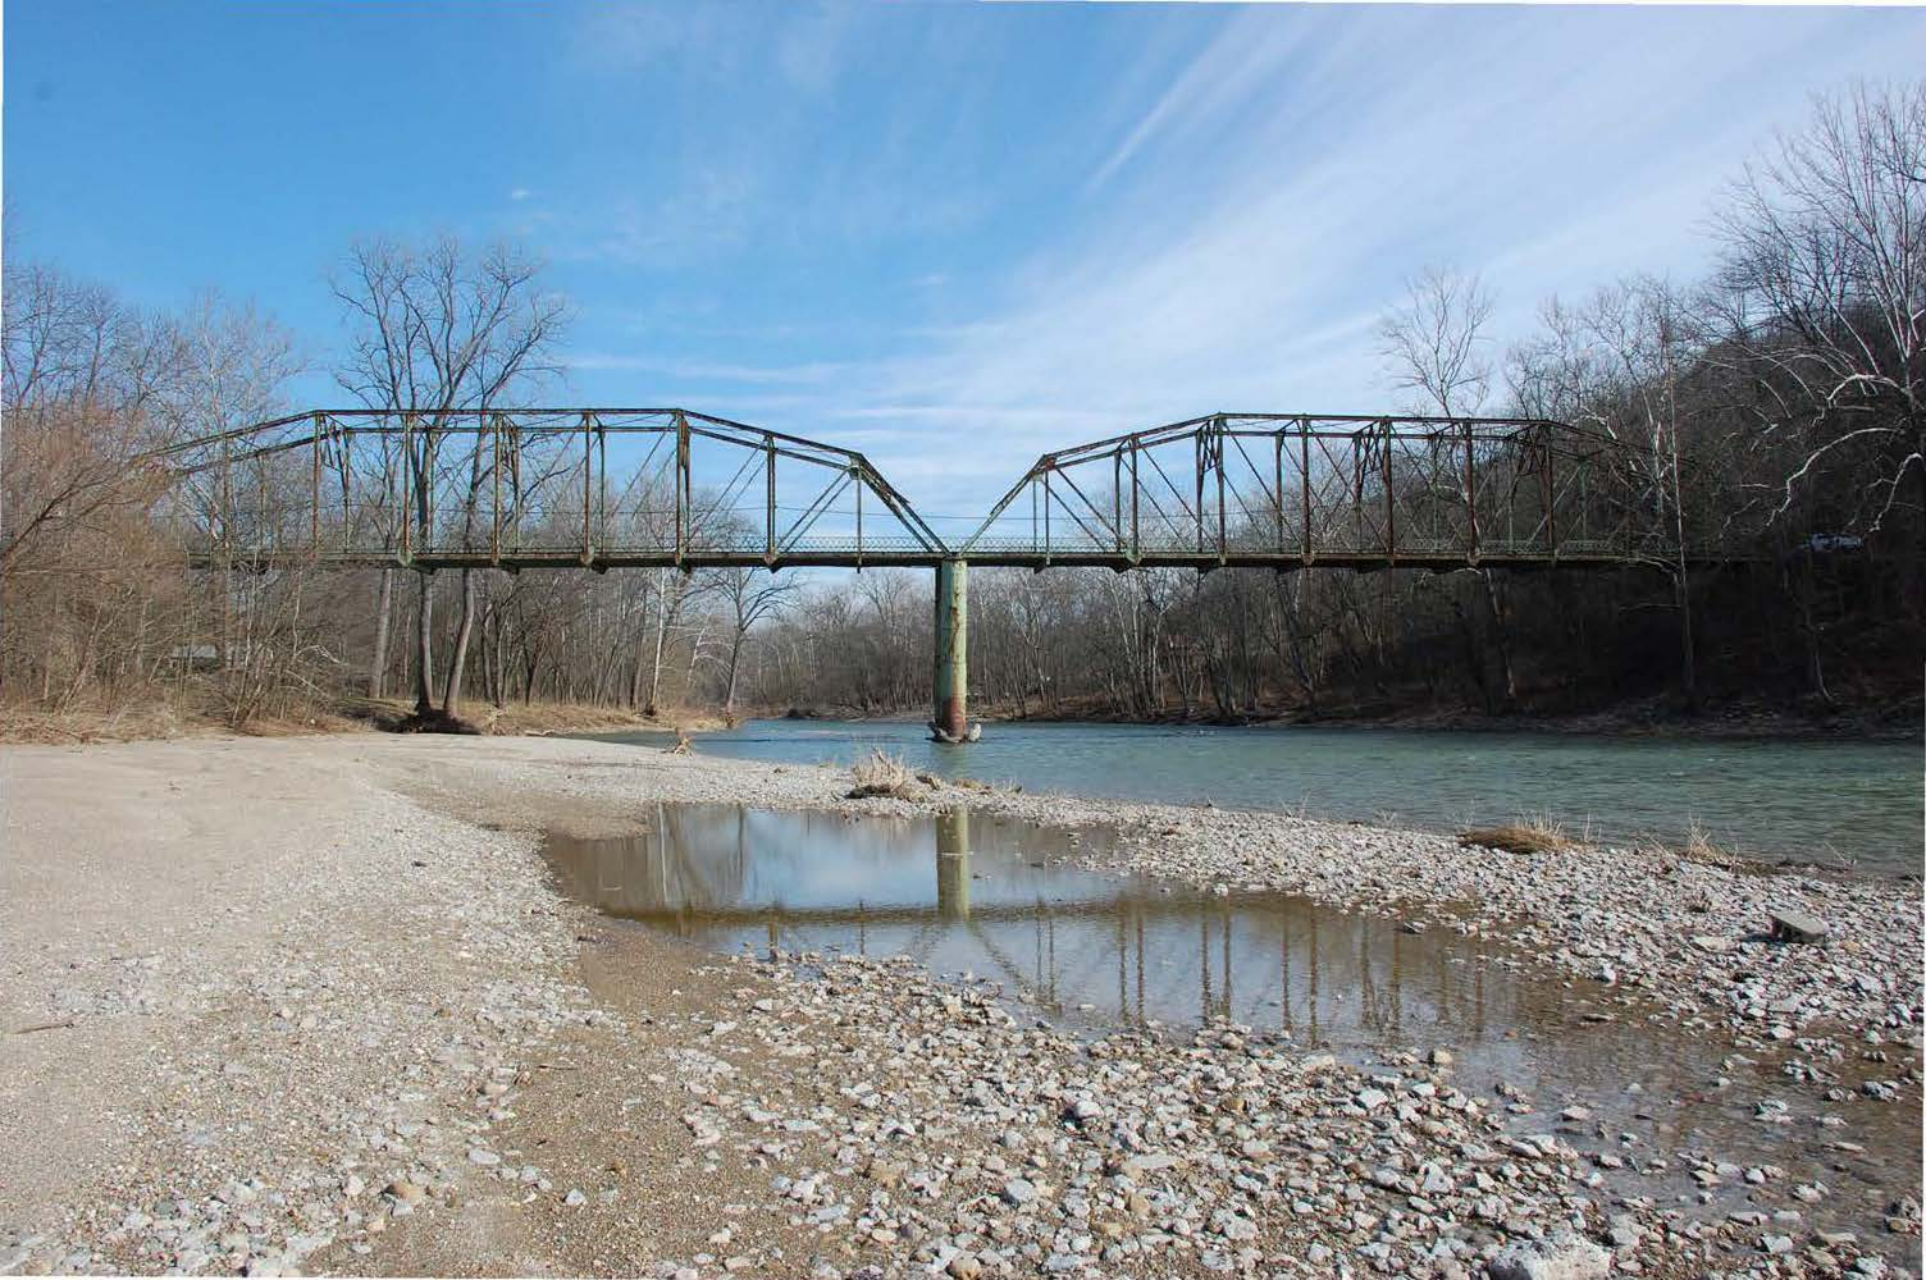
- 1 of 10 Looking east (downstream) at the full length view of the Cedar Grove Bridge.
2. Looking north from the south abutment and south portal of the bridge. Note the condition of the deck but also the good condition of the main truss members. The bridge railing is in need of some repair, mainly straightening. This view also provides a view of the company's use angle iron and battens to fabricate lightweight bridge members without sacrificing strength in verticals and diagonals.

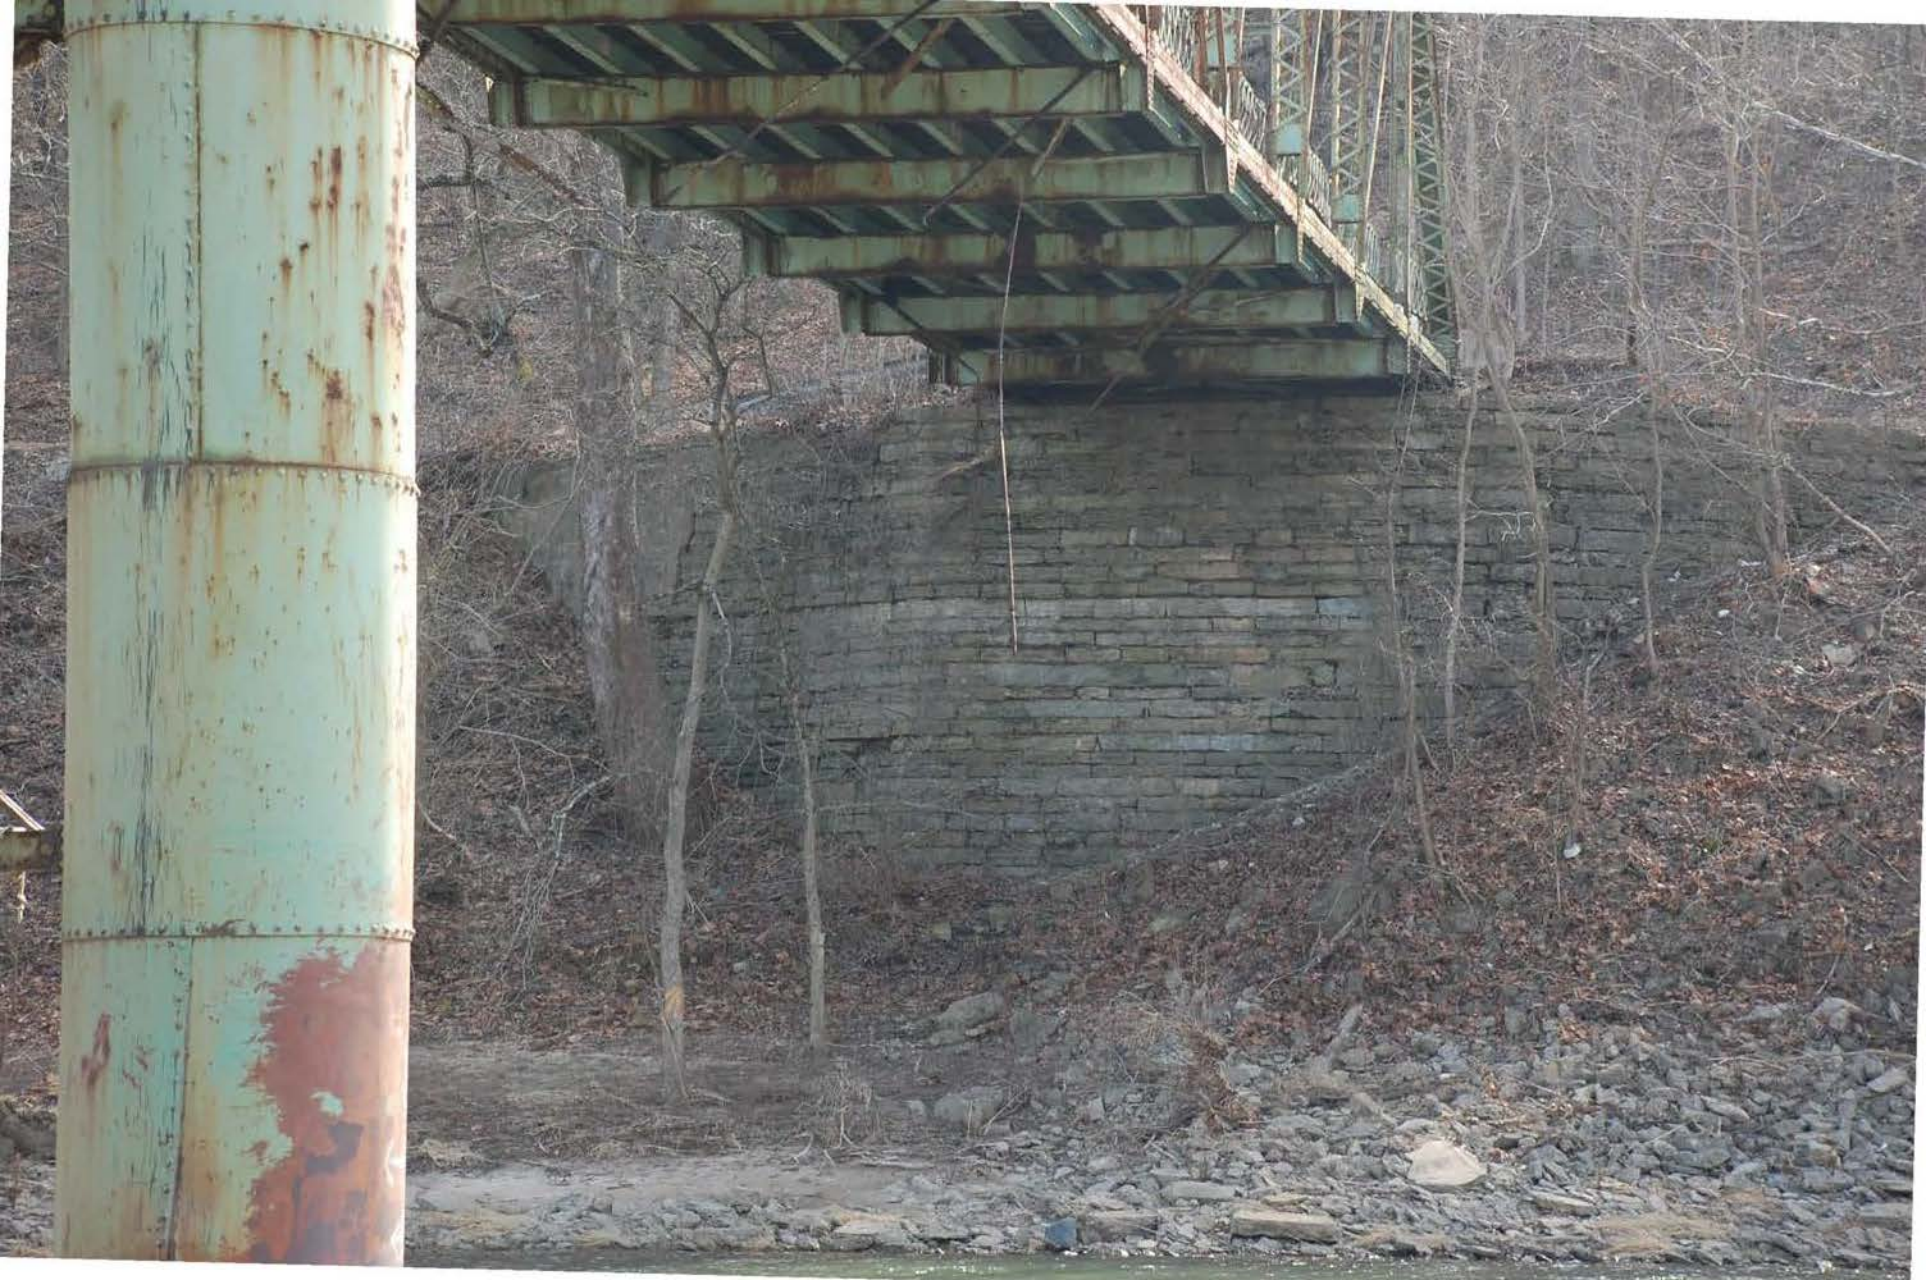
3. Looking south at the south abutment. The projecting course of stones defining the added height to the bridge seat is visible about 15 feet below the top of the face. The upstream caisson is visible in the left portion of the view. The remains of rusted through lower lateral bracing are also visible. Their absence, according to a report by a professional engineer, is not significant to the bridge's use for foot traffic.

The substructure of the bridge consists of abutments and a pair of metal caissons piers that support the spans at mid-point in the river. The abutments are original to a three-span superstructure built in 1870 and lost in the great 1913 flood and date from 1870. A projecting course of stone on the south abutment, approximately two-thirds up the face, shows the additional height applied to the old abutments to deal with future flood conditions in the river (Photograph 3). The north abutment appears to have had a parge coat of cementitious material applied to its surface. The round caissons are fabricated from riveted steel components. Sheet piling, encircling the caissons just above and below water level, protects them from scour (Photographs 4 and 5).¹

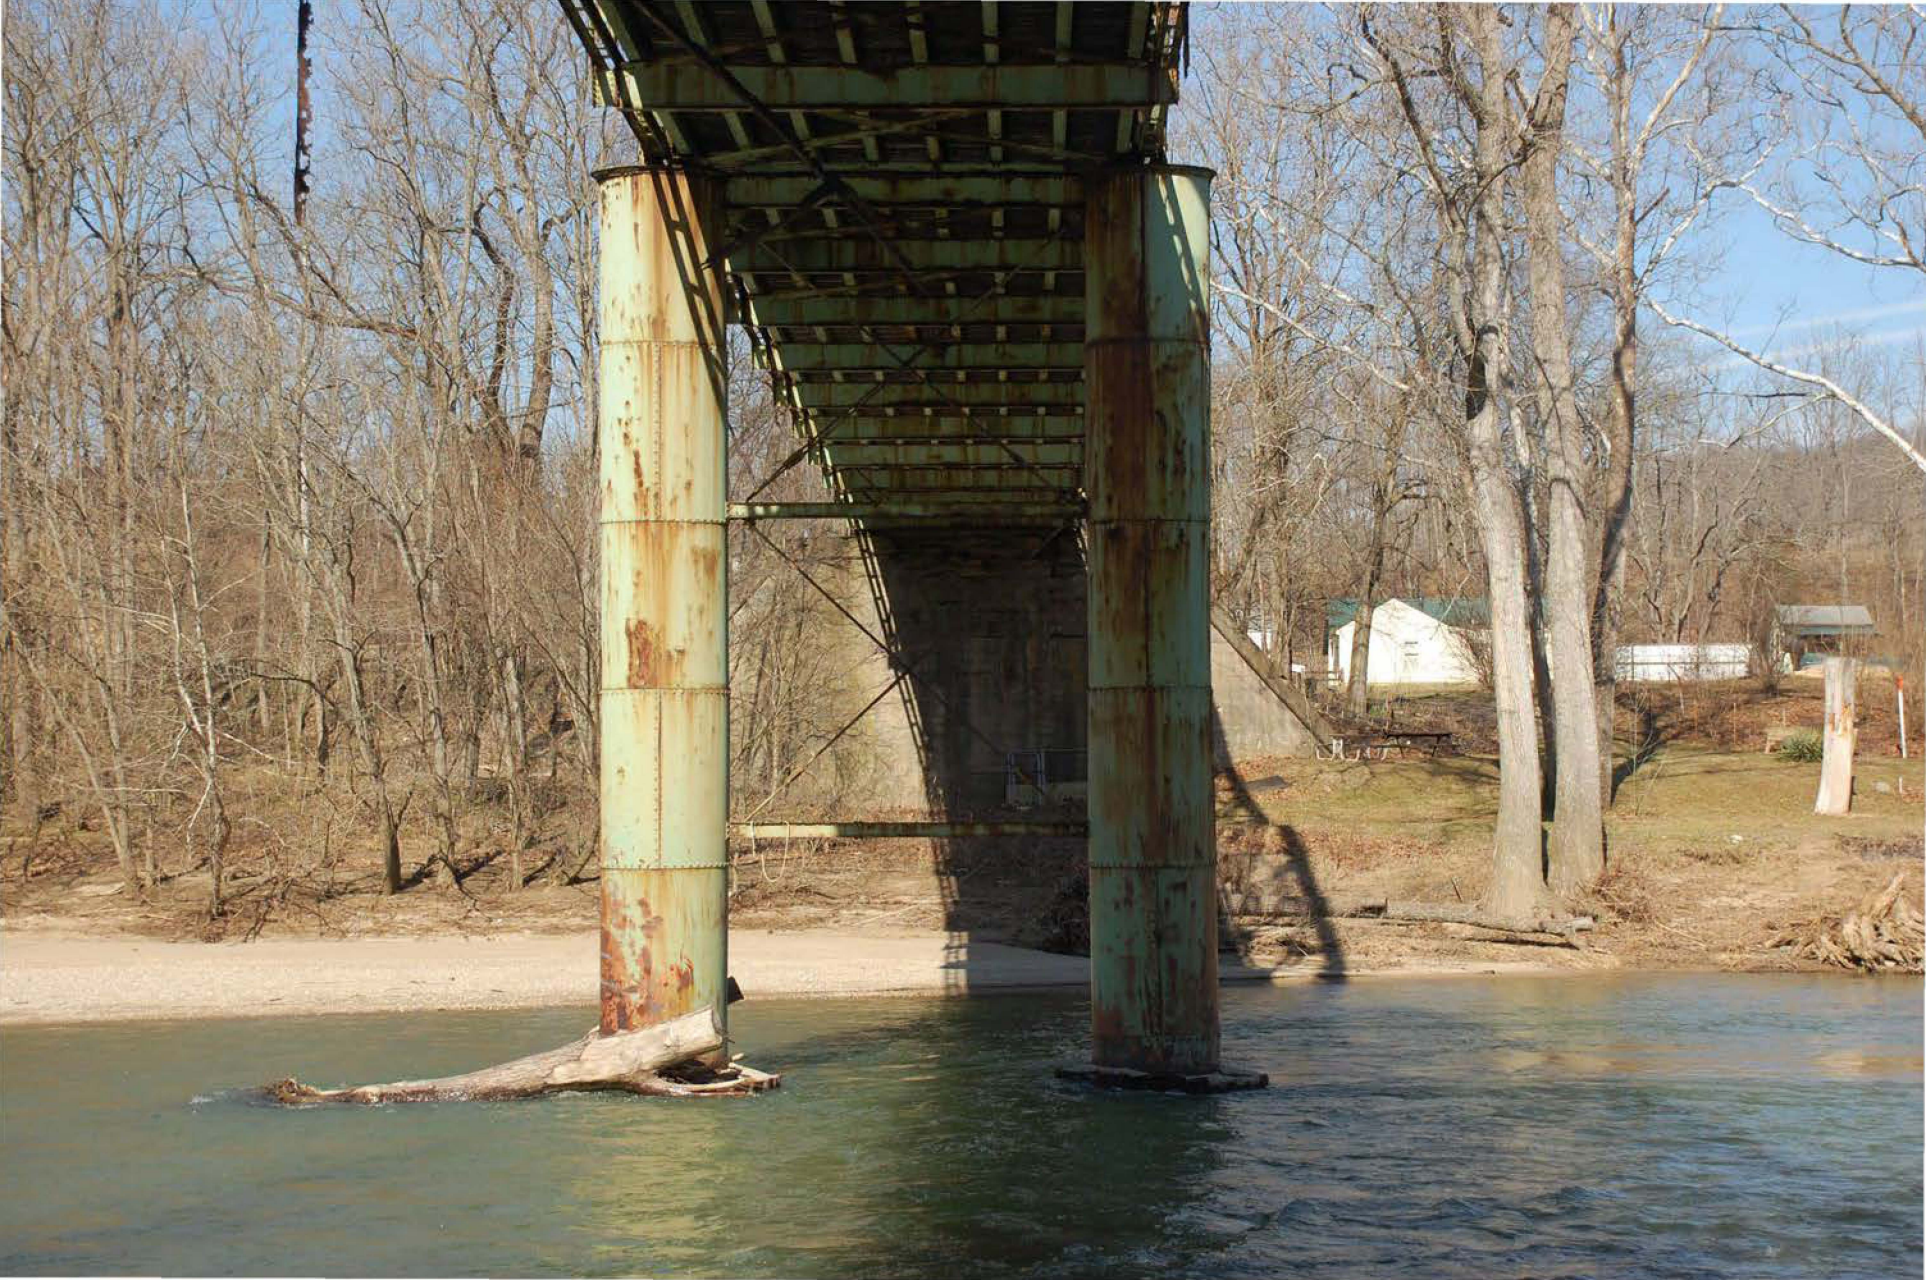
4. Looking north through the caissons at the north abutment. Visible below the end of the span are the stones from the original abutment; i.e., the 15-foot addition in height applied in 1914 to counter/minimize the effect of future floods on the bridge.

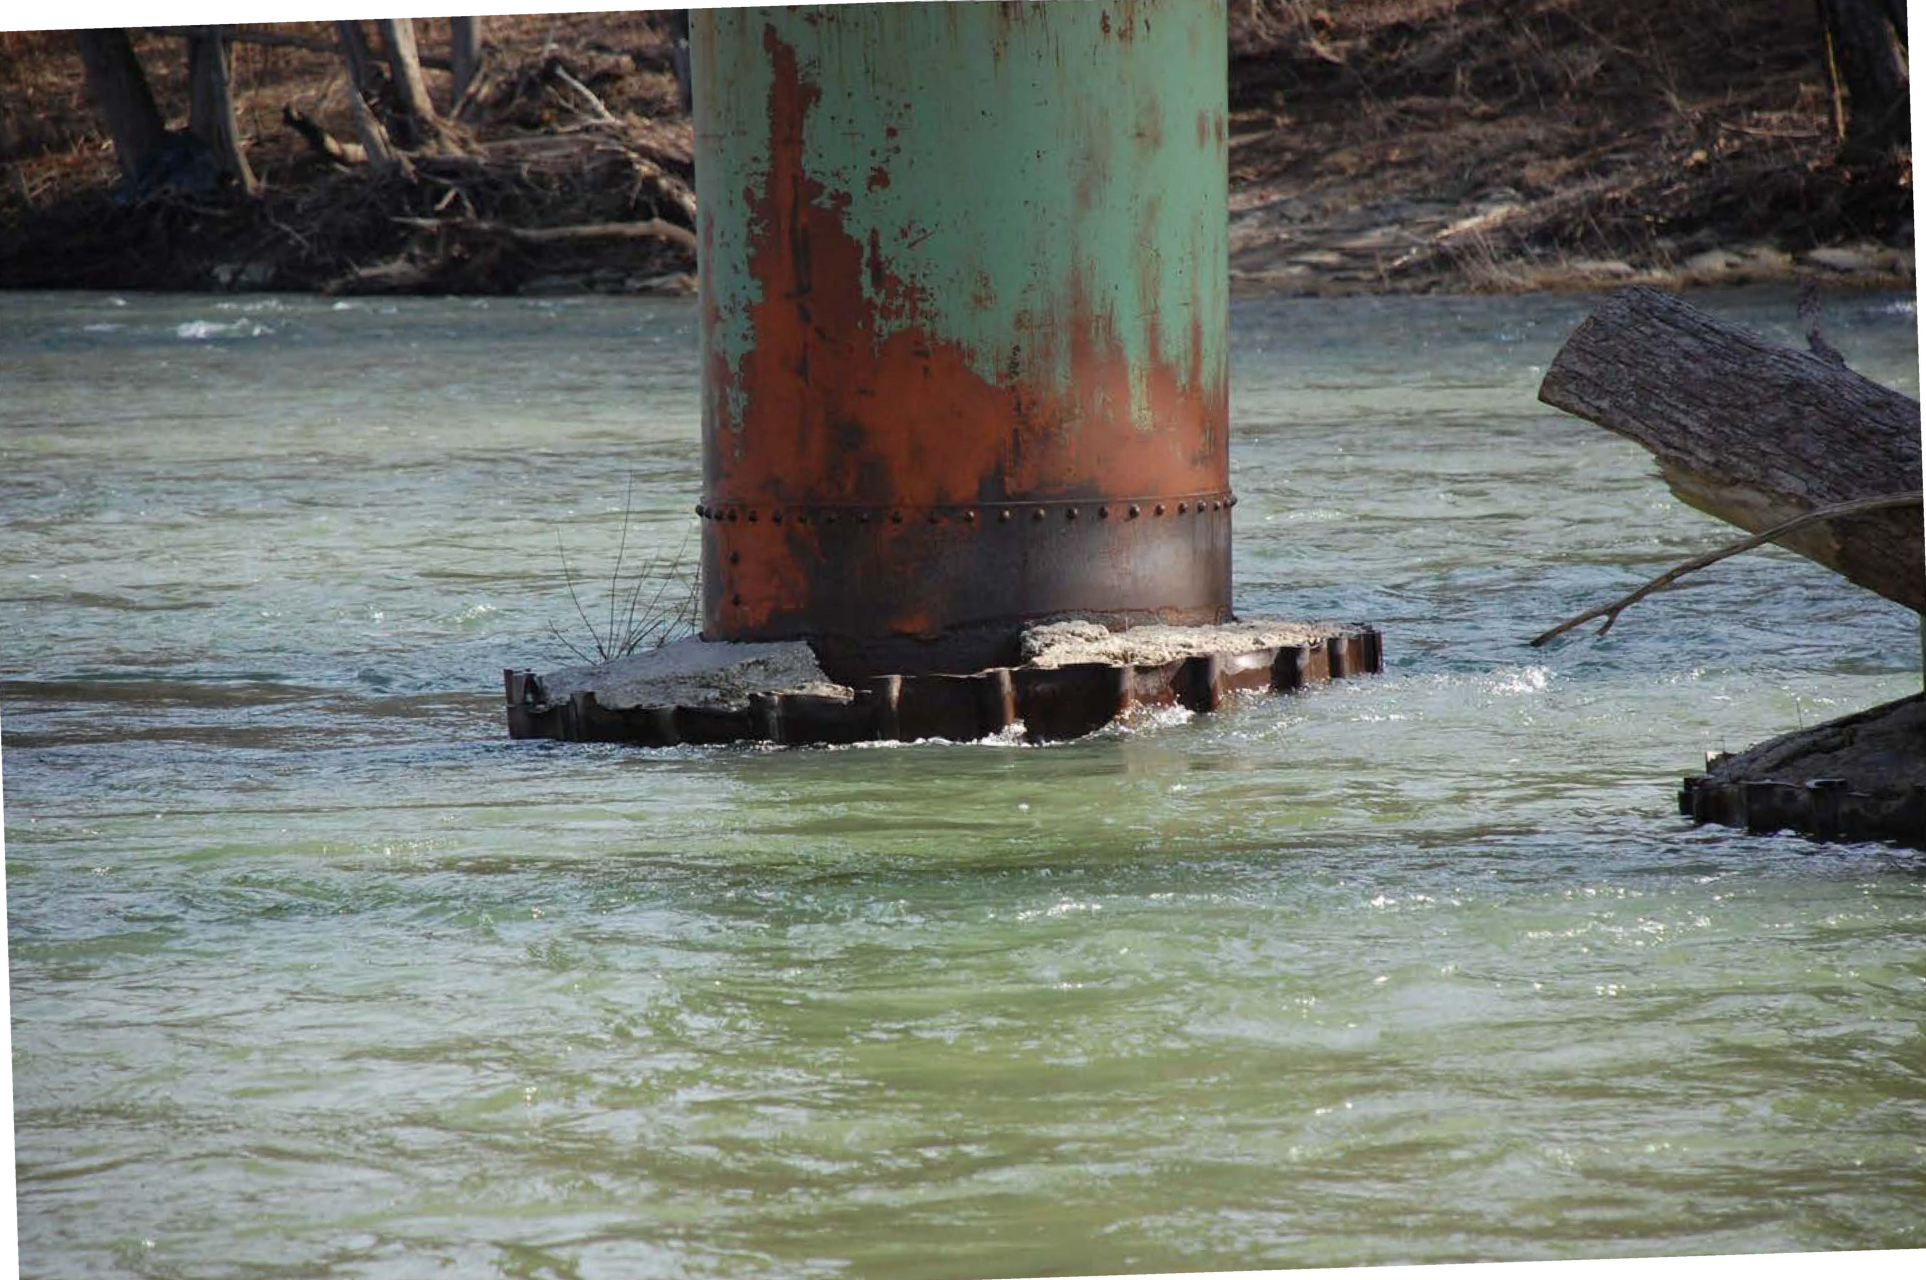
5. Looking southeast at the sheet piling around one of the caisson piers.
6. Looking up at the east truss of the south span. Visible in the photograph are examples of the connections at the gusset plates for the diagonals, counters, floor beams, bottom chord, and verticals. Also visible are examples of the use of angle iron and riveted battens to fabricate various truss members and the lacing on the verticals. The top lateral bracing and the sway bracing members are shown at the top of the view.
