National Register of Historic Places Registration Form

1. Name of Property	FILOEIVED 2280
Historic name: Lincoln Park Bathhouse	JUL 29 2016
Other names/site number: ZooZeum	Nat. Register of Historic Places
Name of related multiple property listing:	National Park Service

Lincoln Park Bathhouse 2000 Remington Place Oklahoma City, Oklahoma County, Oklahoma

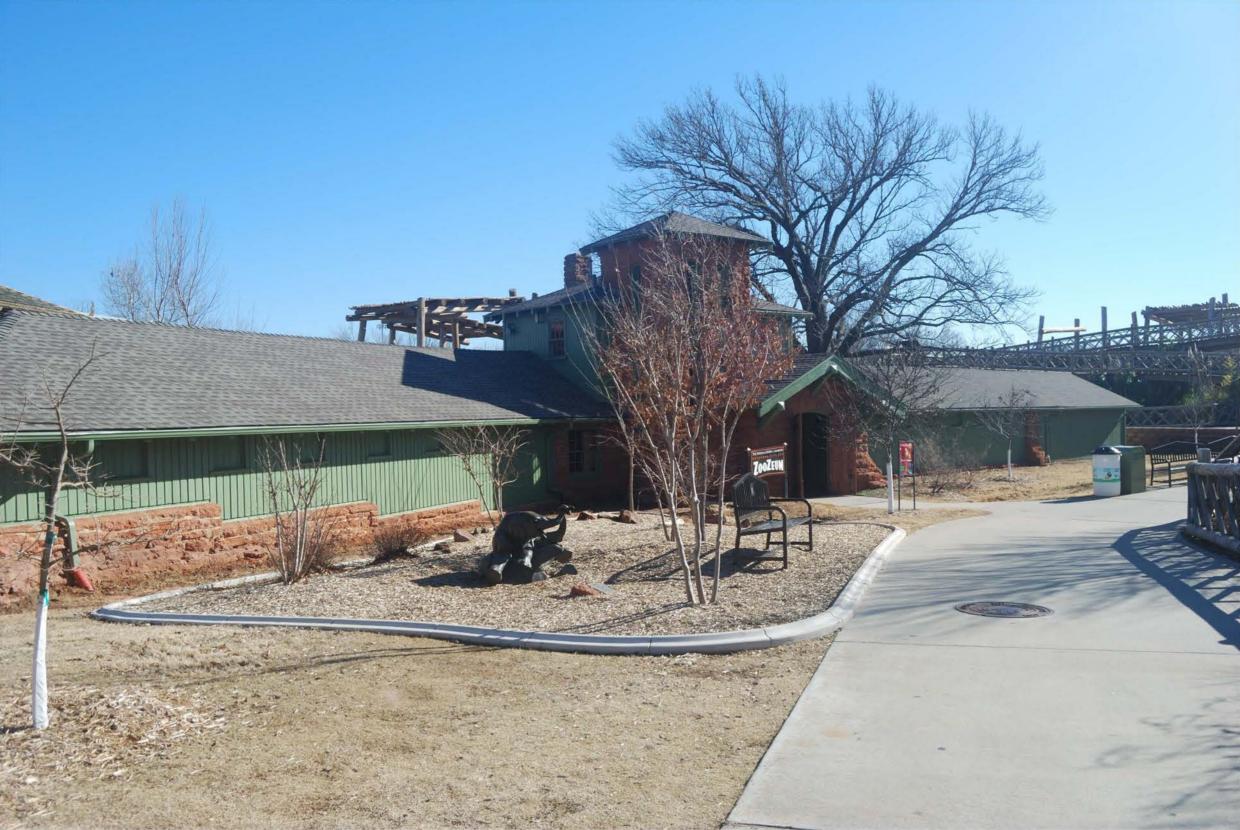
As the building functioned historically as a bathhouse, it has two primary facades. The northwest elevation is how anyone entering from the neighborhood would approach the building. The building is really three distinctive sections: the center two story section; a one story wing that extends to the north at an angle; and, a one story wing that extends to the southwest at an angle. The center section has a slightly projecting one-story gable front entry. The gable roof has large wood fascia boards and large wood brackets. This one-story entry is faced with rusticated stone and has an arched entry with wood doors. The southwest elevation of this entry has a six-oversix wood double hung window. Adjacent to the entry to the north is a two-and-one-half-story tower capped with a pyramidal roof with exposed rafter tails. The tower is faced with rusticated stone. On the northwest elevation of the tower are two, rounded arched windows with stone lintels and sills. One window has eight panes while the other has eleven panes. The north elevation of the tower has one rounded arched window with stone sills and lintels. This window has twelve panes. The southwest elevation of the tower has one rounded arched window with stone sills and lintels. This window has seven panes. The two-story portion of the center section is clad with vertical wood siding. The first floor of the northwest elevation is concealed by the one-story entry and the tower. The second floor has a twelve-pane wood frame window. The north wing is clad in both rusticated stone in a stepped pattern as it extends down the northwest elevation and vertical wood siding that extends to the roof eave. Adjacent to the tower is an eight-over-eight wood double hung window. Extending along the north wing are seven square window openings framed in wood that are covered with wood siding. The southwest wing has rusticated stone at the foundation and a stone pilaster approximately two-thirds along the elevation. Between the central portion and the pilaster are seven square window openings framed in wood that are covered with wood siding. Beyond the pilaster is a vertical wood sided portion that has no openings.

Photograph Number	Subject	Direction	
0001	Park Side Façade	Southeast	
0002	Park Side Entry	Southeast	
0003	Park Side Façade	North	
0004	Lake Side Entry	Northwest	
0005	North Elevation	South	
0006	Interior of Tower

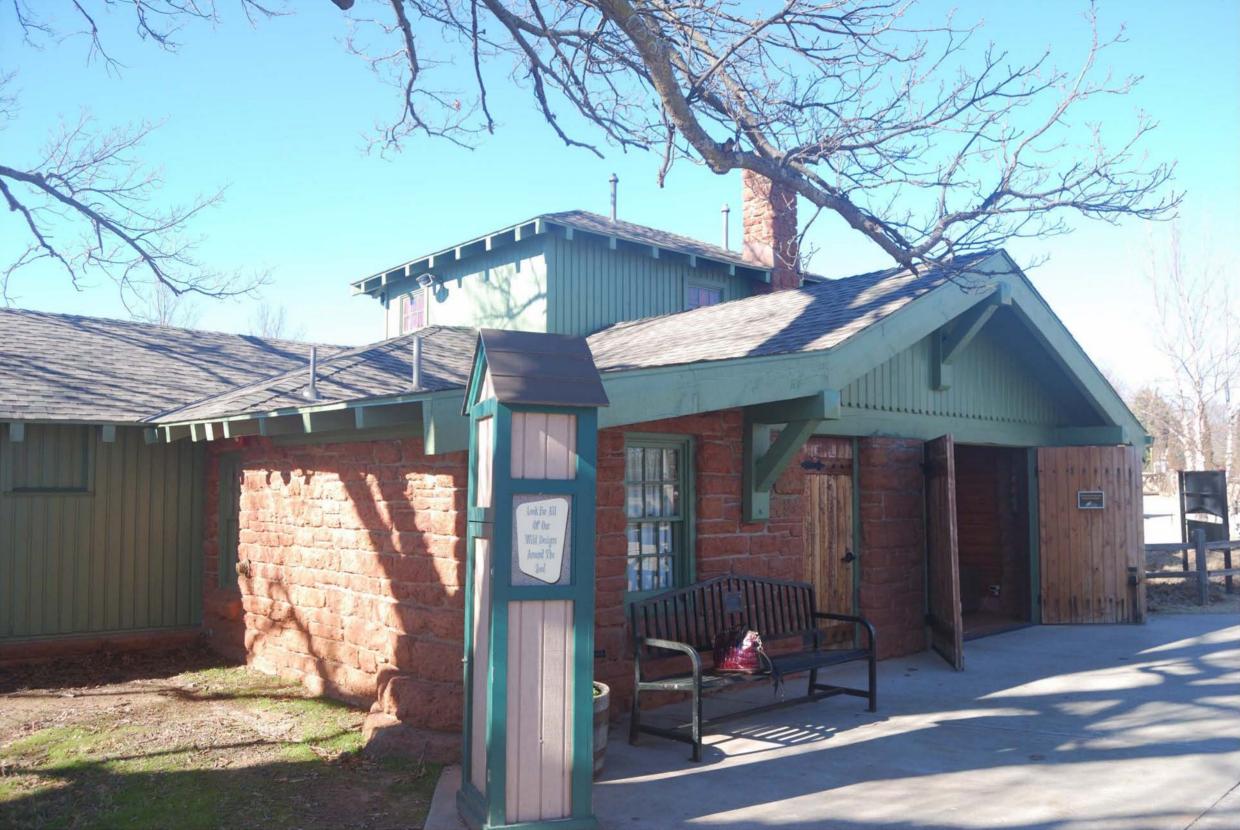
The second façade is how anyone entering from the lake side would approach the building. The building is really three distinctive sections: the center two story section; a one story wing that extends to the north at an angle; and, a one story wing that extends to the southwest at an angle. The center section has a full one-story gable front entry that is clad in rusticated stone. From southwest to northeast is a six-over-six wood double hung window, a small entry door, and a double entry door. The gable end has vertical wood siding, a large fascia board and large wood brackets at the gable eaves. The southwest elevation of the one-story central section has a sixover-six wood double hung window and exposed rafter tails. The northeast elevation has both rusticated stone and vertical wood siding. A chimney is located on this elevation. The two-story central section has a six-over-sox wood double hung window and exposed rafter tails. Both the north and southwest elevation of the central two-story section has a six-over-six wood double hung window. The north wing has two wood frame six-over-six double hung windows, five square window openings framed in wood that are covered with wood siding and a wood entry door. Rusticated stone is located at the foundation and a stone pilaster is located at the northeast corner. The southwest wing has three square window openings framed in wood that are covered with wood siding and rusticated stone at the foundation. The remainder has no openings.

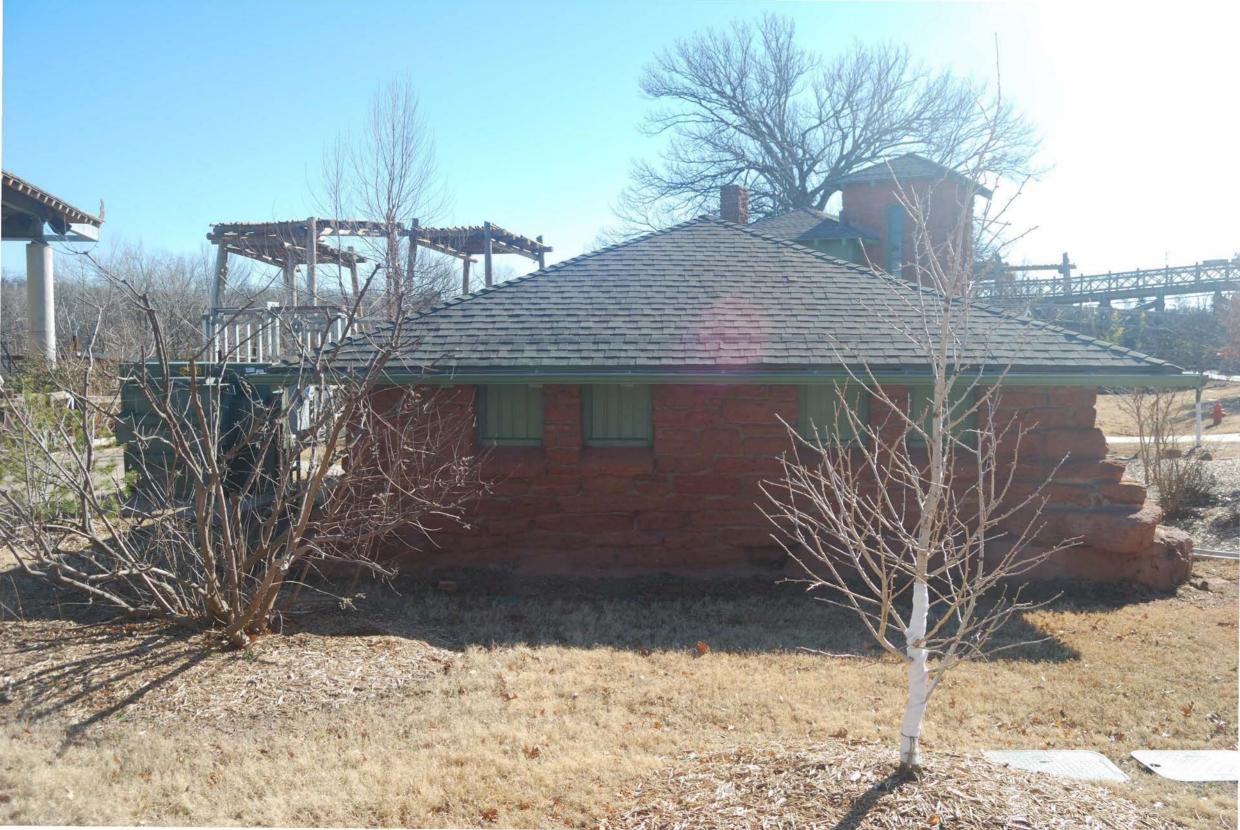
Name of Property County and State The north elevation is clad with rusticated masonry and has stone pilasters at each corner. There are four square window openings on this elevation that are clad with vertical wood siding. The southwest elevation is clad with vertical wood siding. It has one metal entry door.

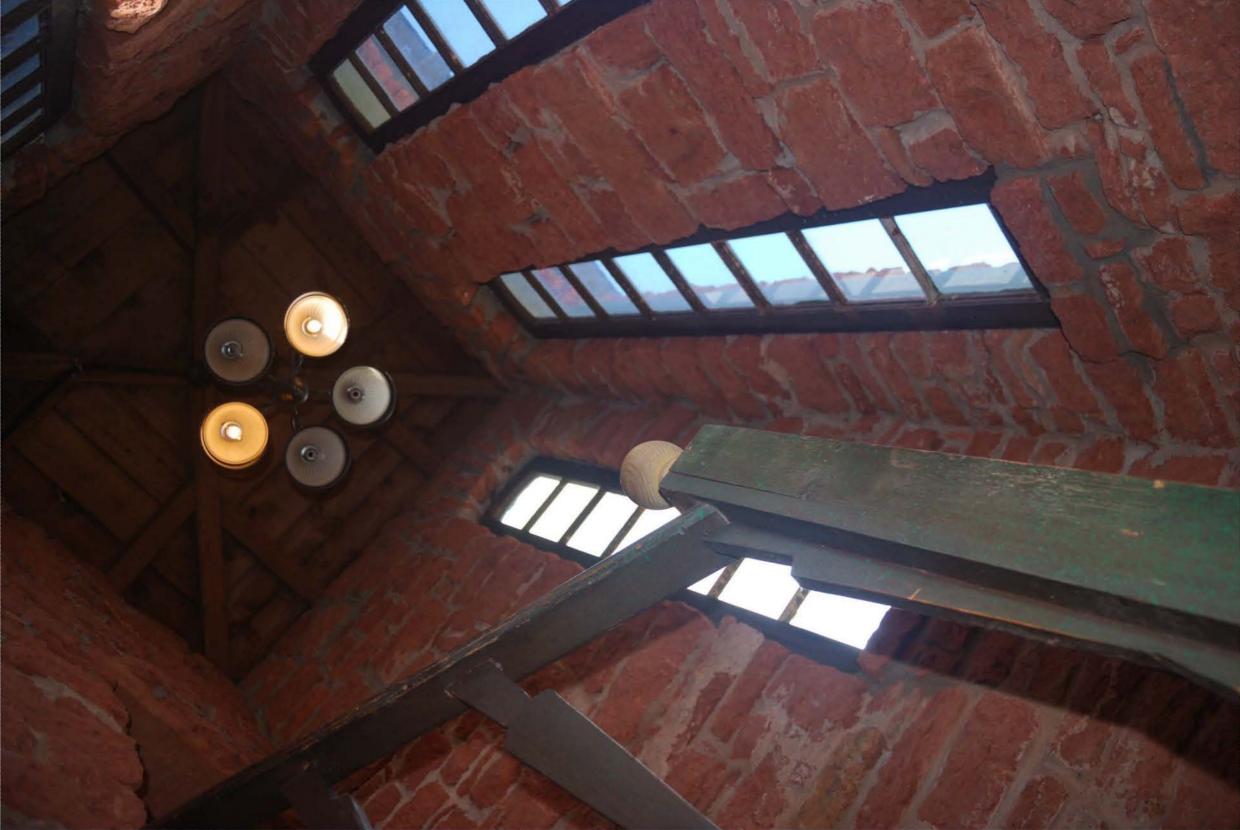
While the interior has been altered to accommodate the museum function of the Oklahoma City Zoo, many defining characteristics are extant. The exterior stone continues through to the interior of the bathhouse. The wooden staircase extends through the tower to the upper level that now houses the mechanical systems. The main floor space still maintains the divided spaces with each wing dedicated to specific uses and the central portion still functioning as the pass-through from one elevation to the other.
