National Register of Historic Places
Registration Form

historic name Ibach House

street & number 1908 Ridge Road

Ibach House, Lake, IN

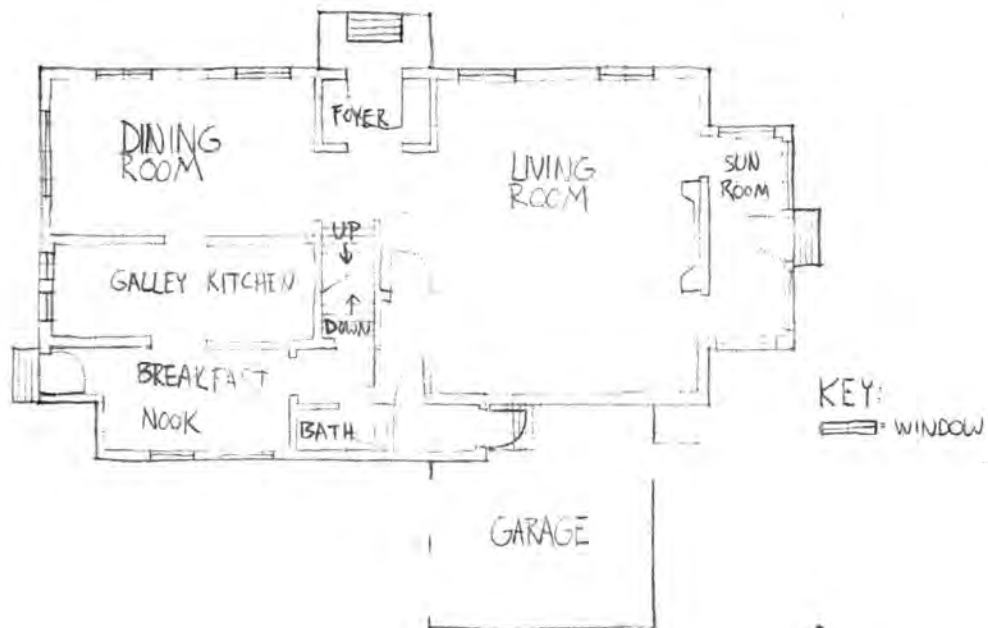
IBACH HOUSE, MUNSTER, LAKE COUNTY, IN
ORIGINAL FIRST FLOOR PLAN c.1924
(APPROXIMATELY)

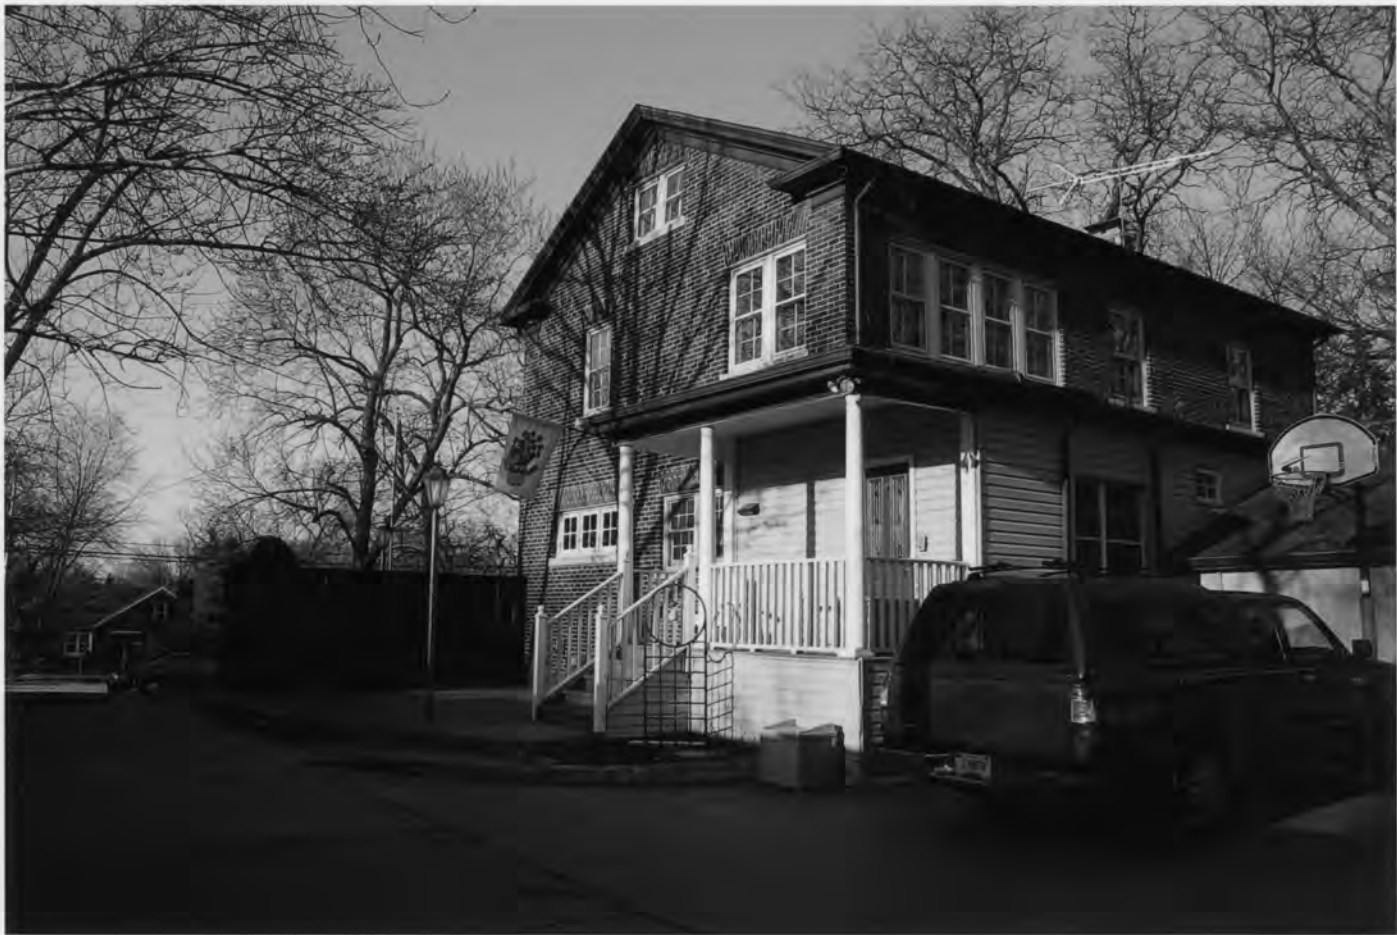
Ibach House, Lake Co., IN #6

6. Soldier bricks above foundation wall: Camera facing northwest

The home sits on a concrete block foundation with a ribbon of soldier bricks sitting atop of it before the exterior wall of stretcher bricks begins. This detailing can be found on all sides of the original body of the home.
