NATIONAL REGISTER OF HISTORIC PLACES
REGISTRATION FORM

historic name McCanless, Napoleon Bonaparte, House

street & number 619 South Main Street not for publication N/A

state North Carolina code NC county Rowan code 159 zip code 28144

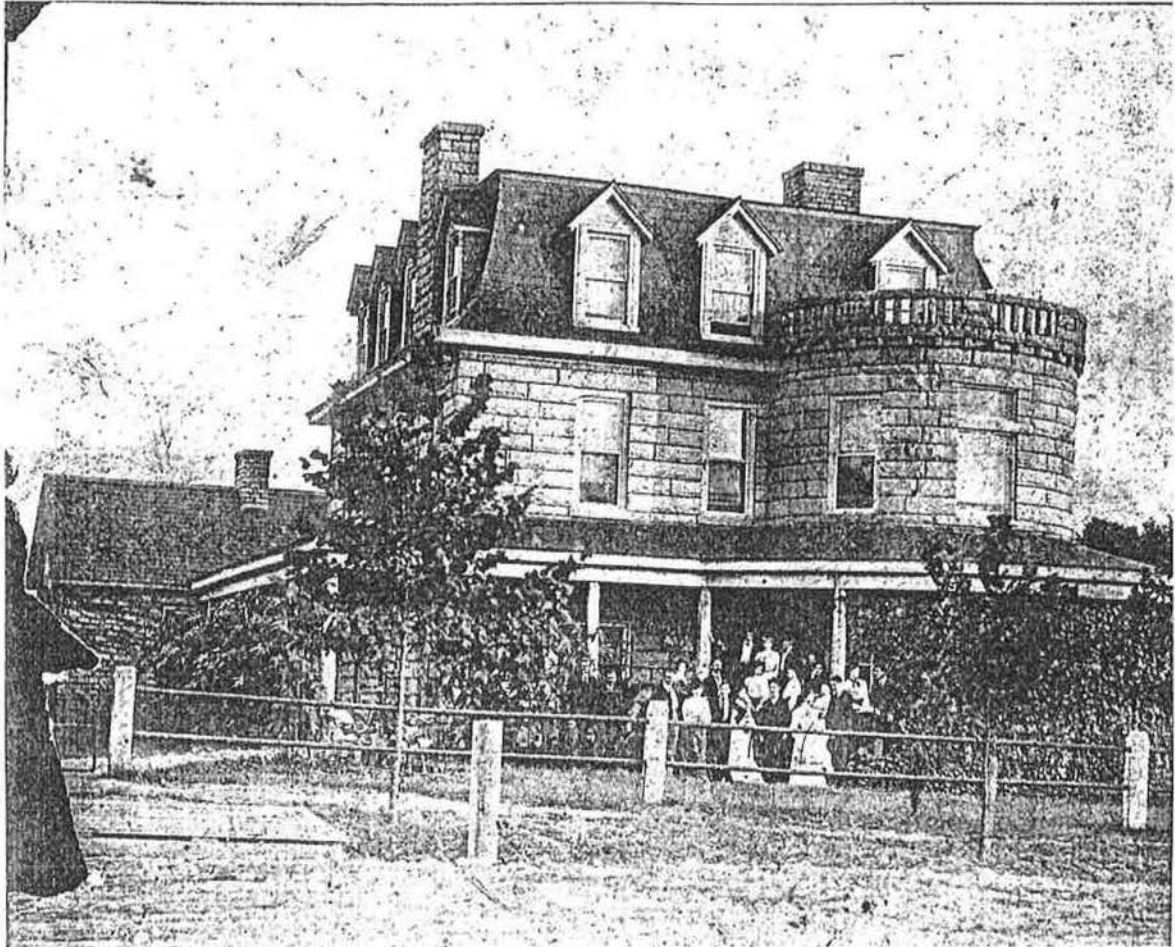
Section Number Documentary Photo Page 28

Ca. 1900 documentary of house with family. Photo courtesy of Mary Jane Fowler, great-granddaughter of N. B. and Georgia McCanless.

The physical integrity of the Napoleon Bonaparte McCanless House differs on the exterior from the interior. Judging from a ca. 1900 overall photograph of the house taken several years after its construction, the exterior remains remarkably intact. It retains its original three-story, three-bay-wide and four-bay-deep form with its round corner tower and wraparound porch. It retains its Second Empire styling with its third-story concave mansard roof with gabled dormers. The exterior retains most of its original materials, including its strong, rusticated-granite facing, its granite chimneys, its granite porch, and the decorative slate tiles that sheathe the roof and dormers. The house retains its unusual wraparound porch with tapered granite posts set on granite blocks and robust granite balustrade that is repeated around the flat roof of the tower. The structure of the porch roof remains intact, but the wood ceiling, boxed cornice, and fascia board are missing, and the replacement plywood decking is covered with asphalt shingles. The condition of the porch roof appears to be the result of unfinished repairs in recent years.

Several young trees in the front yard and the granite-post-and-metal-pipe fence shown in the ca. 1900 photograph do not survive. Despite the changes described above, the most essential features that define the exterior of the house survive in good condition, so that if Napoleon Bonaparte McCanless were riding down South Main Street today, he would have no problem recognizing the house that was his home from its construction in 1897 until his death in 1920.
