# National Register of Historic Places Registration Form

historic name Bedford Veterans Administration Hospital Historic District  
other names/site number Bedford Veterans Affairs Medical Center or Edith Nourse Rogers Memorial Veterans Hospital, Bedford, Massachusetts / BED.D

street & number 200 Springs Road NA not for publication  
city or town Bedford NA vicinity  
state Massachusetts code 25 county Middlesex code 17 zip code 01730

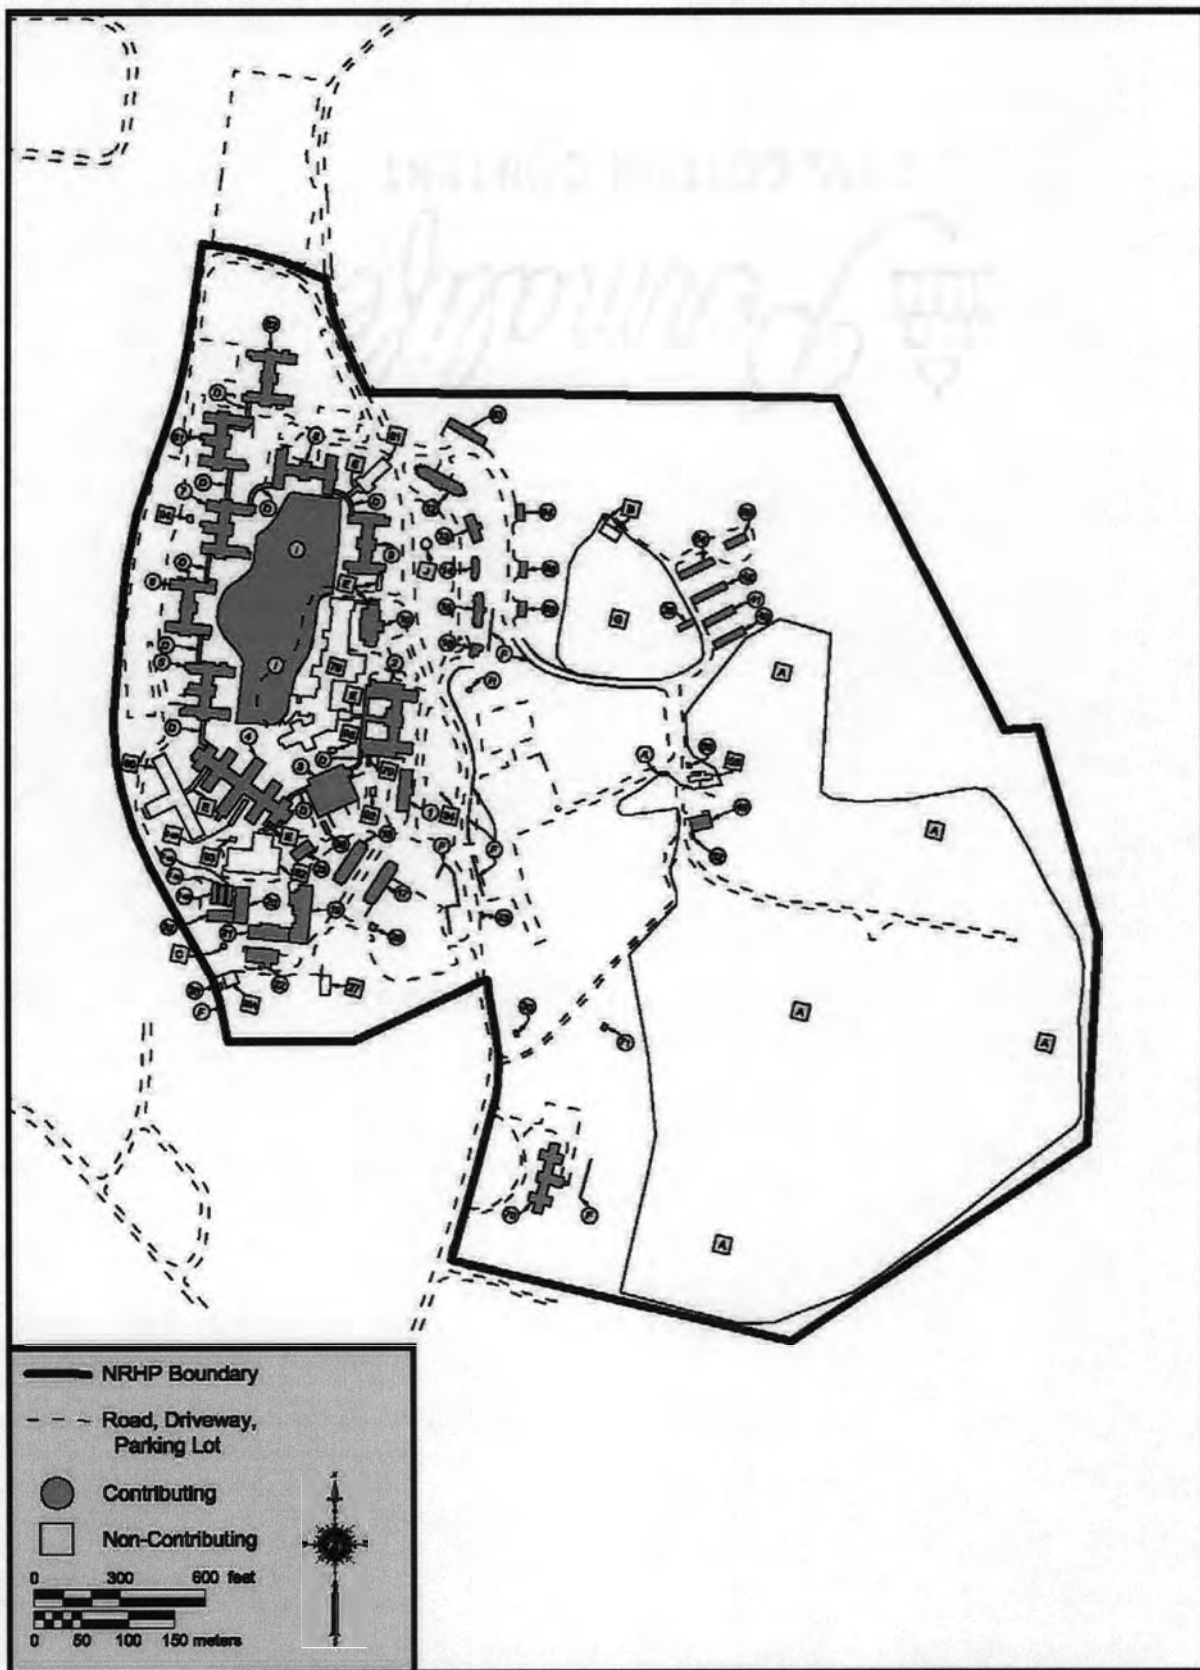
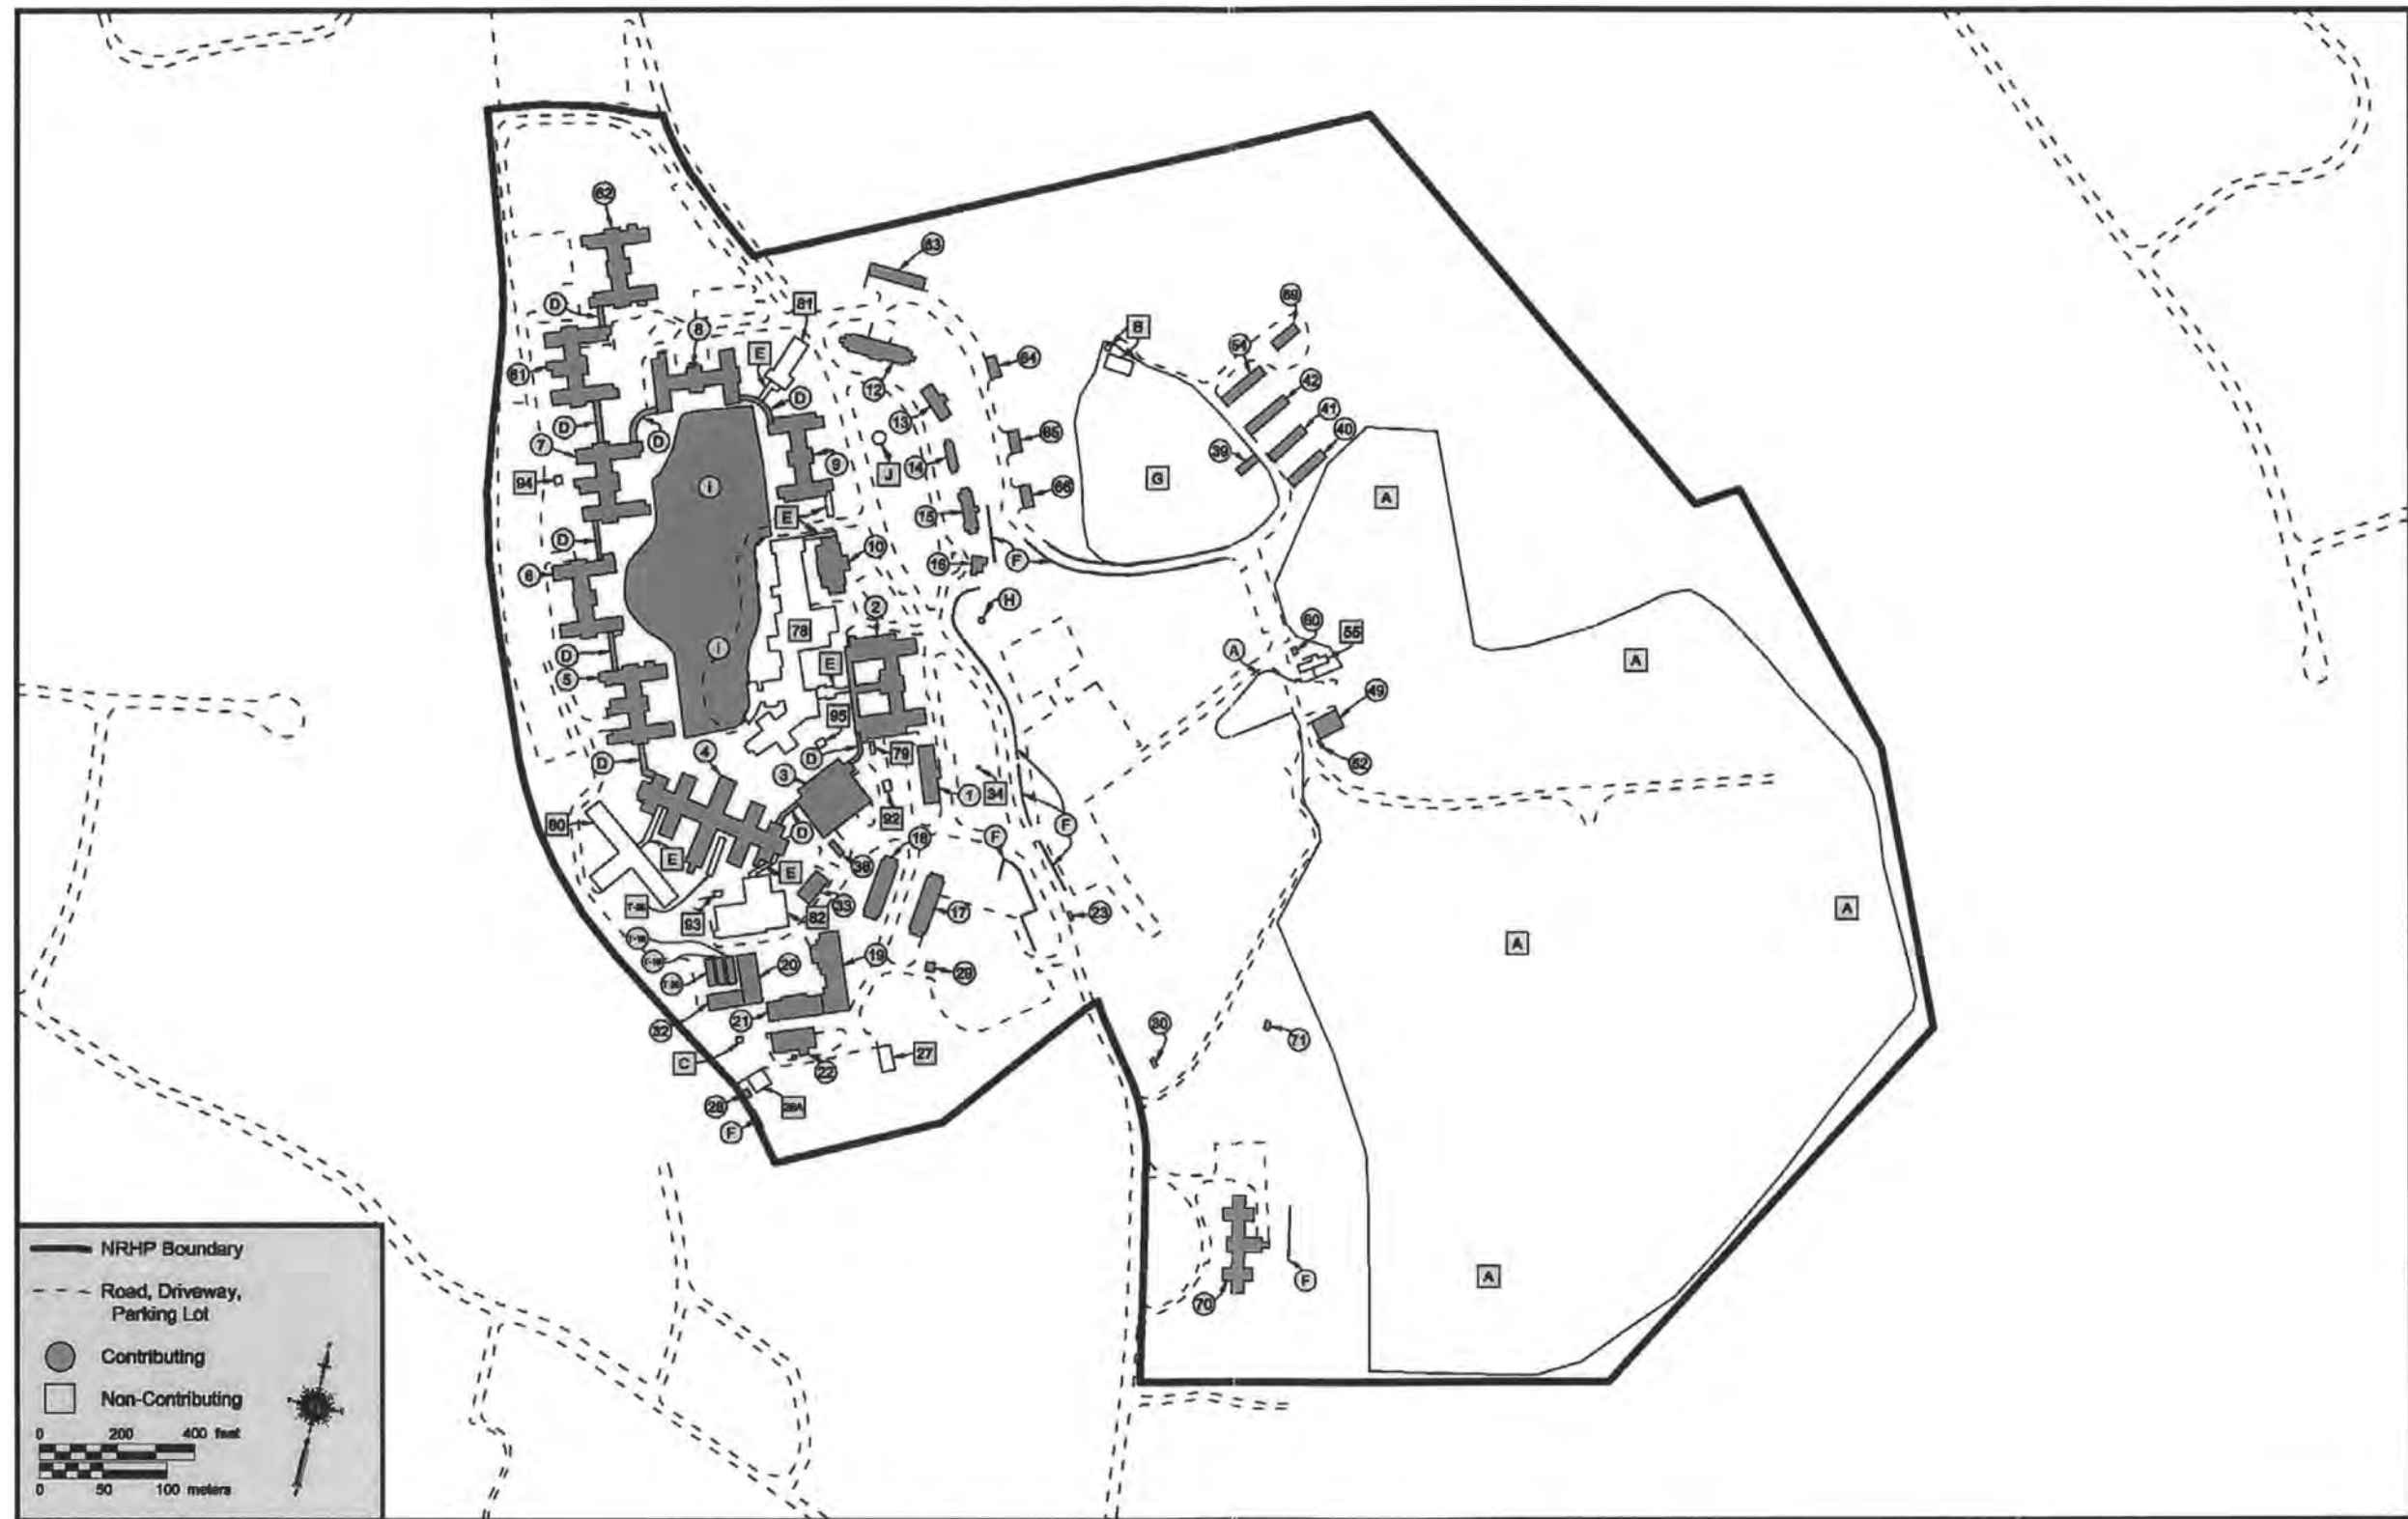
Sketch map indicating the National Register boundary, contributing and noncontributing resources.

Sketch map indicating the National Register boundary, contributing and noncontributing resources (oversize).

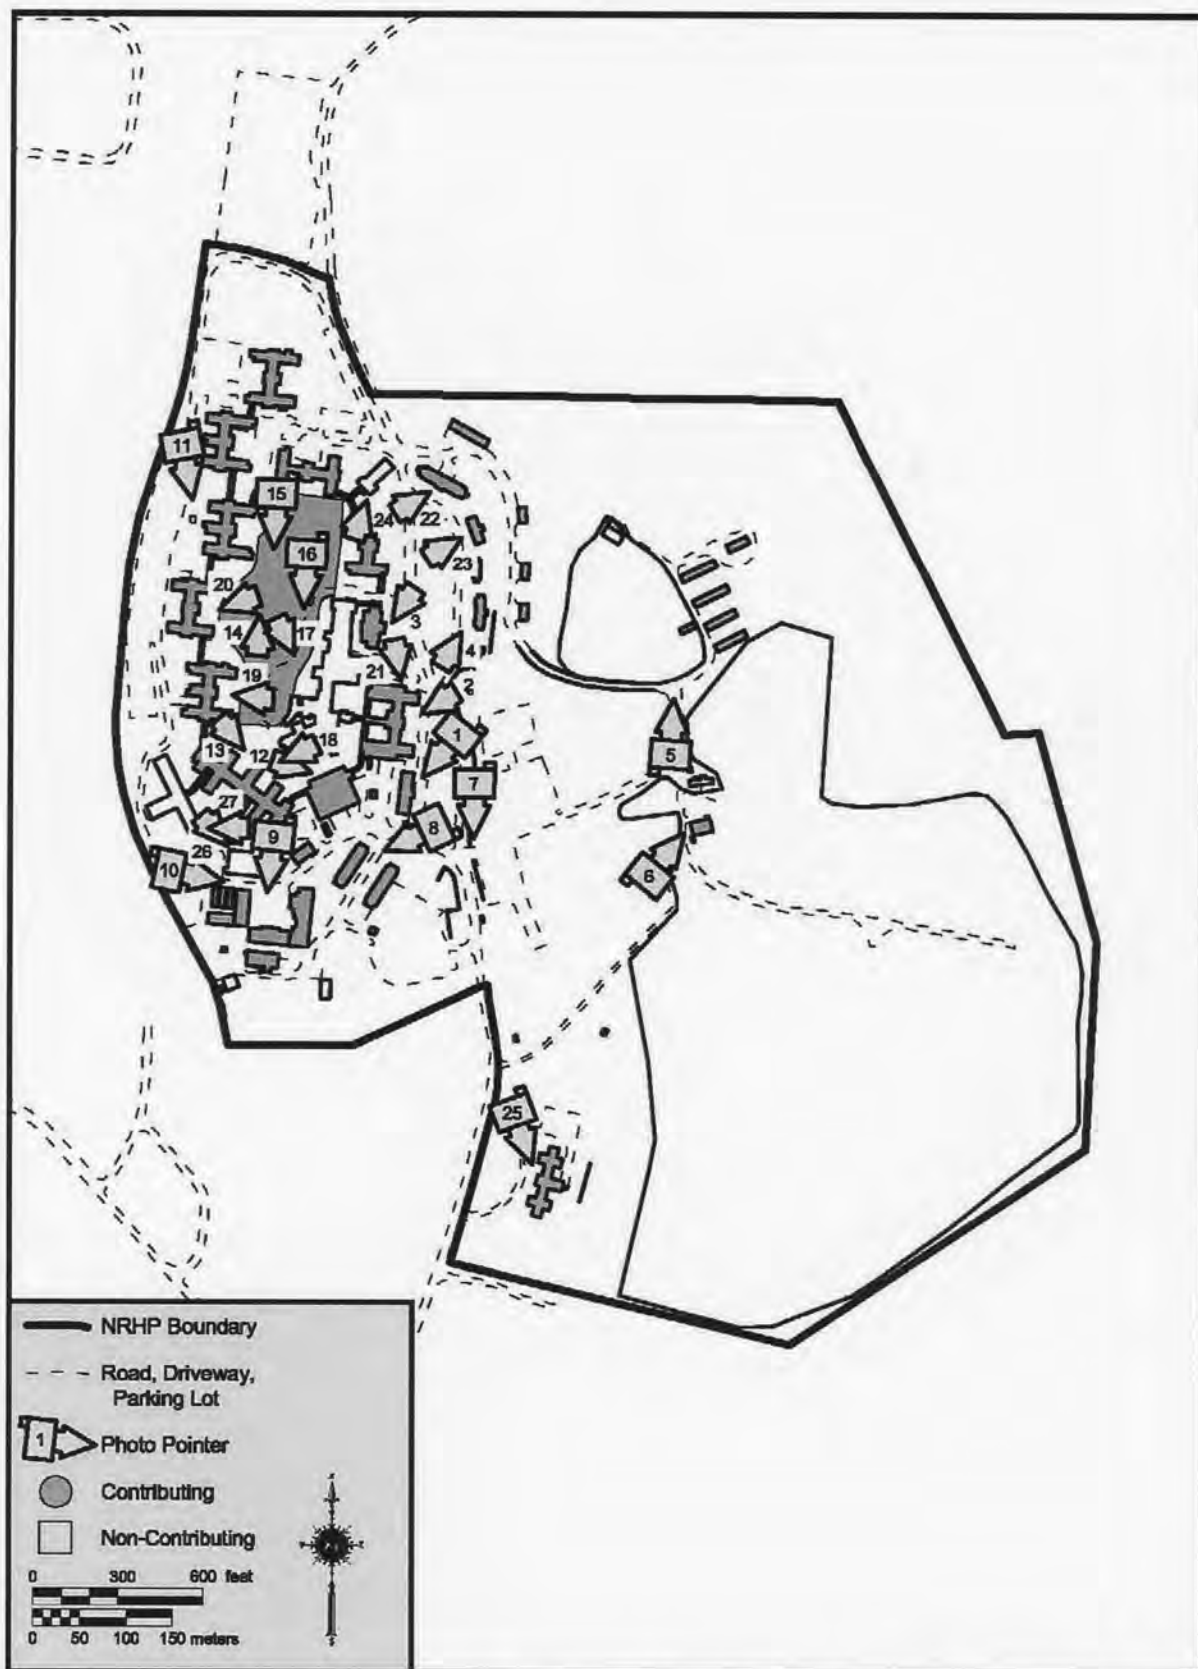
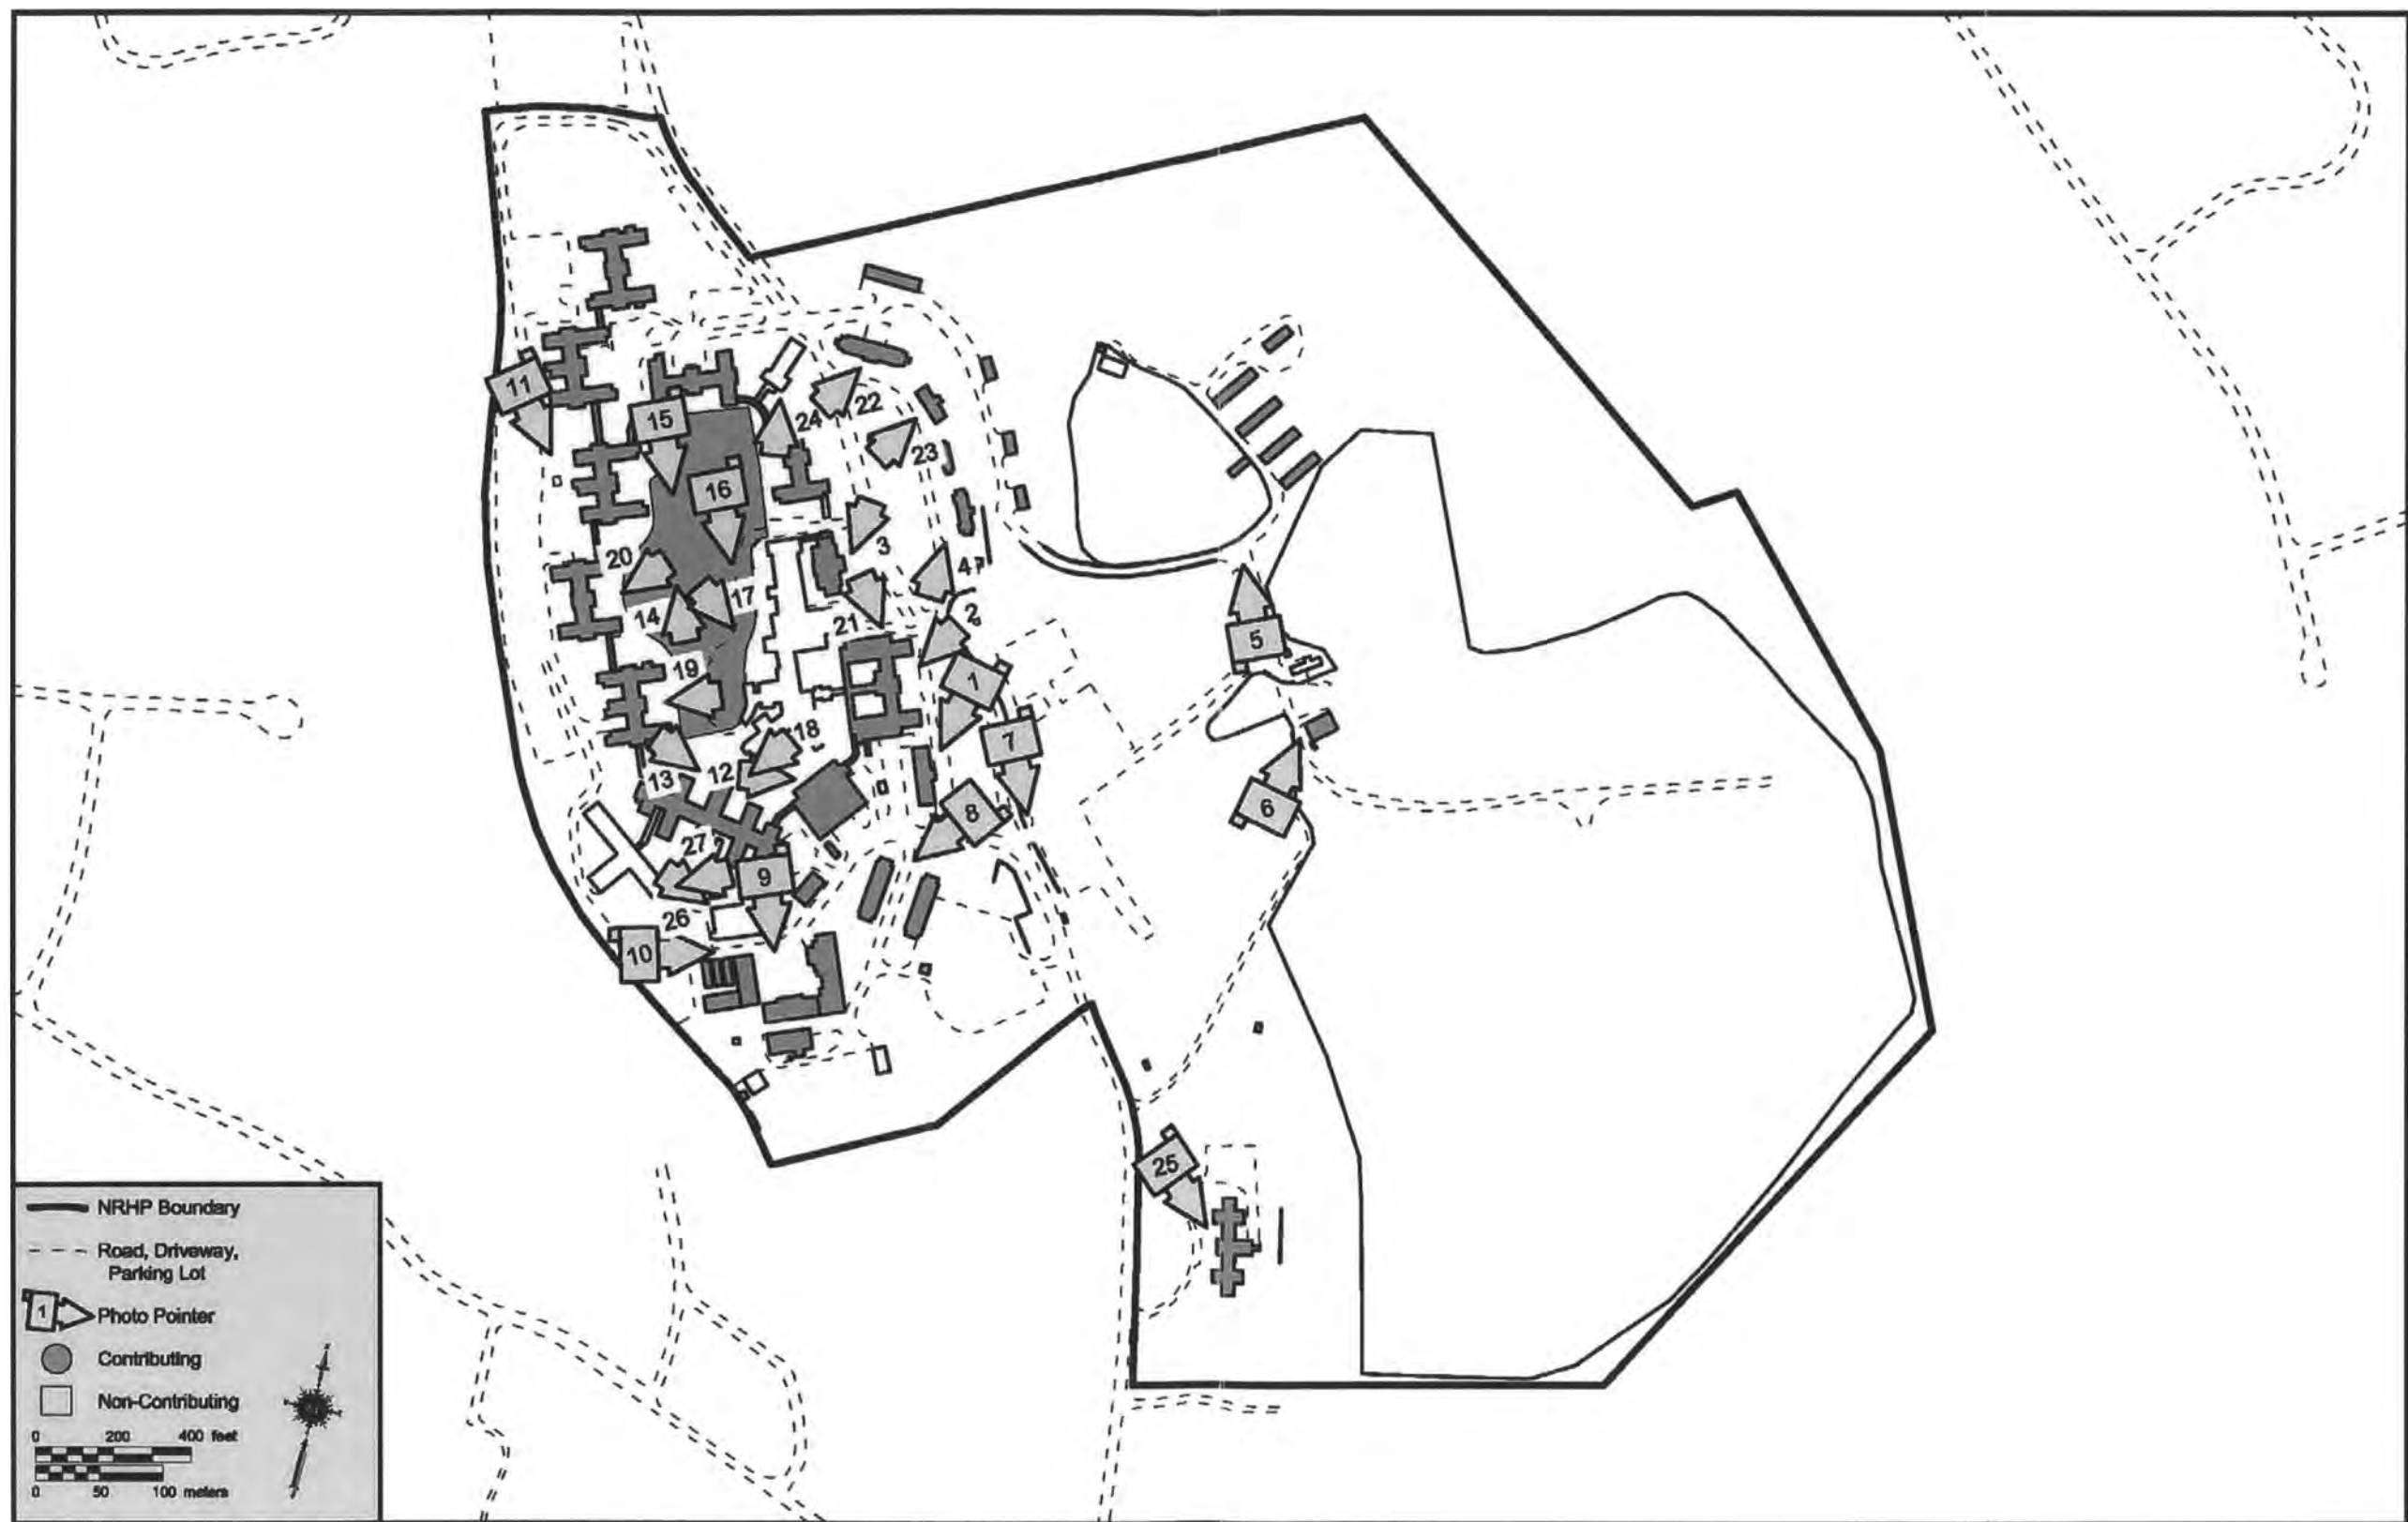
Sketch map indicating locations of photographs corresponding to those of the Photograph Continuation Sheet.

Sketch map indicating locations of photographs corresponding to those of the Photograph Continuation Sheet (oversize).

19. View to the west-northwest to the facade (east elevation) of Resource 5.
20. View to the west-southwest to the facade (east elevation) of Resource 6.
21. View to the south-southeast to the north elevation of Resource 2.
22. View to the northeast to the facade (southwest) elevation of Resource 12.
23. View to the northeast to the facade (southwest) elevation of Resource 13.
24. View to the north-northeast to the facade (southwest) and southeast elevations of Resource 81.
25. View to the southeast to the facade (northwest) elevation of Resource 70.
26. View to the southeast to the facade (north) and west elevations of Resource 82.
27. View to the west to the facade (northeast) and southeast elevations of Resource 80.
