## KENTUCKY HISTORIC RESOURCES Individual Inventory Form

1. Name of Resource	:e:				
Henry Clay Sch					
2. Original Owner:					
Shelby County School Board					
3. Other Names:					
<u>None</u>					
4. Prehistoric Site Historic Site	× Building Structure	Obje Oth			
5 Location:					
Laste	nd of Clay Villa	ge, so	outh		
side o	f U.S. 60

Resource # 113

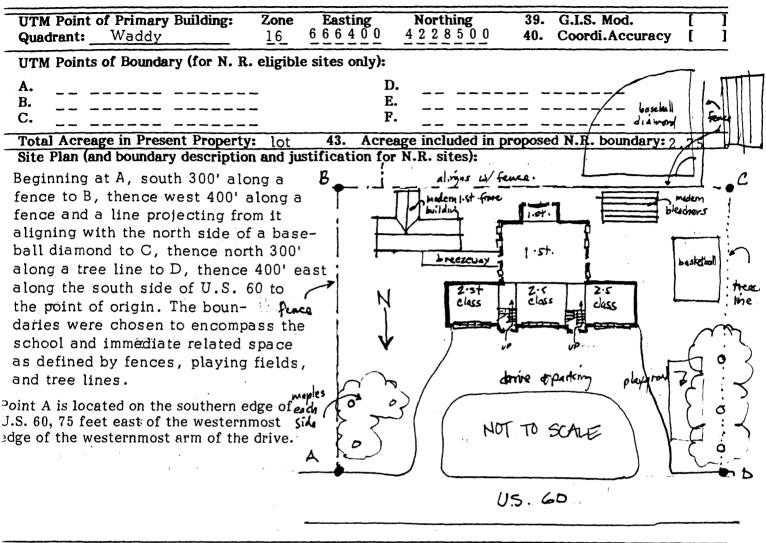
2-story brick running bond school with five-part principal (north) facade in which three classroom blocks are joined by projecting pavilions containing entry halls and stairs. Roof slopes to rear behind parapet with stone coping and belt course. Parapet raised in central bay to form shallow pediment with date 1922 above name of school on stone panel. Five-part banded windows framed by rowlock course frames with stone corner blocks similar to blank wall panels in end walls. Two-part windows light stair halls, which start on the ground a half story below the first floor level. The two entry doors are framed by stone mooded belt courses, a keystone and a blind bull's eye window supported by inset stone volutes. The coursed rubble basement is raised a half story above the ground. A rear (south) wing contains a cafeteria, while access between classrooms on each floor is provided by a 2-story hyphen between it and the main section. A modern 1-story frame classroom structure is connected to the east side of the rear wing by a breezeway.
