National Register of Historic Places
Inventory—Nomination Form

historic Douglas Sonoran Historic District

DOUGLAS SONORAN HISTORIC DISTRICT

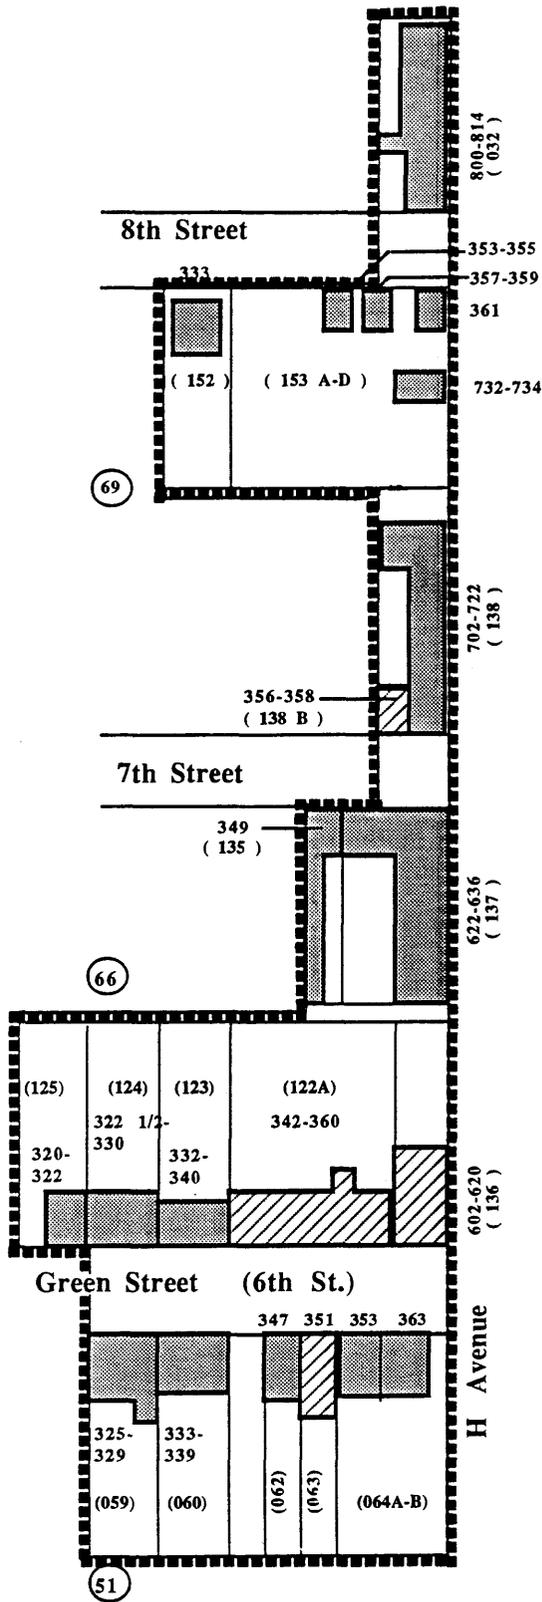
Douglas Sonoran Historic District

(Douglas, Arizona ca. 1986)

Historic District Boundaries are drawn to the nearest curb or property line, as noted in the nomination's verbal boundary description.

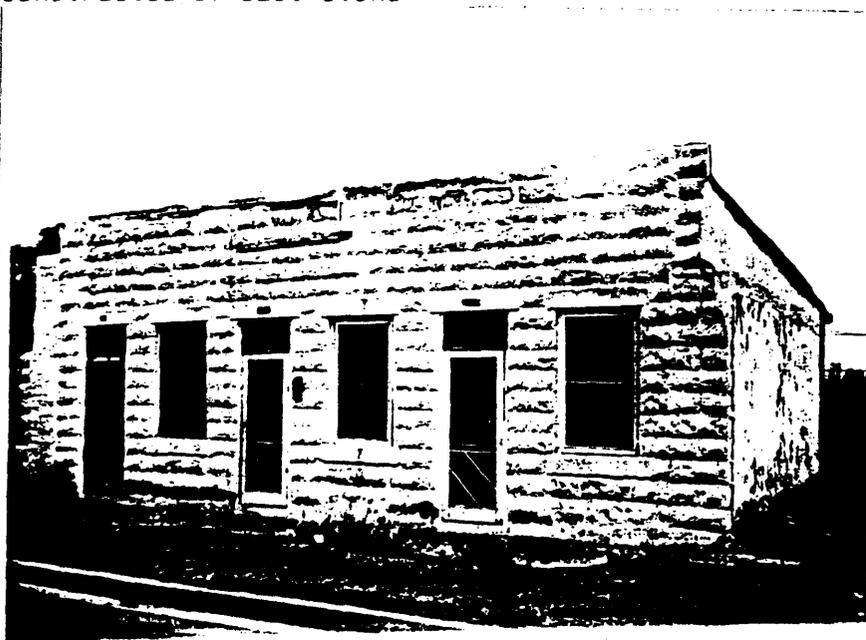
SURVEY AREA NAME - Douglas:	COUNTY - Cochise:	SURVEY SITE: 409-08-059
HISTORIC NAME:	USGS QUAD - Douglas, AZ:	
ADDRESS/LOCATION: 325-329 6th St.	TRS: T24S R27E Sec 13	NE 1/4 of SW 1/4
CITY/TOWN - Douglas:	UTM:	
X TAX PARCEL NUMBER: 409-08-059	HISTORIC USE: Residential	
OWNER: Rascon, M.E. & M.A.	PRESENT USE: Residential	
X OWNER ADDRESS: 327 6th St.	BUILDING TYPE: Apartment	
CITY: Douglas	STATE: Arizona	STYLE: Sonoran
ZIP: 85607	CONSTRUCTION DATE: 1900	
	ARCHITECT/BUILDER:	
	INTEGRITY: Minor alterations	
	CONDITION: Good

STRUCTURAL MATERIAL: Cast stone
 FOUNDATION: Unknown
 WALL SHEATHING: Stucco and cast ashlar stone
 APPLIED ORNAMENT: None
 ROOF TYPE: Flat

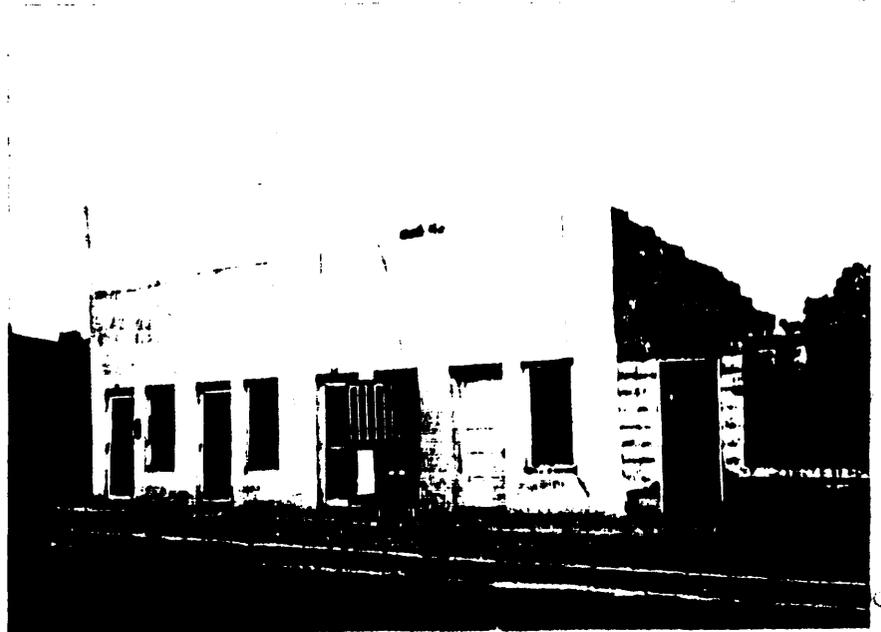
SURVEY AREA NAME - Douglas:	COUNTY - Cochise:	SURVEY SITE: 409-08-060
HISTORIC NAME:	USGS QUAD - Douglas, AZ:	
ADDRESS/LOCATION: 333-339 6th St.	TRS: T24S R27E Sec 13	NE 1/4 of SW 1/4
CITY/TOWN - Douglas:	UTM:	
X TAX PARCEL NUMBER: 409-08-060	HISTORIC USE: Residential	
OWNER: Garcia, Pedro C.	PRESENT USE: Residential	
X OWNER ADDRESS: 335 6th St.	BUILDING TYPE: Apartment	
CITY: Douglas	STATE: Arizona	STYLE: Sonoran
ZIP: 85607	CONSTRUCTION DATE: 1902	ARCHITECT/BUILDER:
	INTEGRITY: Minor alterations	CONDITION: Good

STRUCTURAL MATERIAL: Cast stone
 FOUNDATION: Unknown
 WALL SHEATHING: Stucco
 APPLIED ORNAMENT: None
 ROOF TYPE: Flat

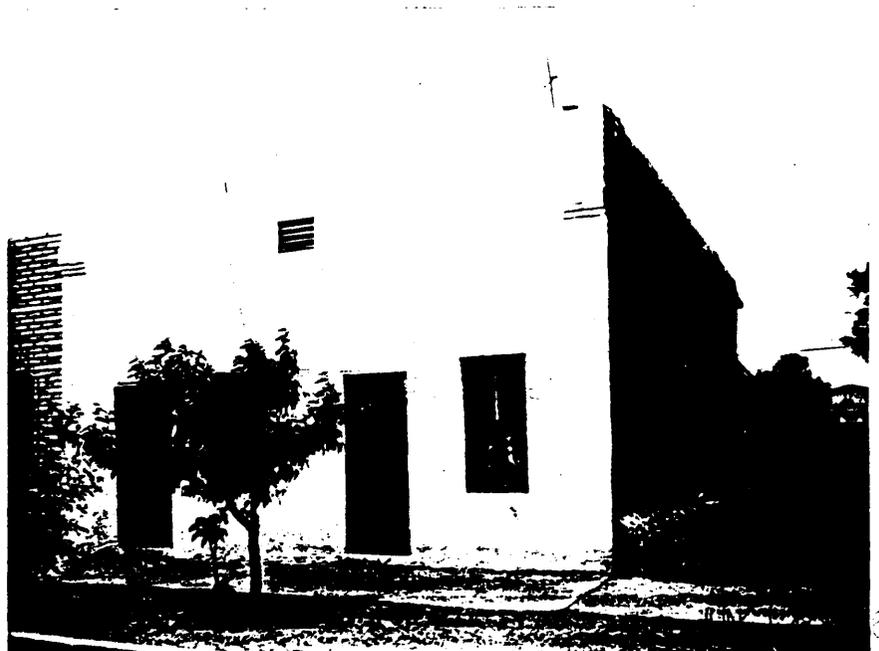
SURVEY AREA NAME - Douglas:	COUNTY - Cochise:	SURVEY SITE: 409-08-062
HISTORIC NAME:	USGS QUAD - Douglas, AZ:	
ADDRESS/LOCATION: 347 6th St.	TRS: T245 R27E Sec 13 NE 1/4 of NW 1/4	
CITY/TOWN - Douglas:	UTM:	
X TAX PARCEL NUMBER: 409-08-062	HISTORIC USE: Residential	
OWNER: Flores, Maria Huitron	PRESENT USE: Residential	
X OWNER ADDRESS: 347 6th St.	BUILDING TYPE: House	
CITY: Douglas STATE: Arizona	STYLE: Sonoran	
ZIP: 85607	CONSTRUCTION DATE: 1919	
	ARCHITECT/BUILDER:	
	INTEGRITY: Moderate alterations	
	CONDITION: Good

STRUCTURAL MATERIAL: Adobe
 FOUNDATION: Unknown
 WALL SHEATHING: Stucco
 APPLIED ORNAMENT: Corbelling
 ROOF TYPE: Flat

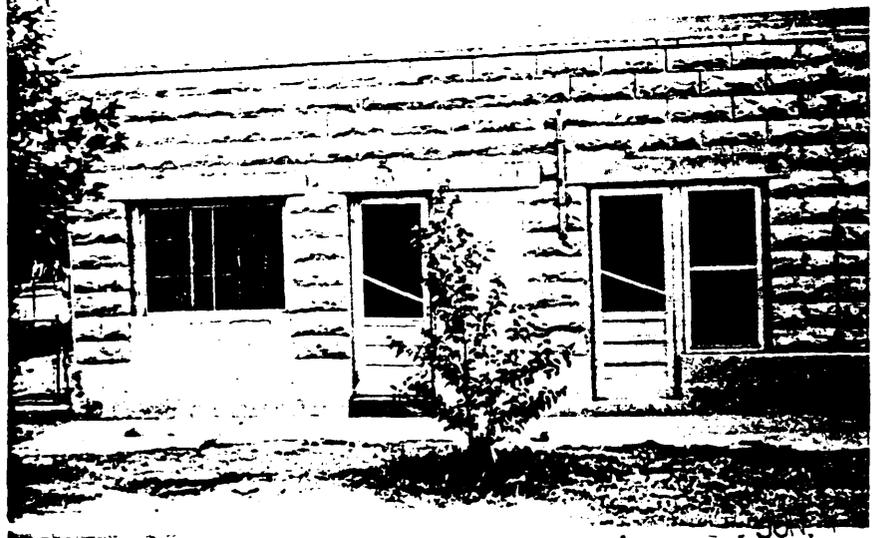
SURVEY AREA NAME - Douglas:	COUNTY - Cochise:	SURVEY SITE: 409-08-064
HISTORIC NAME:	USGS QUAD - Douglas, AZ:	
ADDRESS/LOCATION: 363 6th St.	TRS: T24S R27E Sec 13 NE 1/4 of SW 1/4	
CITY/TOWN - Douglas:	UTM:	
X TAX PARCEL NUMBER: 409-08-064	HISTORIC USE: Residential	
OWNER: Monge, J.M. & S.G.	PRESENT USE: Residential	
X OWNER ADDRESS: 363 6th St.	BUILDING TYPE: House	
CITY: Douglas STATE: Arizona	STYLE: Sonoran	
ZIP: 85607	CONSTRUCTION DATE: 1905	
	ARCHITECT/BUILDER:	
	INTEGRITY: moderate alterations	
	CONDITION: Good

STRUCTURAL MATERIAL: Cast block
 FOUNDATION: Unknown
 WALL SHEATHING: Stucco and cast block
 APPLIED ORNAMENT: Plain lintels
 ROOF TYPE: Flat

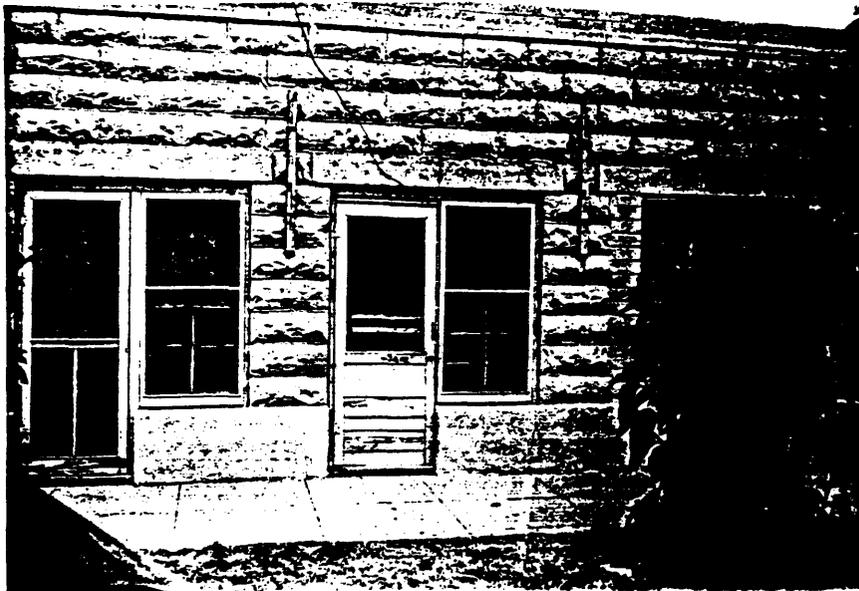
SURVEY AREA NAME - Douglas:	COUNTY - Cochise:	SURVEY SITE: 409-08-064A
HISTORIC NAME:	USGS QUAD - Douglas, AZ:	
ADDRESS/LOCATION: 353 6th St.	TRS: T24S R27E Sec 13 NE 1/4 of SW 1/4	
CITY/TOWN - Douglas:	UTM:	
X TAX PARCEL NUMBER: 409-08-064	HISTORIC USE: Residential	
OWNER: Monge, J.M. & S.G.	PRESENT USE: Residential	
X OWNER ADDRESS: 363 6th St.	BUILDING TYPE: House	
CITY: Douglas STATE: Arizona	STYLE: Sonoran	
ZIP: 85607	CONSTRUCTION DATE: 1905	
	ARCHITECT/BUILDER:	
	INTEGRITY: Minor alterations	
	CONDITION: Fair

STRUCTURAL MATERIAL: Cast ashlar block
 FOUNDATION: Unknown
 WALL SHEATHING: Cast ashlar sheathing
 APPLIED ORNAMENT: Concrete window lintels
 ROOF TYPE: Flat

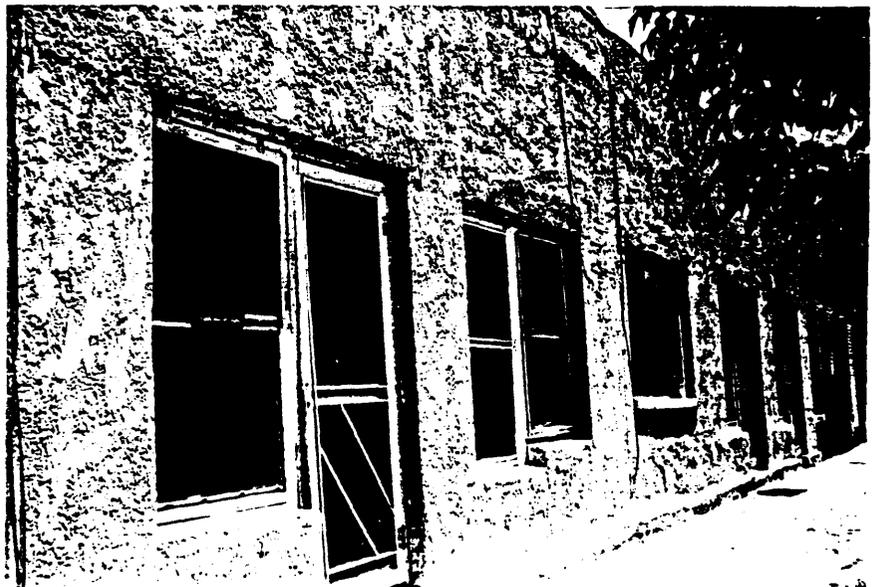
SURVEY AREA NAME - Douglas:	COUNTY - Cochise:	SURVEY SITE: 409-08-123
HISTORIC NAME:	USGS QUAD - Douglas, AZ:	
ADDRESS/LOCATION: 332-340 6th St.	TRS: T24S R27E Sec 13 NE 1/4 of the Sw 1/4	
CITY/TOWN - Douglas:	UTM:	
X TAX PARCEL NUMBER: 409-08-123	HISTORIC USE: Apartment	
OWNER: Durazo, R.R. & B.H.	PRESENT USE: Apartment	
X OWNER ADDRESS: 340 6th St.	BUILDING TYPE: Row House	
CITY: Douglas STATE: Arizona	STYLE: Sonoran	
ZIP: 85607	CONSTRUCTION DATE: 1903	
	ARCHITECT/BUILDER:	
	INTEGRITY: Moderate alterations	
	CONDITION: Fair

STRUCTURAL MATERIAL: Gypsum cast stone
 FOUNDATION: Concrete
 WALL SHEATHING: Stucco
 APPLIED ORNAMENT: None
 ROOF TYPE: Shed

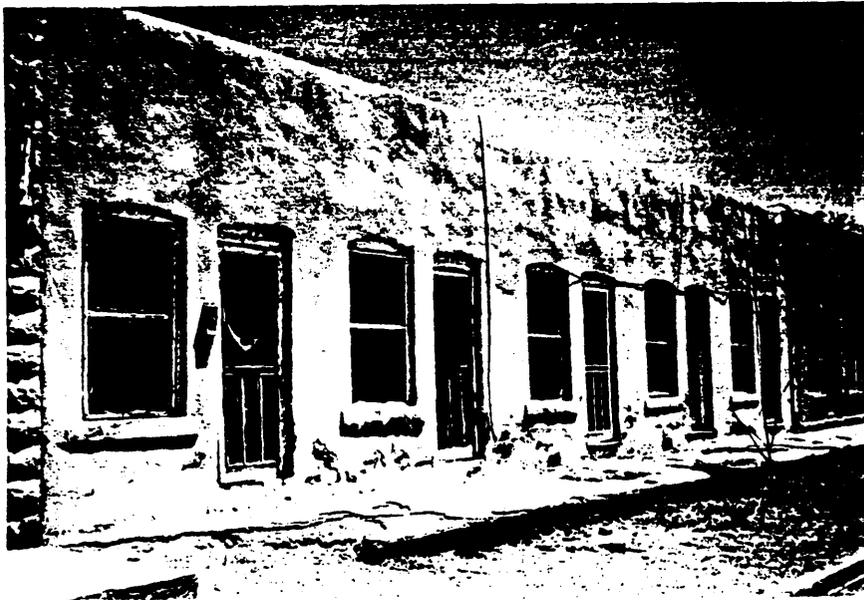
SURVEY AREA NAME - Douglas:	COUNTY - Cochise:	SURVEY SITE: 409-08-124
HISTORIC NAME:	USGS QUAD - Douglas, AZ:	
ADDRESS/LOCATION: 322 1/2 -330 6th	TRNS: T24S R27E Sec 13 NE 1/4 of the SW 1/4	
CITY/TOWN - Douglas:	UTM:	
X TAX PARCEL NUMBER: 409-08-124	HISTORIC USE: Apartments	
OWNER: Anchonda, M.D. & B.S.	PRESENT USE: Apartments	
X OWNER ADDRESS: P.O. Box 26	BUILDING TYPE: Row house	
CITY: Rodeo STATE: NM	STYLE: Sonoran	
ZIP: 88056	CONSTRUCTION DATE: 1903	
	ARCHITECT/BUILDER:	
	INTEGRITY: Moderate alterations	
	CONDITION: Fair

STRUCTURAL MATERIAL: Brick
 FOUNDATION: Concrete
 WALL SHEATHING: Stucco
 APPLIED ORNAMENT: None
 ROOF TYPE: Shed

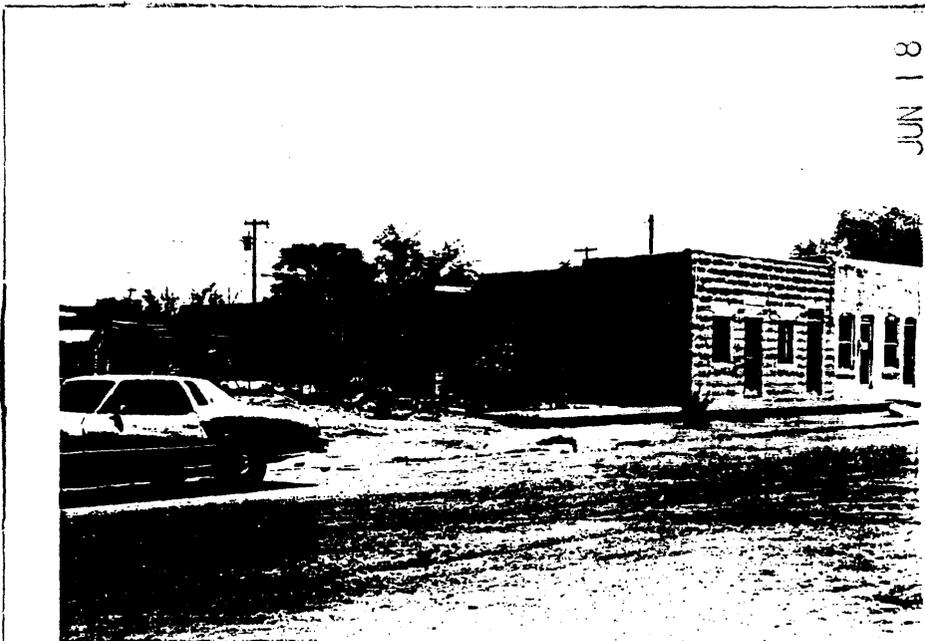
SURVEY AREA NAME - Douglas:	COUNTY - Cochise:	SURVEY SITE: 409-08-125
HISTORIC NAME:	USGS QUAD - Douglas, AZ:	
ADDRESS/LOCATION: 320-322 6th St.	TRS: T24S R27E Sec 13 NE 1/4 of SW 1/4	
CITY/TOWN - Douglas:	UTM:	
X TAX PARCEL NUMBER: 409-08-125	HISTORIC USE: Residential	
OWNER: Renteria, E.	PRESENT USE: Residential	
X OWNER ADDRESS: 320 6th St.	BUILDING TYPE: House	
CITY: Douglas STATE: Arizona	STYLE: Sonoran	
ZIP: 85607	CONSTRUCTION DATE: 1903	
	ARCHITECT/BUILDER:	
	INTEGRITY: Moderate alterations	
	CONDITION: Fair

STRUCTURAL MATERIAL: Cast stone
 FOUNDATION: Unknown
 WALL SHEATHING: Cast stone/stucco
 APPLIED ORNAMENT: None
 ROOF TYPE: 1 flat

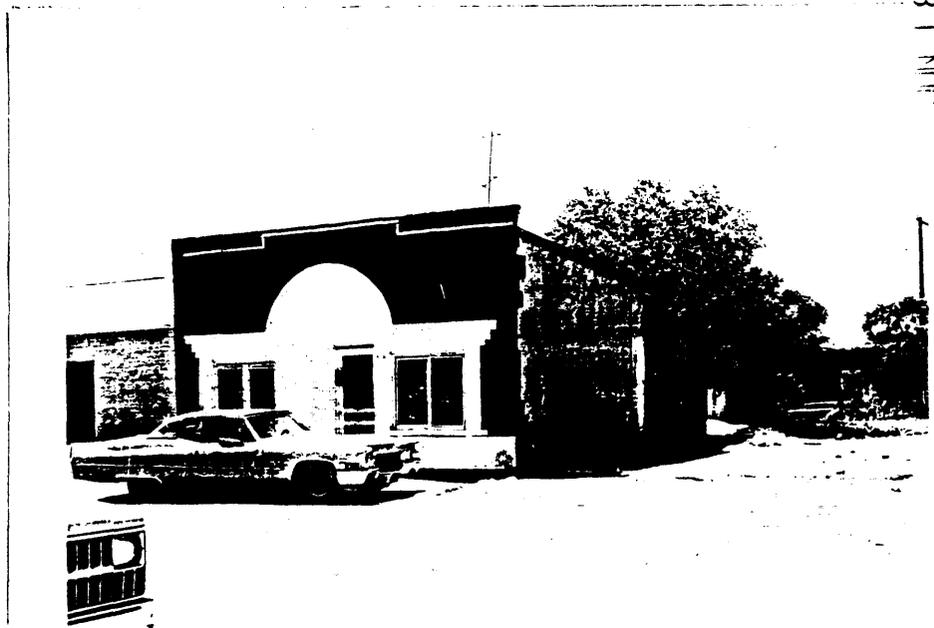
SURVEY AREA NAME - Douglas: COUNTY - Cochise: SURVEY SITE: 409-08-135
 HISTORIC NAME: USGS QUAD - Douglas, AZ:
 ADDRESS/LOCATION: 349 7th St. TRS: T24S R27E Sec 13 NE 1/4 of SW 1/4
 CITY/TOWN - Douglas: UTM:
 X TAX PARCEL NUMBER: 409-08-135 HISTORIC USE: Commercial
 OWNER: Ahumada, Manuel L. PRESENT USE: Residential
 X OWNER ADDRESS: 349 7th St. BUILDING TYPE: House
 CITY: Douglas STATE: Arizona STYLE: Colonial Revival
 ZIP: 85607 CONSTRUCTION DATE: 1900
 ARCHITECT/BUILDER: Mike Simon (builder)
 INTEGRITY: Major alterations
 CONDITION: Fair

STRUCTURAL MATERIAL: Brick and adobe
 FOUNDATION: Concrete
 WALL SHEATHING: Stucco, brick
 APPLIED ORNAMENT: Palladian composition
 ROOF TYPE: 2 low shed roofs

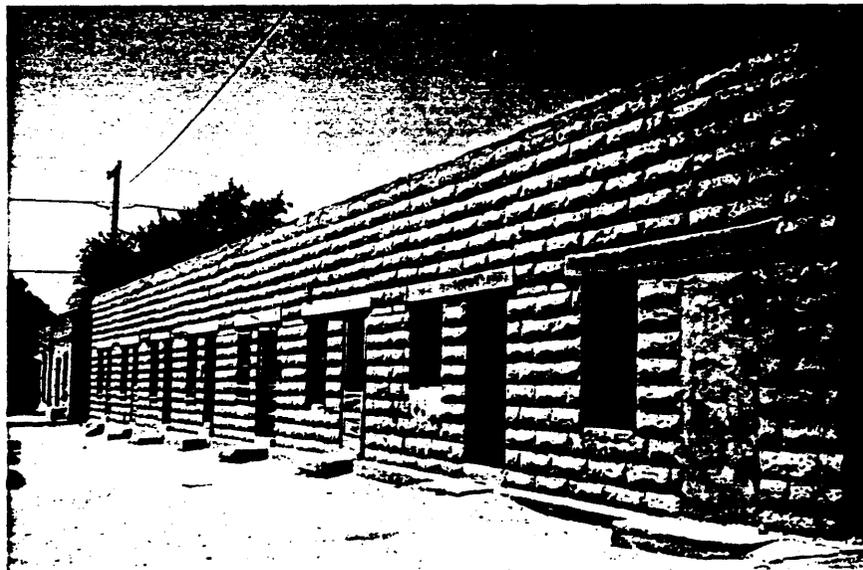
SURVEY AREA NAME - Douglas: COUNTY - Cochise: SURVEY SITE: 409-08-137
 HISTORIC NAME: USGS QUAD - Douglas, AZ:
 ADDRESS/LOCATION: 622-636 H Ave. TRS: T24S R27E Sec 13 NE 1/4 of SW 1/4
 CITY/TOWN - Douglas: UTM:
 X TAX PARCEL NUMBER: 409-08-137 HISTORIC USE: Residential
 OWNER: Villa, Bernardo PRESENT USE: Residential
 X OWNER ADDRESS: 627 H Ave. BUILDING TYPE: Row house
 CITY: Douglas STATE: Arizona STYLE: Sonoran
 ZIP: 85607 CONSTRUCTION DATE: 1900
 ARCHITECT/BUILDER:
 INTEGRITY: Moderate alterations
 CONDITION: Fair

STRUCTURAL MATERIAL: Cast stone
 FOUNDATION: Concrete
 WALL SHEATHING: Fair
 APPLIED ORNAMENT: None
 ROOF TYPE: Shed

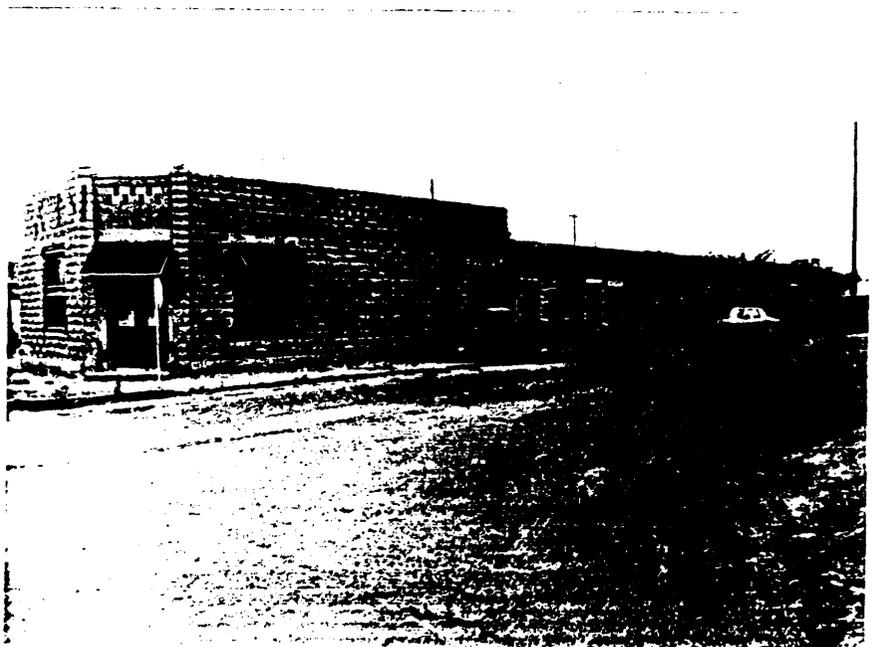
SURVEY AREA NAME - Douglas:	COUNTY - Cochise:	SURVEY SITE: 409-07-032
HISTORIC NAME:	USGS QUAD - Douglas, AZ:	
ADDRESS/LOCATION: 800-814 H Ave.	TRS: T245 R27E Sec 13 SE 1/4 of NW 1/4	
CITY/TOWN - Douglas:	UTM:	
X TAX PARCEL NUMBER: 409-07-032	HISTORIC USE: Comm/Res	
OWNER: Owen, William	PRESENT USE: Comm/Res	
X OWNER ADDRESS: 800 H Ave.	BUILDING TYPE: Apartment/store	
CITY: Douglas STATE: Arizona	STYLE: Sonoran	
ZIP: 85607	CONSTRUCTION DATE: 1905	
	ARCHITECT/BUILDER:	
	INTEGRITY: Minor alterations	
	CONDITION: Good

STRUCTURAL MATERIAL: Ashlar block
 FOUNDATION: Unknown
 WALL SHEATHING: Ashlar block
 APPLIED ORNAMENT: None
 ROOF TYPE: Flat

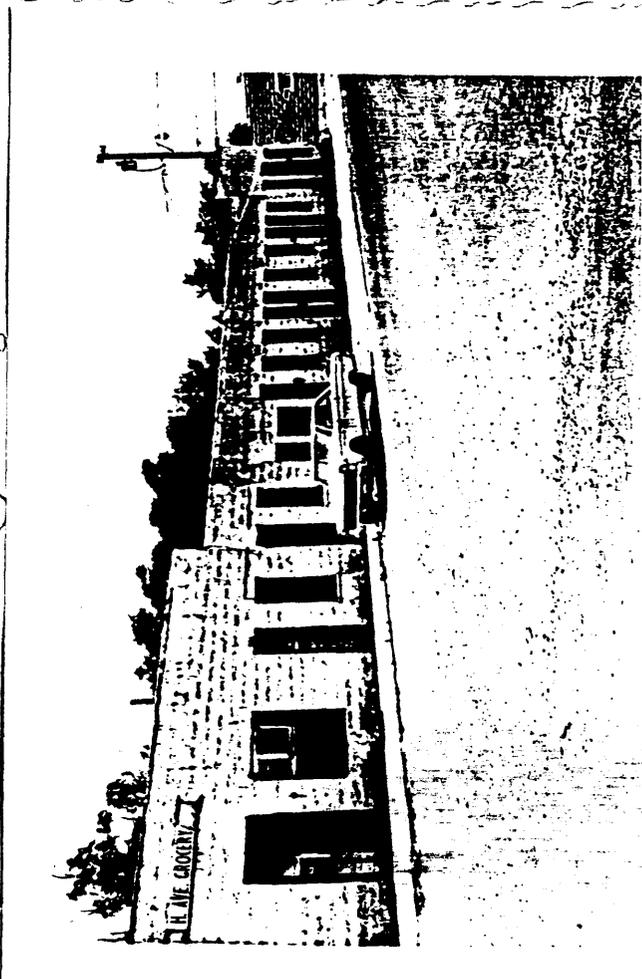
SURVEY AREA NAME - Douglas:	COUNTY - Cochise:	SURVEY SITE: 409-08-138
HISTORIC NAME:	USGS QUAD - Douglas, AZ:	
ADDRESS/LOCATION: 702-722 H Ave.	TRS: T24S R27E Sec 13 NE 1/4 of SW 1/4	
CITY/TOWN - Douglas:	UTM:	
X TAX PARCEL NUMBER: 409-08-138	HISTORIC USE: Commercial/residential	
OWNER: Castellanos, B.	PRESENT USE: Commercial/residential	
X OWNER ADDRESS: PO Box 1027	BUILDING TYPE: Apartments/grocery store	
CITY: Douglas STATE: Arizona	STYLE: Sonoran	
ZIP: 85607	CONSTRUCTION DATE: 1910	
	ARCHITECT/BUILDER:	
alter address is 356-358 7th Street	INTEGRITY: Minor alterations	
	CONDITION: Fair

STRUCTURAL MATERIAL: Cast stone over adobe
 FOUNDATION: Concrete
 WALL SHEATHING: Cast block
 APPLIED ORNAMENT: None
 ROOF TYPE: Flat

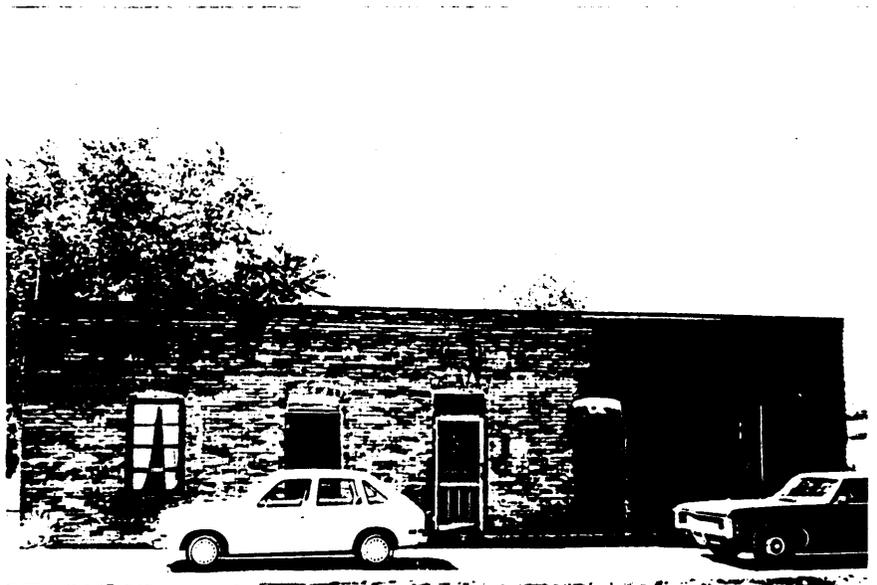
SURVEY AREA NAME - Douglas:	COUNTY - Cochise:	SURVEY SITE: 409-08-152
HISTORIC NAME:	USGS QUAD - Douglas, AZ:	
ADDRESS/LOCATION: 333 8th St.	TRS: T24S R27E Sec 13 NE 1/4 of SW 1/4	
CITY/TOWN - Douglas:	UTM:	
X TAX PARCEL NUMBER: 409-08-152	HISTORIC USE: Residential	
OWNER: Rios, M.D. & G.Q.	PRESENT USE: Residential	
X OWNER ADDRESS: PO Box 26305	BUILDING TYPE: Apartment	
CITY: Tucson STATE: Arizona	STYLE: Sonoran	
ZIP: 85726	CONSTRUCTION DATE: 1918	
	ARCHITECT/BUILDER:	
	INTEGRITY: Minor alterations	
	CONDITION: Good

STRUCTURAL MATERIAL: Brick
 FOUNDATION: Concrete
 WALL SHEATHING: Adobe, fired brick
 APPLIED ORNAMENT: Decorative brick work, vents and segmental window arches
 ROOF TYPE: Flat

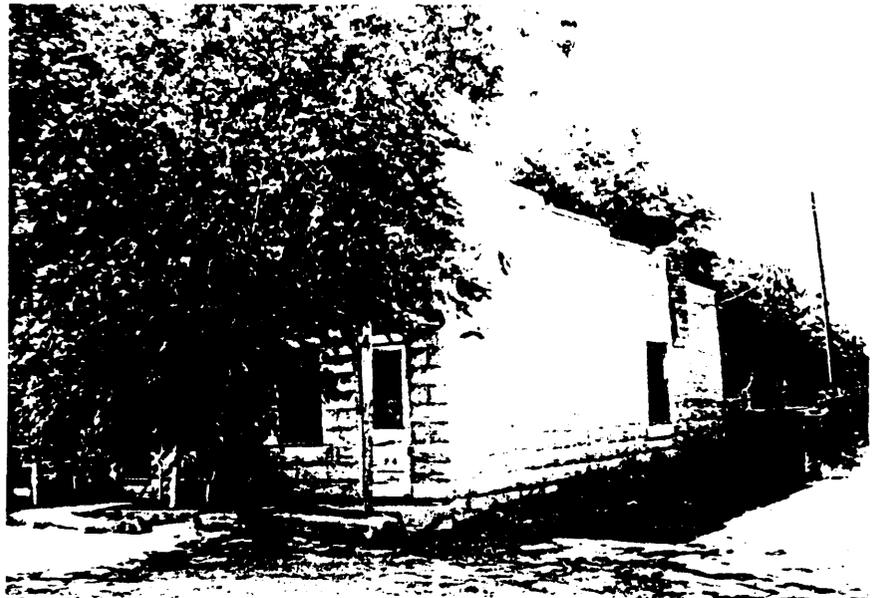
SURVEY AREA NAME - Douglas: COUNTY - Cochise: SURVEY SITE: 409-08-153A
 HISTORIC NAME: USGS QUAD - Douglas, AZ:
 ADDRESS/LOCATION: 353-355 8th St. TRS: T24S R27E Sec 13 NE 1/4 of SW 1/4
 CITY/TOWN - Douglas: UTM:
 X TAX PARCEL NUMBER: 409-08-153 HISTORIC USE: Residential
 OWNER: Garret, M.L. PRESENT USE: Residential
 X OWNER ADDRESS: 2300 15th St. BUILDING TYPE: Duplex
 CITY: Douglas STATE: Arizona STYLE: Sonoran
 ZIP: 85607 CONSTRUCTION DATE: 1900
 ARCHITECT/BUILDER:
 INTEGRITY: Unaltered
 CONDITION: Fair

STRUCTURAL MATERIAL: Cast gypsum block
 FOUNDATION: Concrete
 WALL SHEATHING: Cast concrete block
 APPLIED ORNAMENT: Stepped parapet
 ROOF TYPE: Flat

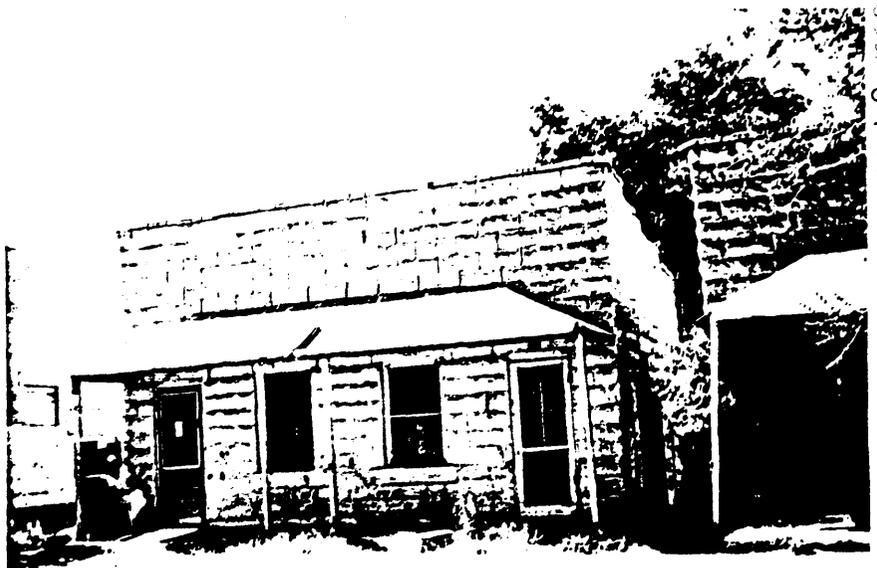
SURVEY AREA NAME - Douglas:	COUNTY - Cochise:	SURVEY SITE: 409-08-153B
HISTORIC NAME:	USGS QUAD - Douglas, AZ:	
ADDRESS/LOCATION: 357-359 8th St.	TRS: T245 R27E Sec 13	NE 1/4 of SW 1/4
CITY/TOWN - Douglas:	UTM:	
X TAX PARCEL NUMBER: 409-08-153	HISTORIC USE: Residential	
OWNER: Garret, M.	PRESENT USE: Residential	
X OWNER ADDRESS: 2300 15th St.	BUILDING TYPE: Duplex	
CITY: Douglas	STYLE: Sonoran	
STATE: Arizona	CONSTRUCTION DATE: 1900	
ZIP: 85607	ARCHITECT/BUILDER:	
	INTEGRITY: Unaltered	
	CONDITION: Fair

STRUCTURAL MATERIAL: Cast gypsum block
 FOUNDATION: Concrete
 WALL SHEATHING: Cast concrete
 APPLIED ORNAMENT: Stepped parapet
 ROOF TYPE: Flat

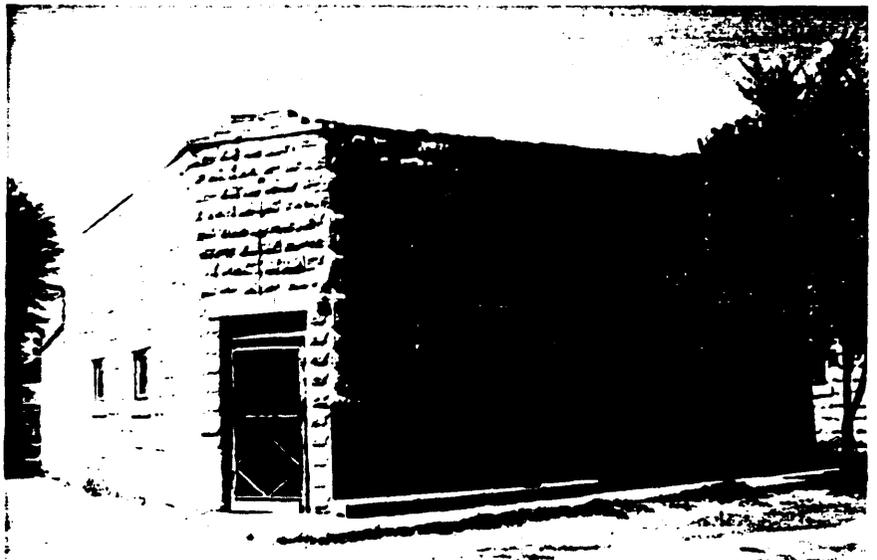
SURVEY AREA NAME - Douglas:	COUNTY - Cochise:	SURVEY SITE: 409-08-1530
HISTORIC NAME:	USGS QUAD - Douglas, AZ:	
ADDRESS/LOCATION: 361 8th St.	TRS: T24S R27E Sec 13 NE 1/4 of SW 1/4	
CITY/TOWN - Douglas:	UTM:	
X TAX PARCEL NUMBER: 409-08-153	HISTORIC USE: Commercial	
OWNER: Garret, M.L.	PRESENT USE: Residential	
X OWNER ADDRESS: 2300 15th St.	BUILDING TYPE: Commercial	
CITY: Douglas STATE: Arizona	STYLE: Sonoran	
ZIP: 85607	CONSTRUCTION DATE: 1900	
	ARCHITECT/BUILDER:	
	INTEGRITY: Minor alterations	
	CONDITION: Fair

STRUCTURAL MATERIAL: Cast gypsum block
 FOUNDATION: Concrete
 WALL SHEATHING: Cast block
 APPLIED ORNAMENT: Sills and lintels
 ROOF TYPE: Flat

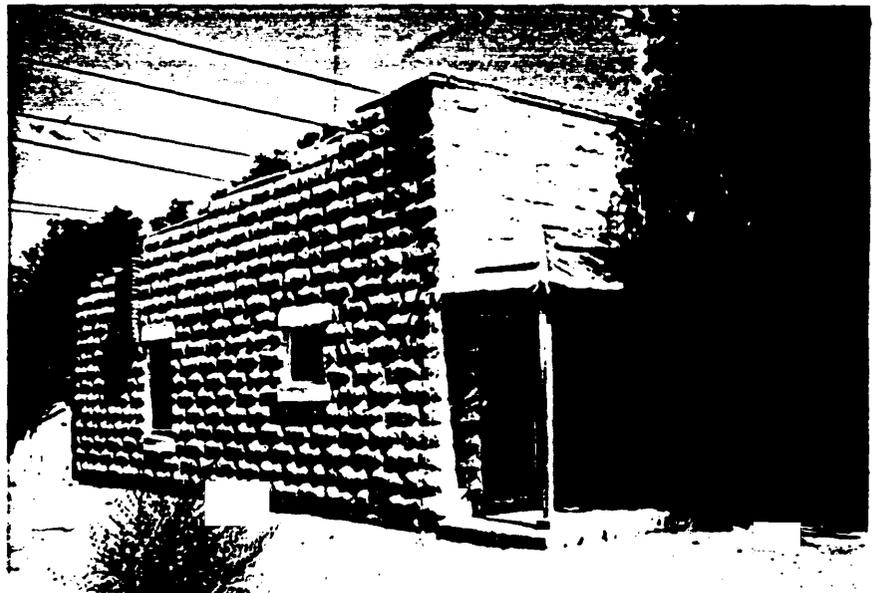
SURVEY AREA NAME - Douglas:	COUNTY - Cochise:	SURVEY SITE: 409-08-153D
HISTORIC NAME:	USGS QUAD - Douglas, AZ:	
ADDRESS/LOCATION: 732-734 H Ave.	TRS: T24S R27E Sec 13 NE 1/4 of SW 1/4	
CITY/TOWN - Douglas:	UTM:	
X TAX PARCEL NUMBER: 409-08-153	HISTORIC USE: Residential	
OWNER: Garret, M.L.	PRESENT USE: Residential	
X OWNER ADDRESS: 2300 15th St.	BUILDING TYPE: Duplex	
CITY: Douglas STATE: Arizona	STYLE: Sonoran	
ZIP: 85607	CONSTRUCTION DATE: 1900	
	ARCHITECT/BUILDER:	
	INTEGRITY: Unaltered	
	CONDITION: Fair

STRUCTURAL MATERIAL: Cast stone block
 FOUNDATION: Concrete
 WALL SHEATHING: Cast block
 APPLIED ORNAMENT: Stepped parapet
 ROOF TYPE: 1 flat

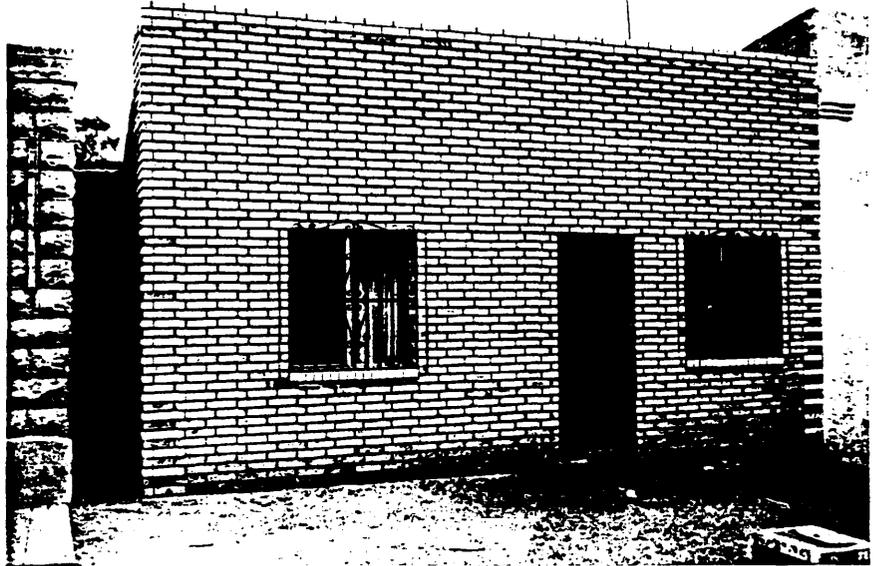
SURVEY AREA NAME - Douglas: COUNTY - Cochise: SURVEY SITE: 409-08-122A
HISTORIC NAME: USGS QUAD - Douglas, AZ:
ADDRESS/LOCATION: 342-360 6th St. TRS: T24S R27E Sec 13 NE 1/4 of the SW 1/4
CITY/TOWN - Douglas: UTM:
X TAX PARCEL NUMBER: 409-08-122A HISTORIC USE: Residence
OWNER: Arvayo, Ramon & O.V. PRESENT USE: Residence
X OWNER ADDRESS: 362 6th St. BUILDING TYPE: Row House
CITY: Douglas STATE: AZ STYLE: Sonoran
ZIP: 85607 CONSTRUCTION DATE: 1905
ARCHITECT/BUILDER: Unknown
INTEGRITY: Minor modifications
CONDITION: Good

STRUCTURAL MATERIAL: Brick
FOUNDATION: Brick
WALL SHEATHING: Brick
APPLIED ORNAMENT: None
ROOF TYPE: Flat
