NATIONAL REGISTER OF HISTORIC PLACES

PROPERTY PHOTOGRAPH FORM GaG 683

COMMON: Old Sealy Building
AND/OR HISTORIC: Hutchings, Sealy & Co. Building

STREET AND NUMBER:
2326-2328 Strand

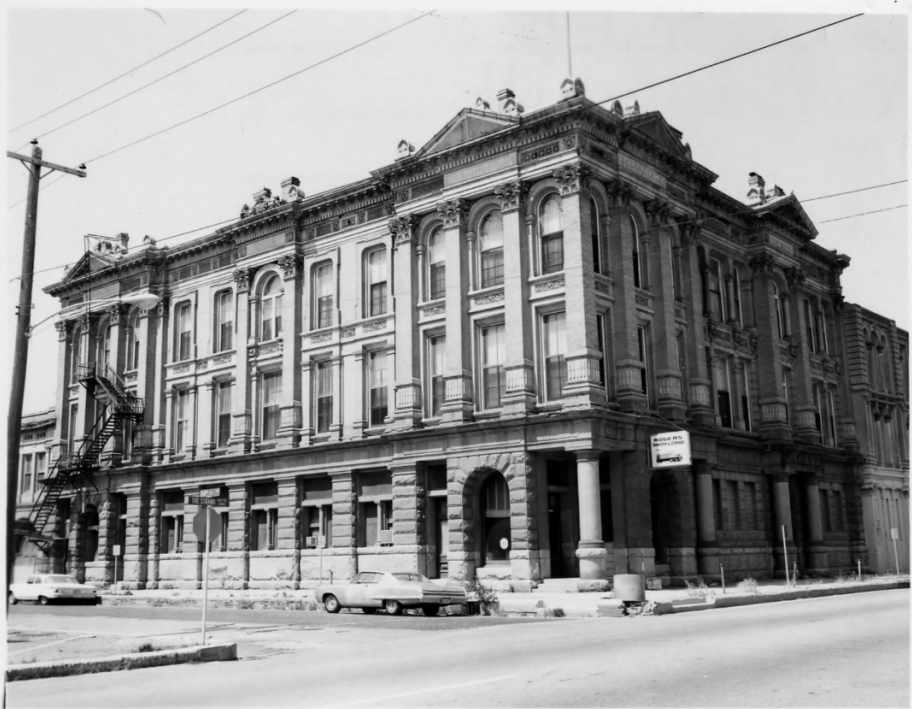
Front and side facade--Southwest elevation of a fine Post-Columbian exposition Classic revival building. The first floor of this three story building is made of rusticated granite with the other two floors constructed of brick and stone. There is rich detail in the moldings, capitals, bases, cornices and pediments.

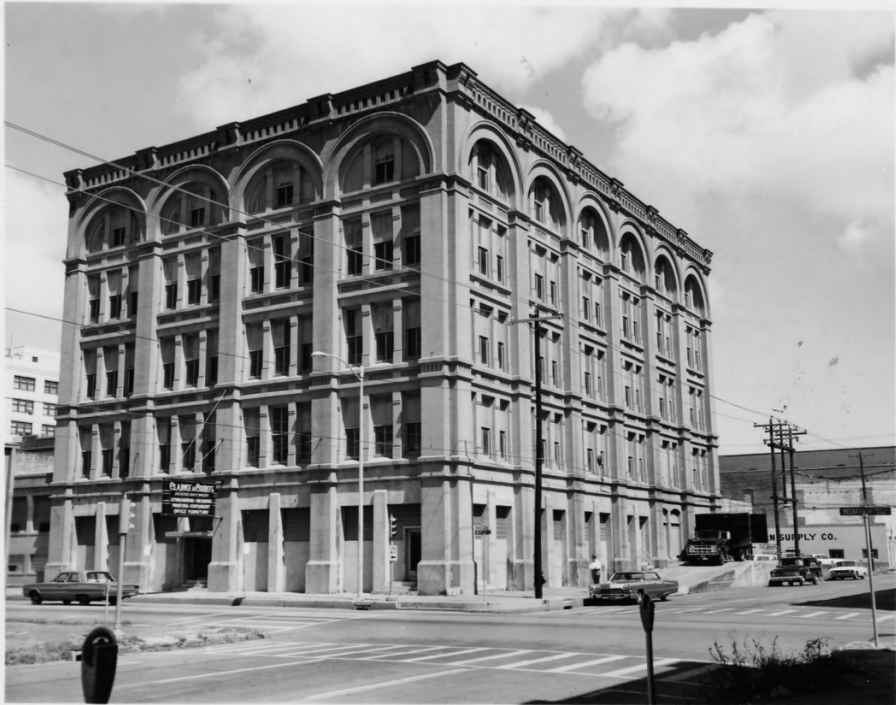
PROPERTY PHOTOGRAPH FORM GaG 624

DESCRIBE VIEW, DIRECTION, ETC. **Front and side facades--Southeast elevation of a five story brick commercial structure showing the influence of Richardson and Sullivan bays are formed by colossal pilasters joined by arches at the fifth floor, each bay three windows wide with proportional large openings than were used in Galveston.**

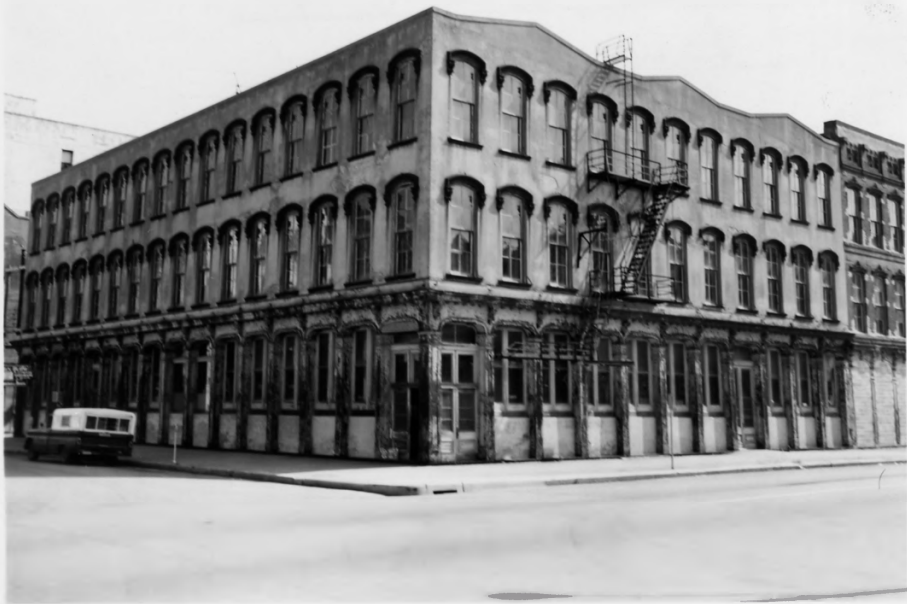
PROPERTY PHOTOGRAPH FORM GaG 623

1. NAME			
COMMON: Focke, Wilkens & Lange Building			
AND/OR HISTORIC:			
2. LOCATION			
STREET AND NUMBER: 2301-2307 Strand			
CITY OR TOWN: Galveston			
STATE:	CODE	COUNTY:	CODE
Texas	042	Galveston	167
3. PHOTO REFERENCE			
PHOTO CREDIT: Texas State Historical Survey Committee			
DATE OF PHOTO: March 19, 1969			
NEGATIVE FILED AT: Texas State Historical Survey Committee			
108 W. 15th. Street, Austin, Texas			
4. IDENTIFICATION			
DESCRIBE VIEW, DIRECTION, ETC. Front and side facades--Northeast elevation of a three story stuccoed brick with cast iron front on the ground floor and cast iron/wood molds and sills. Cornice now altered.

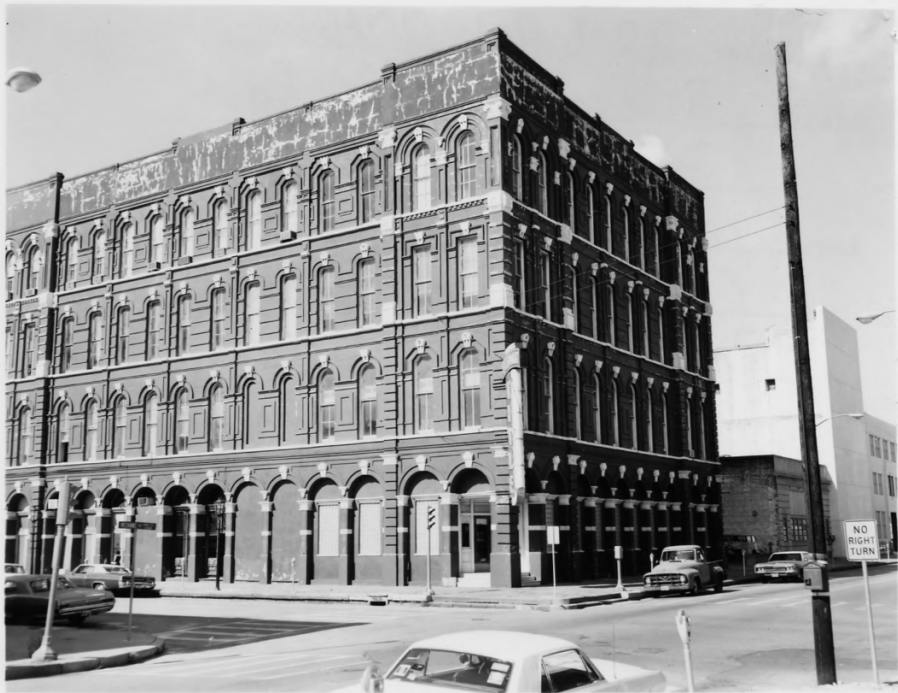
PROPERTY PHOTOGRAPH FORM GaG 621

DESCRIBE VIEW, DIRECTION, ETC. Front and side facades--Southwest elevation of a four story red brick building with white keystones, capitals, and bands. The original cornice and roof are missing, otherwise the building is unchanged. The excellent carved woodwork of some of the doors is notable.

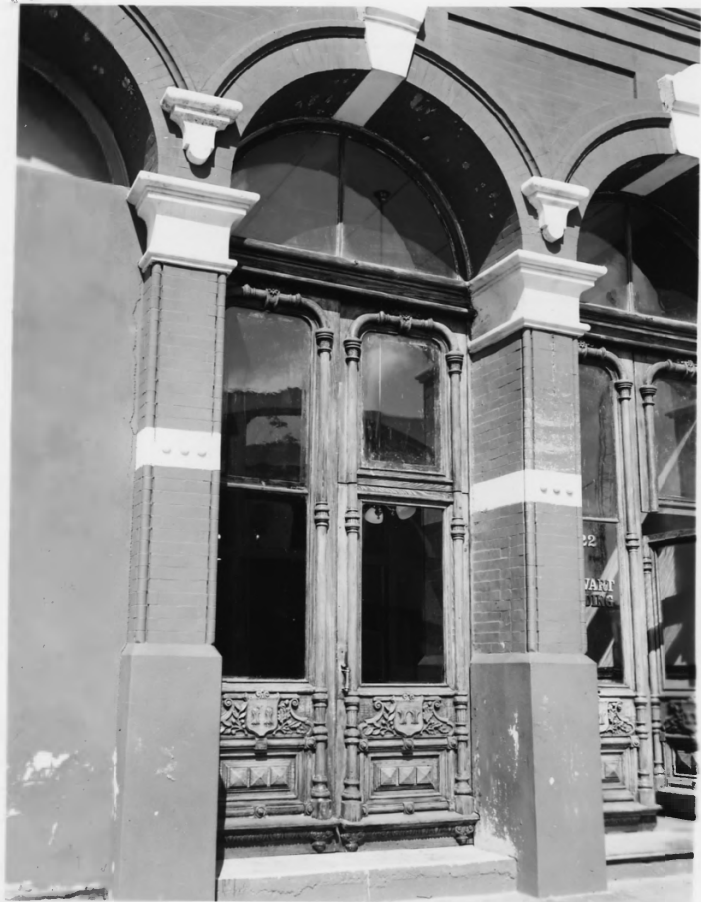
PROPERTY PHOTOGRAPH FORM GaG 621

1. NAME			
COMMON: Stewart Title Co. Building			
AND/OR HISTORIC: Kauffman and Range Building			
2. LOCATION			
STREET AND NUMBER: 220-222 Twenty-second Street			
CITY OR TOWN: Galveston			
STATE: Texas	CODE: 042	COUNTY: Galveston	CODE: 167
3. PHOTO REFERENCE			
PHOTO CREDIT: Texas State Historical Survey Committee			
DATE OF PHOTO: March 19, 1969			
NEGATIVE FILED AT: Texas State Historical Survey Committee 108 W. 15th. Street, Austin, Texas			
4. IDENTIFICATION			
DESCRIBE VIEW, DIRECTION, ETC. Front facade--West elevation detail showing carved wood door recessed in brick and stuccoed columns and arch.

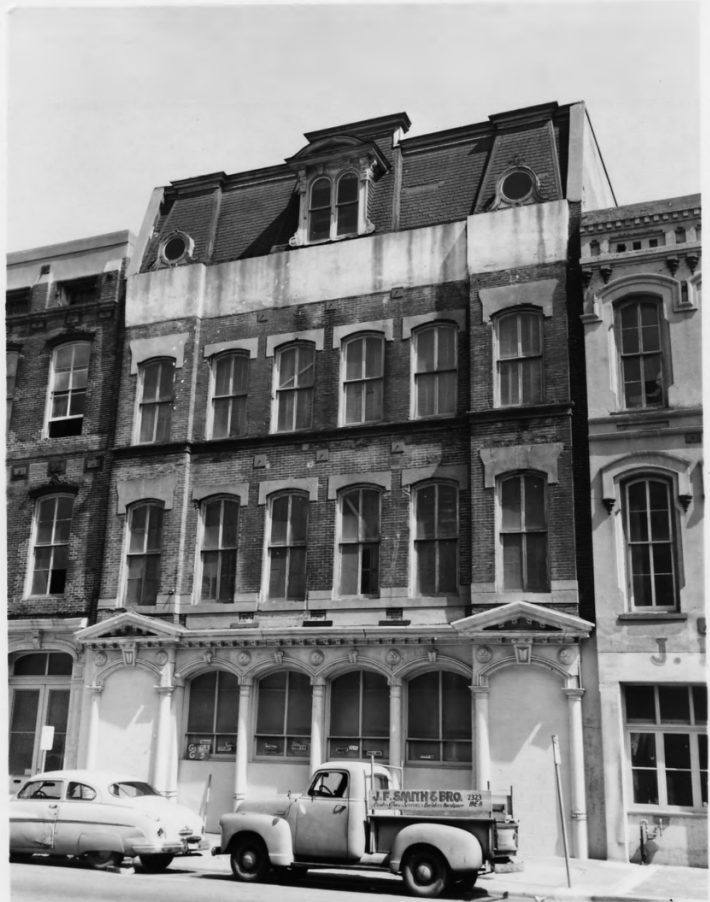
PROPERTY PHOTOGRAPH FORM GaG 623

DESCRIBE VIEW, DIRECTION, ETC. **Front facade--North elevation of a three story brick and cast iron commercial structure with a Mansard roof and an attic dormer. There is a fine Renaissance revival cast iron front at the street level with roundels, keystones, brackets, and two pediments. The cast iron cornice, drip stone mouldings and other decorations have been removed.**

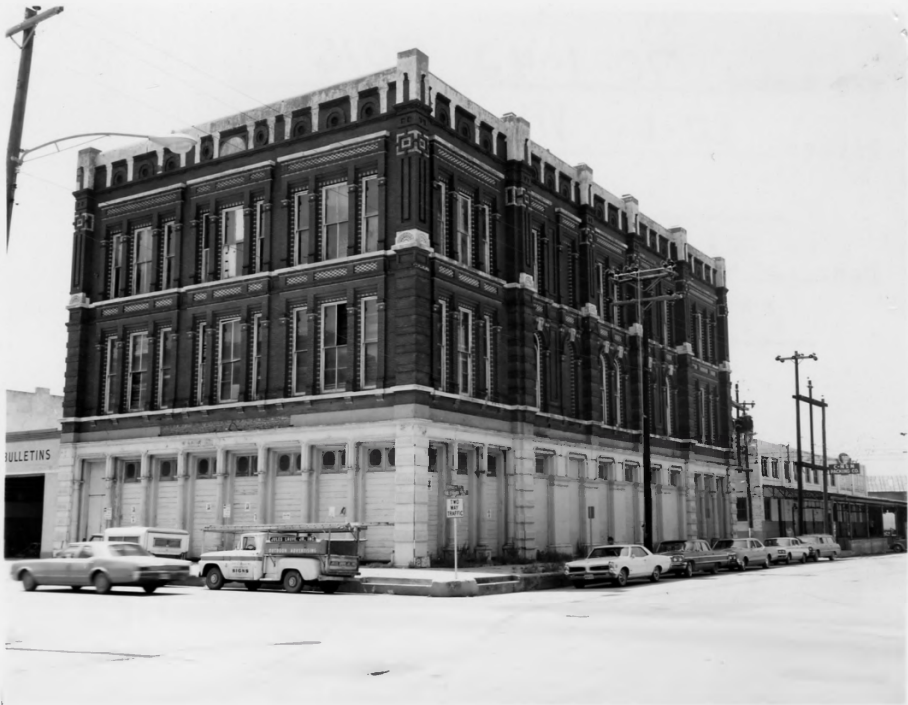
PROPERTY PHOTOGRAPH FORM GaG 682

Front and side facades--Southeast elevation of a three story pressed brick and terracotta building with the facade divided into bays by grouped flat moldings and pilasters. There are flat lintels throughout with the first floor supports made of cast iron columns in combination with brick piers.

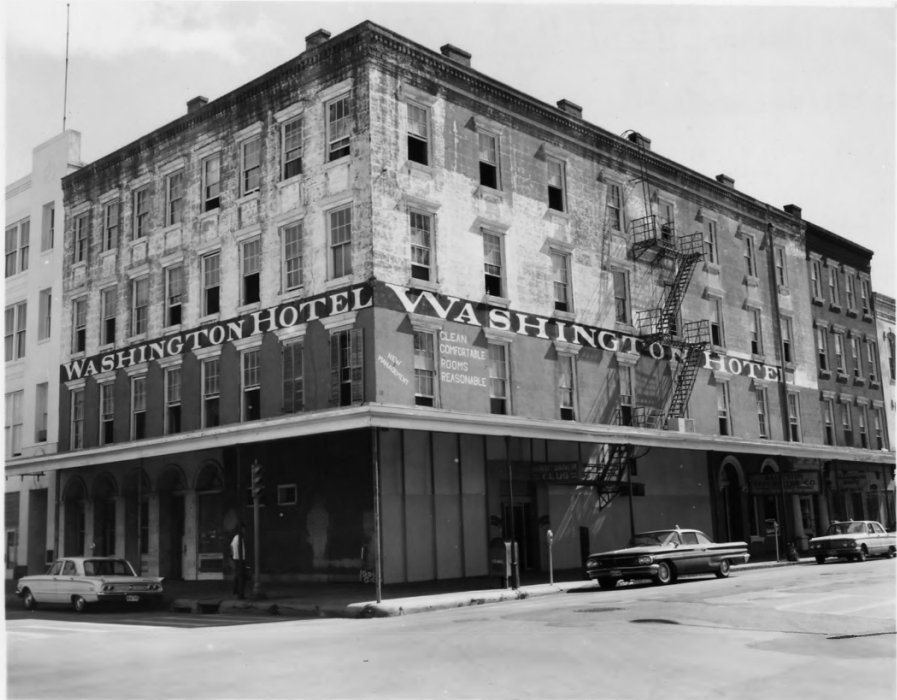
PROPERTY PHOTOGRAPH FORM ^{GAG 622}
_{p12,13,14}

DESCRIBE VIEW, DIRECTION, ETC. Front and side facades--Southwest elevation of a four story stuccoed brick Greek Revival commercial building with simple classic detail, simple brick cornice.

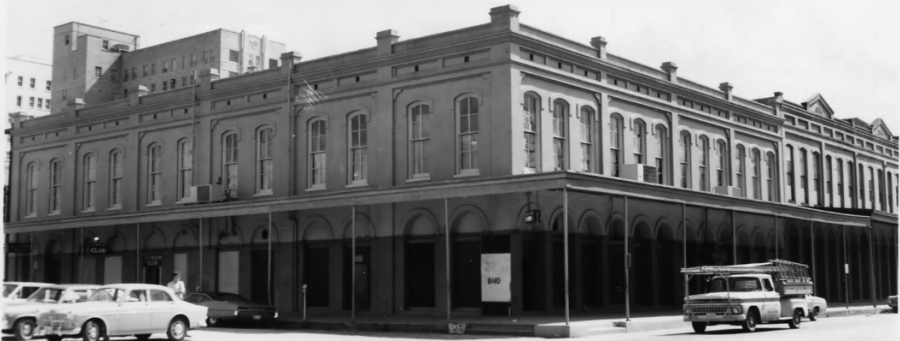
PROPERTY PHOTOGRAPH FORM GaG 620

DESCRIBE VIEW, DIRECTION, ETC. **Front and side facades--Northeast elevation of a two story brick building with three windows to a bay on the shorter (four bays) side and two windows to a bay (six bays) on the longer side. It has simple detailing with an arcade formed by the first floor arched opening and square piers.**

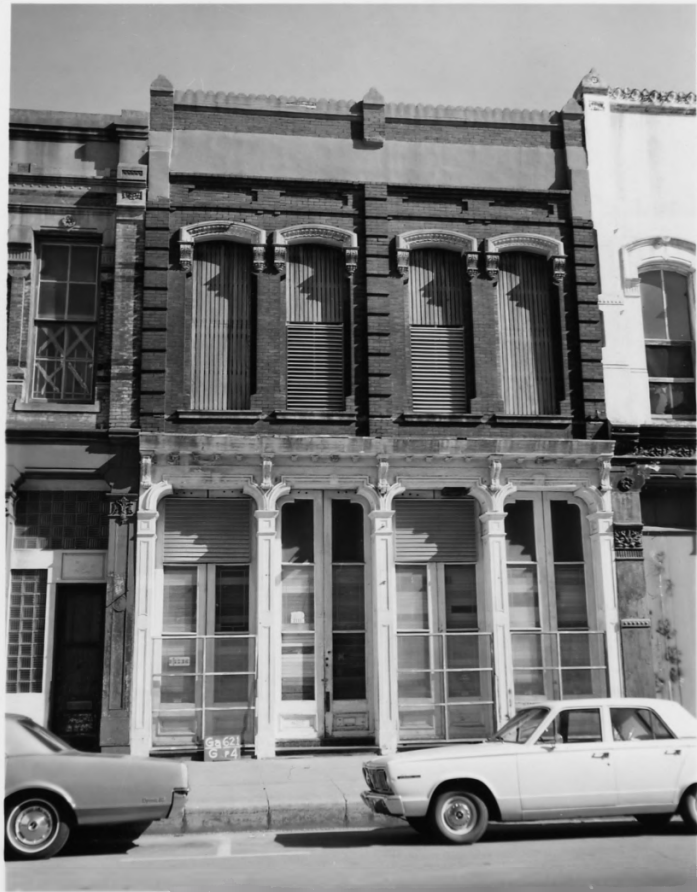
PROPERTY PHOTOGRAPH FORM GaG 621

1. NAME			
COMMON: J. S. Brown Building			
AND/OR HISTORIC:			
2. LOCATION			
STREET AND NUMBER: 2111 Strand St.			
CITY OR TOWN: Galveston			
STATE: Texas	CODE: 042	COUNTY: Galveston	CODE: 167
3. PHOTO REFERENCE			
PHOTO CREDIT: Texas State Historical Survey Committee			
DATE OF PHOTO: March 19, 1969			
NEGATIVE FILED AT: Texas State Historical Survey Committee 108 W. 15th. Street, Austin, Texas			
4. IDENTIFICATION			
DESCRIBE VIEW, DIRECTION, ETC. Front facade--North elevation of a two story brick and iron structure divided into two bays with two windows per bay. The first floor has a cast iron front with slender pilasters. The second floor is exposed brick with cast iron hood moulds above the windows.

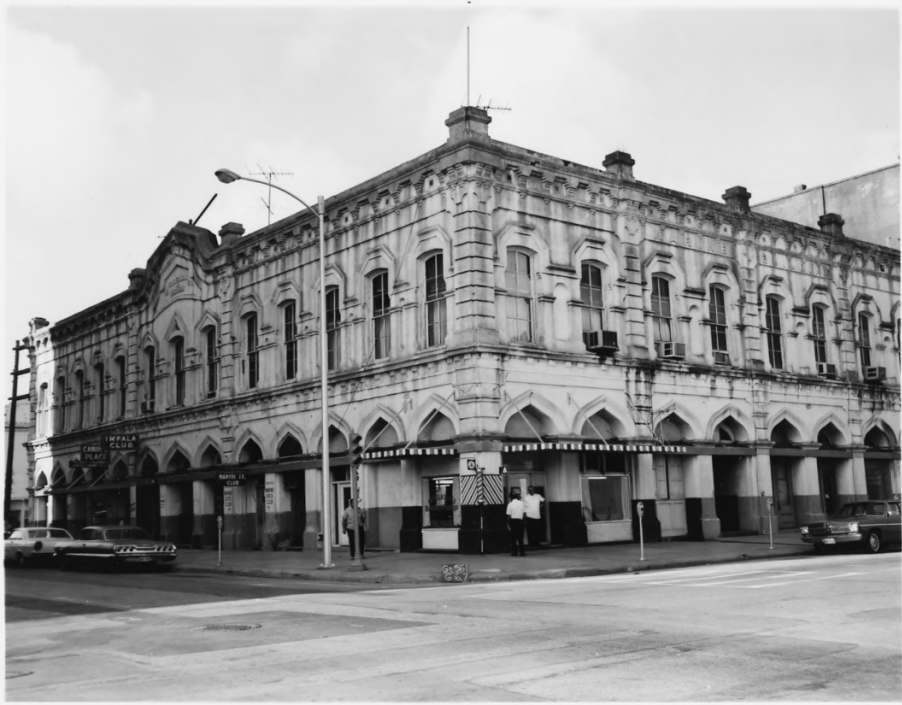
PROPERTY PHOTOGRAPH FORM GaG 561

DESCRIBE VIEW, DIRECTION, ETC. Front and side facades--Northeast elevation of a Victorian style two story stucco covered brick building. The first floor openings form an arcade with ogee or "Moorish" arches. A central pavilion is created with rusticated pilasters and slightly raised cornice. Segmental arched second floor windows are emphasized by an ornamental string course. The names "Suderman & Dolson" and date 1904 inscribed above main entrance.
