KENTUCKY HISTORIC RESOURCES  
Individual Inventory Form

Resource # 81  
Shelby County

1. Name of Resource:  
Thomas Weakley House

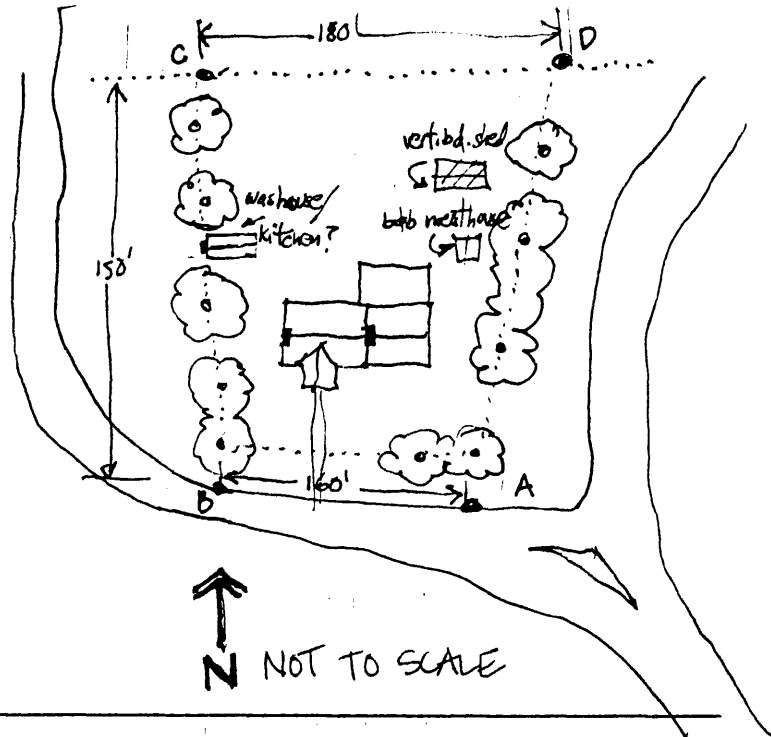
44. Site Plan (and boundary description and justification for N.R. sites):

Beginning at a point of intersection of two treelines in the southeastern corner of the yard that is 56 feet south/southeast of the southeastern corner of the house (A), 160 feet westward along southern treeline to intersection with another treeline (B), 150 feet northward along western treeline to intersection with another treeline (C); 180 feet eastward along line of yard/field boundary to treeline (D); 160 feet south/southwestward to point of origin.

The boundaries were chosen to encompass the house and its domestic-related outbuildings.

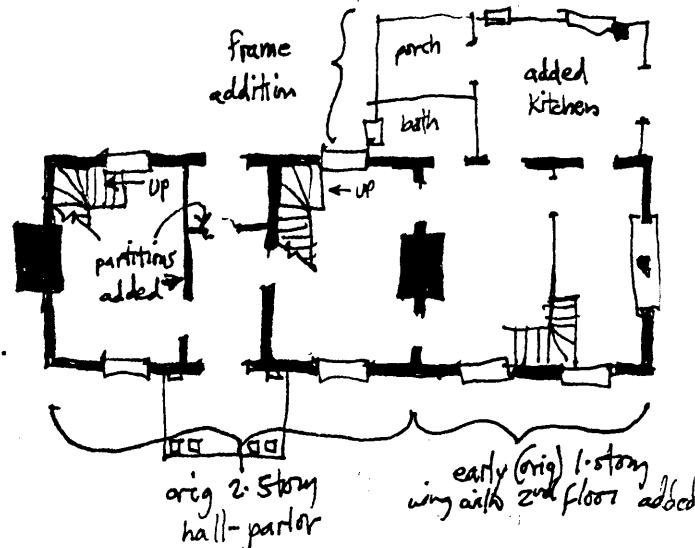
45. Description and House Plan:

Exterior: 2-story, 3-bay brick hall-parlor plan, original 1-story, 2-bay wing, wing raised to 2 stories later in 19th century, original 6/6 sash, Flemish bond principal facade(south), exterior end chimneys, gabled roof, coursed stone foundation, box cornice, eared surrounds added to central doors possibly at same time porch added and wing enlarged, segmental arched windows cut into east end wall probably at same time, shed-roofed frame kitchen with enclosed porch added to rear of wing may also be late 19th century. 2nd fl. door added w/ center passage inside to achieve form of typical mid-century Greek Revival center passage house.  
Interior: Hall-parlor plan altered on first floor to center passage by addition of frame partition to west of front door, all federal woodwork intact throughout the house including panelled

wainscot in both hall (west room) and parlor (east room), pin rails in both hall and wing, panelled door and window jambs, six-panel federal doors, second floor west room has federal mantel, chairrail, beaded baseboard, original railing from enclosed stairs in northwest corner, second floor east room has federal mantel, chairrail, and baseboard, enclosed stairs from northwest corner of parlor, graining visible on back of door of stairs, enclosed stairs in southwest corner of east room of ell open into west room; alterations include third quarter 19th century partition froming center passage, door in center bay of second floor; kitchen probably late 19th century, enclosed section at rear of passage is 20th century.
