KENTUCKY HISTORIC RESOURCES INVENTORY

Site No. Ni-85

1. Historic Name(s) <u>John Henry Thompson House</u>		22. ADD/County <u>Bluegrass / Nicholas</u>	
Original Owner <u>John Henry Thompson</u>		23. U.S.G.S. Quadrant (15'/75') <u>Millersburg v.c.</u> G.I.S. Mod.

STONE HOUSE SURVEY
BOUNDARY INFORMATION FORM

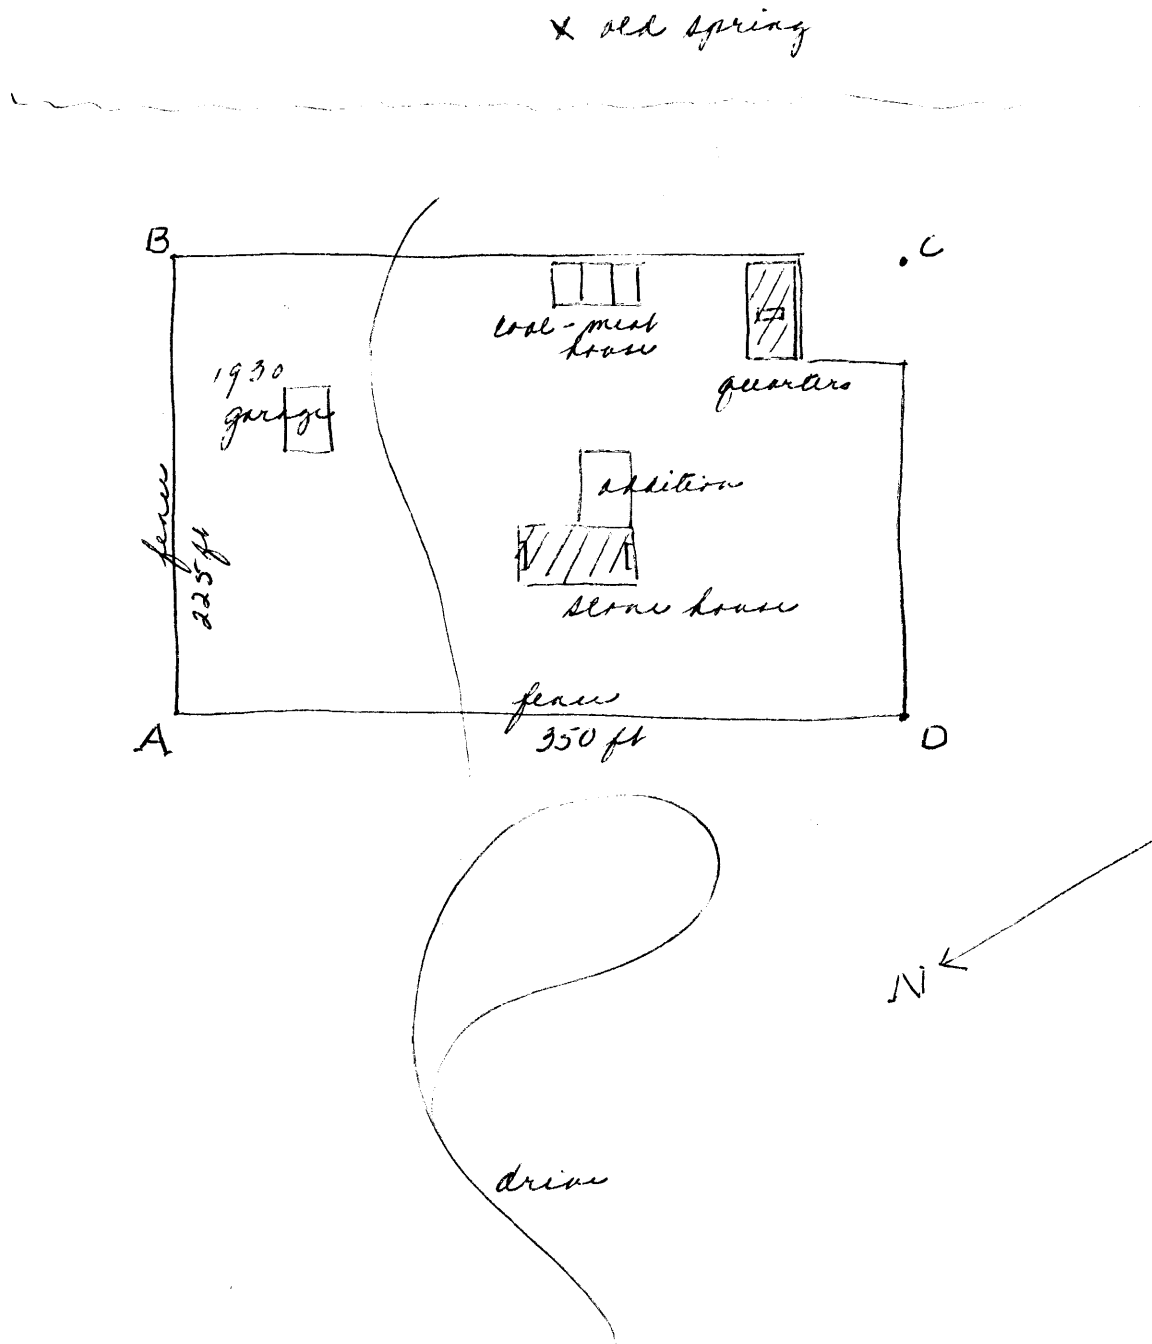
SKETCH MAP OF SITE SHOWING BOUNDARIES AND KEY BUILDINGS AND FEATURES WITH NORTH ARROW.

Beginning at A in the N corner of the yard, thence with fence SE 225 ft, SW 350 ft, NW 225 ft, and NE 350 ft to the beginning containing the stone house, frame quarters, pool, meat house and stone garage, about 1.8 acre. The barns outside the yard are later.
