NATIONAL REGISTER OF HISTORIC PLACES
REGISTRATION FORM

historic name: Beckman, Oscar and Christina, Farmstead

other name/site number: Beckman, Milo and Emma, Farmstead / 000758

Name of related multiple property listing: New Sweden and Riverview
Farmsteads and Institutional Buildings, 1894-1941

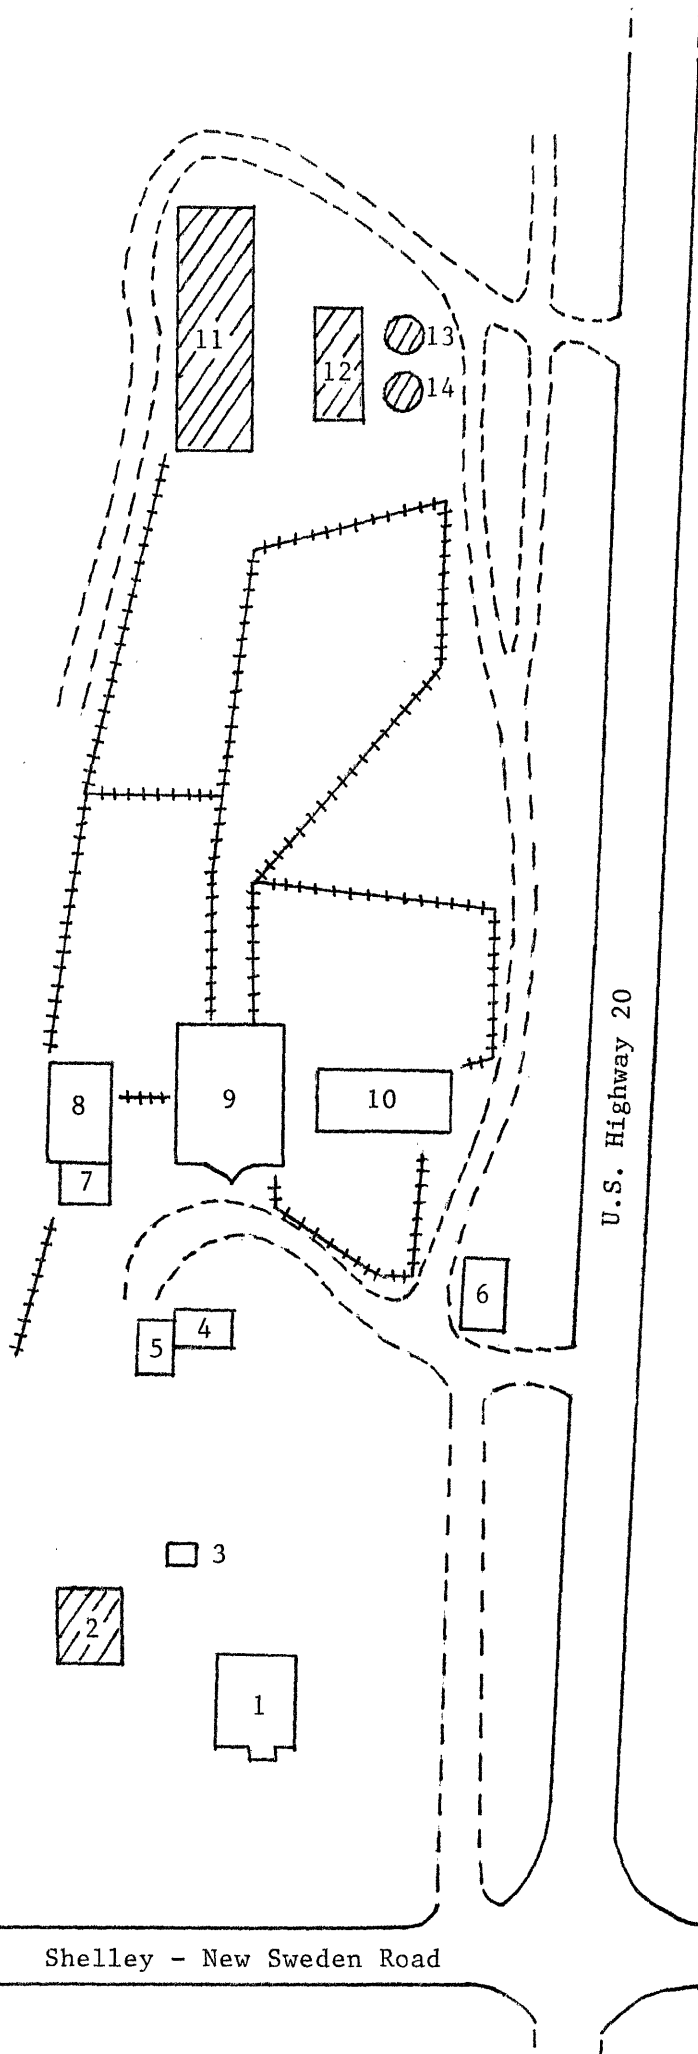
BECKMAN, OSCAR AND
CHRISTINA, FARMSTEAD

The Oscar and Christina Beckman Farmstead is located at the corner of two section-line roads, the Shelley-New Sweden Road and U.S. Highway 20. The farmstead parallels Highway 20 in an elongated layout. The farmstead plan is a scattered one in which there are three groupings of buildings. From east to west, the groupings include a domestic group, a group of old outbuildings, and a group of new outbuildings. The first grouping is domestic and includes two houses and a washhouse/bunkhouse (buildings 1, 2, and 3). In this grouping, building 1 replaced an earlier house that occupied close to the same place, and building 2 is a modern addition to the grouping. Access to the domestic part of the farmstead is via a lane off of the Shelley-New Sweden Road.

The second group of buildings is separated from the domestic grouping by a space of several yards and is visually separated by the distinction between the landscaped yard around the houses and the hardpacked earth of the farmyard. The second grouping consists of contributory outbuildings (buildings 4-10) arranged in a vague courtyard plan but with few of the buildings actually contiguous. Most of the outbuildings functioned for animal shelter and feeding or for machinery storage and maintenance. This grouping represents the farmyard as it gradually accumulated buildings during the period ca. 1896 to 1930. Lost from the assemblage were several pre-1900s straw sheds, that is outbuildings with balloon frame construction and roofs of pole rafters and straw and dirt roofing. The primary access to the farmyard is via a lane off of U.S. Highway 20.

The third grouping consists of new outbuildings (buildings 11-14) set several yards west of the older grouping and separated from the older grouping by corrals. The buildings in this grouping function for crop and feed storage. Lost from this assemblage of buildings is a machine shed built in the World War II period. The primary access to this area of new outbuildings is via a lane off of U.S. Highway 20.
