United States Department of the Interior
National Park Service
National Register of Historic Places
Registration Form

historic name Heister House

other names/site number 5CF.2366

street & number 102 Poncha Boulevard [N/A] not for publication

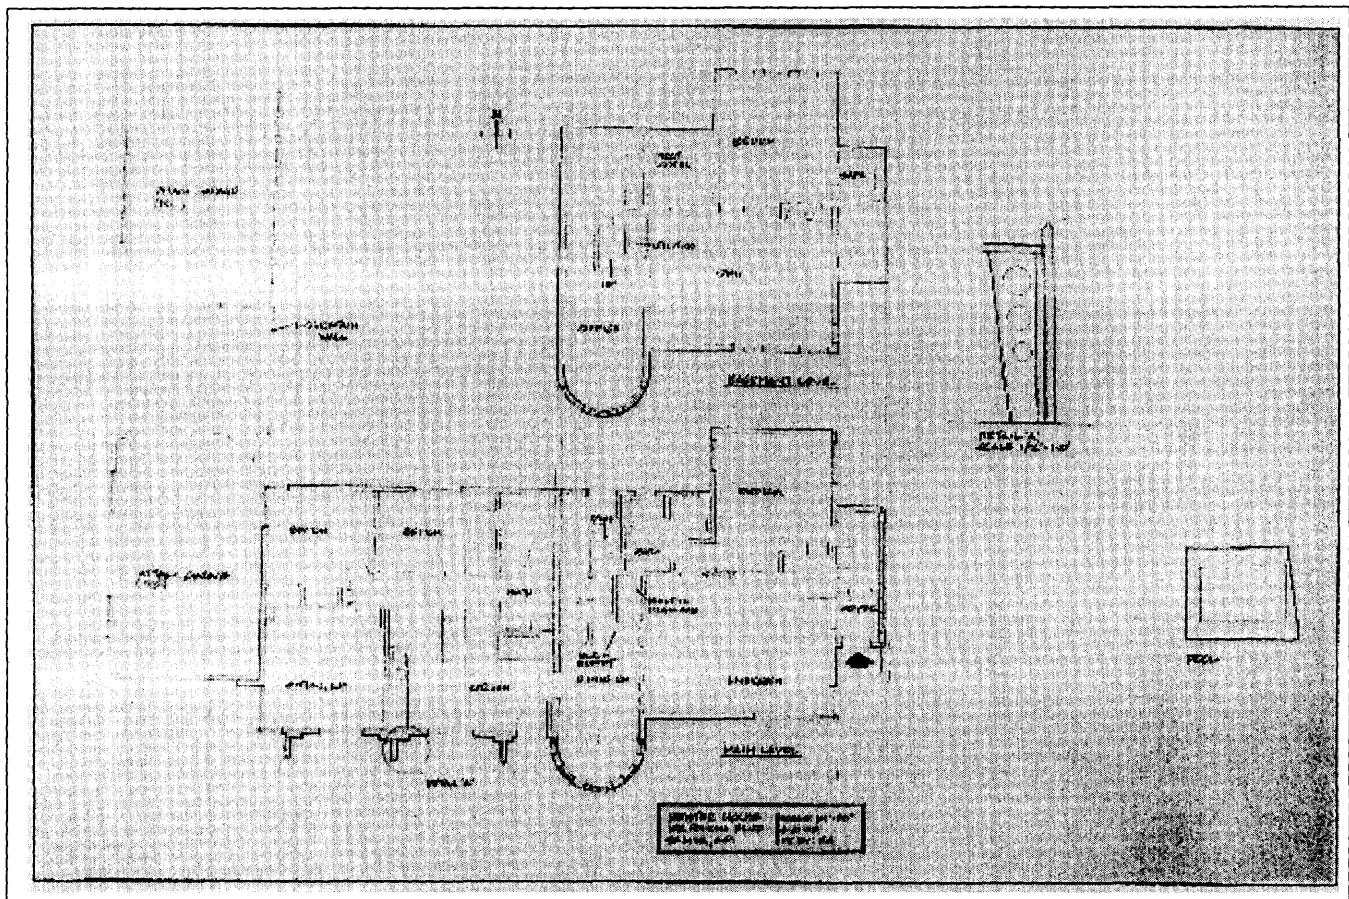
Floor Plan

The 1943-1954 Moderne style Heister House is an irregular plan, one story, brick and concrete block house covered with stucco that sits on a poured concrete foundation. A full basement exists under the east side. The roof of the house is flat and covered with metal sheets while the attached garage has a flat rolled asphalt roof. Two chimneys extend from the flat roof: a brick chimney covered in stucco at the west end and a brick chimney with a curved metal hood at the east end. Constructed in Salida, Colorado, starting in 1943, the house sits on a corner lot in the Eddy Brothers Addition at the intersection of Poncha Boulevard and Park Place, adjacent to Thonhoff Park. The Chaffee County Courthouse, a National Register-listed Art Deco building completed in 1932, is located on the north side of the park.

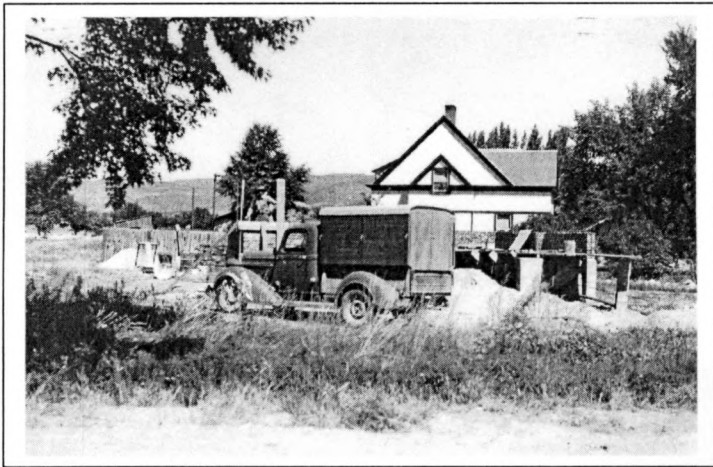
Photo H1- South facade, brick structure seen at west end. Date unknown.

| <u>Photo No.</u> | <u>Photographic Information</u> |
|---|--|
| H1 | South facade, brick structure seen at west end. Date unknown. |

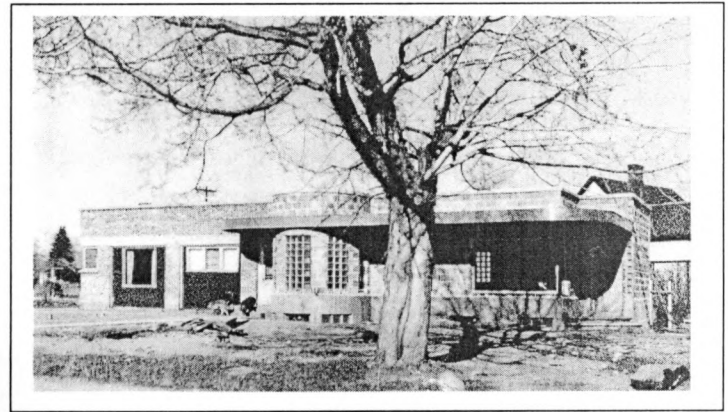
Photo H2- South elevation, brick & block structure waiting for stucco. Window in brick section yet to be placed. Date Unknown.

| <u>Photo No.</u> | <u>Photographic Information</u> |
|---|--|
| H2 | South elevation, brick & block structure waiting for stucco. Window in brick section yet to be placed. Date Unknown. |

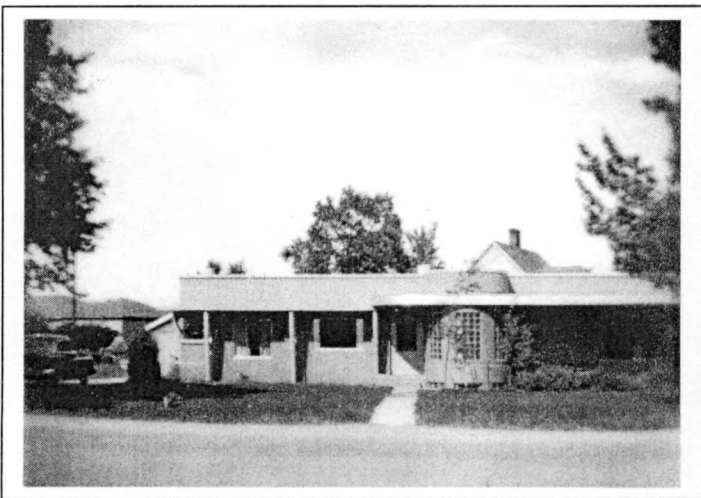
Photo H3- House in 1954. Interior yet to be completed.

| <u>Photo No.</u> | <u>Photographic Information</u> |
|---|--|
| H3 | House in 1954. Interior yet to be completed. |

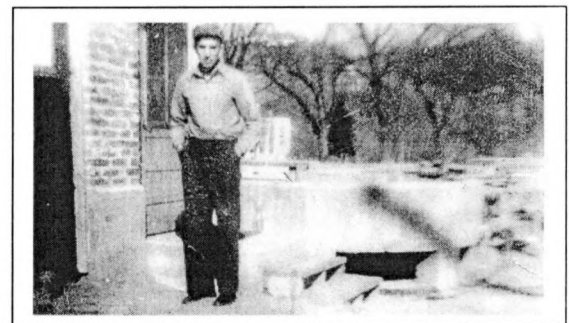
Photo H4- Elwood Heister at south secondary entry- basement started. Date unknown, probably 1942-43.

| <u>Photo No.</u> | <u>Photographic Information</u> |
|---|--|
| H4 | Elwood Heister at south secondary entry- basement started. Date unknown, probably 1942-43. |
