### National Register of Historic Places Registration Form

historic name Entrance Station  
other names/site number Entrance Checking Station; Checking Station

Entrance Station  
Crook County, WY  
Devils Tower National Monument  
Multiple Property Submission

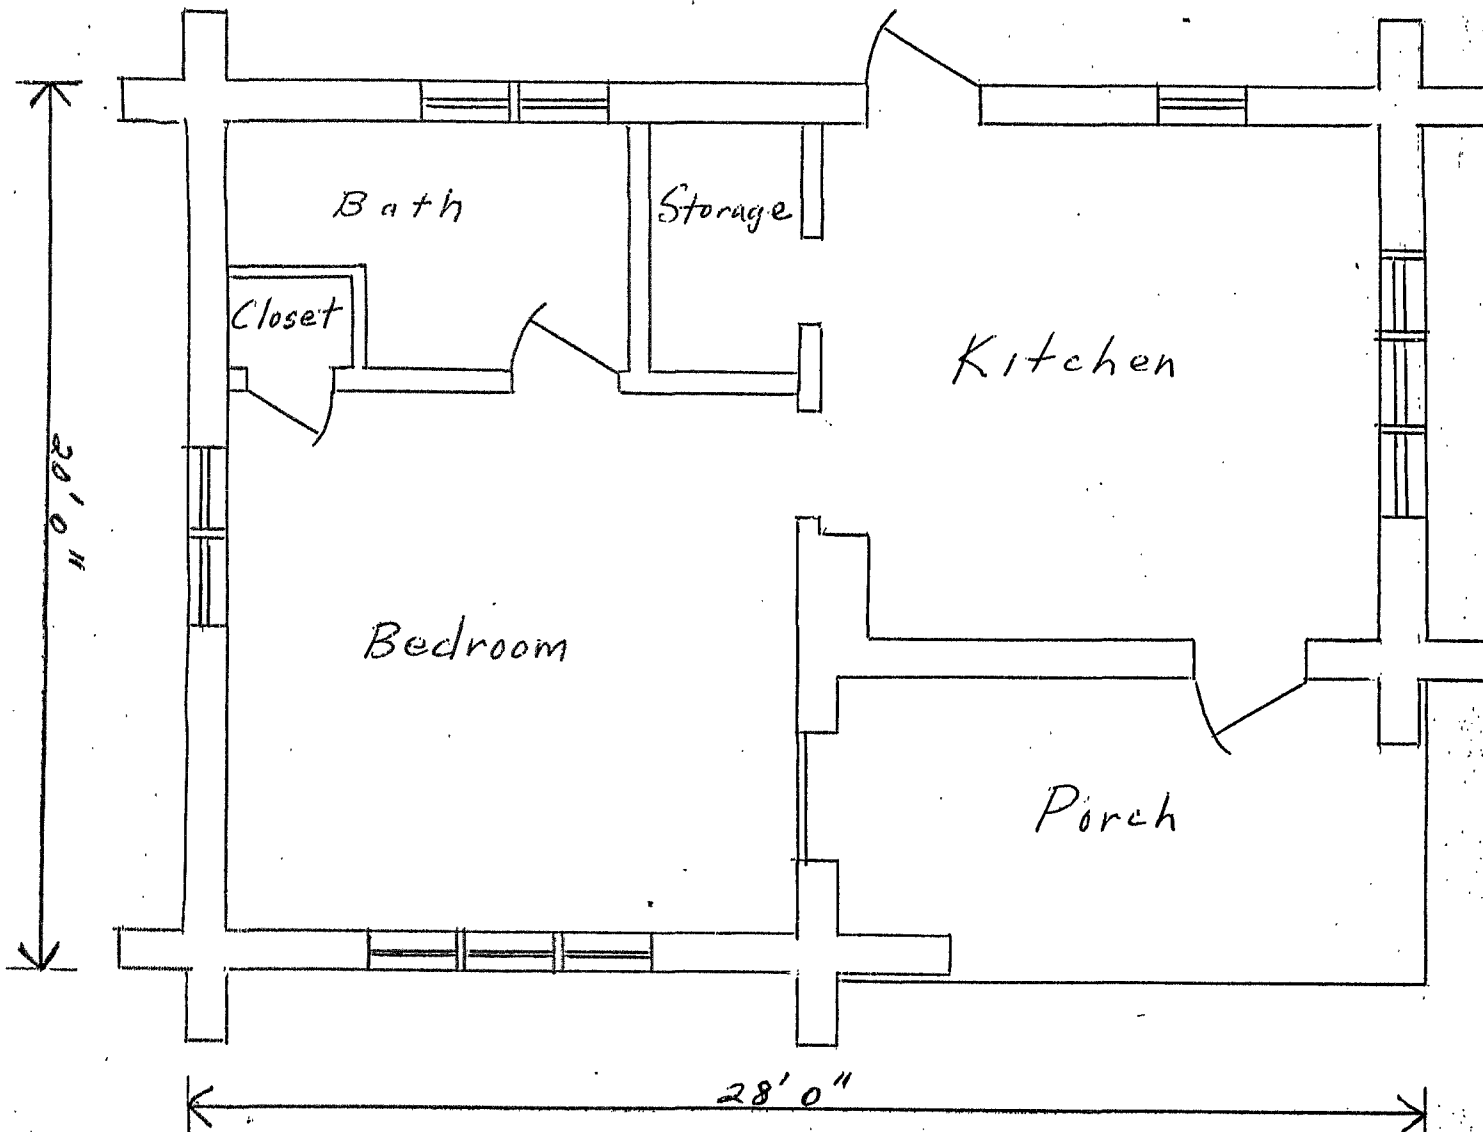
FLOOR PLAN  
BLDG NO. 4  
ENTRANCE CHECKING STATION  
Devils Tower National Monument

Scale: 1/4" = 1'-0"

As late as 1998, the interior retained some original features and its original floor plan. The layout consisted of a bathroom, bedroom, and small living area that had a small kitchen with built-in wood cabinets. (Other original built-ins were bunk beds and a table, but these were removed at an unknown date.) Interior walls and ceilings were fiberboard with 3-inch fiberboard battens. Floors were varnished 1/2-inch hardwood in the living room and rolled linoleum in the bathroom. While the bathroom had an old sink, it also had a non-historic toilet and metal shower stall. The living/kitchen area floor was linoleum tile over fir. The bedroom and living/kitchen area each retained a historic metal ceiling light fixture, missing original globes. Exposed electrical metal conduit was added to the interior some time after construction.

Floor Plan: photocopied and appended to nomination  
from Intermountain Region files, Denver Support Office (undated)

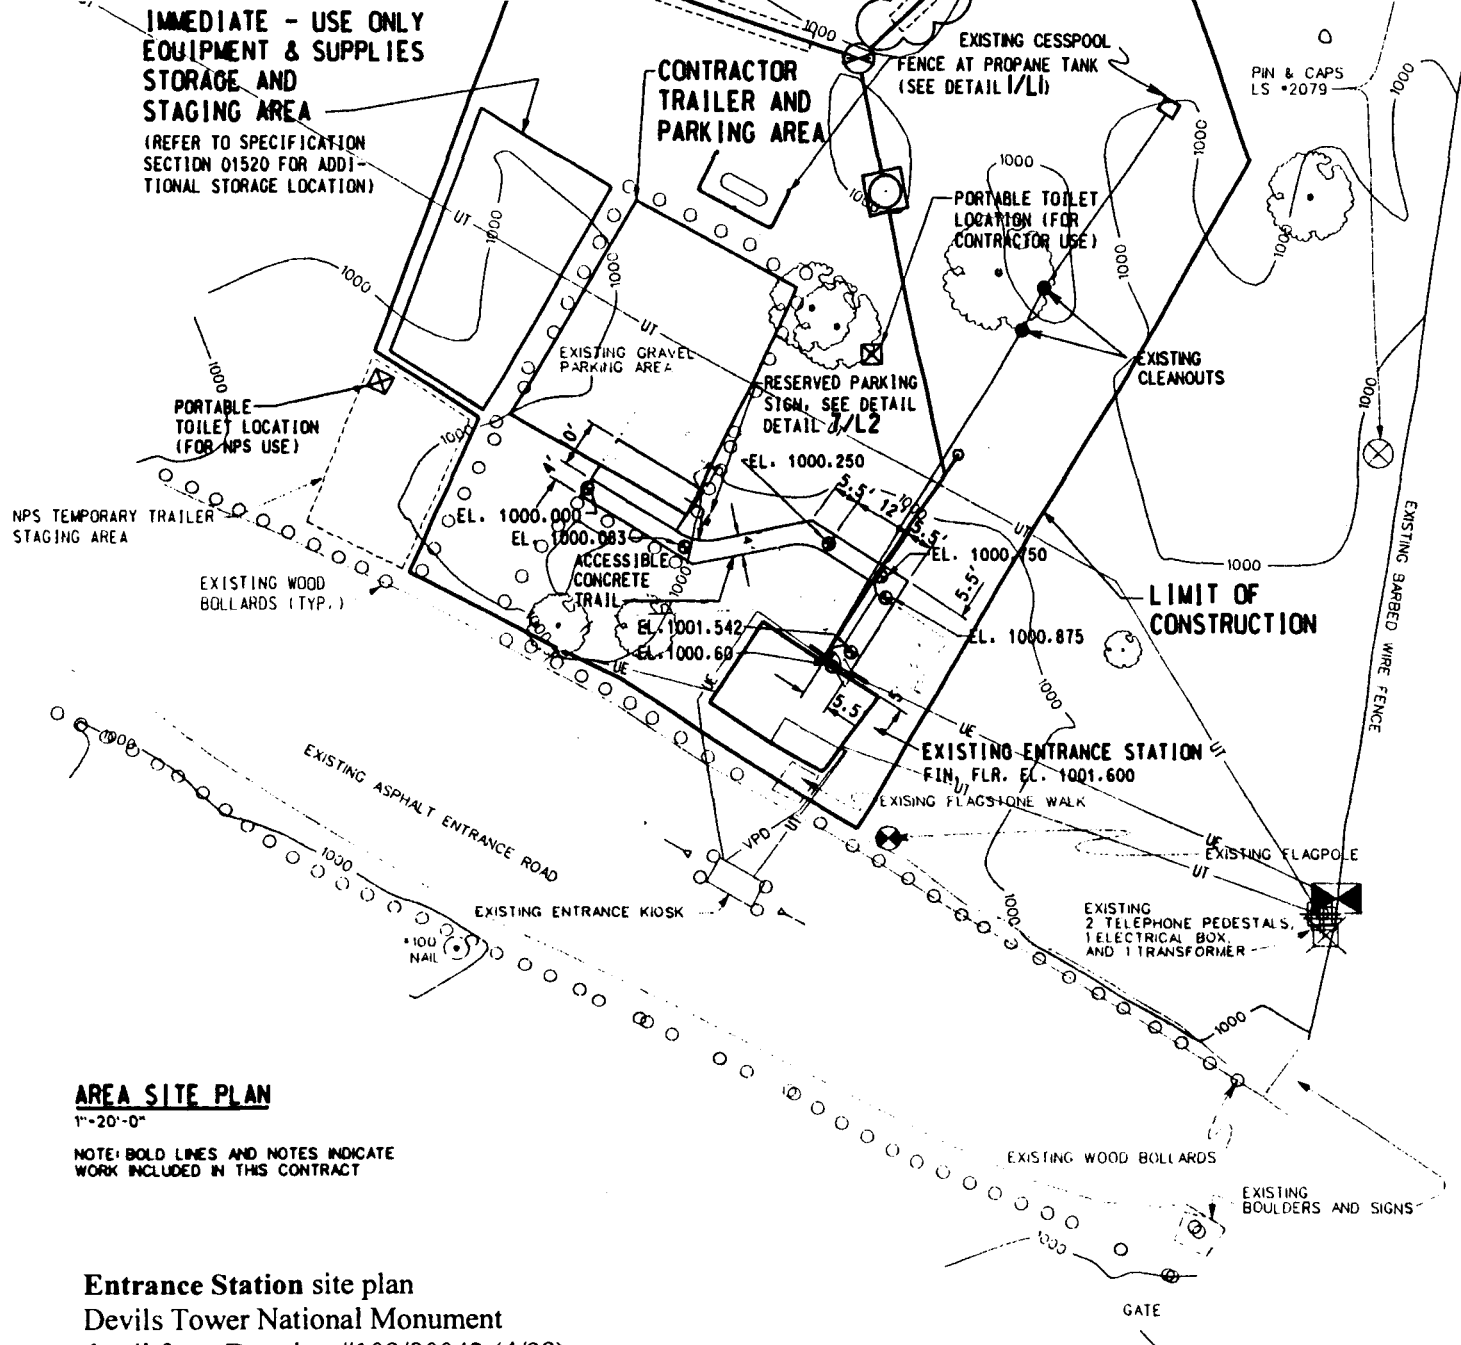
**Entrance Station site plan  
Devils Tower National Monument  
detail from Drawing #109/80042 (4/99)**

**AREA SITE PLAN**

NOTE: BOLD LINES AND NOTES INDICATE WORK INCLUDED IN THIS CONTRACT

In 1999 a number of changes to the entrance station's immediate setting occurred, all relatively minor and confined to the rear (northwest and north) of the building. To provide accessibility, a four-foot wide concrete path was constructed from the parking area to the entrance station's back door. Installation of the access ramp to this door required removal of original flagstone pavers and replacement with a concrete landing. Minor modifications were also made to the original door and its frame to accommodate the changes. Also that year, in connection with interior rehabilitation (described later), a 500-gallon liquid propane tank was installed approximately 80 feet northwest of the entrance station, north of the graveled parking area. A solid wood fence screens the tank. A small air conditioner unit was located behind the entrance station at its northwest corner. Because all these changes are located to the rear of the building, the impact to the historic setting is minimal, particularly when viewed while approaching or entering the monument. (See map detail of the entrance station site plan, appended as additional documentation.)
