National Register of Historic Places  
Registration Form

historic name Montgomery, T. Harlan & Helen, House

street & number 628 N. Poplar Street

Section number 7 Page 1 *Montgomery, T. Harlan & Helen, House, Jackson County, IN*

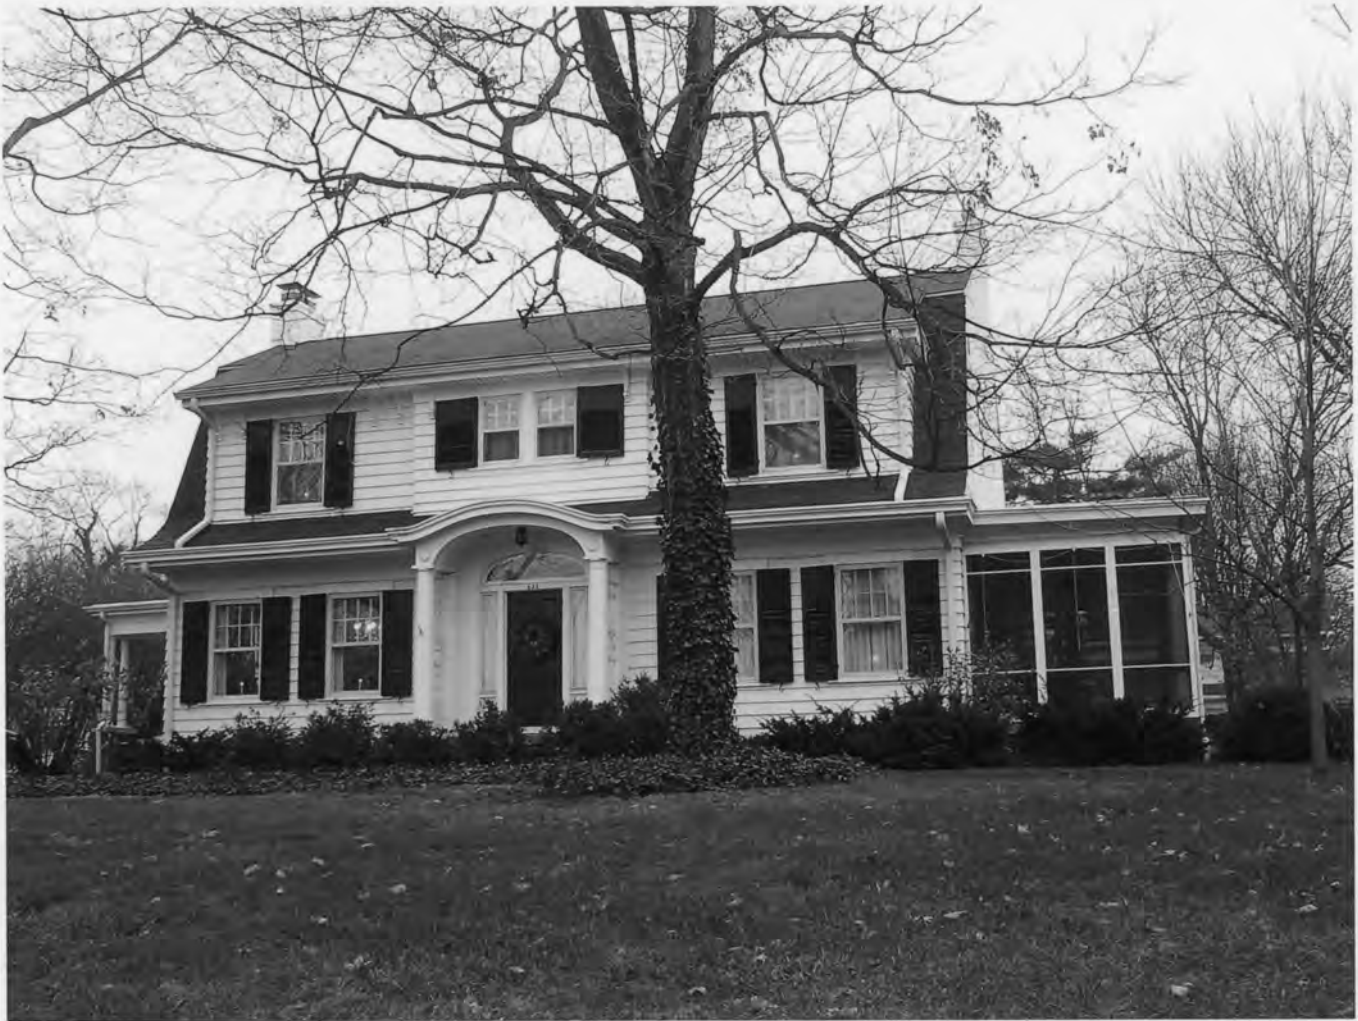
T. Harlan and Helen Montgomery House, Jackson Co., IN #1

**West Elevation (Photo 1)**

The west elevation is the front or primary elevation facing Poplar Street. On this elevation, the home's main mass is symmetrical with a screened porch visible on the south end and a porte-cochere visible on the east (both to be fully described in their respective elevations). The gambrel roof extends down to the first floor level with deep eaves. These eaves are accented with dentiled molding. On this elevation, a single, shed-roof dormer spans the width of the main mass of the home. The dormer eaves are supported by curved knee braces.

A brick walk and steps lead to a brick and concrete portico. The portico has an elliptical, shallow arched roof. The portico roof is supported by two columns and two pilasters. The pilasters and columns are of the Tuscan order. The entry is a six-paneled door with single-pane sidelights. A multi-pane fanlight spans the width of the door and sidelights. Its arched shape follows the curve of the portico roof and ceiling. The entry is flanked by two windows on each side. Each window is a double-hung, 8/1 pane configuration. Each is framed by operable shutters.

Above the portico roofline, the flat plane of the 2<sup>nd</sup> floor dormer is broken as the façade projects slightly out. Two smaller window openings with a 6/1 configuration are centered in this section. Each has operable shutters. On either side of this centered section, a single window opening is centered above the 1<sup>st</sup> floor windows. Each is an 8/1 configuration with operable shutters.

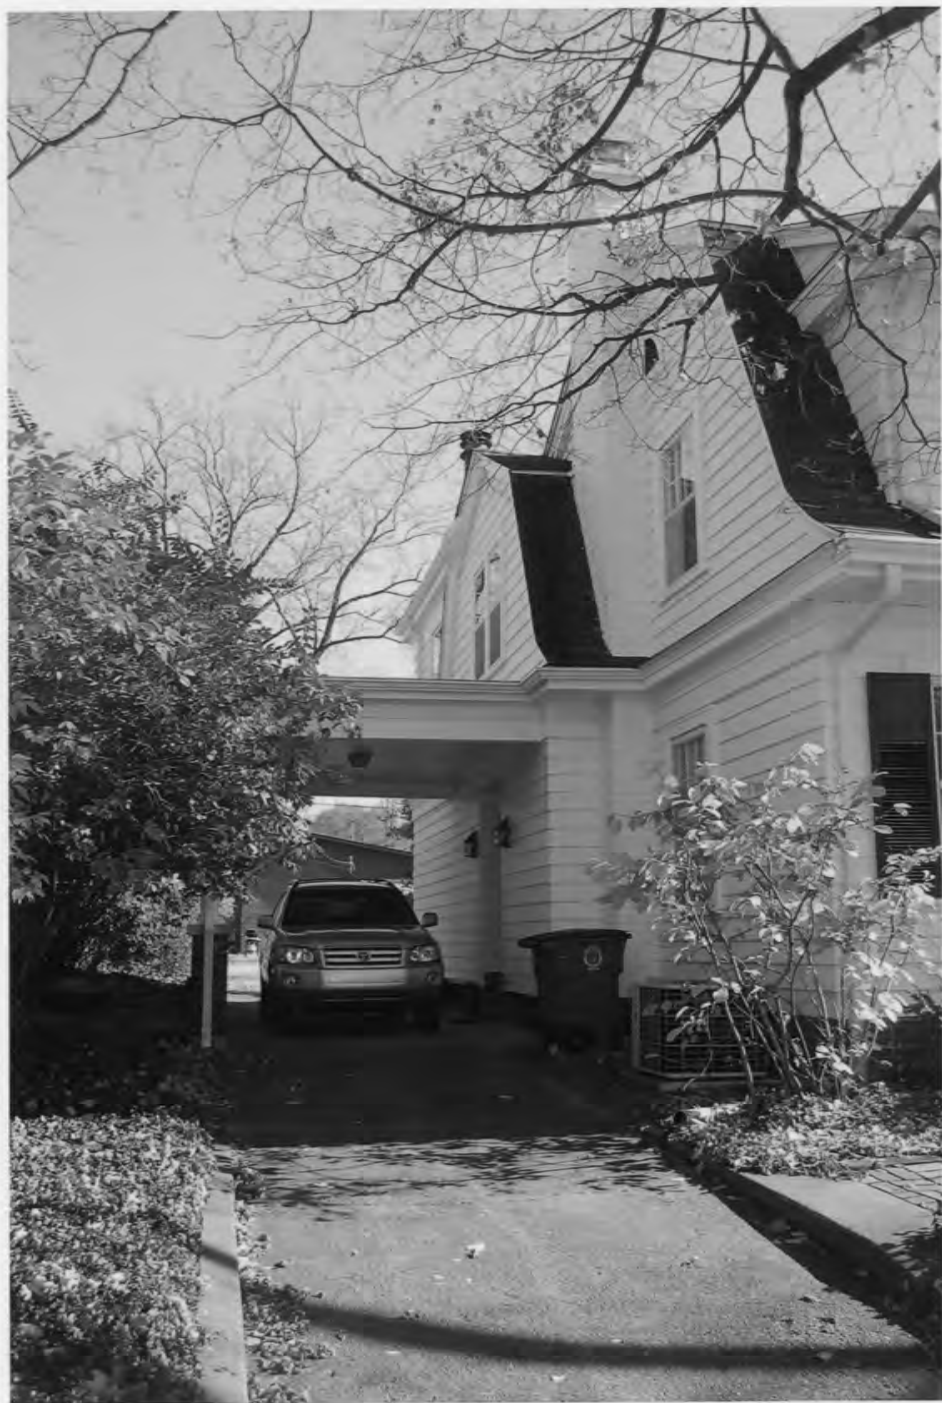
T. Harlan and Helen Montgomery House, Jackson Co., IN #2

**North Elevation (Photos 2 and 3)**

The home's north elevation is comprised of several sections and has been altered twice since the original home's construction. The gable end is prominent with shallow eaves and features a chimney running through the gable peak. On the east side of the chimney, single, 8/1 windows are located on the 1<sup>st</sup> and 2<sup>nd</sup> floor with a ¼ fanlight window in the upper peak. Dentil trim from the west elevation continues along this elevation.

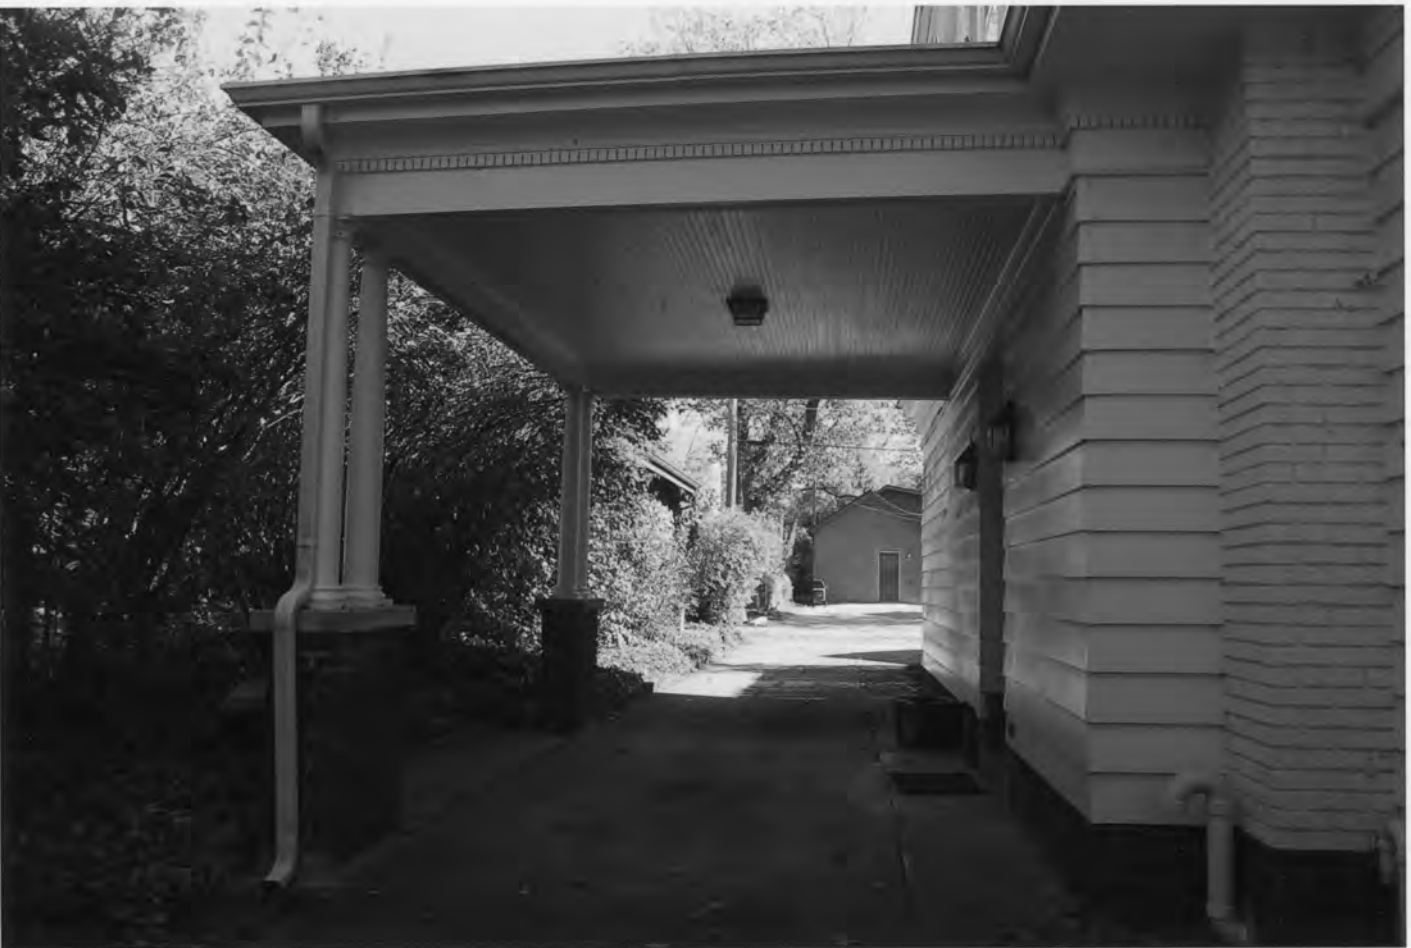
T. Harlan and Helen Montgomery House, Jackson Co., IN #3

A secondary gambrel extends out from the main mass of the home, east of and slightly lower than the primary gambrel. A porte-cochere with a flat roof is attached to the elevation along this secondary gable (Photo 3). The

porte-cochere is supported on the opposite end by pairs of smooth round columns resting on tall brick piers. The ceiling of the porte-cochere is beadboard. A single pendant light is centered within the ceiling.

Beneath the porte-cochere and recessed within the secondary gable is a side entrance to the home. The door was recessed by the current owners to improve functionality when cars are parked under the porte-cochere. Red brick steps lead to the recessed door. A modern aluminum storm door was installed with an aluminum entry door. The entry door has recessed panels in the lower half with a glass pane mimicking nine panes in the upper half. Coach lamps highlight the opening. A pair of window openings is centered on the 2<sup>nd</sup> floor above the roofline.

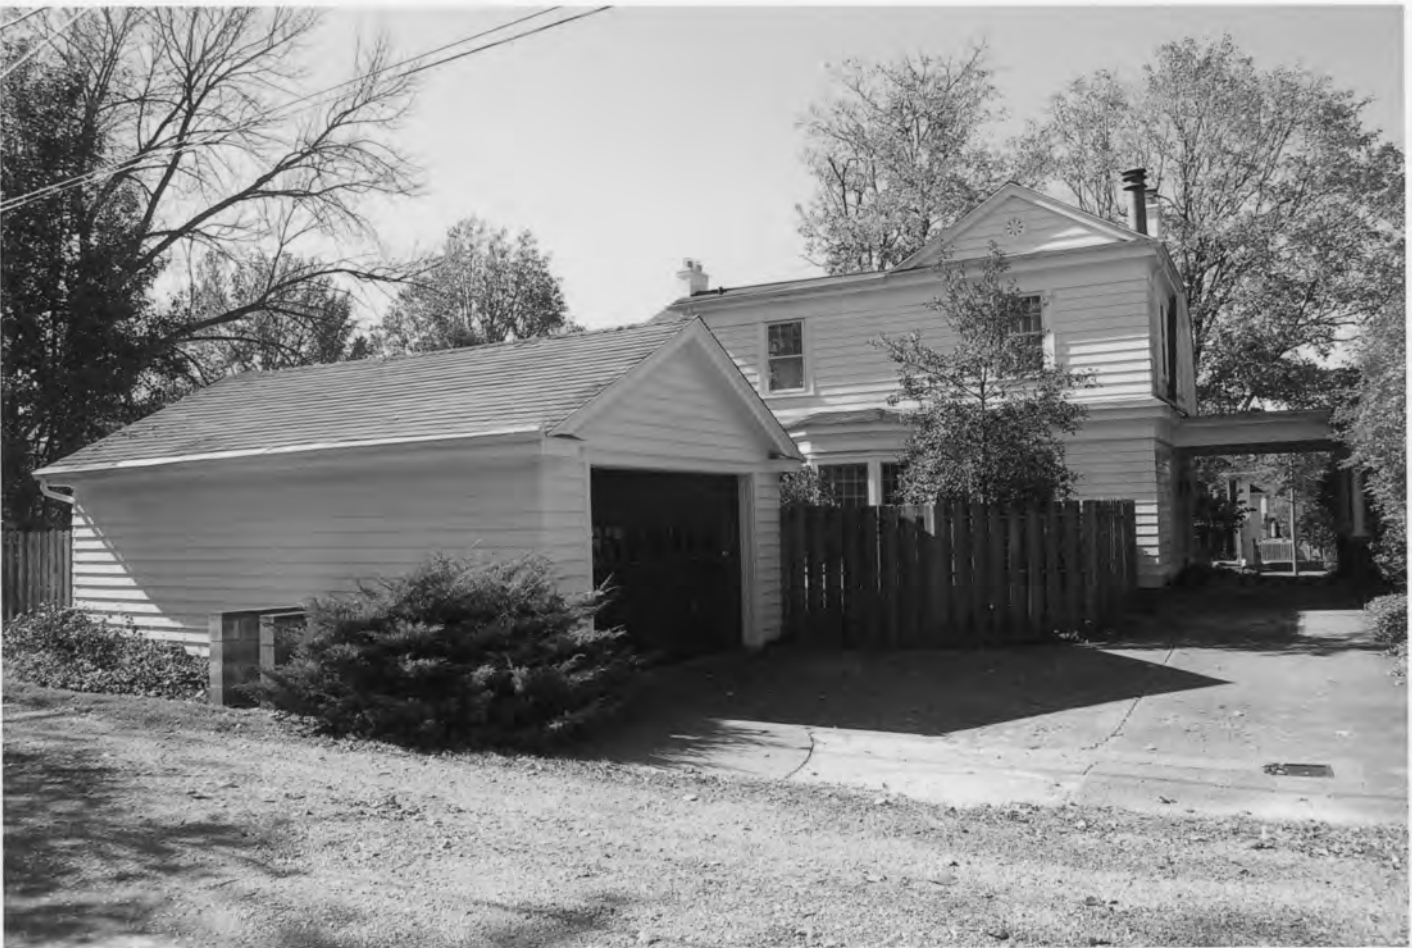
T. Harlan and Helen Montgomery House, Jackson Co., IN #4

**East Elevation** (Photos 4 and 5)

The east (rear) elevation has two primary sections in an L-shaped layout. The left side is the rear of the main mass of the home. It features a single window opening, 8/1 pane configuration centered on the 1<sup>st</sup> floor and a 4/1 window opening, off-center on the 2<sup>nd</sup> floor. Like the west elevation, the gambrel roofline forms a cornice band between the 1<sup>st</sup> and 2<sup>nd</sup> floors.

A small entry overhang is located within the "L" plan. The cornice-like banding continues along the overhang. The portico floor, foundation and steps are brick, like those used at the north side entrance.

**Garage** (Photos 4 and 7)

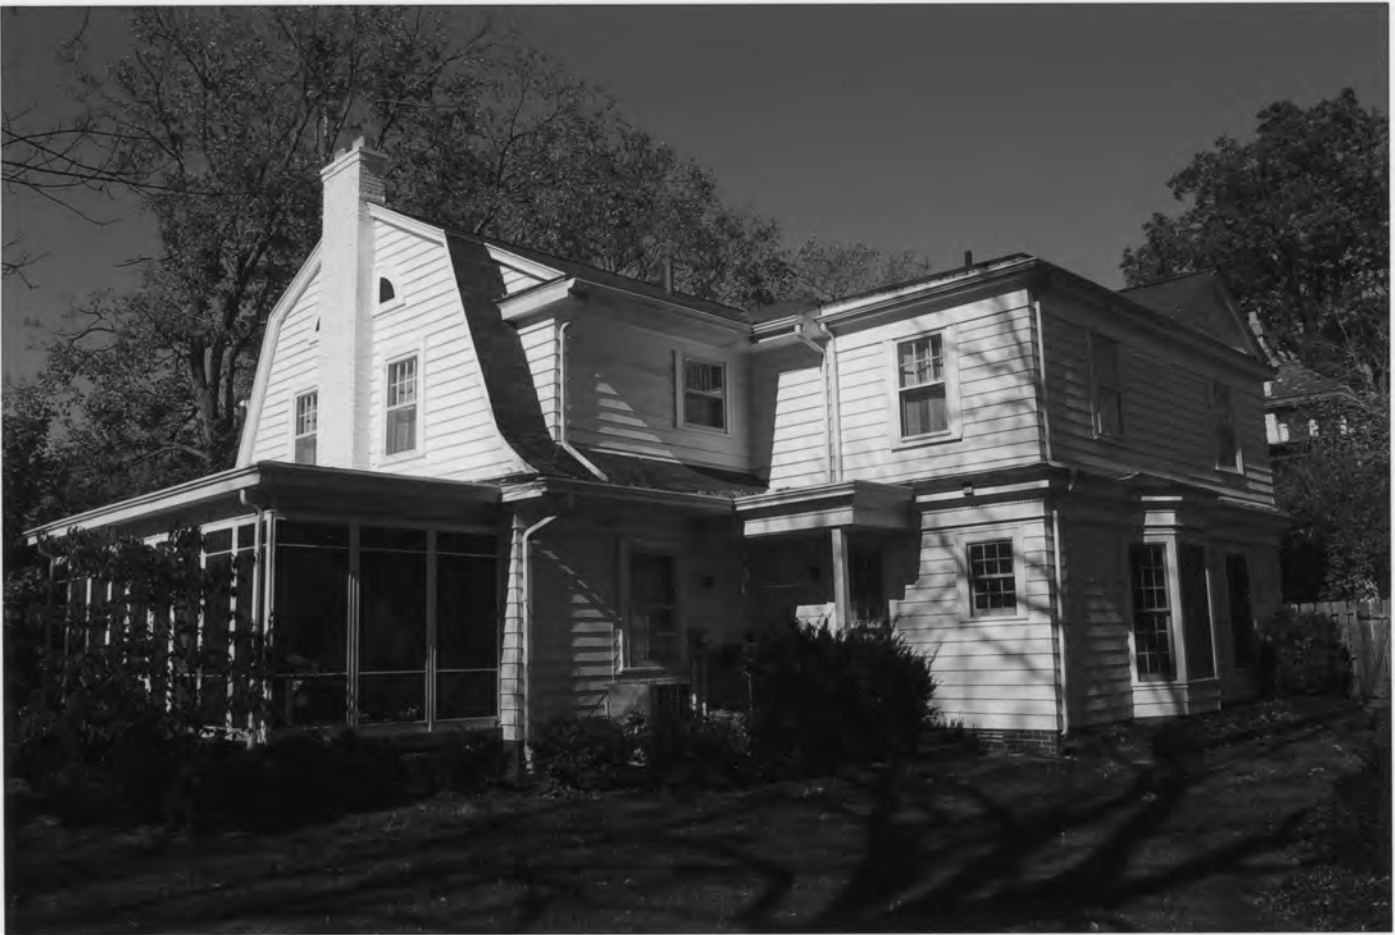
T. Harlan and Helen Montgomery House, Jackson Co., IN #5

The rear elevation continues with a 90-degree turn to the home's rear ell. The ell has a very shallow pitch, almost invisible from the ground level. The south-facing section of the ell has two openings on the 1<sup>st</sup> floor, an exterior door that opens onto the previously described portico and an 8/1 window opening. On the 2<sup>nd</sup> floor, a 6/1 window opening is off-center in this section. Although the gambrel roofline is absent, the deep cornice banding continues along this section.

An ornamental gable is positioned near the home's northwest corner on the rear ell. On the 1<sup>st</sup> floor, the flat plane of the elevation is broken by a 3-sided bay window with 12/12 and 9/9 window openings. North of the bay window is a 12/12 window opening. The bay and this window are modern alterations by the home's current owners. On the 2<sup>nd</sup> floor, two windows with 6/1 and 8/1 pane configurations are evenly spaced along the elevation. The cornice banding with dentil molding continues across this elevation, including the bay window. The 2-story southeast corner with flat roof adjacent to the ornamental gable was added in 1978. This addition included a casual dining room on the 1<sup>st</sup> floor and an office/den on the 2<sup>nd</sup>.

**South Elevation** (Photos 5 and 6)

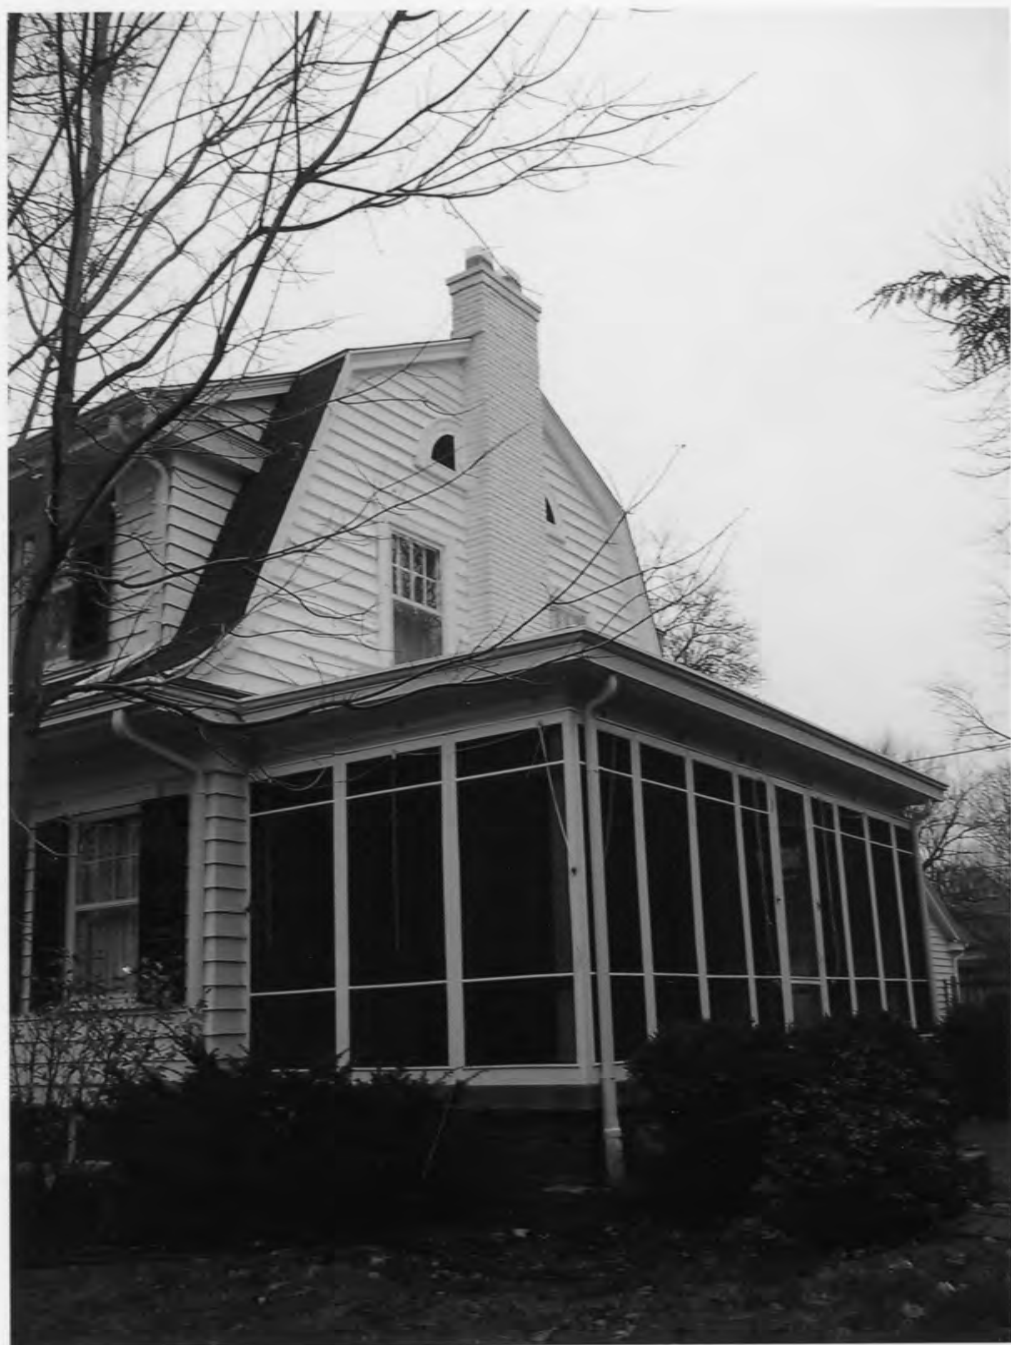
T. Harlan and Helen Montgomery House, Jackson Co., IN #6

A brick chimney located outside the exterior wall is centered on the south elevation. The chimney is painted white. On the 2<sup>nd</sup> floor, single window openings, 8/1, are located on either side of the chimney. Above these windows, ¼ fanlight windows provide light for the attic space.

On the 1<sup>st</sup> floor, a screened porch spans the entire width of this end of the home. Four columns along the outer wall and two pilasters at the home's exterior wall support the porch's flat roofline. These are also in the Tuscan order.

The porch has a flat roofline with deep eaves. The eaves are accented with dentiled molding. The porch is screened-in by removable, individual screens. The screens have wood frames and rest on brick knee walls on all three sides. A screened door is centered in the south elevation. The porch floor is tile; the ceiling is wood. Within the porch, a modern ceiling fan hangs in the middle of the ceiling. Within the screened porch, two pairs of French doors are evenly spaced on the home's exterior wall. Each door has 18 panes of glass.
