National Register of Historic Places Registration Form

Historic name: Oxford Downtown Historic District

Street & number: Washington Street/Michigan-24 and Burdick Street

City or town: Oxford State: MI County: Oakland

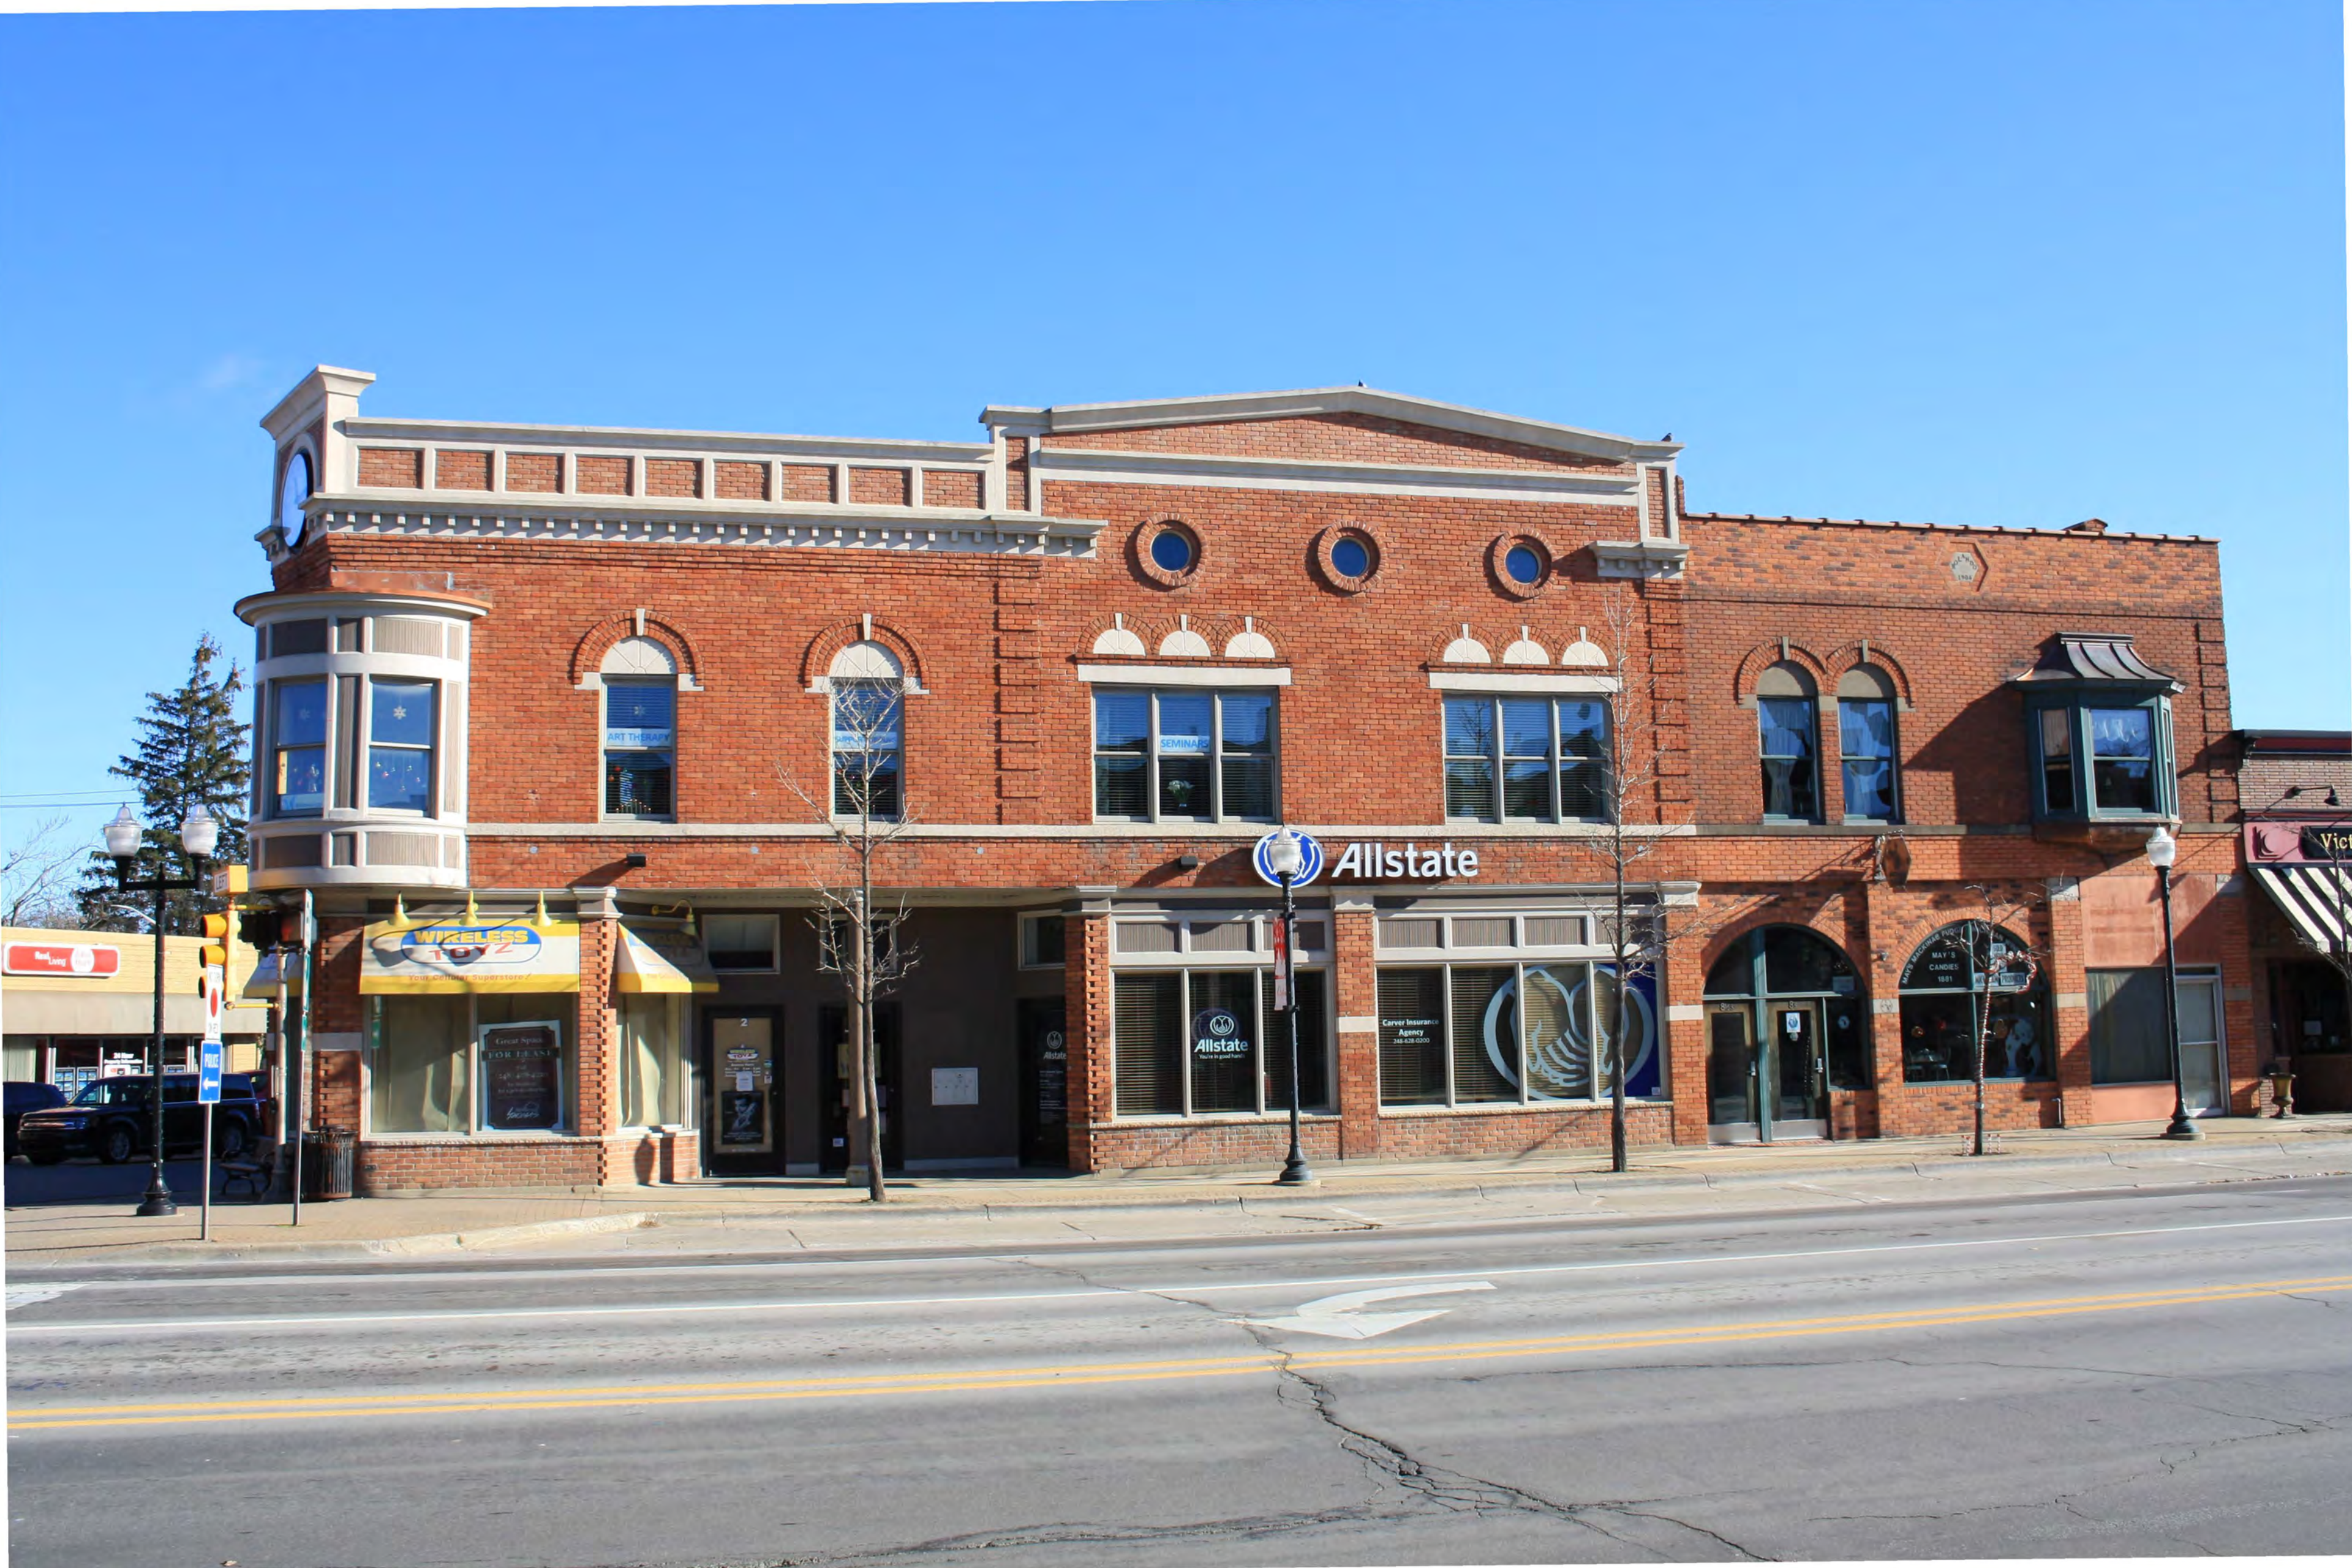
A three-story red brick building with a prominent corner bay window on the left. The second floor features several arched windows, some with signs for 'ART THERAPY' and 'SEMINARS'. The ground floor has a large 'Allstate' sign above the windows and a yellow awning for 'WIRELESS TOYS' on the left. A small arched window on the right side of the ground floor has a sign that reads 'MAY 5 CANDIES 1981'. The building has a decorative cornice with a row of three circular windows.
