KENTUCKY HISTORIC RESOURCES INVENTORY

Site No. Wd-136

1. Historic Name(s) <u>Benjamin Wilson House</u>		22. ADD/County <u>Blount / Woodford</u>	
Original Owner <u>Benjamin Wilson</u>		23. U.S.G.S. Quadrant (15'/75') <u>Versailles</u> G.I.S. Mod. <input type="checkbox"/>

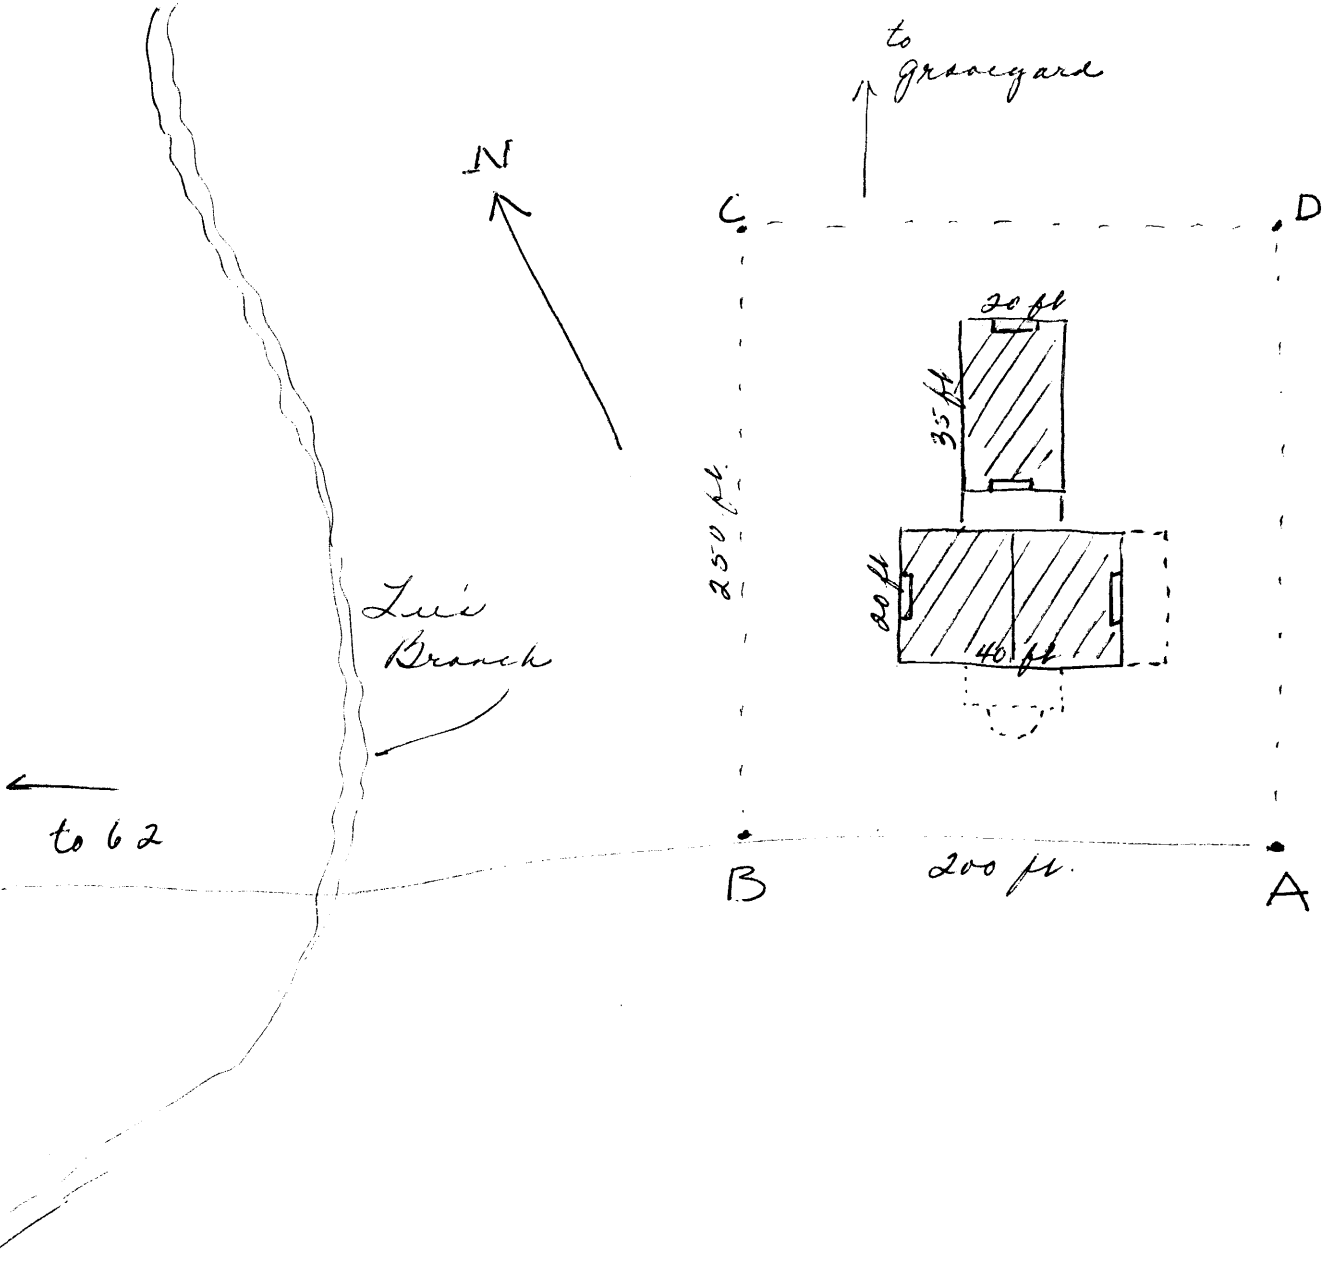
SKETCH MAP OF SITE SHOWING BOUNDARIES AND KEY BUILDINGS AND FEATURES WITH NORTH ARROW.

Beginning at A, S of the front of the house, thence parallel to the front of the house WNW 200 ft to B, thence at right angles NNE 250 ft to C, ESE 200 ft to D, and SSW 200 ft to the beginning, containing the stone house in the center; about 1 1/6 acre. No other buildings near site.
